Model: General (GW Models)		Date: 20-Dec-01	No.: RGene010
Subject: Series Print Mode		Prepared by: K. Misugi	
From: Technical Services Dept., GTS Division			
Classification:	<input checked="" type="checkbox"/> Troubleshooting	<input type="checkbox"/> Part information	<input type="checkbox"/> Action required
	<input type="checkbox"/> Mechanical	<input type="checkbox"/> Electrical	<input type="checkbox"/> Service manual revision
	<input type="checkbox"/> Paper path	<input type="checkbox"/> Transmit/receive	<input type="checkbox"/> Retrofit information
	<input type="checkbox"/> Other (      )

Model: Model U-P1		Date: 20-Dec-02	No.: RG071001
Subject: Image Skew		Prepared by: H.K.	
From: Technical Services sec. Service Planning Dept.			
Classification:	<input checked="" type="checkbox"/> Troubleshooting	<input type="checkbox"/> Part information	<input type="checkbox"/> Action required
	<input type="checkbox"/> Mechanical	<input type="checkbox"/> Electrical	<input type="checkbox"/> Service manual revision
	<input type="checkbox"/> Paper path	<input type="checkbox"/> Transmit/receive	<input type="checkbox"/> Retrofit information
	<input type="checkbox"/> Other (       )

Model: Model U-P

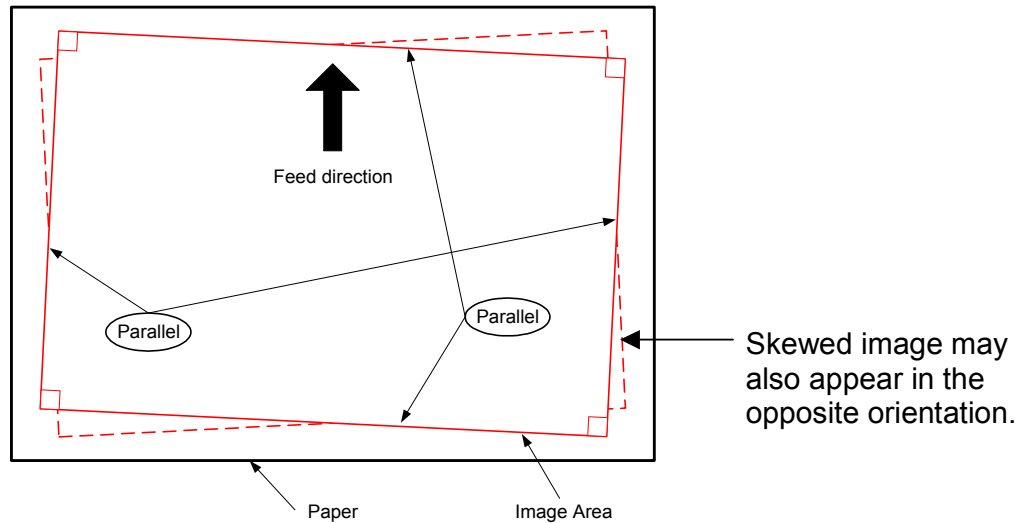
## 1.1 SKEWED IMAGES

- The image's leading and trailing edges are parallel to one another.
- The image's left and right edges are also parallel.
- However, **all four sides** are slanted with respect to the paper's edge.

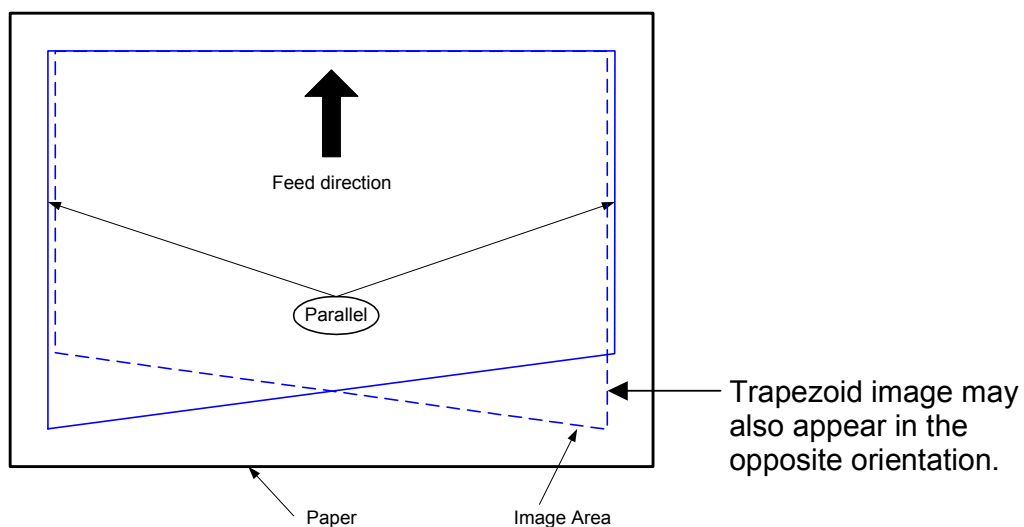
## 1.2 TRAPEZOID IMAGES

- Only the image's **trailing edge** is slanted with respect to the paper. The remaining 3 sides are parallel to the paper's edges.

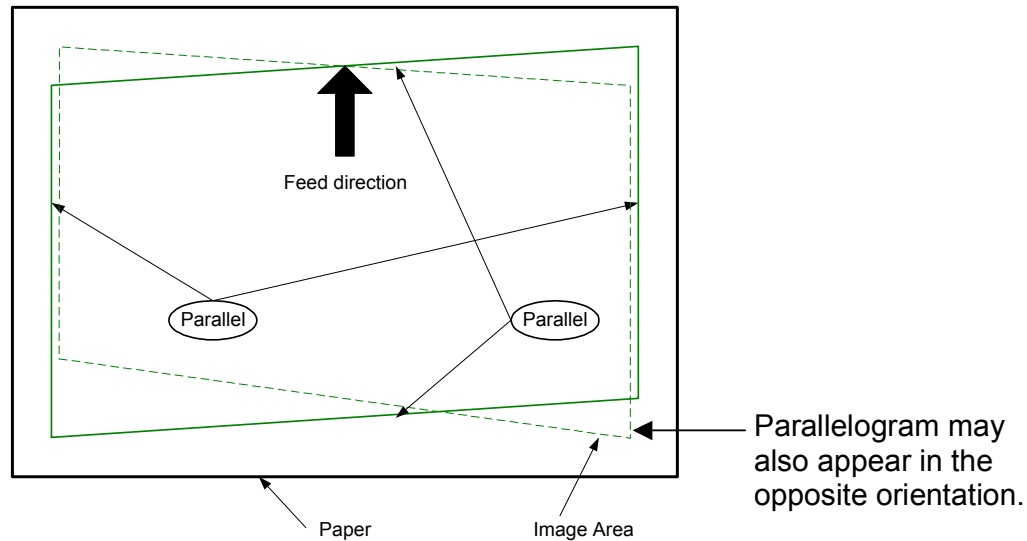
## 1.3 PARALLELOGRAM IMAGES

- Like skewed images, the leading/trailing edges and left/right edges are parallel to each other, but here, the **leading and trailing edges** are both slanted with respect to the paper's edge.
