Model: General RTB	Date: 4-Feb-03	No.: RGene013b
--------------------	----------------	----------------

Subject: Service remarks at installation		Prepared by: T. Itoh	
From: Technical Service Sec. Service Planning Dept.			
Classification:	<input type="checkbox"/> Troubleshooting	<input type="checkbox"/> Part information	<input type="checkbox"/> Action required
	<input type="checkbox"/> Mechanical	<input type="checkbox"/> Electrical	<input type="checkbox"/> Service manual revision
	<input type="checkbox"/> Paper path	<input type="checkbox"/> Transmit/receive	<input type="checkbox"/> Retrofit information
	<input checked="" type="checkbox"/> Other (Specification change)

Model: Model J-P2		Date: 2-Apr-03	No.: RG080001
Subject: Service Manual Revision		Prepared by: H.Taguchi	
From: 1st Tech. Support Sec. Service Support Dept.			
Classification:	<input type="checkbox"/> Troubleshooting <input type="checkbox"/> Mechanical <input type="checkbox"/> Paper path <input type="checkbox"/> Other (      )	<input type="checkbox"/> Part information <input type="checkbox"/> Electrical <input type="checkbox"/> Transmit/receive	<input type="checkbox"/> Action required <input checked="" type="checkbox

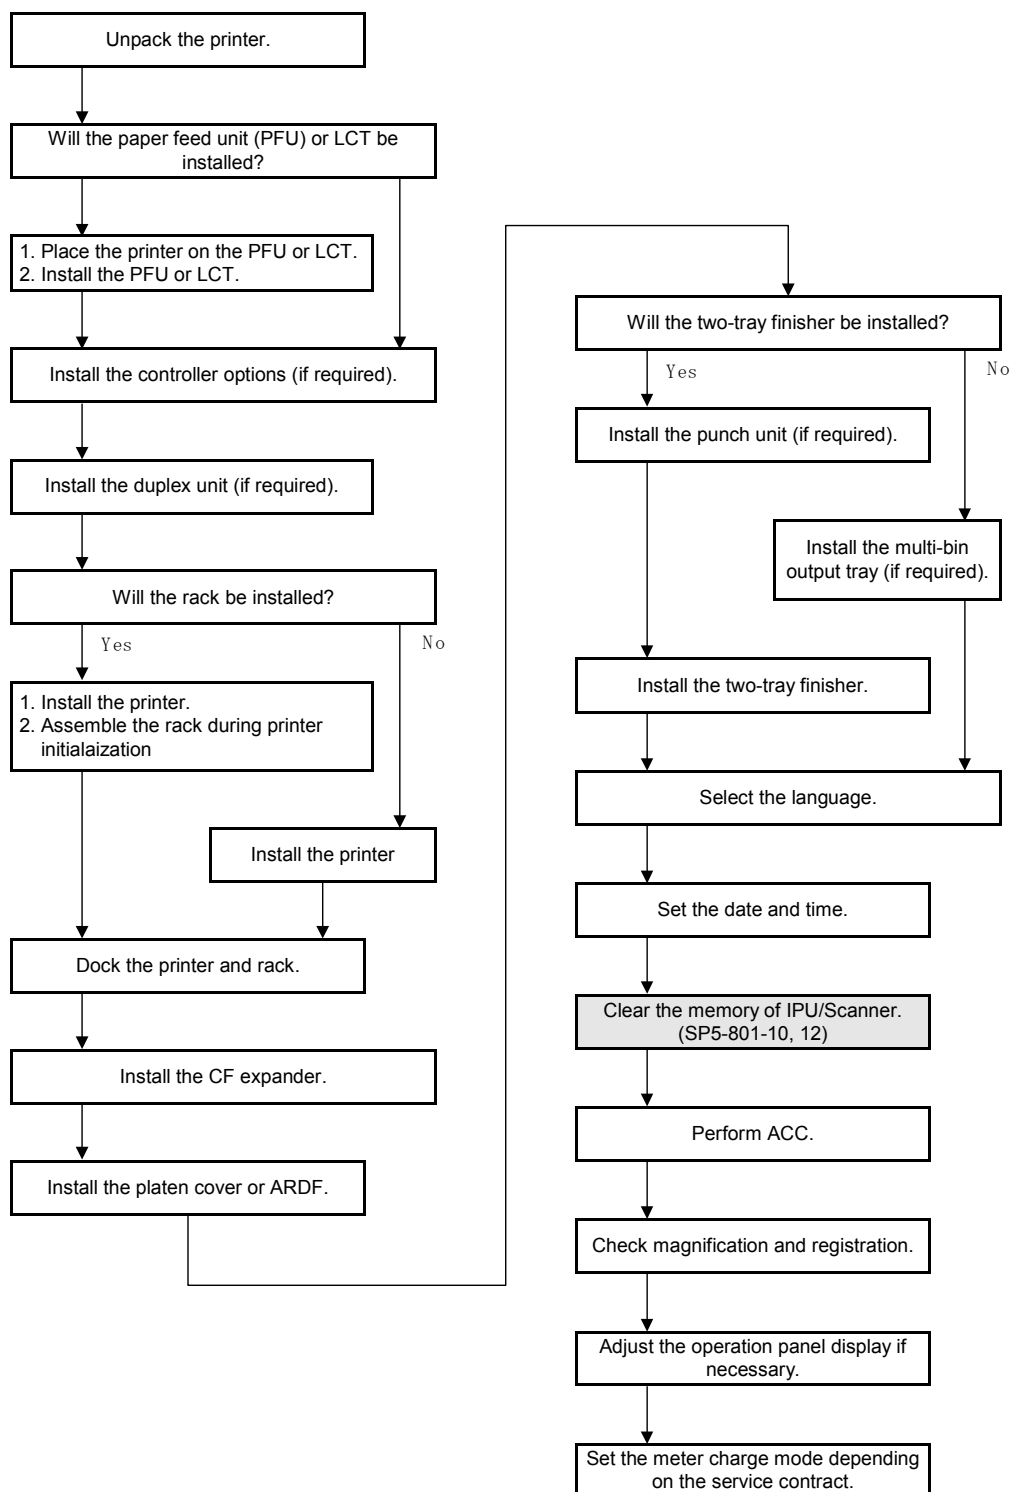
Contents revised: The following bold word was deleted from the flowchart illustration.

Clear the memory of IPU/**Netfile**/Scanner (SP-5-801-10,12) ].

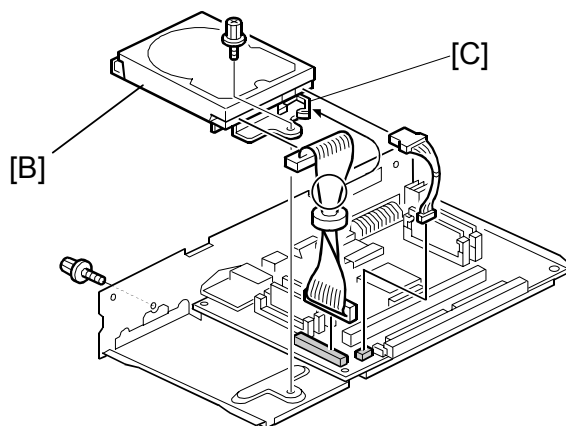
## Page 1-32

A harness clamp [C] and harness core have been added, and the harness attachment has been revised as follows.

- Step 2 revised as follows:

2. Mount the 40GB HDD [B] on the controller (Harness x 2, Screw x 2, **Clamp[C] x 1**)

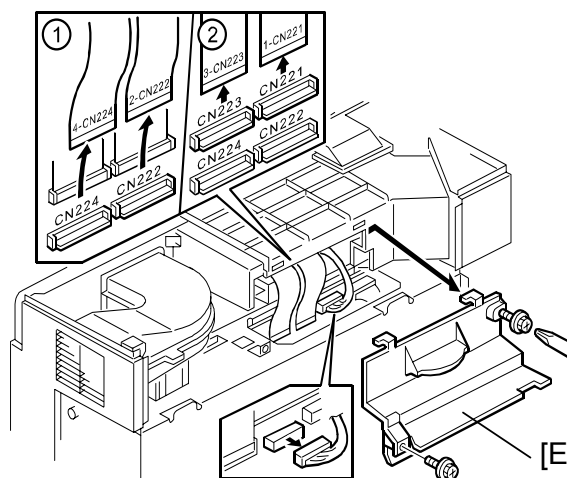
## Page 3-10

- A screw has been added and the shape of the connector cover has been changed as follows.

- Step 12 revised as follows:

12. Connector cover [E] (Screw x **2**)

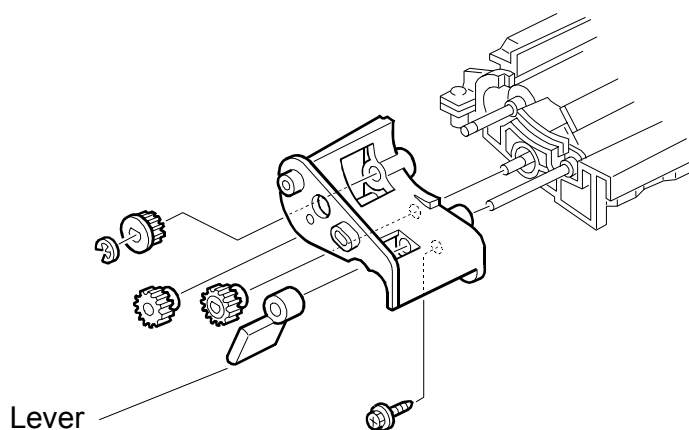
## Page 3-23

- The screw which stops the lever has been deleted, and the shape of the lever has been changed as follows.

- Step 4 deleted.

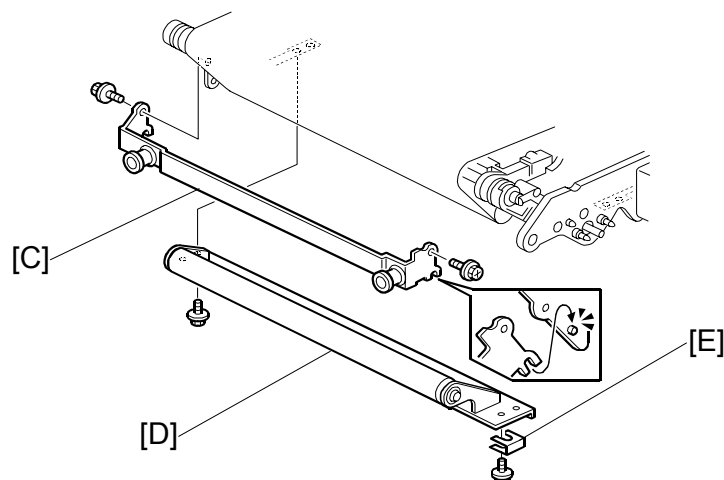
## Page 3-25

- A spacer [E] has been added.

- Step 6 revised as follows.

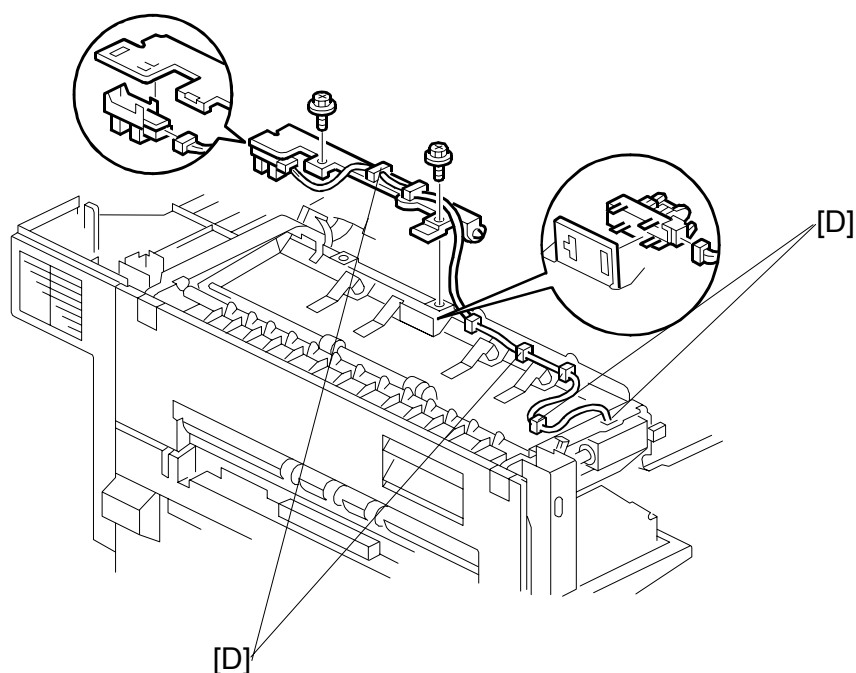
Page 3-42

- Four clamps [D] have been added, and the attachment of the harness has been changed as follows. The clamp at the right-hand end is not visible in the drawing.

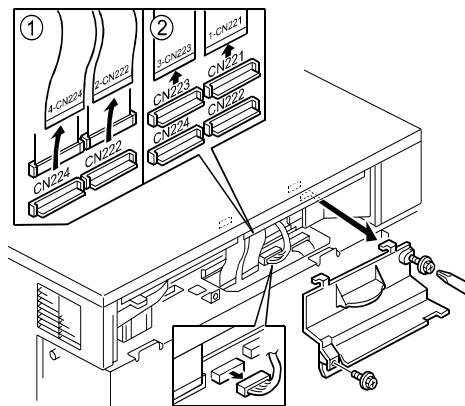
## Page 3-43

- A screw has been added, and the shape of the connector cover has been changed as follows.

- Step 4 revised.

4. Connector cover [E] (Screw x 2)

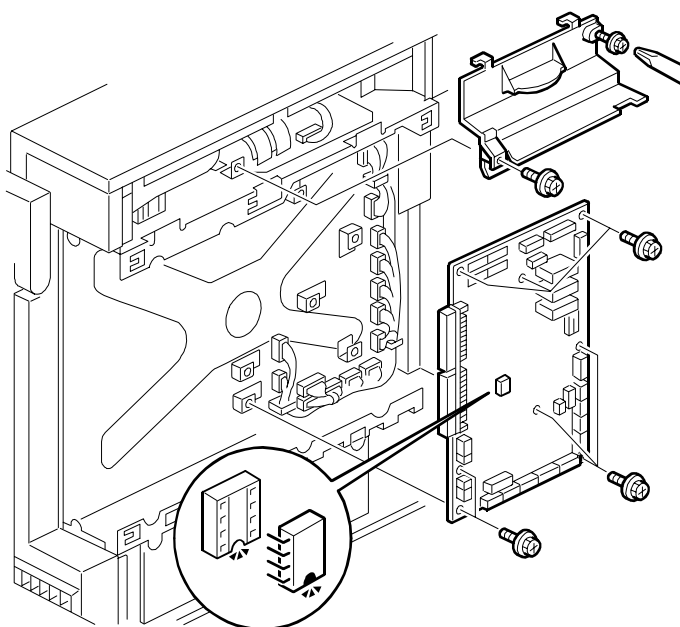
Page 3-45

- A screw has been added and the shape of the connector cover has been changed as follows.

- Step 6 revised.

6. Connector cover [E] (Screw x 2)

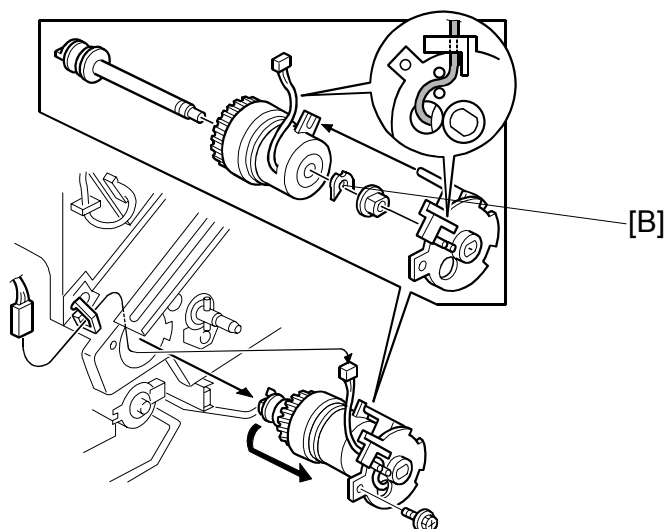
**Page 3-50**

- A retaining ring [B] has been inserted between the magnetic clutch and the bushing, as follows.

- Step 3 revised.

3. Development clutch [A] (Connector x 1, Screw x 1, **Retaining ring [B] x 1**)

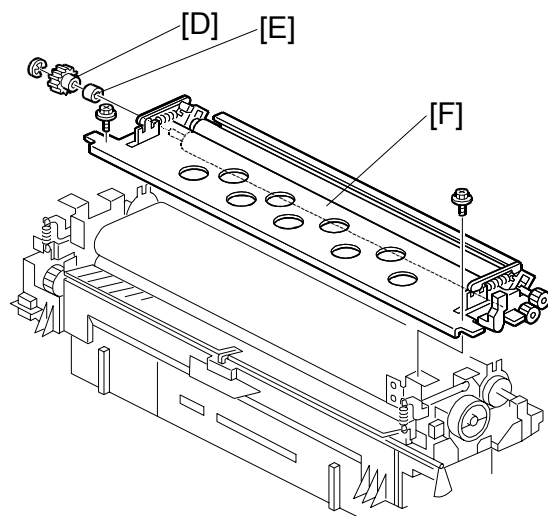
**Page 3-32**

Illustration revised to show the gear and collar:

- Steps 4, 5 revised as follows:

4. Gear [D] and Collar [E] (retaining ring x 1).
5. Cleaning unit [F] (screw x 2).
