# RIGOH

# Technical Bulletin

Model: EMP156		Date: 22-Nov-05		No.: RG155001	
Subject: Firmware Release History (Controller)			Prepared by: N. Sakamoto		
From: 2nd Tech. Support Sec. Service Support Dept					
Classification:	Troubleshooting	Part information Action require		n required	
	Mechanical	Electrical		Servic	ce manual revision
	Paper path	Transm	it/rec	eive 🗌 Retro	fit information
	🔀 Other ( )

This RTB contains the software release history for the Controller.

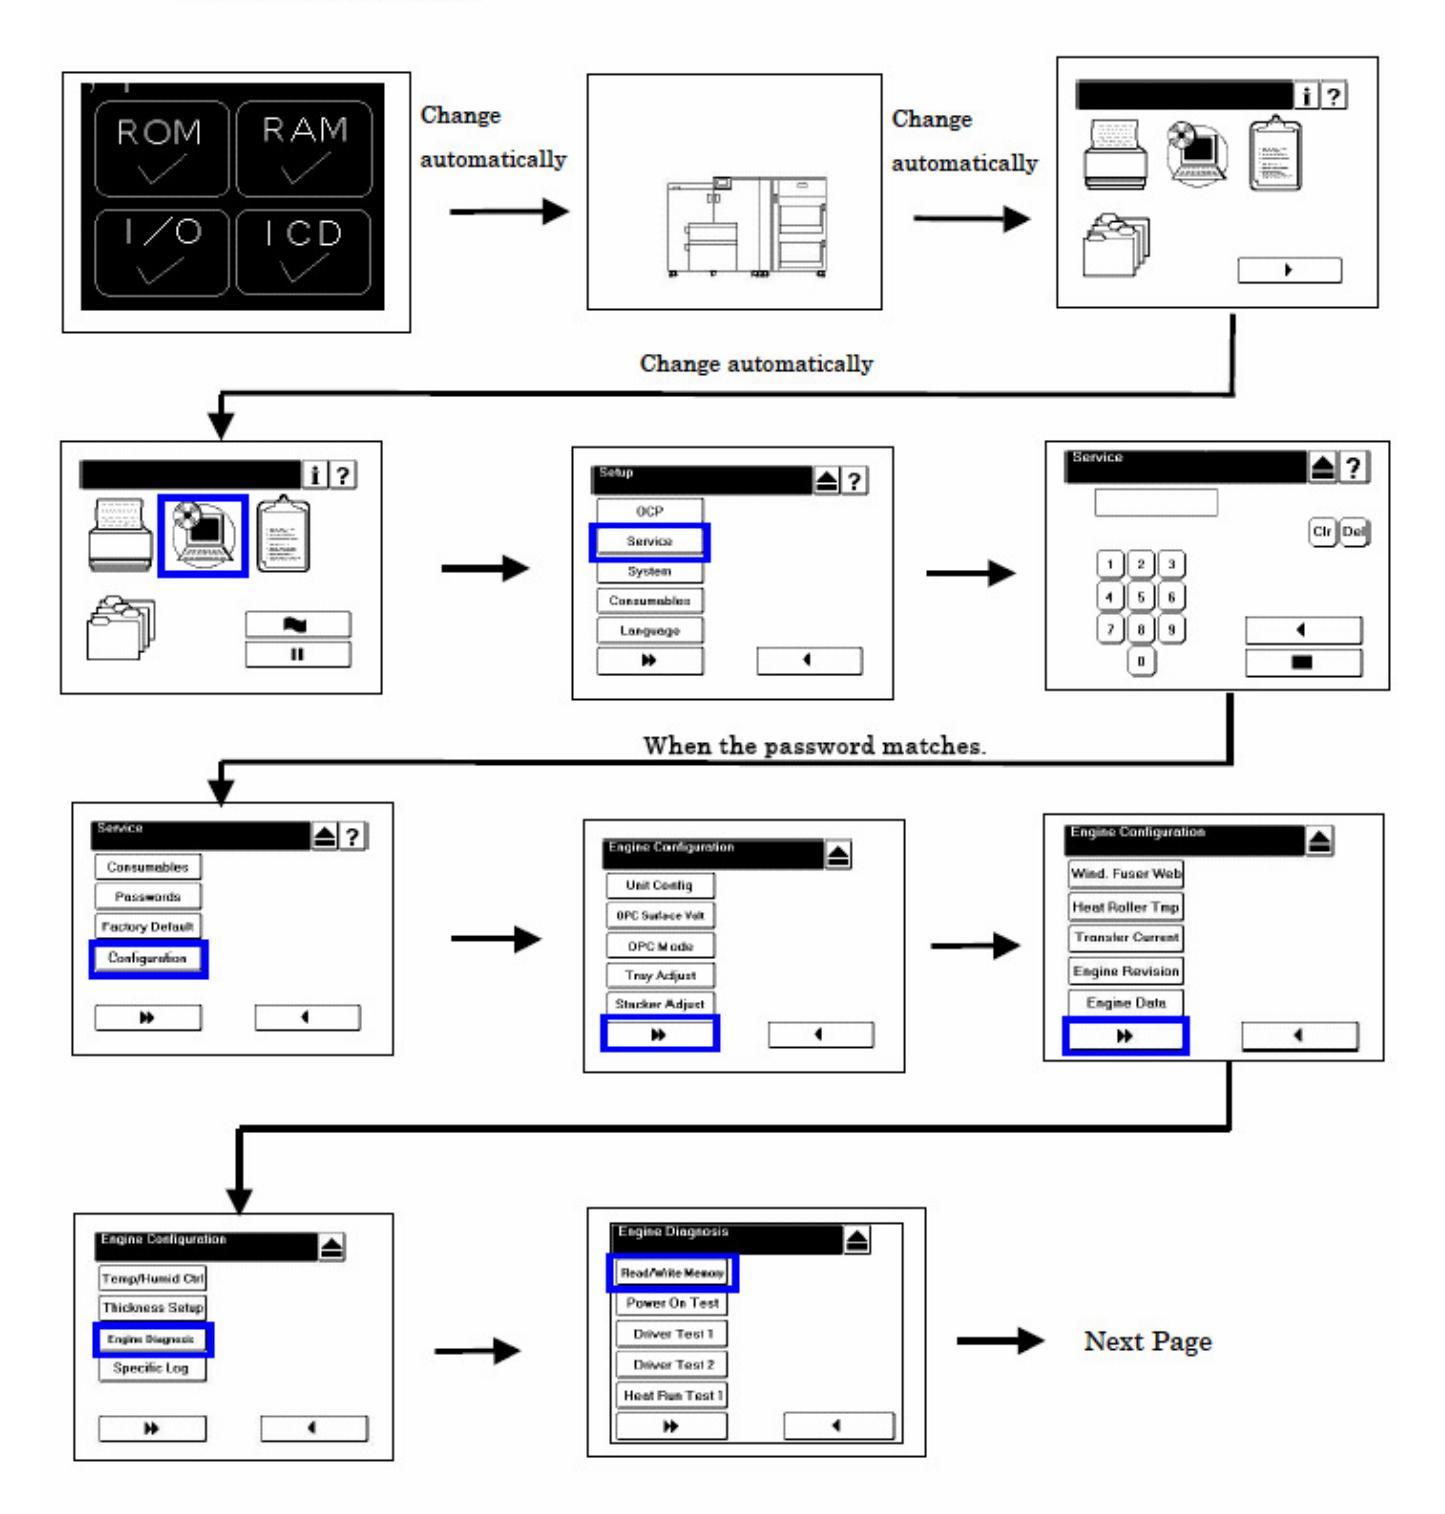
- 8. Add the following adjustment procedure after 7.9.11.
  - 7.9.12. Adjustment of the amount of reversal of Regist Roller.
  - 1.When Paper Skews from return occurs by thin papers, change the amount of reversal of Regist Roller.

Write in the date 40 at the address 0408 and the date 28 at the address 0502. (Refer to "Maintenance Diagnostics" on page 6-1 and "Read / Write Memory Function on page 6-3)

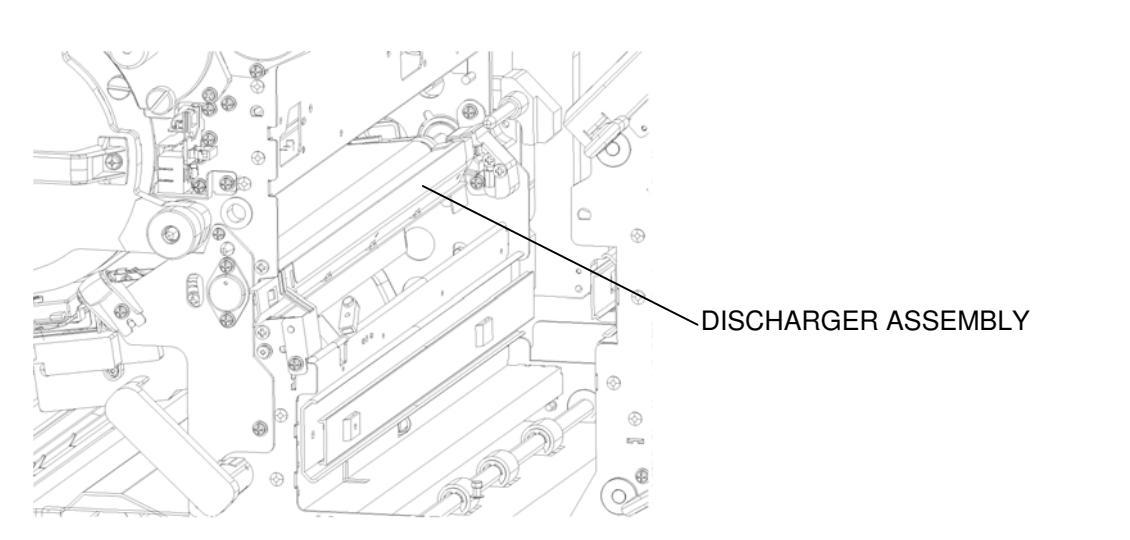
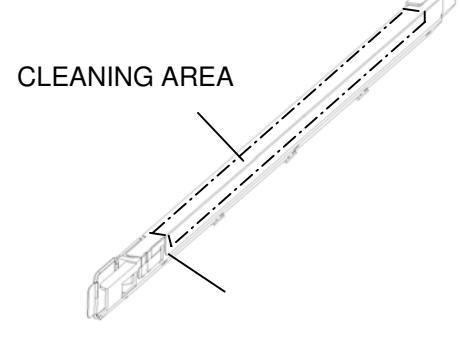
Figure 4-. Cleaning of the paper guide in Discharger Assembly

2. There is a lot of toner on the OPC roll (the Charger Assembly is stained)	<ol> <li>Clean the Shield and Grid.</li> <li>Clean the Erase Wire Assembly or the LED Eraser.</li> <li>Clean the Surface Voltage Sensor.</li> <li>Wind up the OPC Roll.</li> <li>Replace the Developer mix.</li> <li>Replace the Toner Control Sensor.</li> </ol>	4.4.1.1, 4-19 4.4.1.2, 4-20 4.4.1.9, 4-29 4.4.1.10, 4-30 Refer to the Controller Maintenance Manual. 7.2.4.29, 7-134 7.2.4.21, 7-125
	Clean the paper guide of the Discharger Unit.	4.4.2.9, 4-34

- 1. Pull out the Fuser Assembly (Refer to item 7.3.4.1)
- 2. Clean the paper guide in the Discharger Assembly with gauze. Important: Clean the area shown by the dotted line in the illustration below.
- 3. Do the cleaning procedures in the reverse order.

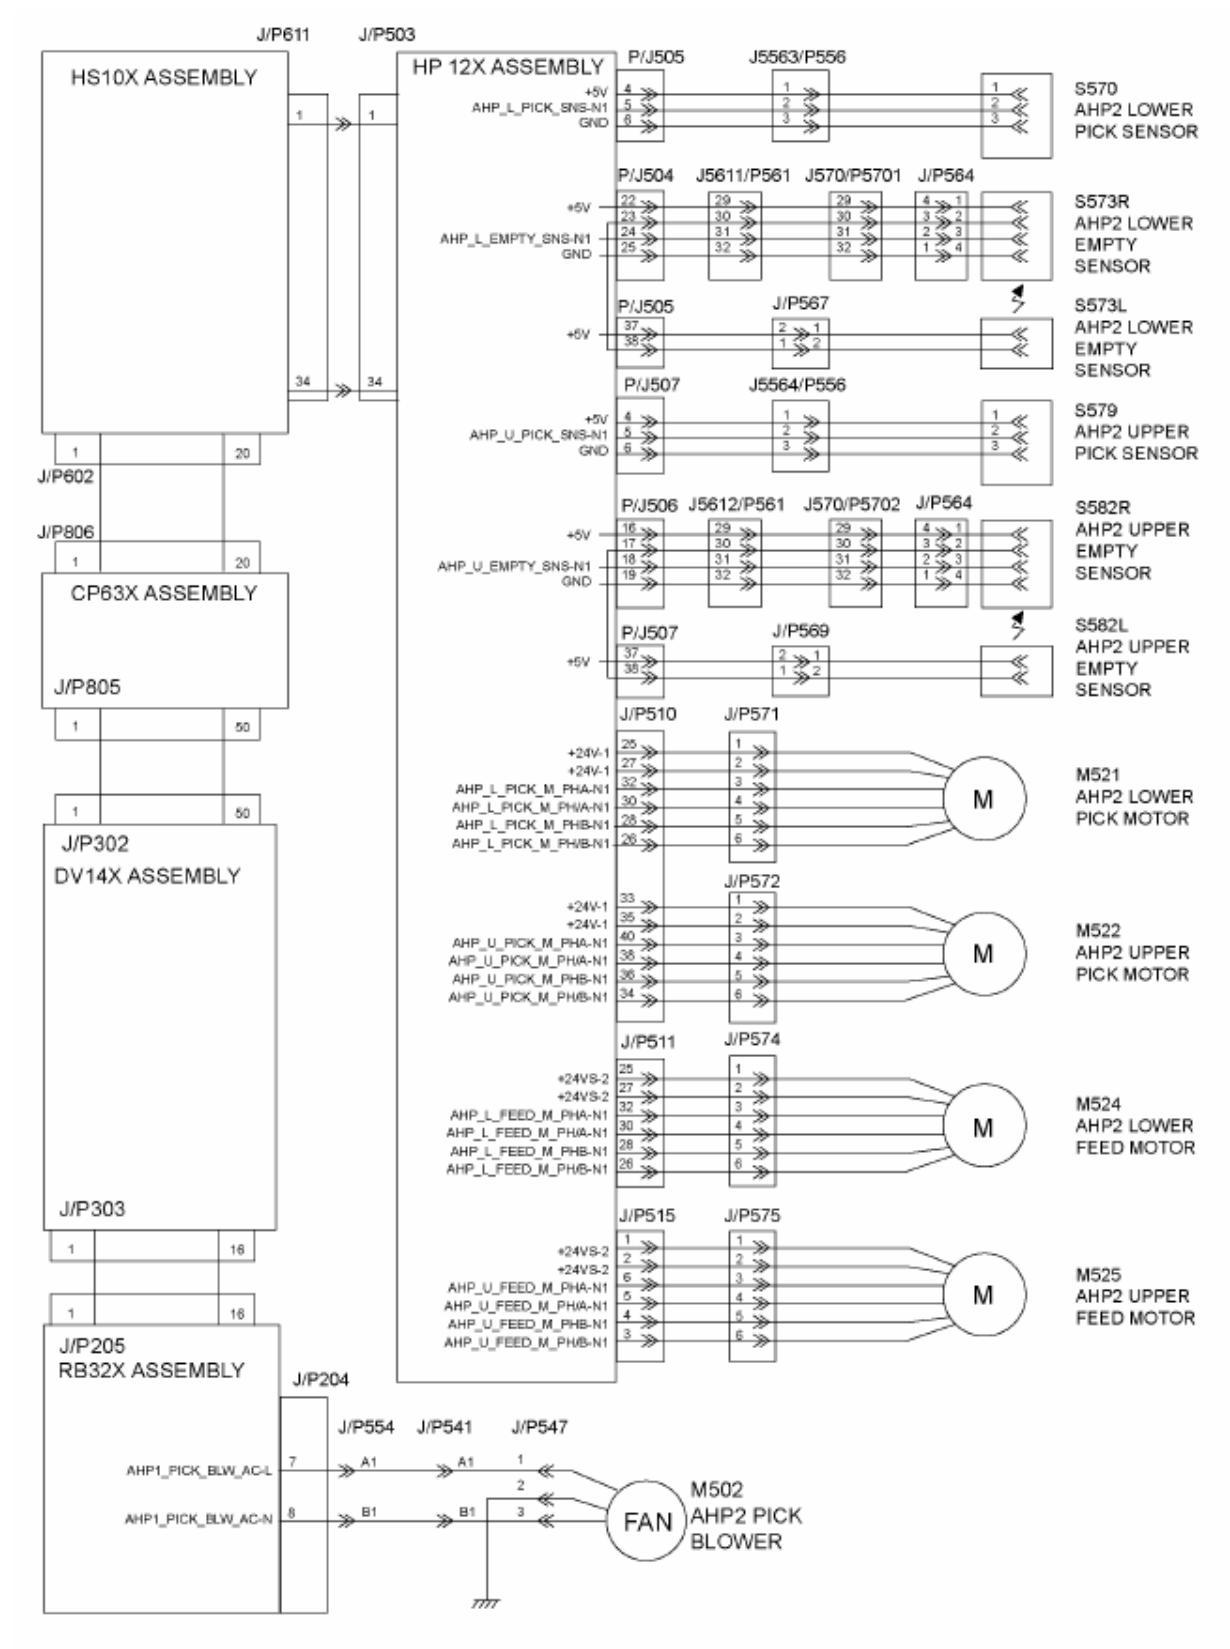
Figure 5-122. Error Codes E1AF, E1B0, E1B1, E1B2, E1B3, and E1B4

Empty Sensor is radii.	Replace: AHP2 Lower Empty Sensor (S573) Replace: AHP2 Upper Empty Sensor (S582)	7.8.5.3, 7-661 7.8.2.5, 7-597					
	<ol> <li>Poor connection of connectors, or cable damaged.</li> </ol>	Repair the cable or reset the connector in the correct position.	Figure 5-122 on page 5-224

5. Continued.	3. PCB fault.	Replace: HP12XPK	7.8.2.26, 7-621
	<ol> <li>Poor connection of connectors, or cable domocod</li> </ol>	Repair the cable or reset the connector in the correct position.	Figure 5-122 on page 5-224

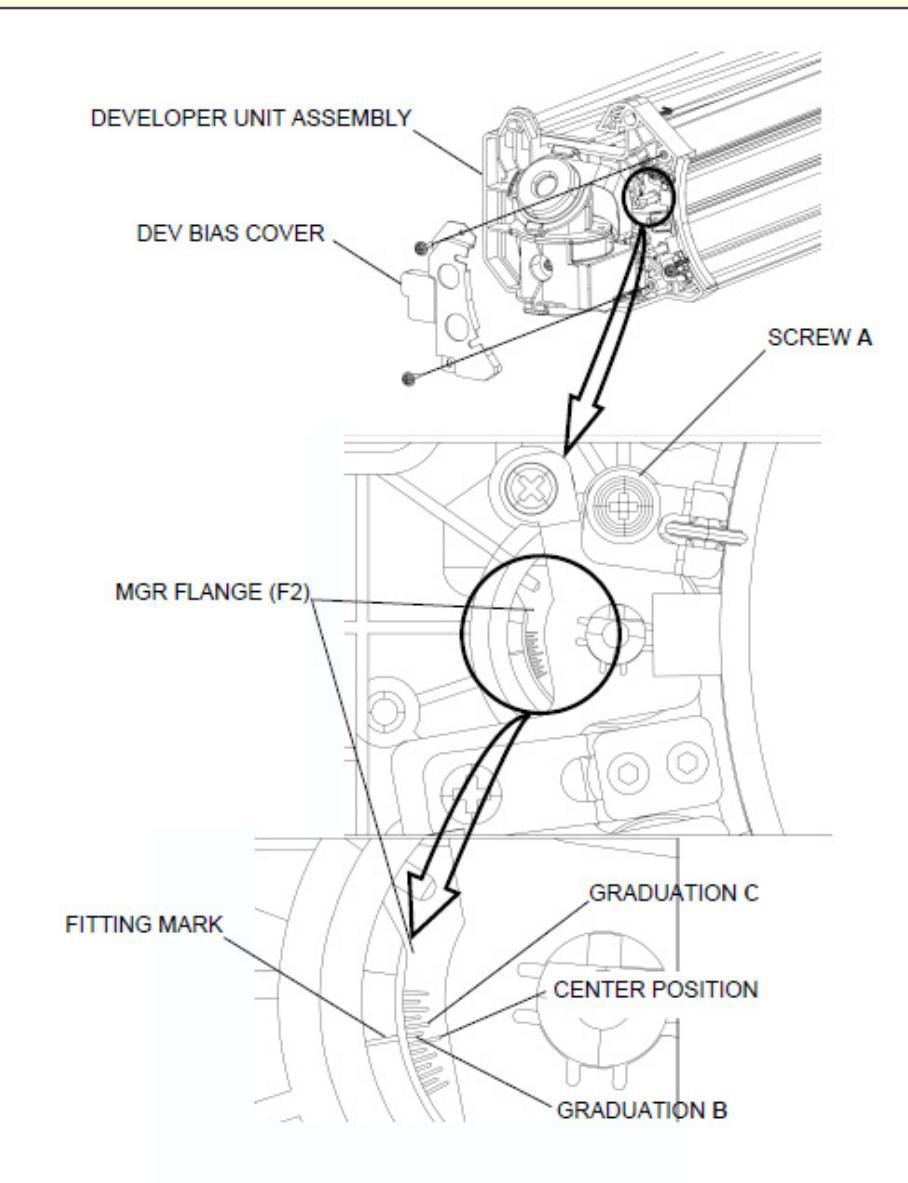
Note: Conform the Graduation C to the Fitting Mark when E245 is not improved even if the Graduation B is conformed to the Fitting Mark. It is necessary to do another investigation or to exchange the Developer Unit Assembly because the cause is different when not improving it by this adjustment.

- Remove the Developer Unit Assembly. (Refer to item 7.2.4.1 on page 7-100) [Disassembling Procedures - Items 2 to 6]
- 2. Remove the DEV Bias Cover (Refer to item 7.2.4.18 on page 7-121).
- 3. Loosen the screws A.
- 4. Rotate the MGR Flange (F2) so that the Graduation B accords with the Fitting Mark.

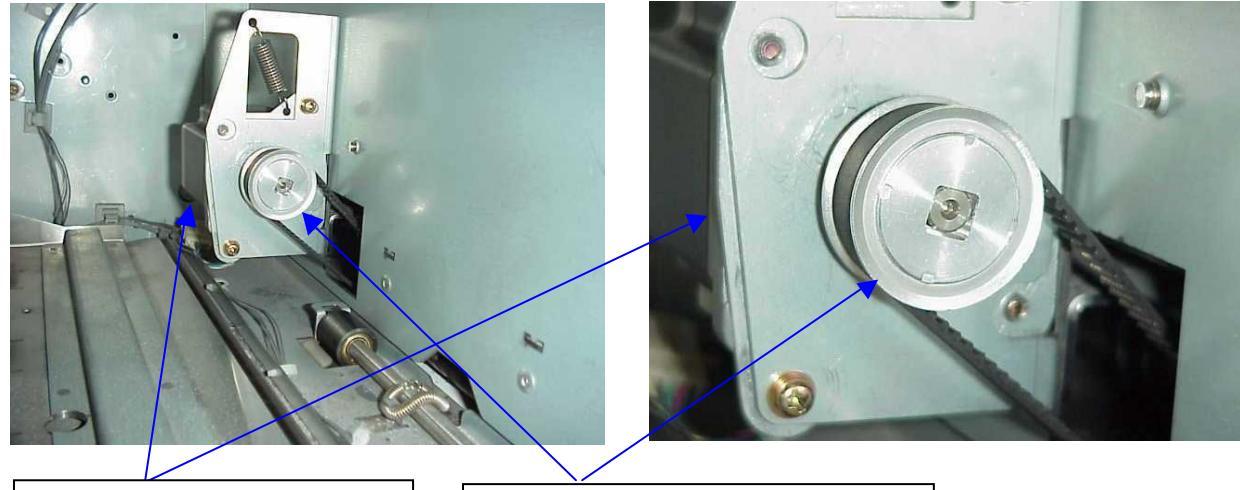
Pick Motor pulley for all hoppers

Pick Motor (Stepping Motor 6)

Pick Motor Pulley (Pulley Assembly)

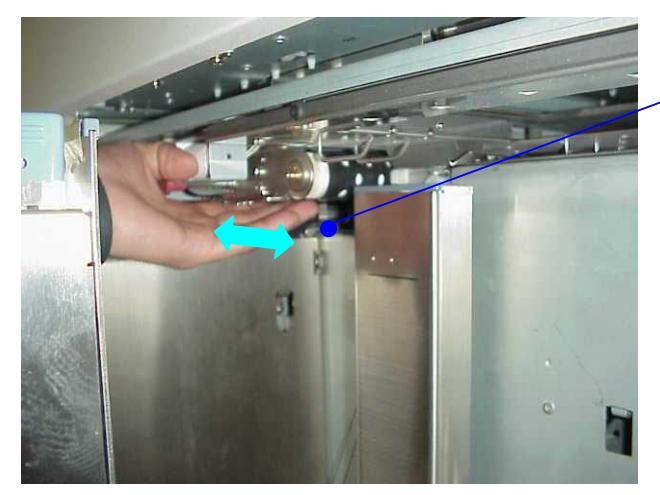
(2) Check for play (movement) between the Pick Motor Pulley and Pick Motor by rotating the pick belt forwards and in reverse by hand.

If rattling can be felt upon moving the pick belt, there is play between the Pick Motor Pulley and the Pick Motor.

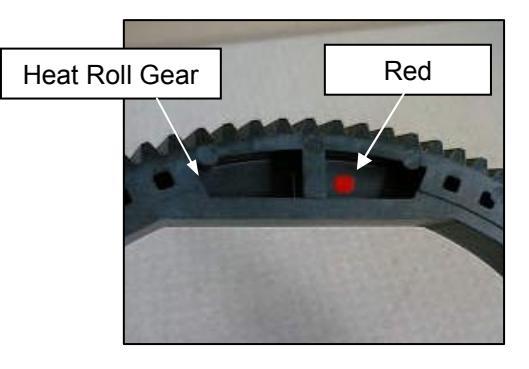
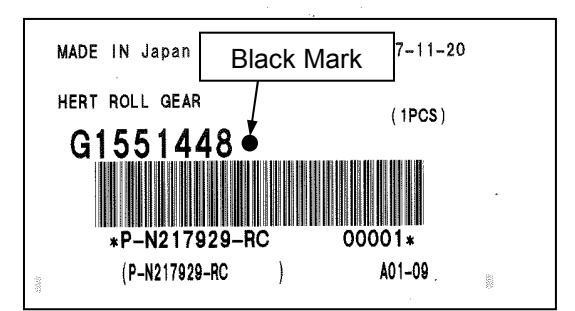
Part Label on the Carton Box

The cause of the damage was an air cavity in the Heat Roll Gear.

**Note:** So that old and newly revised Heat Roll Gears and Heat Roll Assy's can be distinguished from one another, a red dot on the Heat Roll Gear and a black dot at the end of the part number, located on the carton box, have been added.

Molding conditions (molding machine's settings/ mold/die temperature) for the Heat Roll Gears will be changed to prevent air cavities from being produced.

Please replace the Heat Roll Gears on installed machines and machines in the warehouse, during installation or PM.

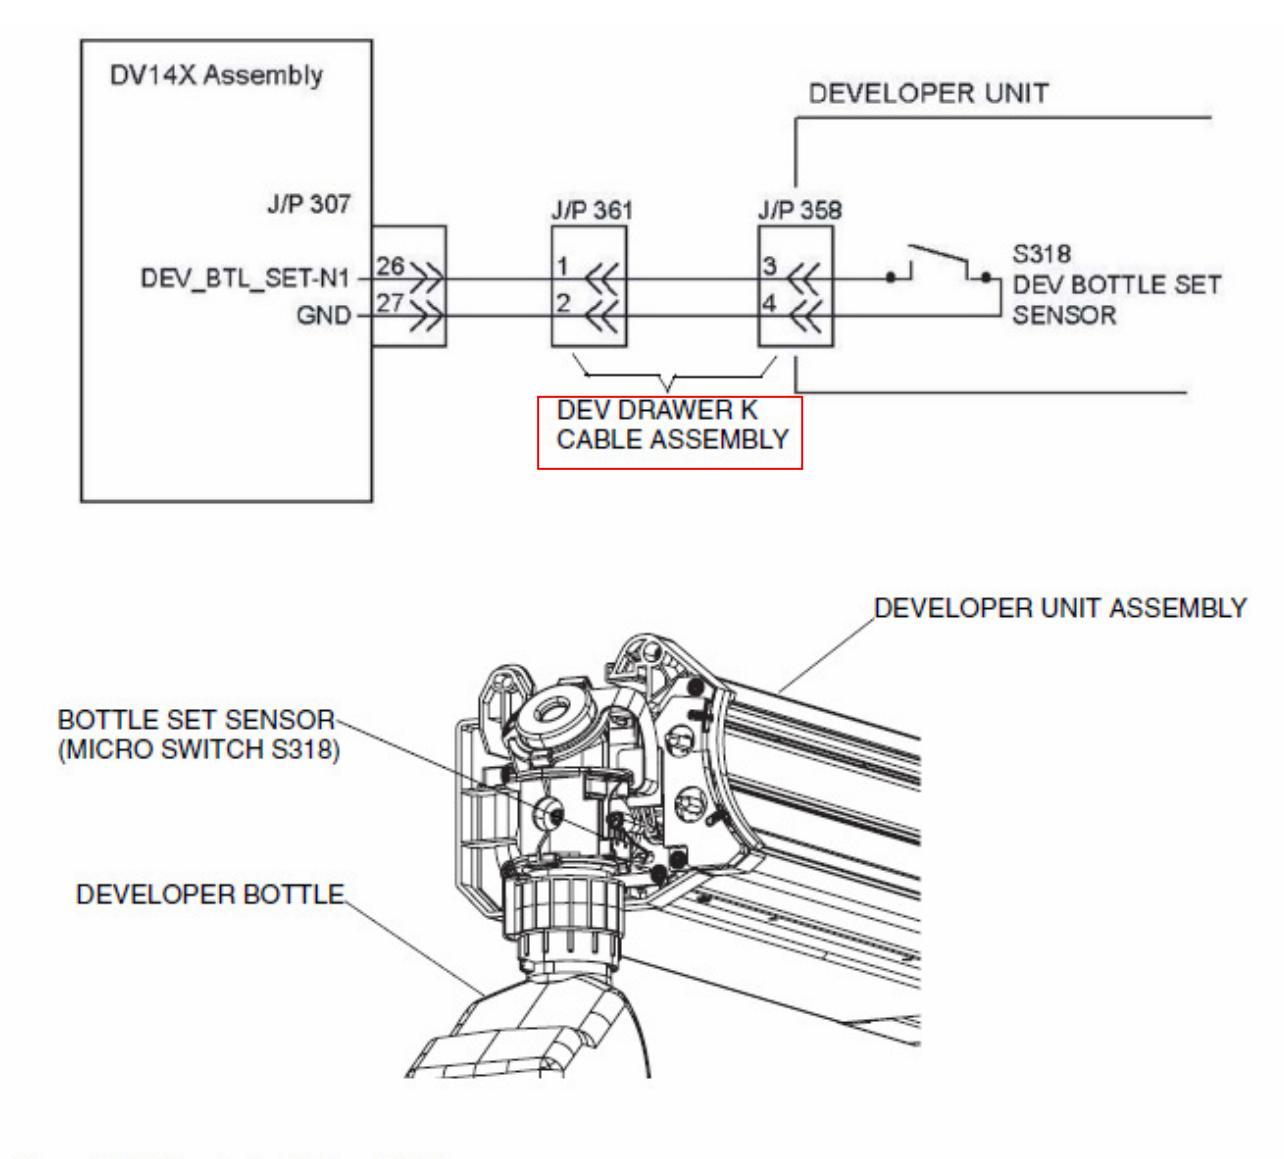
Figure 5-18. Error Code E031, and E036

2. Drawer Connector fault. Loose connection of contact pin damaged.		Replace: DEV Drawer K Cable Assembly	7.2.1.28, 7-42		
3. Poor connection of connectors, or cable damaged.		Repair the cables or reset the connector in the correct position.	Figure 5-18 on page 5-47

4. Sensor f	ault.	Replace: Micro Switch (S318)	7.2.4.20, 7-125		
	5. PCB fau	lt.	Replace: DV14X Assembly	7.6.1.8, 7-387		
Refer to Figure 5-18 on	page 5-47.

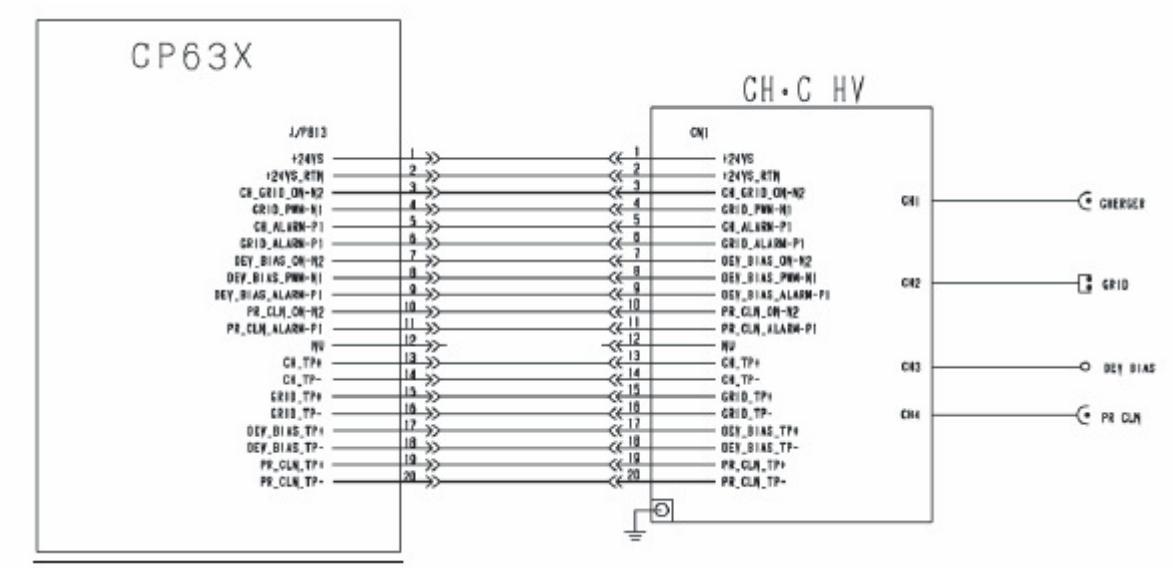
Figure 5-167. Error Code E218 (1)

2. Grid, or Charger Wire is damaged.	Replace: Grid Replace: Charger Wire	7.2.1.2, 7-7 7.2.1.3, 7-8	
	3. Grid is discharging. Drum Unit Assembly, or the Drum Cap is damaged. Chargor voltage is	Check: Drum Unit Assembly Rewind: OPC Roll Check: Grid, changes in the Spring, Charger contamination	7.2.2.1, 7-81 7.2.2.2, 7-83 4.4.1.1, 4-20	
	incorrect.	Clean: Charger Replace: Charger	4.4.1.1, 4-20 7.2.1.1, 7-5	
	<ol> <li>High Voltage Cable fault. Short circuit or leak. Terminal has separated, or it is disconnected.</li> </ol>	Check: High Voltage Cable (CH2)	Figure 5-167 on page 5-301 Figure 5-168 on page 5-302	
	<ol> <li>+24V or the signal is not connected with the High Voltage Power Supply. Poor connection of connectors, or cable damaged.</li> </ol>	Check: High Voltage Power Supply 1 CN1 to P/J813 between the cable, and connector.	Figure 5-167 on page 5-301 Figure 5-168 on page 5-302	
	<ol> <li>Abnormalities in the High Voltage Power Supply.</li> </ol>	Check: HV monitor output *1 Replace: High Voltage Power Supply 1	<u>3.6.3, 3-22-2</u> 7.6.1.5, 7-383

7. Abnormalities in the PCB.	Replace: CP63X Assembly	7.6.1.7, 7-386	
*1 The HV monitor outp	out confirmation cannot be execute	ed while E218 is detected.		
The HV monitor output confirmation is used when there is no error because the phenomenon is intermittent etc.

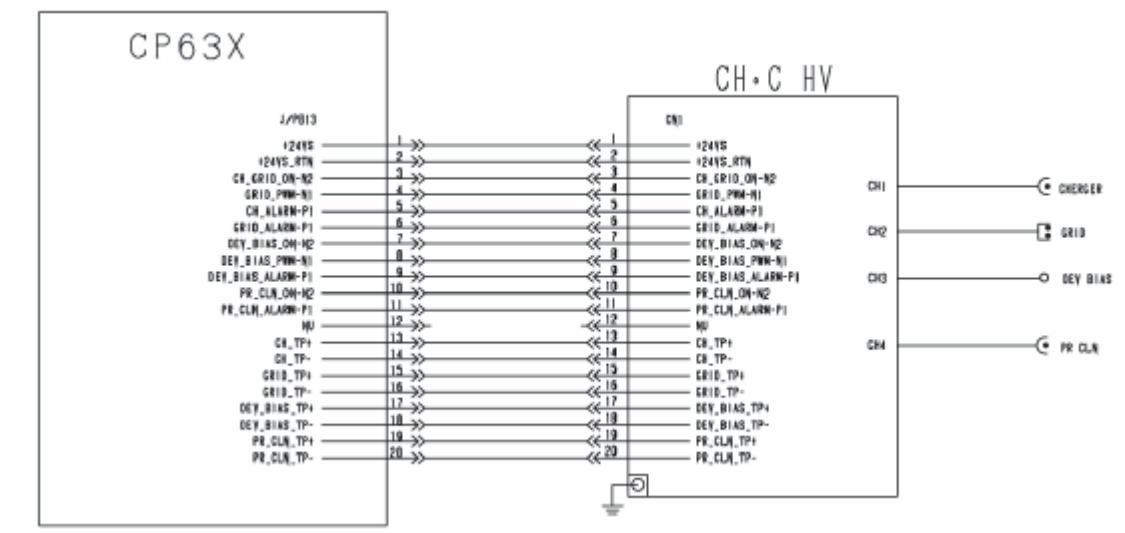
Figure 5-169. Error Code E21D (1)

4. High Voltage Cable fault.	Check: High Voltage Cable (CH4)	Figure 5-169 on	
	Short circuit or leak.		page 5-303 and	
	Terminal has separated,		Figure 5-170 on	
	or it is disconnected.		page 5-304

2. Even if the High	1. +24V or the signal is not	Check: Cable.	Figure 5-169 on	
Voltage Cable is	connected with the High		page 5-303 and	
removed from	Voltage Power Supply.		Figure 5-170 on	
CH4 where this	Poor connection of	Repair the cables or reset the	page 5-304	
error occurs, then	connectors, or cable	connector in the correct position.		
the phenomenon	damaged.			
does not change.	2. Abnormalities in the High	Check: HV monitor output *1	3.6.3, 3-22-2	
	Voltage Power Supply.	Replace: High Voltage Power	7.6.1.5, 7-383	
		Supply 1

3. Abnormalities in the PCB.	Replace: CP63X Assembly	7.6.1.7, 7-386	
*1 The HV monitor output confirmation cannot be executed while E21D is detected.				
The HV monitor output confirmation is used when there is no error because the phenomenon is intermittent etc.

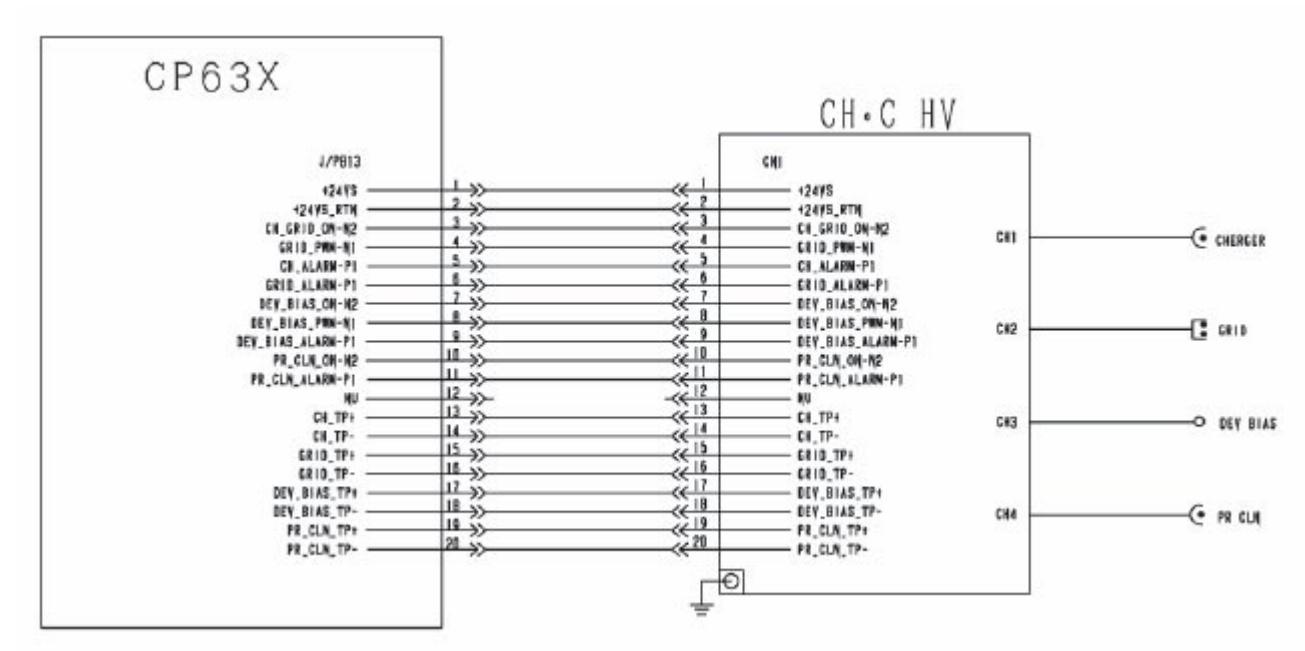
Figure 5-171. Error Code E220

1. When this error occurs, then the High Voltage	1. High Voltage Cable fault. Short circuit or leak.	Check: High Voltage Cable (CH3)	Figure 5-171 on page 5-305	
Cable is removed from the CH3	2. Leak, or contact fault. OPC Roll is damaged.	Replace: OPC Roll Rewind: OPC Roll	7.2.2.2, 7-83	
turning off this error.	Developer Unit failure. Developer Unit is contaminated.	Replace: Developer Unit Assembly Clean: Developer Unit	7.2.4.1, 7-100

3. Foreign substances are mixed with the Developer mix.	Replace: Developer mix	7.2.4.29, 7-135	
2. Even if the High Voltage Cable is removed from	1. +24V or the signal is not connected with the High Voltage Power Supply.	Check: Cable.	Figure 5-171 on page 5-305	
CH3 where this error occurs, then the phenomenon	Poor connection of connectors, or cable damaged.	Repair the cables or reset the connector in the correct position.		
does not change.	2. Abnormalities in the High	Check: HV monitor output *1	3.6.3, 3-22-2	
	Voltage Power Supply.	Replace: High Voltage Power Supply (CH)	7.6.1.5, 7-383

3. PCB fault.	Replace: CP63X Assembly	7.6.1.7, 7-386	
*1 The HV monitor output confirmation cannot be executed while E220 is detected. The HV monitor output confirmation is used when there is no error because the phenomenon is intermittent etc.

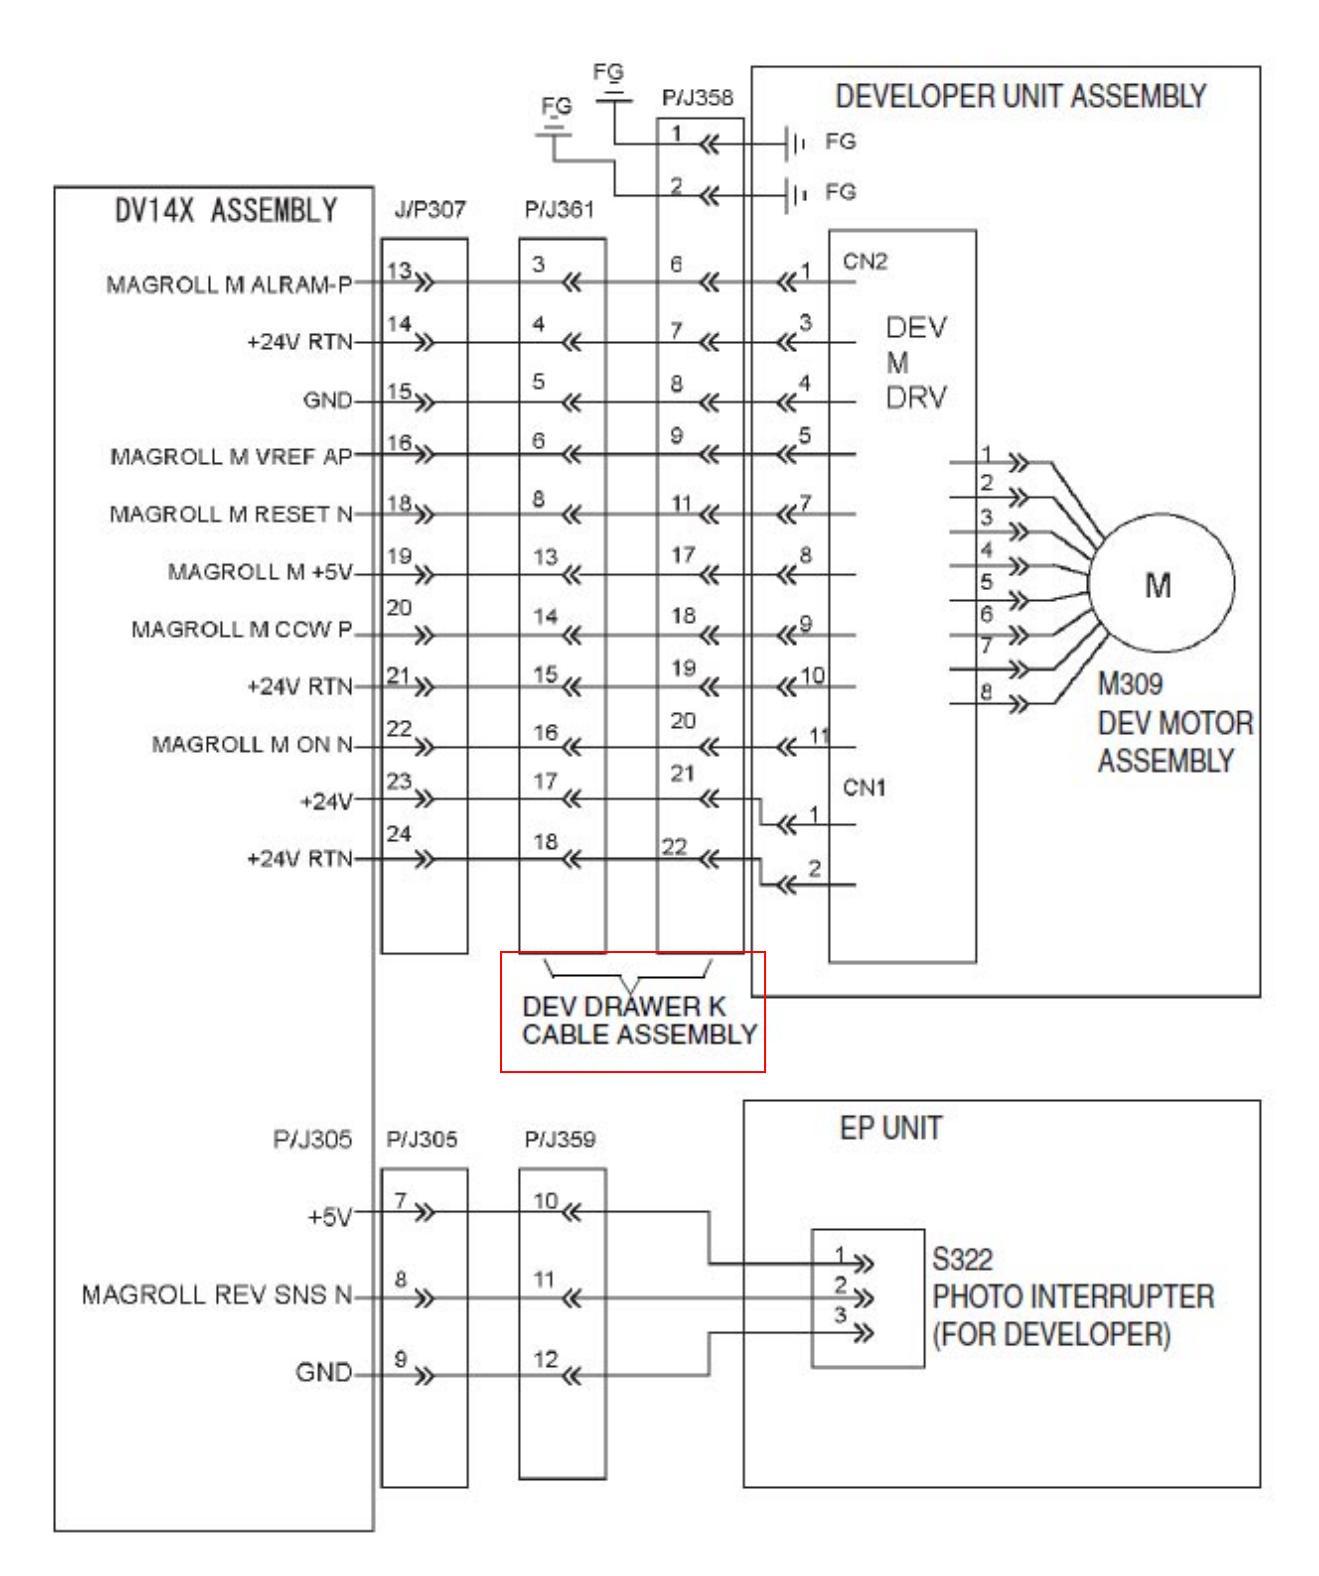
Figure 5-178. Error Codes E240, and E245

4. PCB fault.	Replace: DV14X Assembly CP63X Assembly	7.2.4.16, 7-119 7.6.1.8, 7-387 7.6.1.7, 7-386		
	5. Poor connection of connectors, or cable damaged.	Repair the cable or reset the connector in the correct position.	Figure 5-178 on page 5-316

4. PCB fault.	Replace: DV14X Assembly CP63X Assembly	7.6.1.8, 7-387 7.6.1.7, 7-386		
	5. Poor connection of connectors, or cable damaged.	Repair the cable or reset the connector in the correct position.	Figure 5-178 on page 5-316

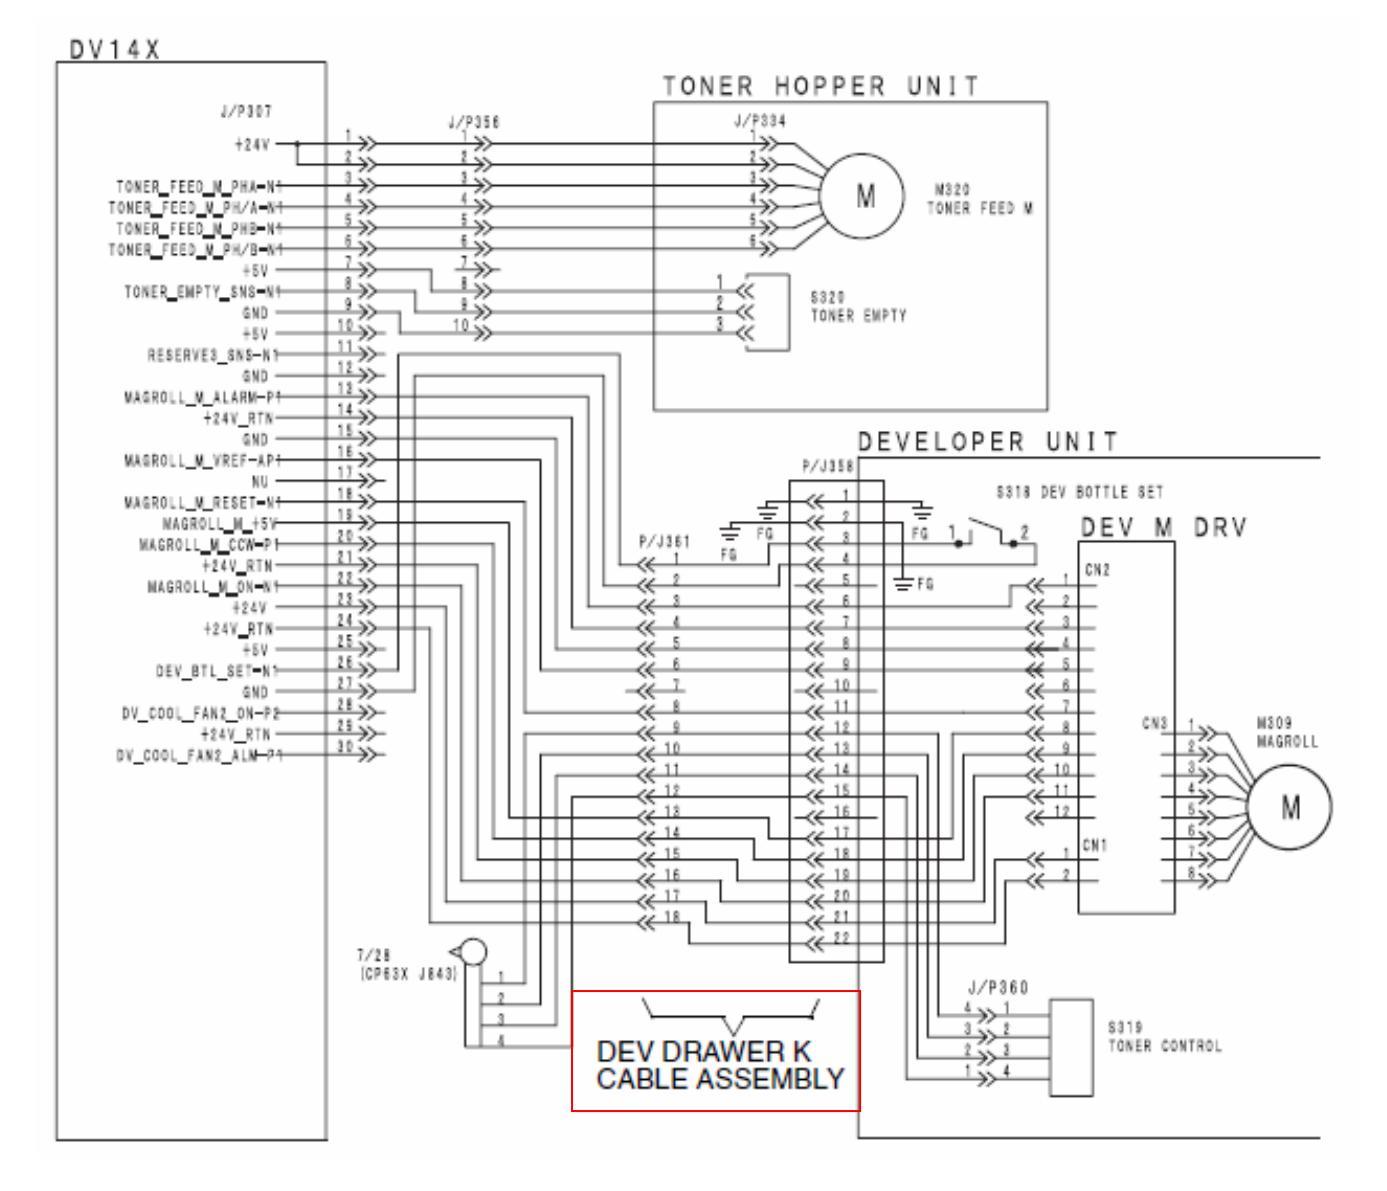
Figure 5-183. Error Codes E24A, E24F, and E25A

4. PCB fault.	Replace: DV14X Assembly CP63X Assembly	7.6.1.8, 7-387 7.6.1.7, 7-386			
	5. Poor connection of connectors, or cable damaged.	Repair the cable or reset the connector in the correct position.	Figure 5-183 on page 5-323

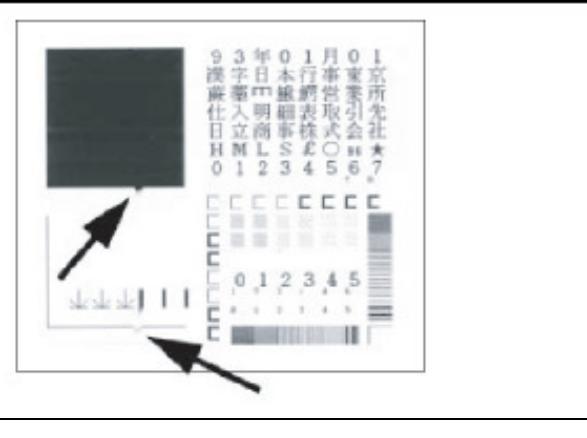
Phenomenon 16. - White Streak (In the Vertical Direction, stains around the Image)

Cause and Inspection Area	Remedy	Maintenance Ref. + Page
1. Foreign substances attach between the Developer Unit and the OPC.	Clean around the Developer Unit.	4.4.1.7, 4-26

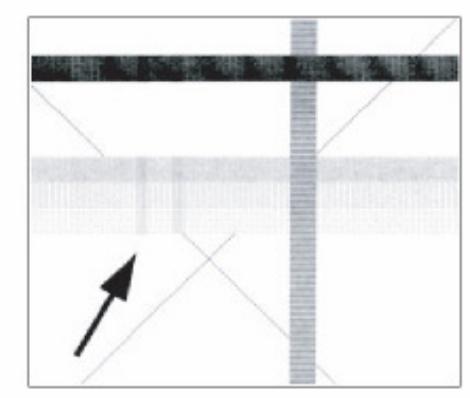
#### Phenomenon 17. - Black Streak (In the Vertical Direction)

Cause and Inspection Area	Remedy	Maintenance Ref. + Page
1. The Charger Assembly is stained.	Clean the Shield and Grid of the Charger Assembly.	4.4.1.1, 4-20
2. The OPC surface voltage is too low.	Clean the Shield and Grid of the Charger Assembly.	4.4.1.1, 4-20
	Clean the Surface Voltage Sensor.	4.4.1.11, 4-34
	Check the output of the High Voltage Power	3.6.3, 3-22-2
	Supply (CH).(CH1.CH2)	
	Replace the High Voltage Power Supply 1.	7.6.1.5, 7-383
3. The OPC Roll is damaged.	Wind up the OPC Roll.	Refer to the Controller Maintenance Manual.
4. Foreign substances attach around the Drum Unit.	Clean around the Drum Unit, and clean the Shield and Grid of the Charger Assembly.	4.4.1.1, 4-20
	Clean around the Developer Unit.	4.4.1.7, 4-26

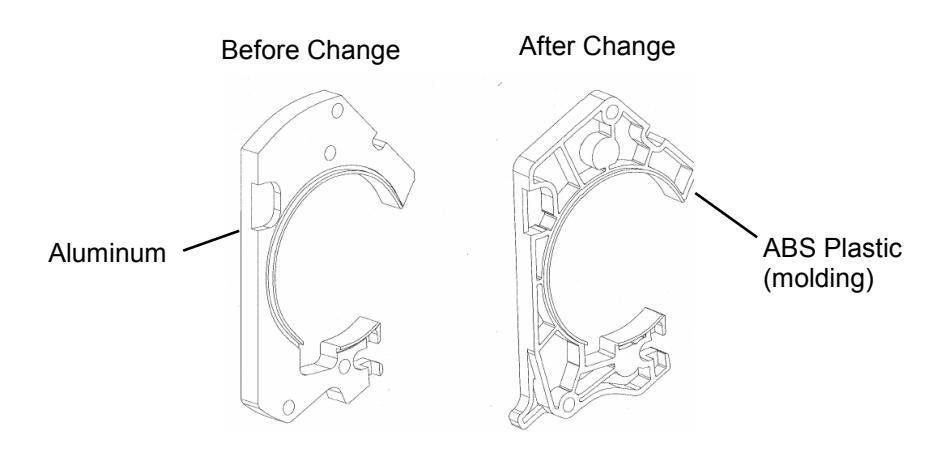
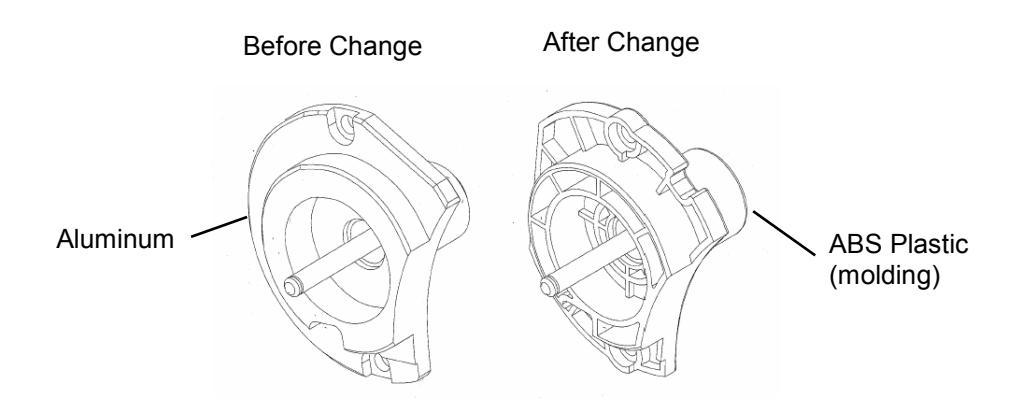
Change: Material for the two parts has been changed from aluminum to ABS.
