Model: T-G1s		Date: 03-Sep-07	No.: RJ015001a
Subject: Firmware Release History Network I/F GX3		Prepared by: Y.Murata	
From: 1st Tech. Support Sec. Service Support Dept.			
Classification:	<input type="checkbox"/> Troubleshooting <input type="checkbox"/> Mechanical <input type="checkbox"/> Paper path <input type="checkbox"/> Product Safety	<input type="checkbox"/> Part information <input type="checkbox"/> Electrical <input type="checkbox"/> Transmit/receive <input checked="" type="checkbox"/> Other ()	<input type="checkbox"/> Action required <input type="checkbox"/> Service manual revision <input type="checkbox"/> Retrofit information

Model: T-G1s/T-G1W/T-MF1		Date: 3-Dec-07	No.: RJ015003
Subject: SC 979		Prepared by: Y. Murata	
From: 1st Tech. Support Sec. Service Support Dept.			
Classification:	<input checked="" type="checkbox"/> Troubleshooting	<input type="checkbox"/> Part information	<input type="checkbox"/> Action required
	<input type="checkbox"/> Mechanical	<input type="checkbox"/> Electrical	<input type="checkbox"/> Service manual revision
	<input type="checkbox"/> Paper path	<input type="checkbox"/> Transmit/receive	<input type="checkbox"/> Retrofit information
	<input

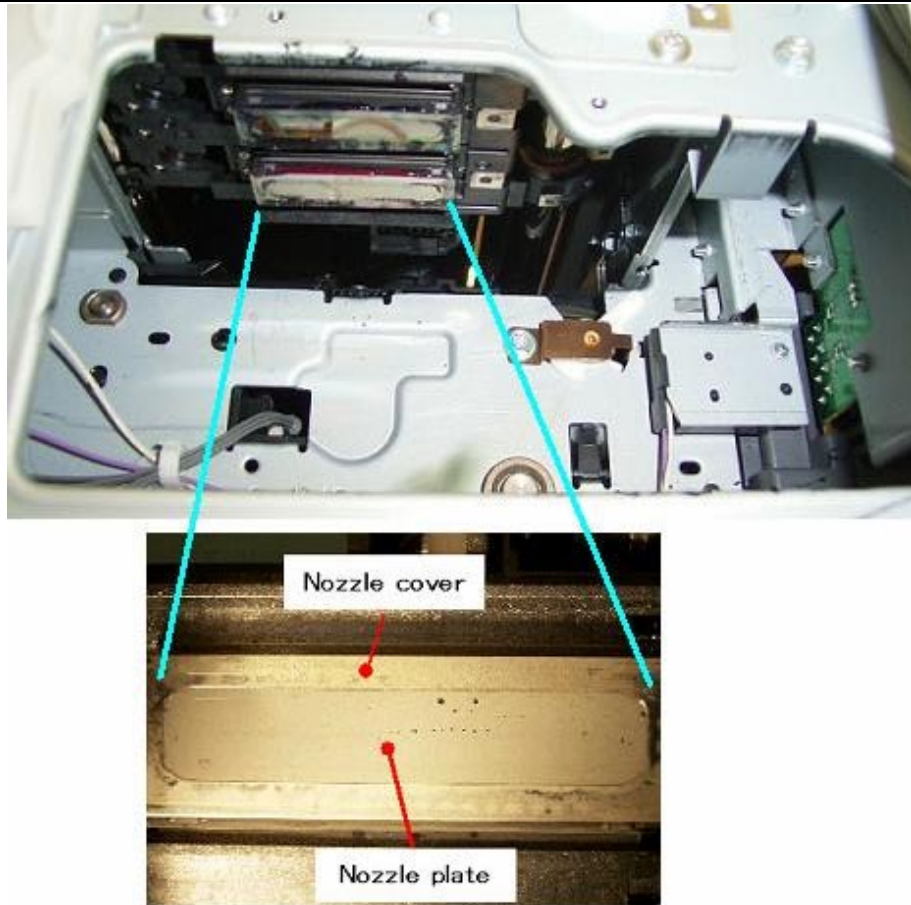
Note: You will then see the nozzle cover and nozzle plate.

4. Clean each side of the nozzle twice with a slightly damp cloth.
Important: Move the cloth back and forth along the surface.

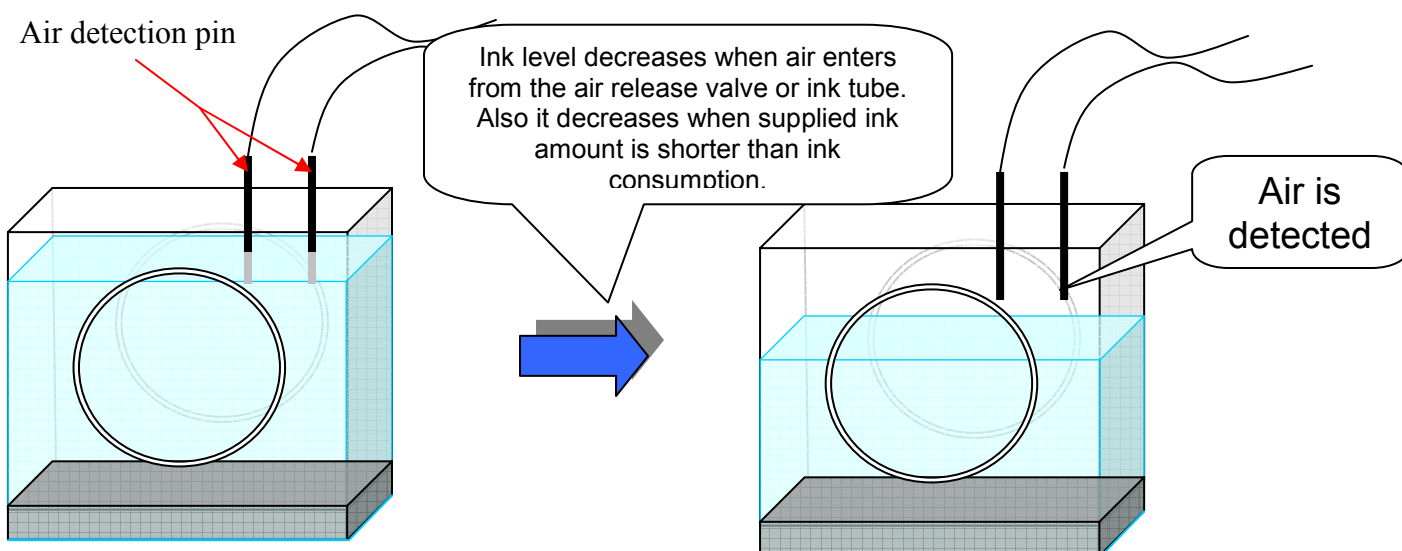
< Schematic view of head tank >

- In order to eject the ink properly from the print head, it is necessary to maintain negative pressure (with respect to the surrounding air) inside the head tank. If negative pressure is lost, the ink can leak out from the nozzle and adversely affect the image quality. If this occurs, the negative pressure must be re-established. This process is known as "air release filling".
- When the surface of the liquid dips below the detection pins (see the diagram below), the machine will perform air release filling. This is because if this happens, negative pressure may have been lost. To perform air release filling, the air release valve is opened (which re-calibrates the internal pressure), ink is poured into the ink head, and ink is sucked out by the suction cap with the air release valve closed. Therefore, to perform this process, the machine consumes ink.

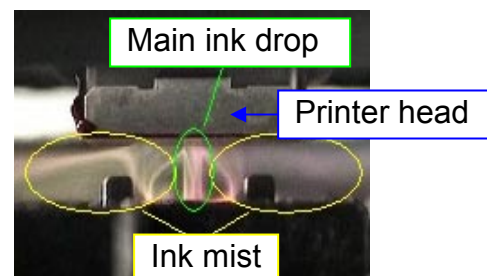
- The model in the photos is the T-MF1.
- The ink mist (see CAUSE below) has no effect on the function of the belts.
- In the photos above, the ink mist looks magenta when attached to a dark surface, and black when attached to a light surface. However, the actual amount of ink mist released is the same for each ink color.

Normally, a small amount of ink mist is discharged from the nozzles. When it does, air streams or the electrical charge on the transport belt can sometimes redirect the mist. As a result, this mist does not hit the target area (on the paper). This symptom is noticeable when printed under the conditions listed below.

- High print volume
- Low P/J
- High Quality Mode is used
- Paper with a high surface resistance is used, such as recycled paper
- The envelope lever is in the envelope position when printing onto plain paper
