Model: T-G1	Date: 5-Jun-06	No.: RJ007001b
-------------	----------------	----------------

Subject: Firmware Release History		Prepared by: Hiromoto Saitoh	
From: 1st Tech. Support Sec. Service Support Dept.			
Classification:	<input type="checkbox"/> Troubleshooting <input type="checkbox"/> Mechanical <input type="checkbox"/> Paper path <input type="checkbox"/> Product Safety	<input type="checkbox"/> Part information <input type="checkbox"/> Electrical <input type="checkbox"/> Transmit/receive <input checked="" type="checkbox"/> Other ()	<input type="checkbox"/> Action required <input type="checkbox"/> Service manual revision <input type="checkbox"/> Retrofit information

This RTB has been issued to announce the firmware release information for the controller

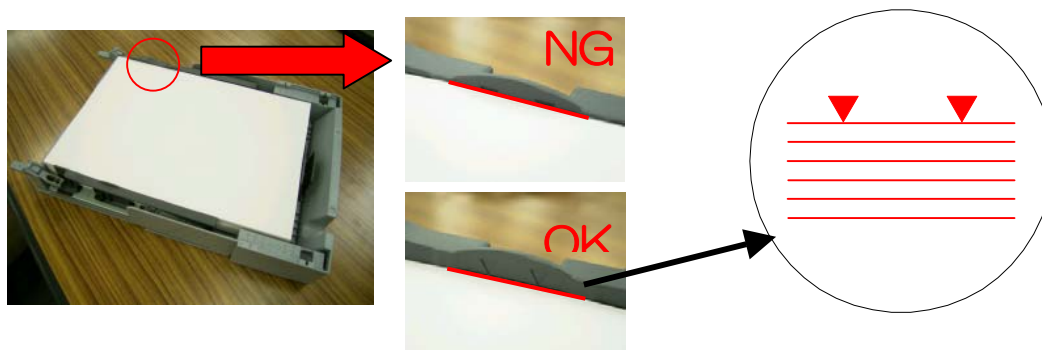
A multi-feed jam occurs and causes a critical EM condition (e.g. encoder sheet damage, print head damage, jammed paper remaining in the machine, etc. See below.)

Advise the customer on the correct way to load the paper:

- When the paper tray is fully pushed in, the rear side of the paper stack is raised by the tray's bottom plate. Therefore, when you want to load new paper inside the tray, first pull the cartridge toward you until the paper stack is completely flat. Then, load the new paper in the tray.
- Be sure not to load more paper in the tray than its capacity.
 - Do not load paper higher than the triangles on the label inside the tray (see below).
 - For 80g/m² plain paper, the maximum number of sheets is 250.

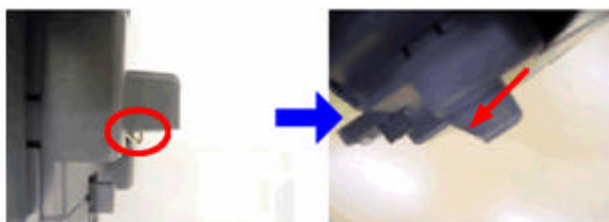
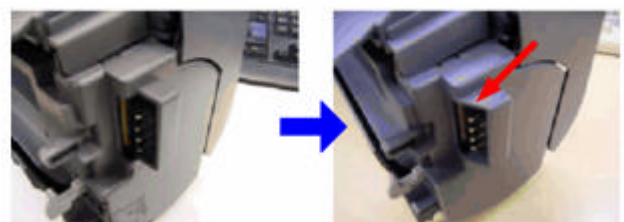
The duplex unit is opened/closed with excessive force many times. As a result, one or more of the terminal pins on the duplex unit connector is bent or damaged.

If the symptom is reported from the field, and you confirm that one or more of the pins is bent or damaged:

- Advise the customer to open/close the duplex unit more carefully
- Replace the duplex unit.

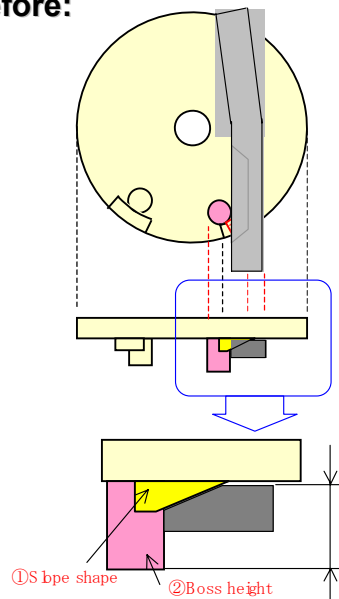
Before:

1. The shape of the lever was changed.
2. The height of the pin was changed.

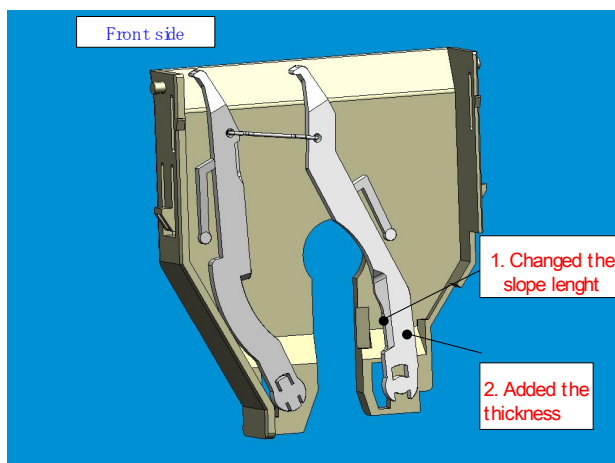
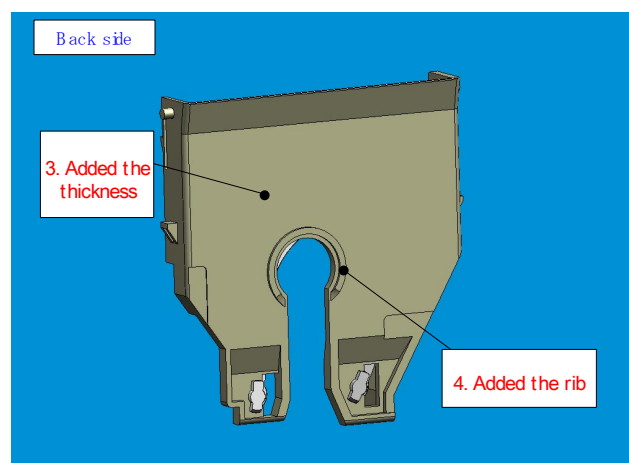
Step 2 (Applied from: Feb. 2008 production):

1. The slope length was changed.
2. The thickness of the lever was changed.
3. The thickness of the plastic backing plate was **increased**.
4. A rib was added.

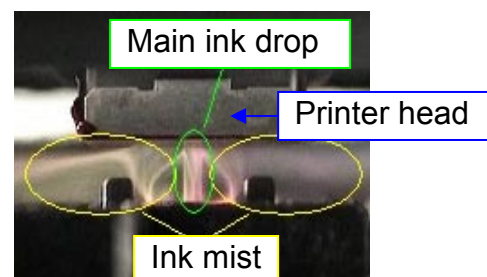
Normally, a small amount of ink mist is discharged from the nozzles. When it does, air streams or the electrical charge on the transport belt can sometimes redirect the mist. As a result, this mist does not hit the target area (on the paper). This symptom is noticeable when printed under the conditions listed below.

- High print volume
- Low P/J
- High Quality Mode is used
- Paper with a high surface resistance is used, such as recycled paper
- The envelope lever is in the envelope position when printing onto plain paper
