Model: T-G1W	Date: 07-Aug-07	No.: RJ016001a
--------------	-----------------	----------------

Subject: Firmware Release History		Prepared by: Gimpei Hirao	
From: 1st Tech. Support Sec. Service Support Dept.			
Classification:	<input type="checkbox"/> Troubleshooting	<input type="checkbox"/> Part information	<input type="checkbox"/> Action required
	<input type="checkbox"/> Mechanical	<input type="checkbox"/> Electrical	<input type="checkbox"/> Service manual revision
	<input type="checkbox"/> Paper path	<input type="checkbox"/> Transmit/receive	<input type="checkbox"/> Retrofit information
	<input type="checkbox"/> Product Safety	<input checked="" type="checkbox"/> Other ()

This RTB has been issued to announce the firmware release information for the engine

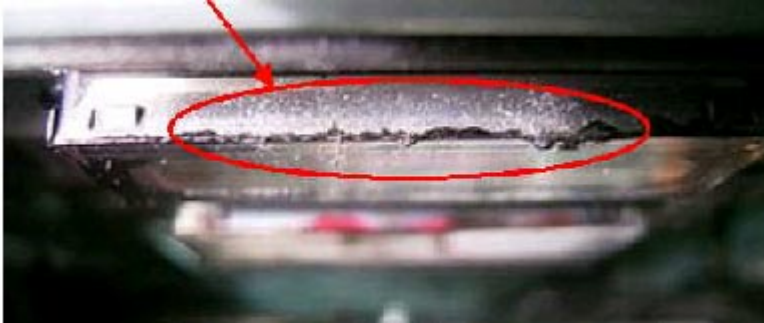
Cause

Paper dust or ink builds up on the nozzle cover and then scratches the paper/stack.

Solution

Clean the nozzle cover and nozzle plate.

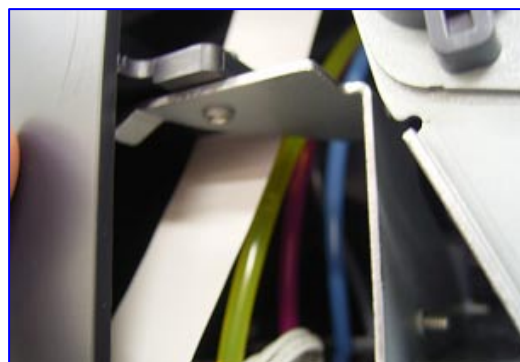
< Normal Condition >

The operation harness was assembled while caught on the front stay. This may cause an electrical short in the harness and smoke can be generated from the short area.

Re-assemble the operation harness according to the procedure below.

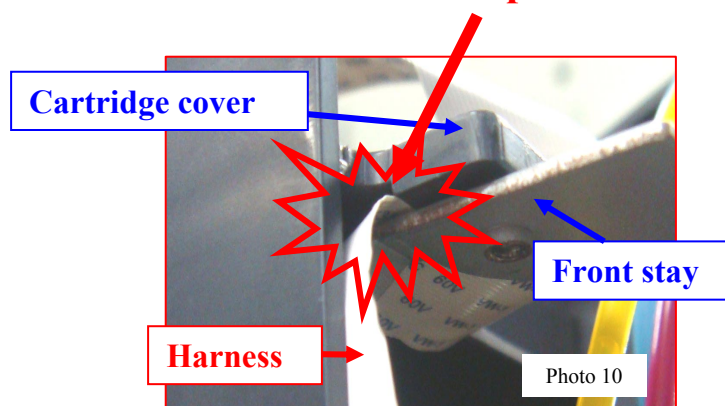
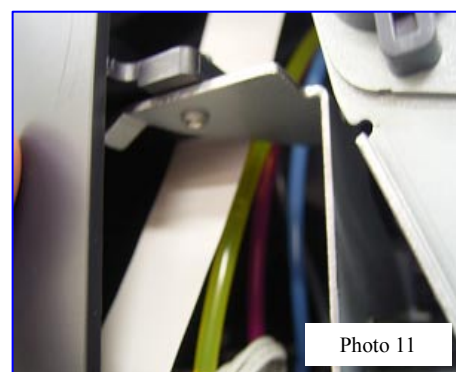
(view from below, right side)

NG: Harness is pinched

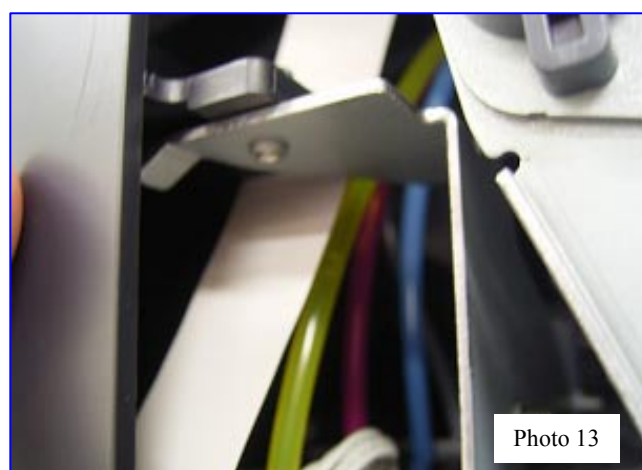
OK: Normal position

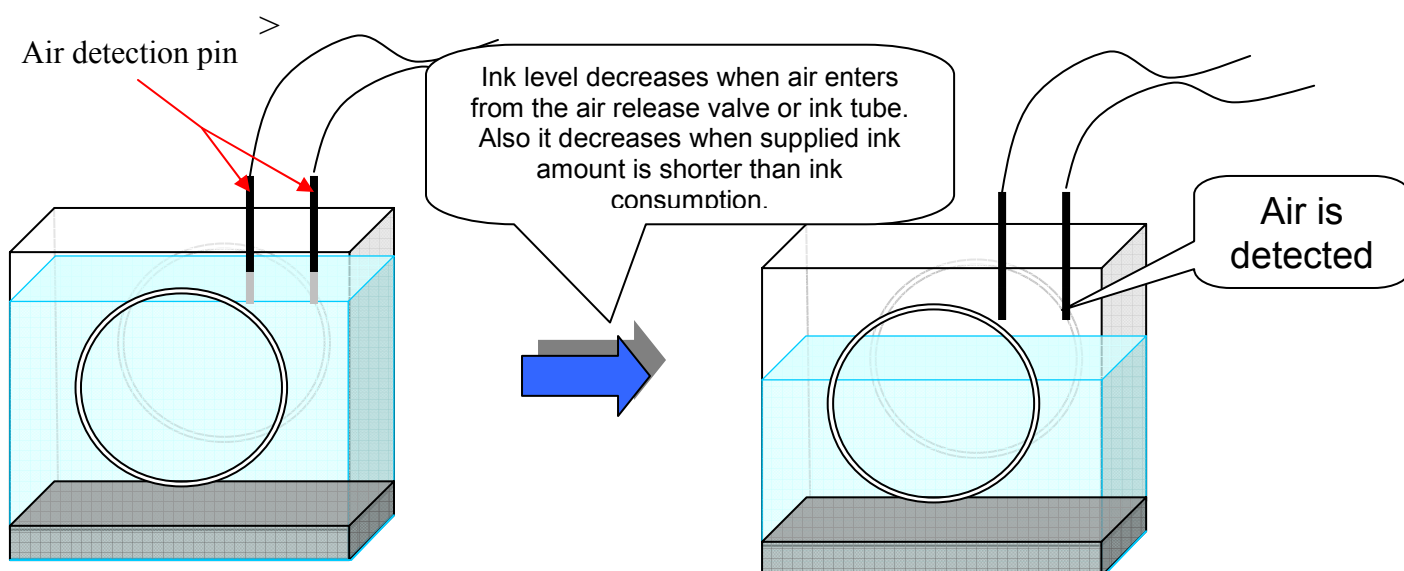
< Schematic view of head tank

- In order to eject the ink properly from the print head, it is necessary to maintain negative pressure (with respect to the surrounding air) inside the head tank. If negative pressure is lost, the ink can leak out from the nozzle and adversely affect the image quality. If this occurs, the negative pressure must be re-established. This process is known as "air release filling".
- When the surface of the liquid dips below the detection pins (see diagram below), the machine will perform air release filling. This is because if this happens, negative pressure may have been lost. To perform air release filling, the air release valve is opened (which re-calibrates the internal pressure), ink is poured into the ink head, and suction the ink by suction cap with air release valve is closed. Therefore, to perform this process, the machine consumes ink.

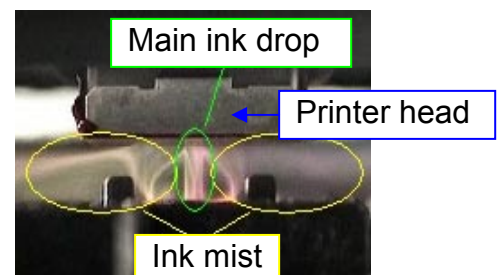
Normally, a small amount of ink mist is discharged from the nozzles. When it does, air streams or the electrical charge on the transport belt can sometimes redirect the mist. As a result, this mist does not hit the target area (on the paper). This symptom is noticeable when printed under the conditions listed below.

- High print volume
- Low P/J
- High Quality Mode is used
- Paper with a high surface resistance is used, such as recycled paper
- The envelope lever is in the envelope position when printing onto plain paper

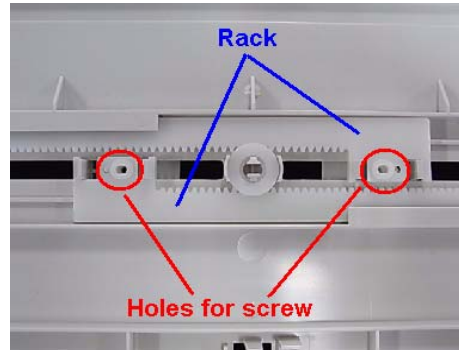
Changes made to the rack and side fences:**Rack: Side Fence**

Screw holes were added.

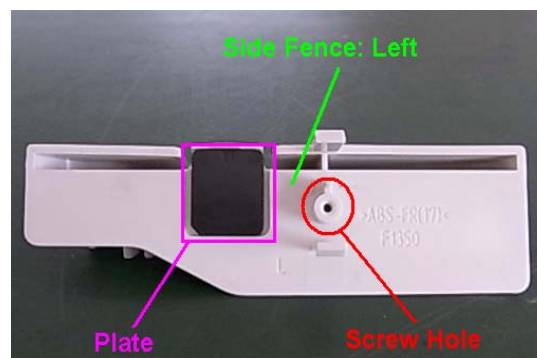
**Side Fence: Left / Plate: Side Fence: Left**

A screw hole and a plate were added.
