Model: M-G1a	Date: 25-May-09	No.: RJ017001j
--------------	-----------------	----------------

Subject: Firmware Release Note: Engine/Controller		Prepared by: Y. Gaman	
From: 1st Tech Service Sect., MFP/Printer Tech Service Dept.			
Classification:	<input type="checkbox"/> Troubleshooting <input type="checkbox"/> Mechanical <input type="checkbox"/> Paper path <input type="checkbox"/> Product Safety	<input type="checkbox"/> Part information <input type="checkbox"/> Electrical <input type="checkbox"/> Transmit/receive <input checked="" type="checkbox"/> Other ()	<input type="checkbox"/> Action required <input type="checkbox"/> Service manual revision <input type="checkbox"/> Retrofit information <input checked="" type="checkbox"/> Tier 2

This RTB has been issued to announce the firmware release information for the **Engine/Controller**.

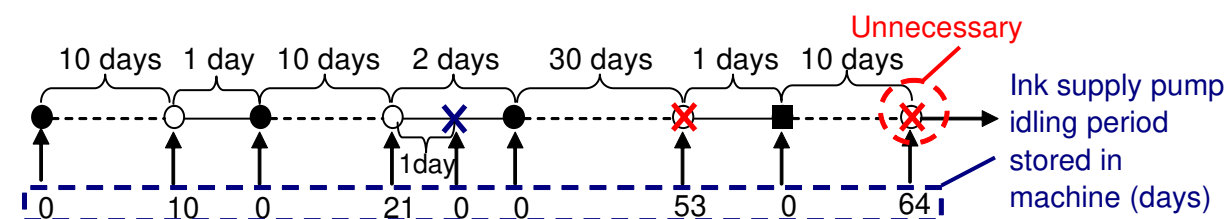
Old:

Note: Ink purge will be performed when the monthly print volume is under 10 pages (5% chart at 3P/J) because the ink pump does not rotate for such a low print volume. Therefore, for customers who make mainly black and white printouts, the color ink pumps will not rotate, and the ink purge will be initiated for the color pumps.

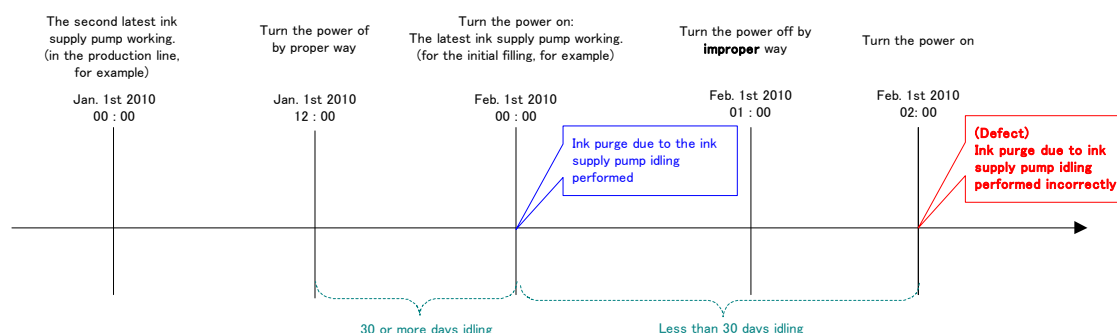
Fig. 5: Ink purge due to disconnection of the power cord (1)

- If the power cord is removed after initial ink filling:

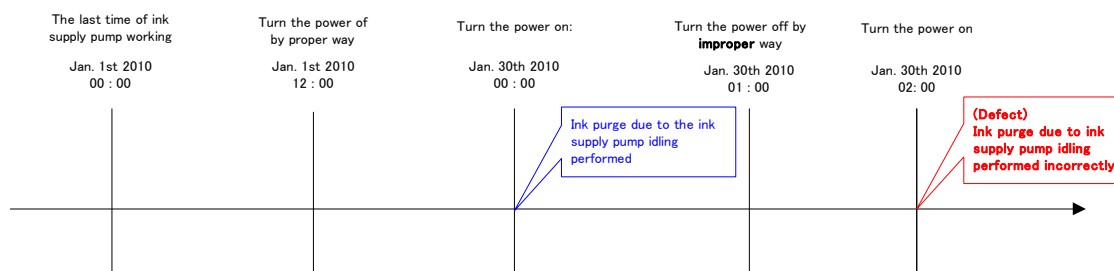
- If the power cord is removed after ink purge due to ink supply pump idling is performed:

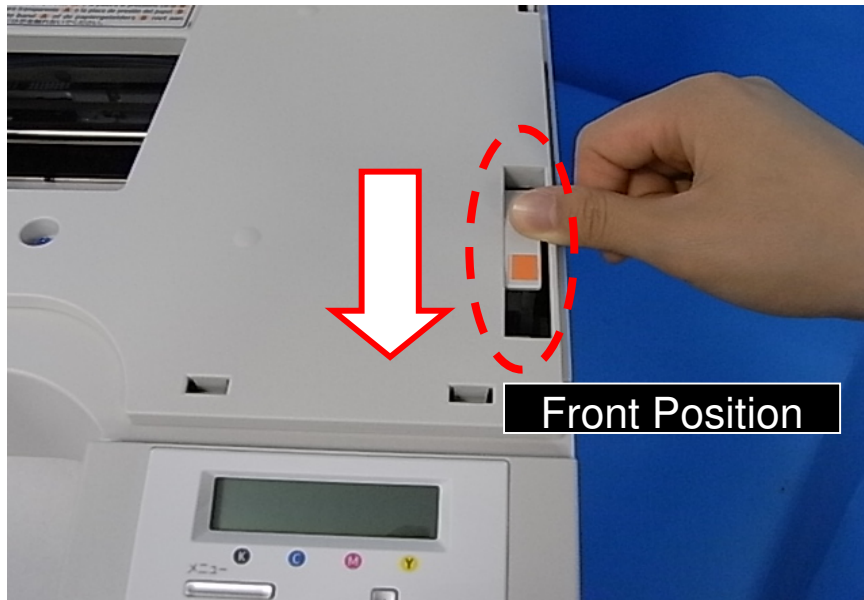
The carriage position lever is mistakenly set to the envelope position (rear position), which raises the carriage unit. A gap develops between the print heads and caps on the maintenance unit. As a result, the machine cannot properly perform ink suction (which causes the SC) or head cleaning (which causes the white lines).

1. Please remind users not to move the carriage position lever to the envelope position when performing ink initialization. Also, remind them that the lever should be set to the front position except when printing onto envelopes.
