Technical Bulletin

Model: Andromeda-P2		Date: 6	Jun-18	No.: RM0B1001
Subject: SP modification to change special characteristic v of the TIM-RED/MAG unit shading plates		ristic values	Prepared b	9 y : Hiroaki H Matsui
From: PP Tech Se	rvice Dept., 1st PP Tech Service S	ect.		
Classification:	□ Troubleshooting □ □ Mechanical □ □ Paper path □ □ Product Safety □	Part informa Electrical Transmit/rec Other (tion ceive) X	Action required Service manual revision Retrofit information Tier 2

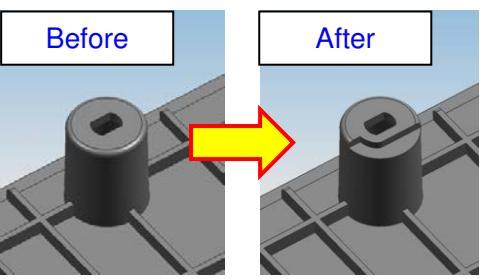
The projection on the rear cover of the operation panel will be modified of its shape to prevent contact with the resistor.

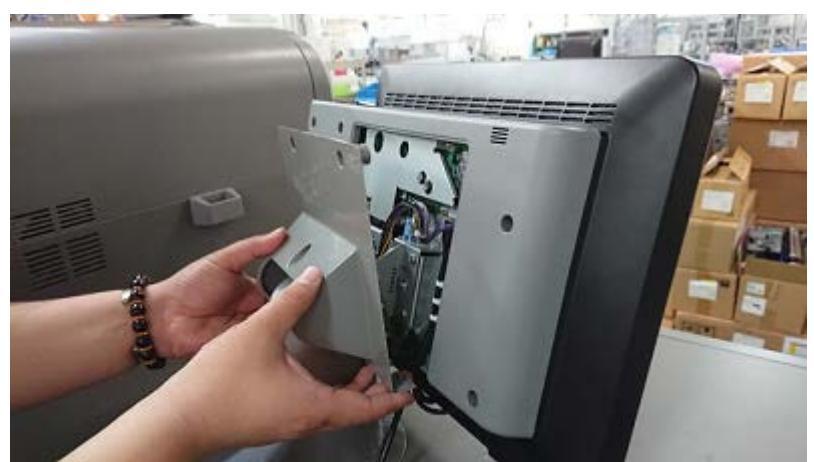
Make sure the two hooks at the bottom of the rear cover are hooked onto the panel (as mentioned on page139 of the FSM).

Take note of the following points when attaching the rear cover of the operation panel at installation, to avoid breakage of the resistor.

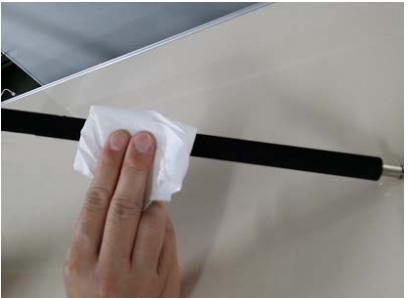
If wiped with wet cloth, make sure to dry the roller before installing.

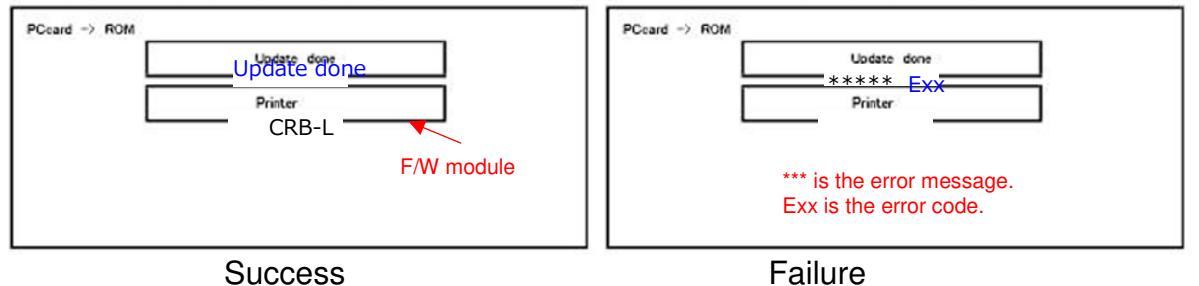
A successful firmware update is notified by the operation panel displaying "Update done." However, if the update fails, the failure is notified with an error code SC (See FSM for detail on error codes.) Power cycling the machine OFF/ON will not resolve the error and the firmware update screen will not disappear until the firmware is successfully updated.

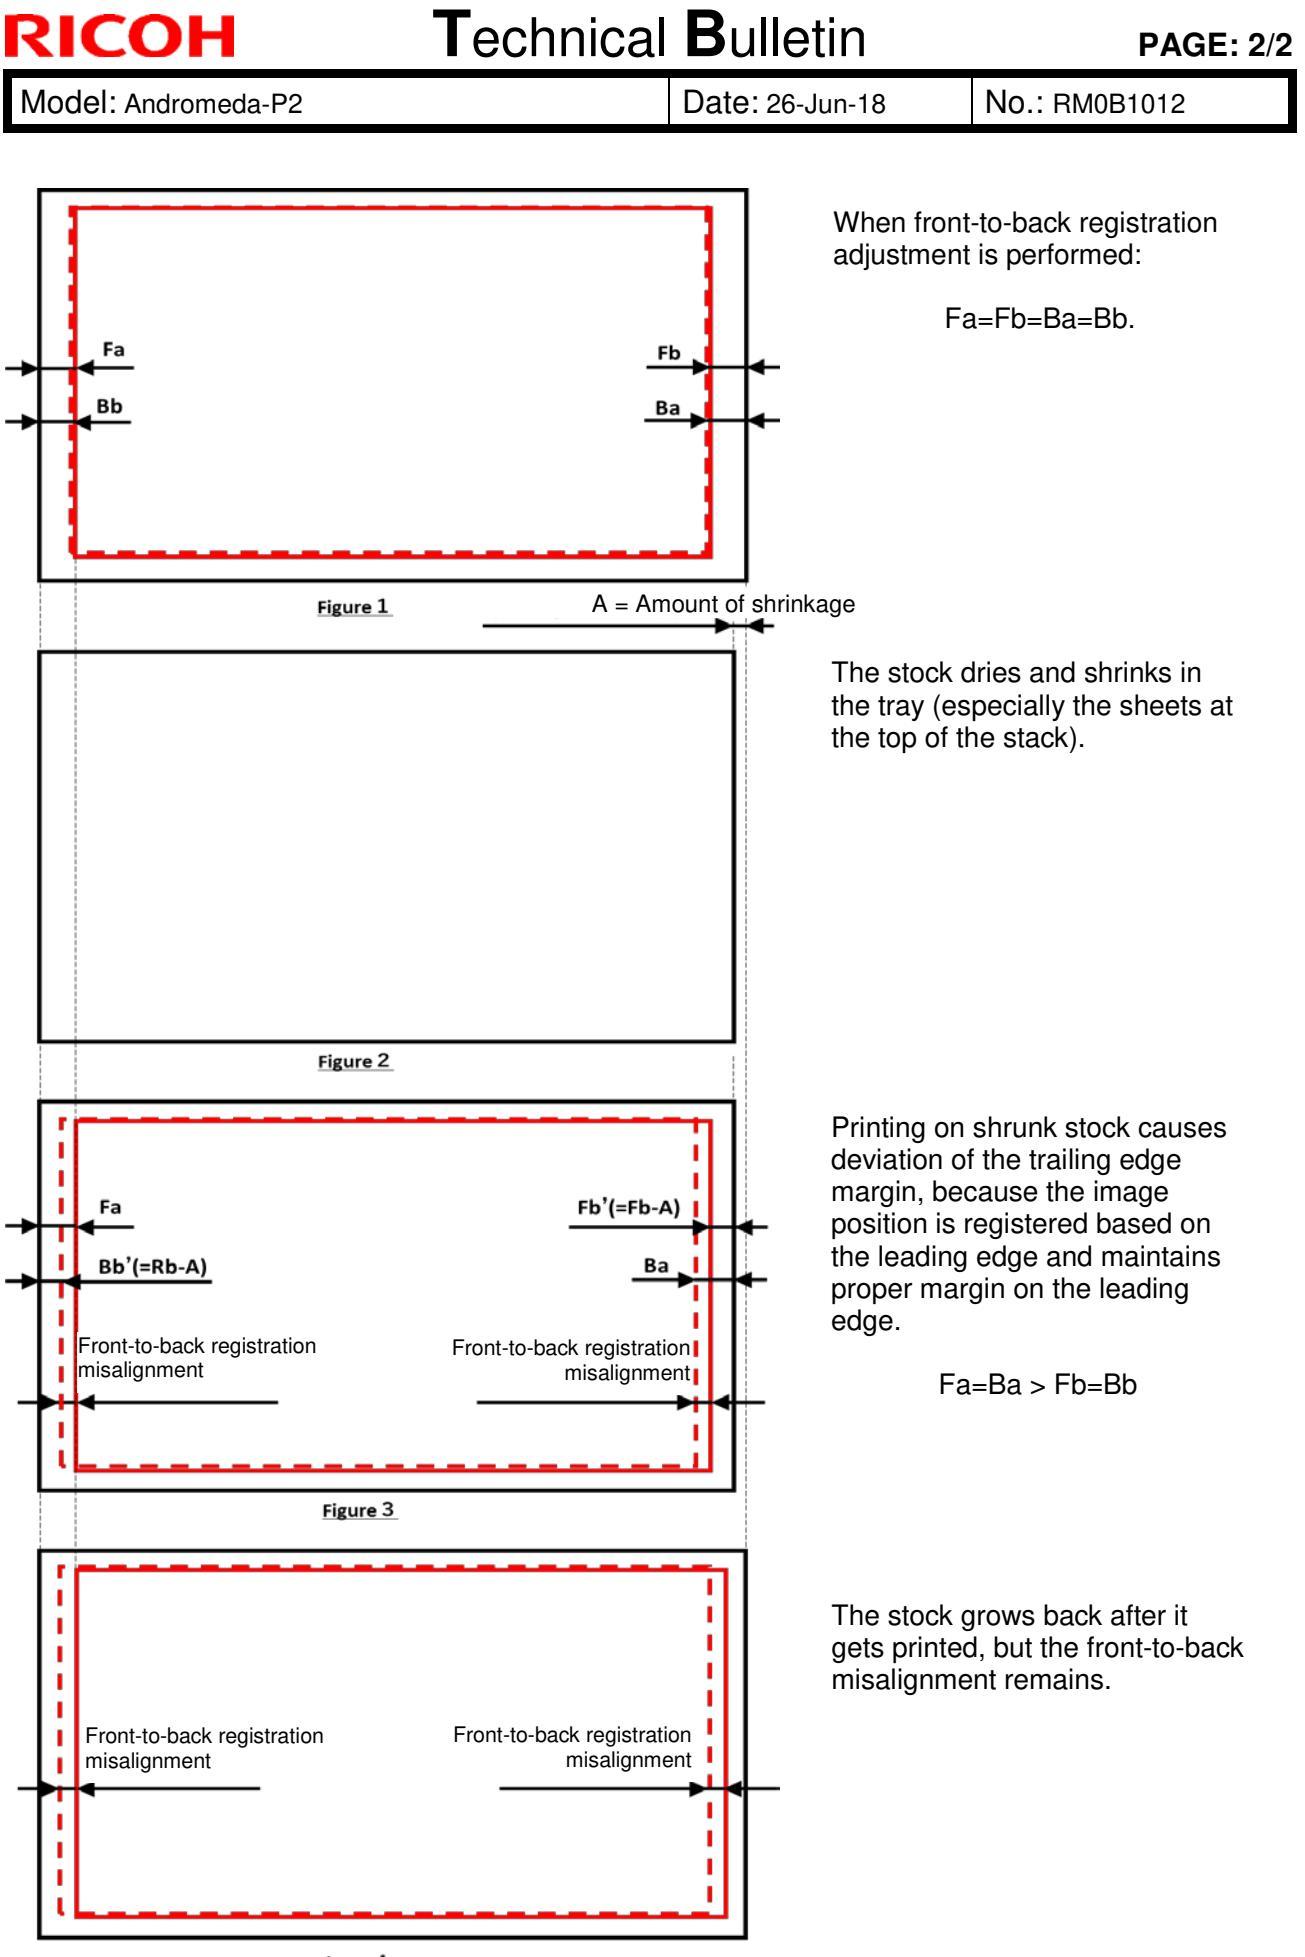
Figure 4

CAUSE

The size of the paper fluctuates due to moisture absorption. (See next page for detail.)

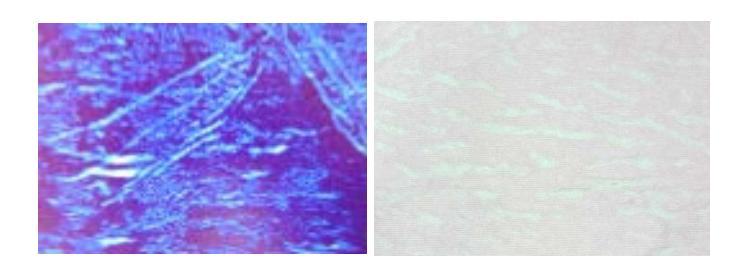
SYMPTOM

White spots (toner not transferred) in depressed/concave portions on surface of textured media.

CAUSE

Insufficient or excessive paper transfer voltage for textured media

Adjust the paper transfer output or paper transfer pressure. See **PROCEDURE** below.

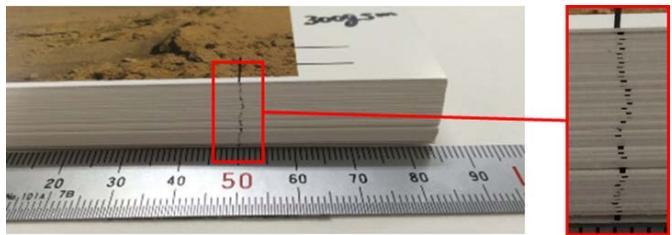
SYMPTOM

Image scaling in sub scan direction (feed direction) fluctuates especially with Weight 7 or heavier stocks.

CAUSE

High image coverage (lots of toner) causes slippage between the paper and the PTB (paper transfer belt).

- 2. Select a media entry indicated with the suffix '_RA' from the media library or set Advanced Settings #1331-02 and #1229-01 to the 'For troubleshooting' values described in the table below.
 - For entries with the suffix '_RA', the default value of the PTB Speed and Transfer Pressure were modified to prevent the above symptom.
 - Note the possible side effects of Color registration shift and Grainy image when applied of the following revised settings.

Advanced Settings	Default	For troubleshooting	
#1331-02 PTB Speed	0%	0.5%	
#1229-01 PTB Pressure	0	3

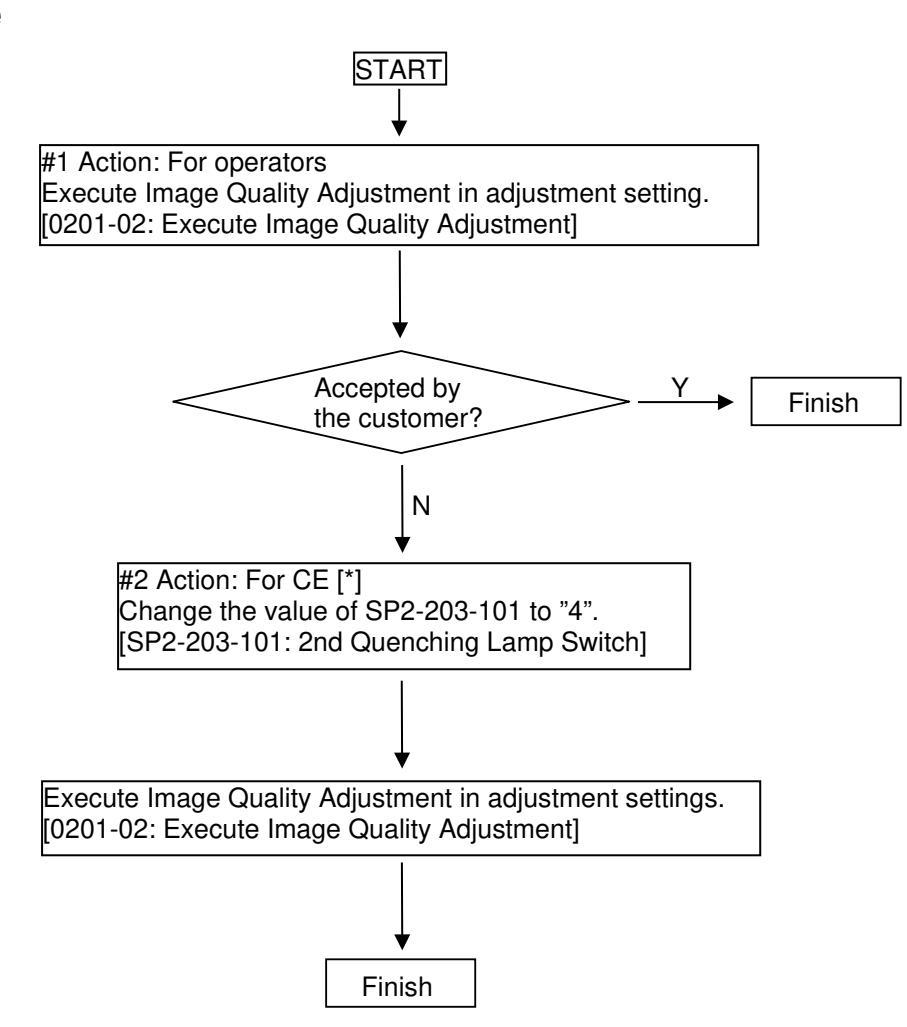
A ghost image may occur at a pitch of about 310 mm in low-temperature, low-humidity environments (absolute humidity of about 3.5 to 5.0 g/m3).

- It is likely to occur in an environment where the 2nd quenching lamp turns off (absolute humidity less than 5.0 g / m 3)
- The higher the development γ (the higher the absolute humidity), the lower the margin.
- It is likely to occur at an absolute humidity of about 3.5 to 5.0 g / m 3

By adjusting the development γ , the image creation condition is adjusted to the area where no ghost image occurs.

Note [*]:

As a side effect, uneven density image (streak along the paper feed direction) in halftone area may occur. When it occurs, refer to the following troubleshooting in the service manual.

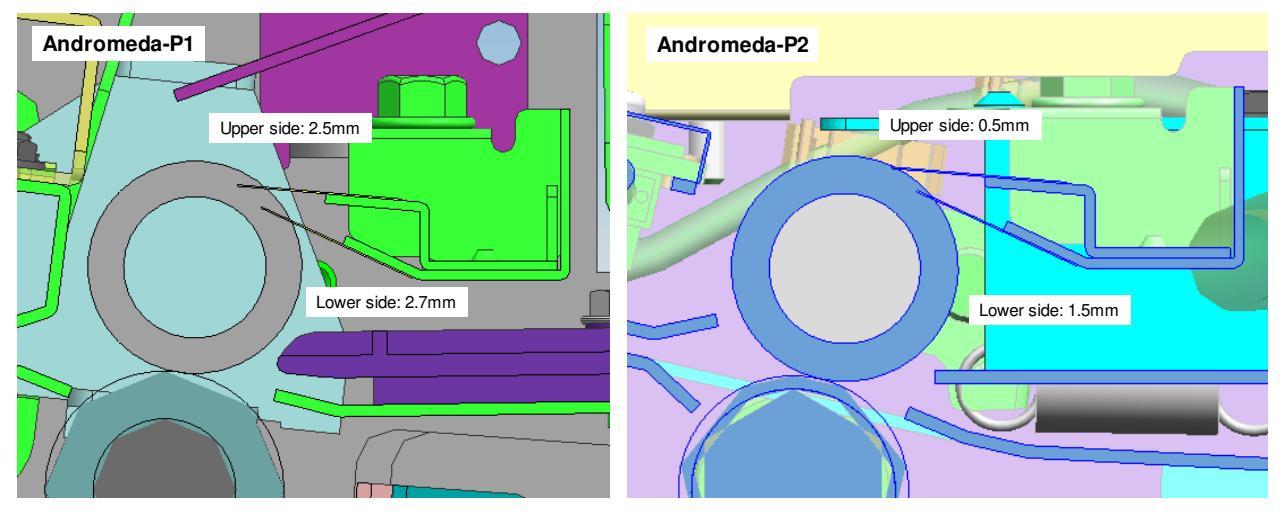
- The contact area of the scraper is lower than on the Andromeda-P1. This in turn results in insufficient paper dust removal.
- The symptom is more likely to occur when using paper with a thickness of 7 or higher that contains a large amount of paper dust.

Amount of contact between the scraper and roller:

Replace to the following modified parts using the PROCEDURES below.

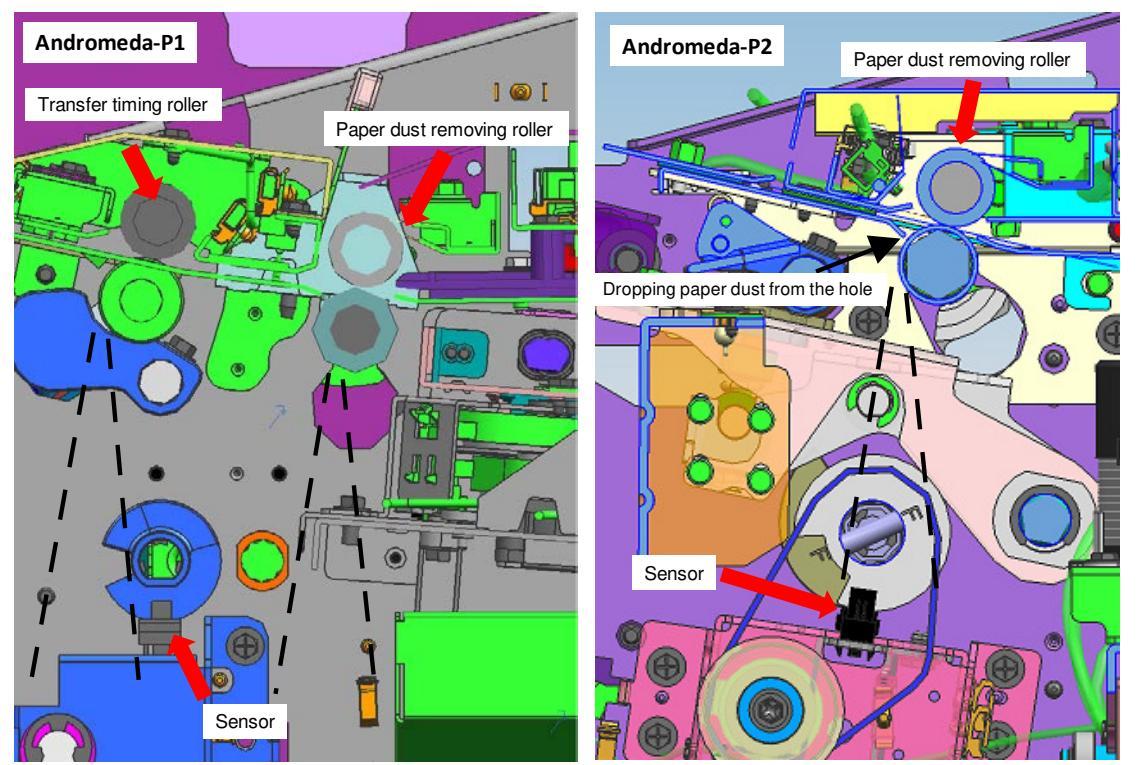
Locations of the PTR position sensor and paper dust removing roller:

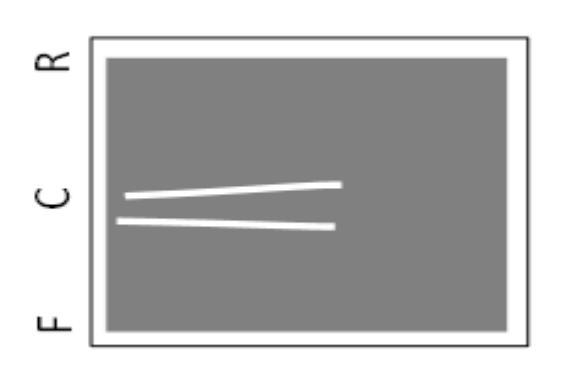
The following two symptoms occur in conjunction when printed in duplex on synthetic paper:

- 1) On the first side, 'River marks' gloss differential in the shape of river is observed.
- 2) On the second side, gloss streaks are observed as an after effect of river marks.

Lower the fusing temperature by referring to the flowchart on the next page.

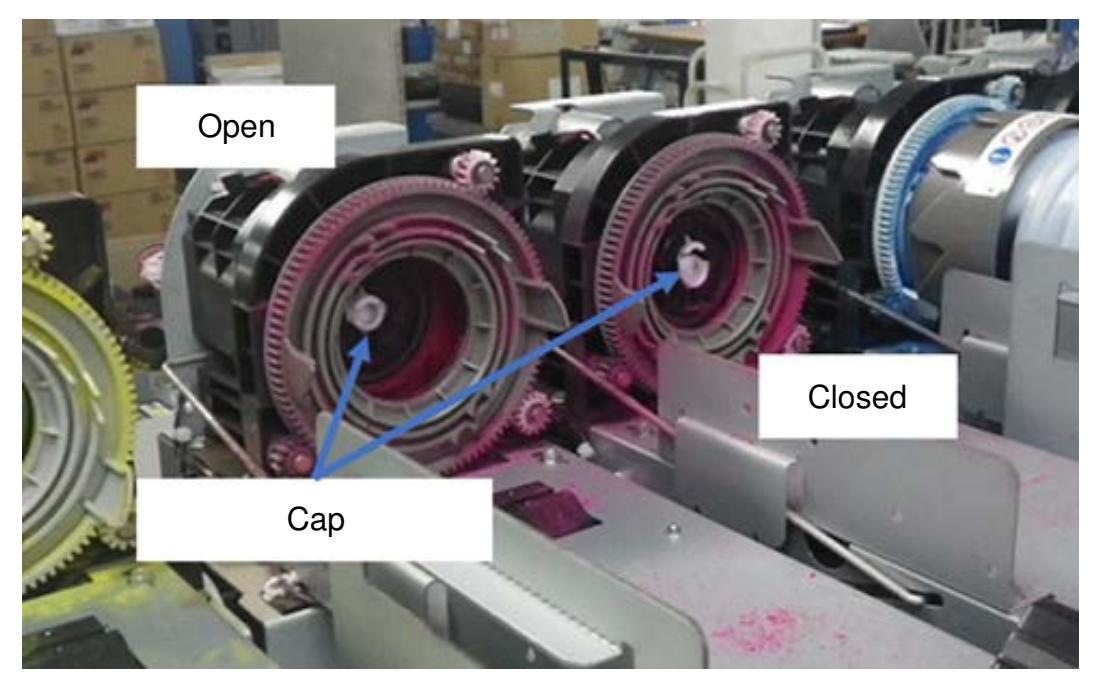
Open : The cap sinks in.

Closed : The cap sticks out.

- 1. Enter the SP mode and select the affected toner bottle(s) from SP3-162-001 to 008.
- 2. Set the SP to [1: Open], to open the toner bottle cap.
- 3. Verify that the cap opens.
- 4. Set the SP to [0: Close] and then to [1: Open].
- 5. Verify that the cap closes and opens smoothly.
- 6. Set the SP to [0: Close], to close the cap.

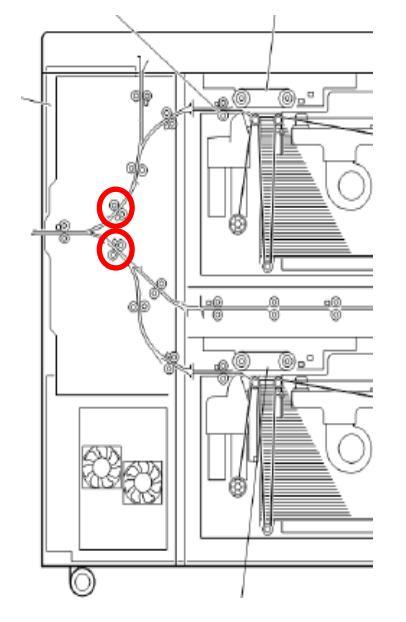
The trailing edge of banner sheets is curled and damaged by the transport rollers when printed from the Vacuum Feed Banner Sheet Tray Type S9 or Multi Bypass Banner Sheet Tray Type S9.

The sheet buckles and the vertical transport exit rollers in the LCIT rub the trailing edge due to the slight difference in the paper transport speed between the mainframe and LCIT.

The problem occurs under the following conditions:

- 667~700mm banner sheets
- Weight 4, 5
- NOTE: The number of Vacuum Feed LCIT RT5120 units installed is irrelevant to the problem.

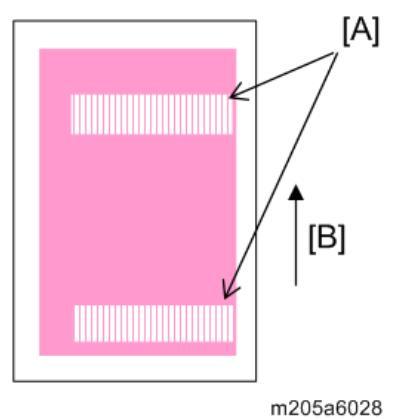
Figure 1. Example of abnormal image

White areas appear inside halftone images at 310mm intervals.

[A]: White areas appear inside halftone images at 310mm intervals.

Corona products emitted from the charger unit react to the lubricant on the surface of the OPC drum and this causes abnormal electric potential, which leads to the appearance of white areas. Correct it by removing the objects on the OPC drum surface.

- 1. Print the pattern SP2-109-003-12 in each of Black/Cyan/Magenta/Yellow on A3 or DLT sheets of paper to identify which color the white areas appear on.
- 2. In [Adjustment Settings for Operators], execute 0509 [Execute Photoconductor

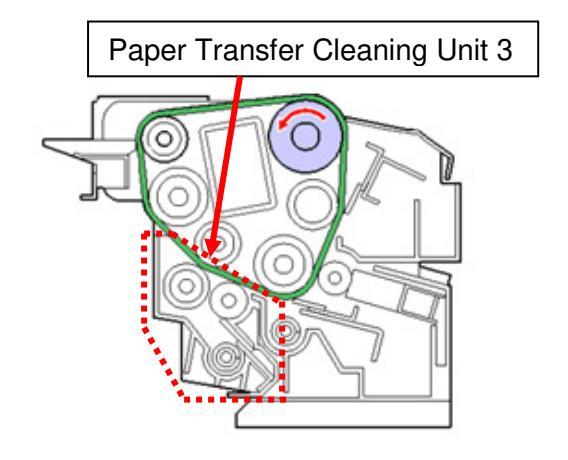
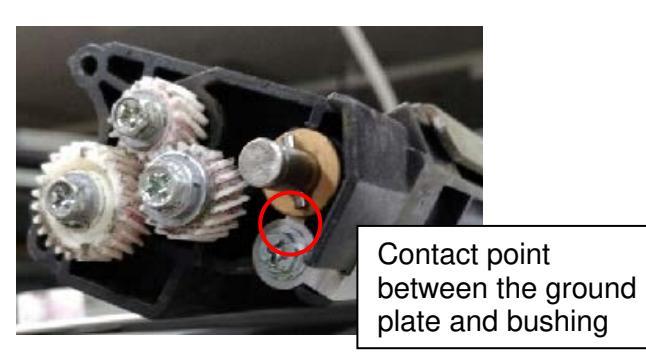
Ground fault occurs after replacing with a new ground plate (p/n: M0B16466) contained in 'Paper transfer cleaning unit 3' of the PTR unit, because the ground plate is not installed correctly and is not in contact with the bushing.

Set the ground plate correctly in the following procedure.

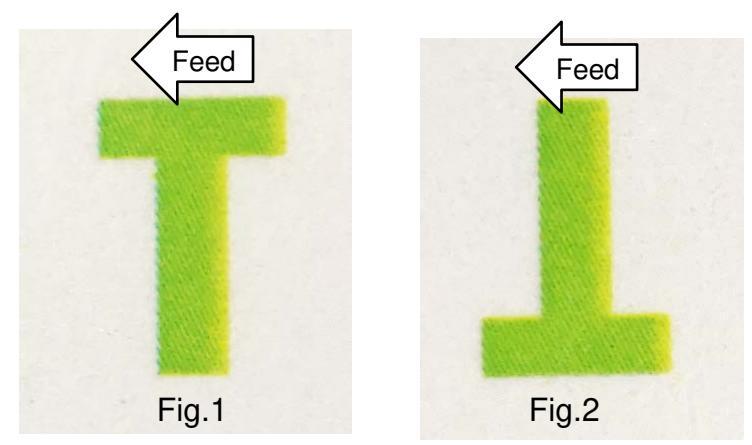
If the blur appears at the edge toward the trailing side of the texts as in Fig.2 below even after rotating 180 degrees, it is not a color registration problem.

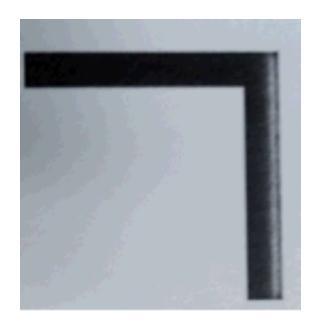
Images located near the main-scan paper edge may blur when printing onto paper wider than 321.5mm. In some cases, the accuracy of image position feedback may also worsen.

The adjustment of the image center and paper feed center performed at the factory (in order to align the two) was near the specification upper limit. As a result, the image may sometimes be transferred outside the area defined by product warranty.

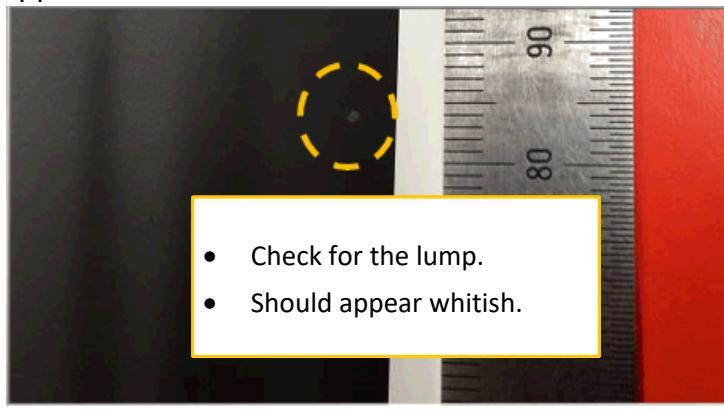
Foreign substance adhered to the belt should be projected from the belt surface and appear whitish.

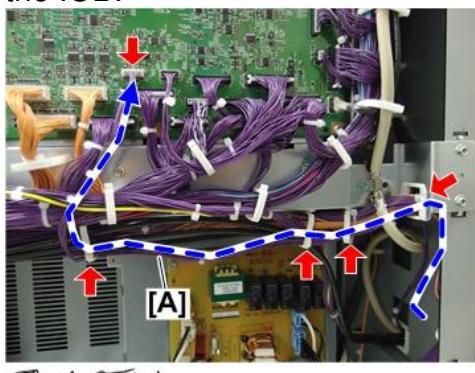
Incorrect:

14. Route the one harness (purple) [A] as shown below, and then connect it to CN354 on the IOB.

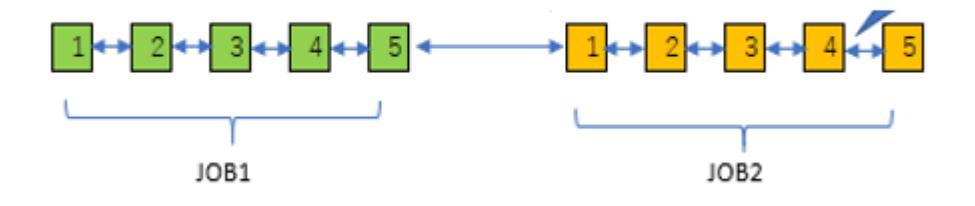
Normally, when the target fusing temp differs by at least degrees between two jobs with different paper type/size/weight, the system waits until the target temp is reached before starting the second job. Once reached, the job is printed at the rated speed. This is the expected behavior by spec.

However, the bug in the f/w forces the system to check if the target fusing temp is reached for every page of the second job even after the target temp was achieved at the start of the second job, thus considerably decreases the print speed.

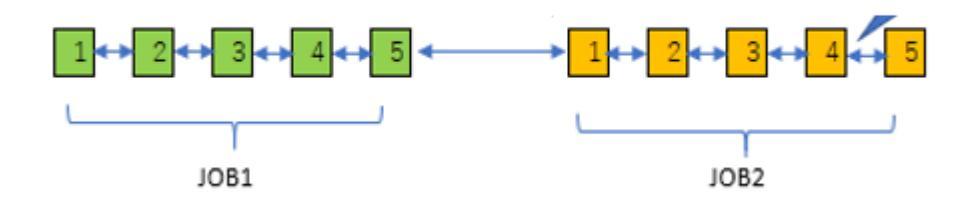
Normally, when the target fusing temp differs by at least degrees between two jobs with different paper type/size/weight, the system waits until the target temp is reached before starting the second job. Once reached, the job is printed at the rated speed. This is the expected behavior by spec.

However, the bug in the f/w forces the system to check if the target fusing temp is reached for every page of the second job even after the target temp was achieved at the start of the second job, thus considerably decreases the print speed.

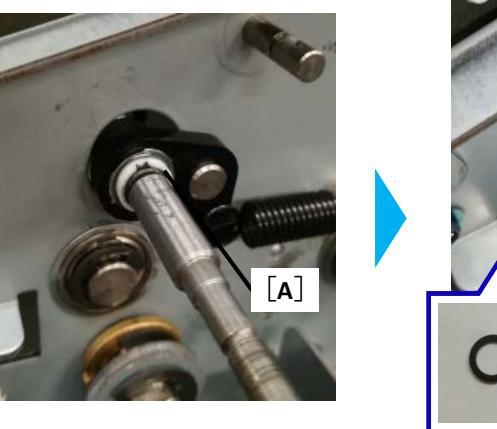
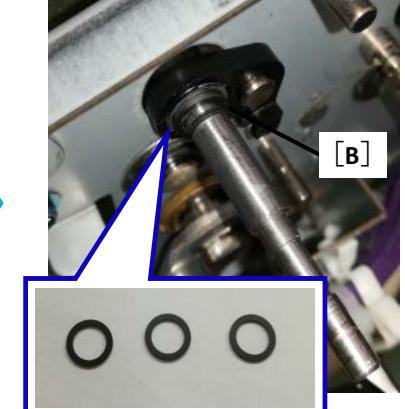
This spacer is supposed to be 1.6mm thick. If it is 0.5mm or thinner, replace with a new set of spacers [B].

1. Check the spacer. If it is 0.5mm or thinner, replace it with a new set of spacers, and then apply grease to the shaft of the transfer timing roller.

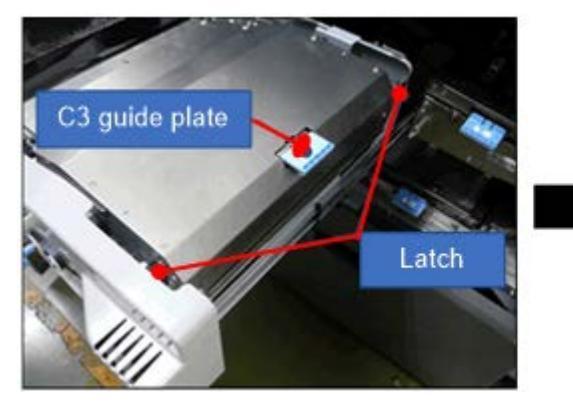
When the [C3] guide plate is opened and then closed, for instance, to remove a jam, the guide plate is not shut completely before pushing back in the registration (drawer) unit or the guide plate opens due to the shock generated when the drawer unit is pushed back in. Initialization under this condition causes the registration contact timing motor to miss steps, resulting in the SC.

The guide plate is shut but the latch is open.

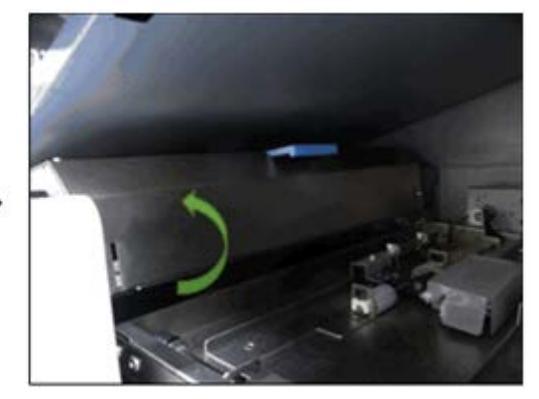
The shock generated when the drawer unit is pushed back in causes to open the guide plate.

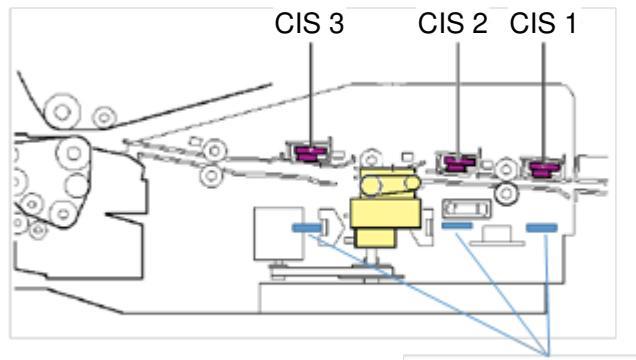
Shading plate (x3)

Paper dust accumulates on the shading plate that positions under the CIS in the registration unit and affects the CIS output level. Paper edges are not detected with accuracy in this state. The risk of the problem is higher under the following conditions:

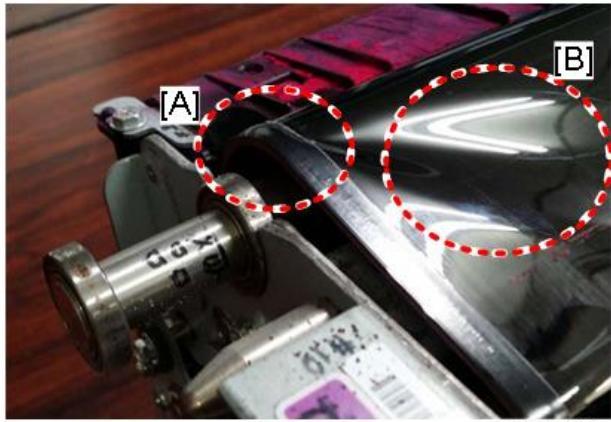
m0b2c9901

Touch the belt edge with your fingers. If the edge is running over, the difference in level should be at least 1.5mm.

Note that wavering can occur even when the belt is installed correctly without the edge running over.

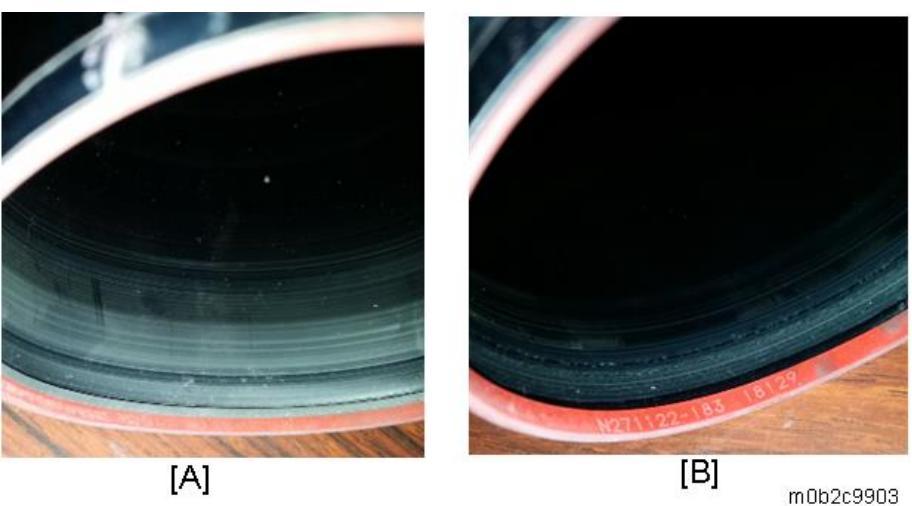
Photo [A] shows an example of a belt that ran over the edge.

Photo [B] shows an example of a correctly installed belt. The color of the belt guide remains red.

• When the belt runs off the edge, abrasion causes the belt guide to change its color from red to gray. Area [C] shows the affected area and [D] the unaffected area.

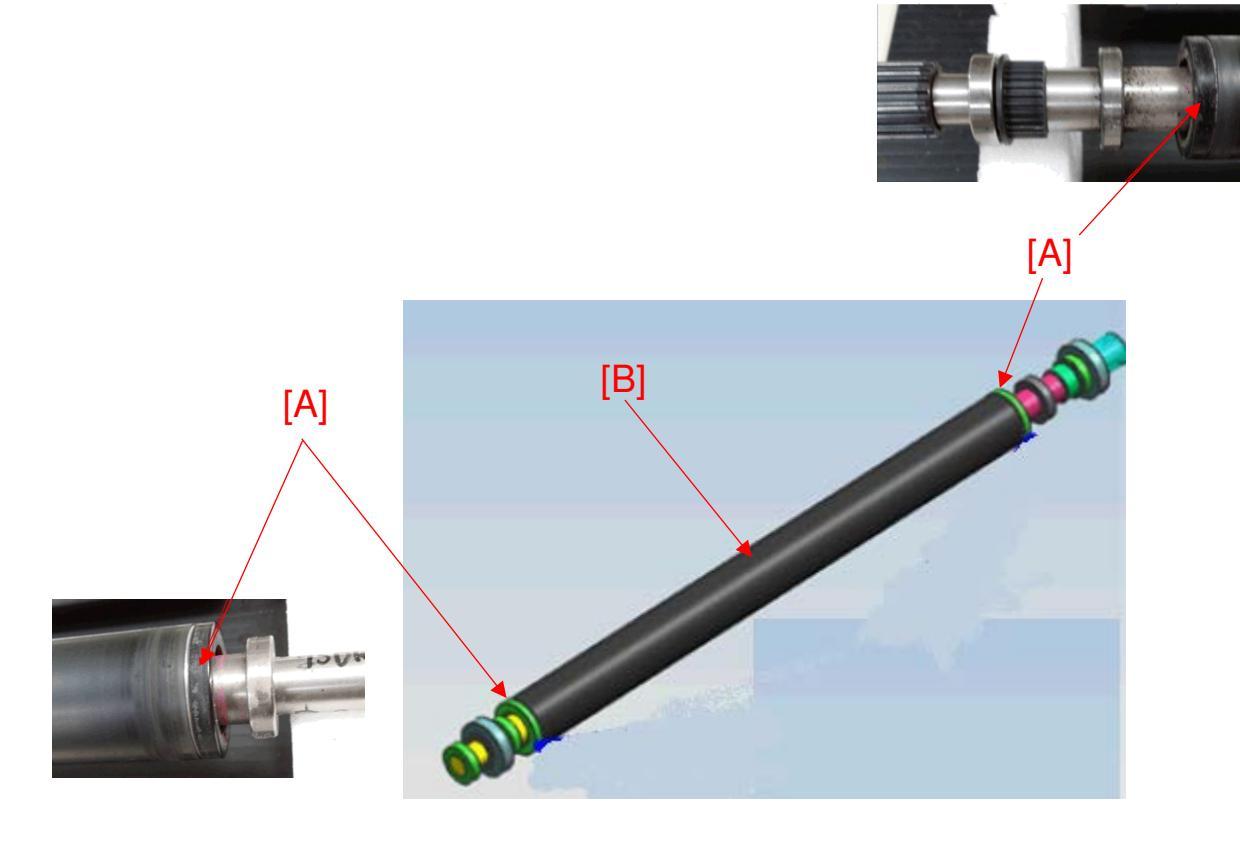
- DO NOT use alcohol or water. Doing so will remove grease applied at the factory from the plastic part [A].
- DO NOT touch the plastic part [A]. Oil from your fingers will affect the grease.

If the counter value of SP7-621-001 (PM Counter/#Development Unit(Bk)) is greater than 1900k, replace the paper transfer roller [B] with a new one (p/n: M0B16249).

This helps the PTB (paper transfer belt) to revolve properly on the guide without derailing, preventing unwanted damages to the belt.

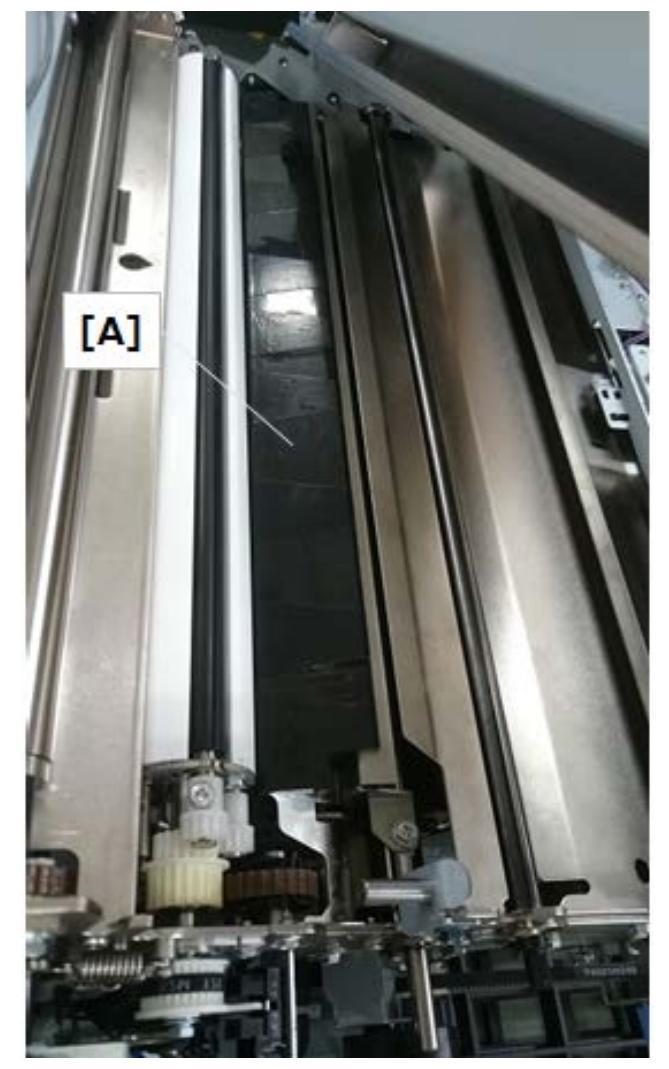
The operation time of the inverter unit gate pawl and shape of the pawl bracket were changed, which altered the point where the pawl contacts the cushion. As a result, impact is greatly magnified, which damages the pawl bracket and prevents the pawl from operating correctly.

15. Remove the gate pawl [A] and then replace with the modified parts.

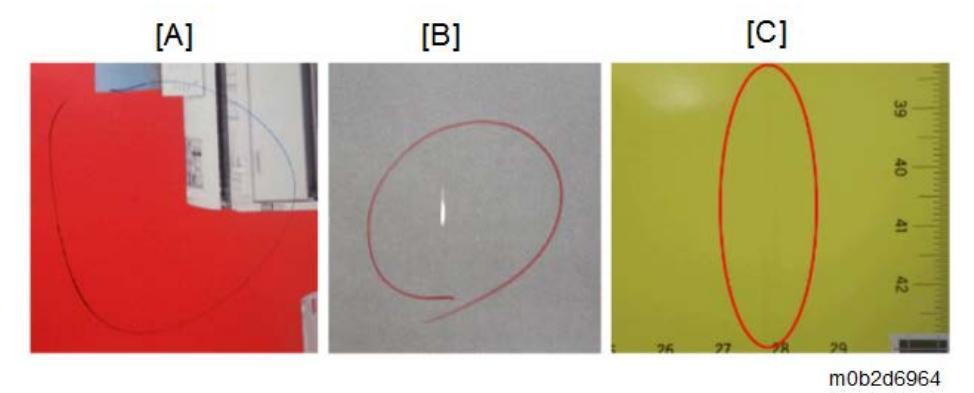
- A) Toner drops and dirties the printout.
- B) An unprinted mark is observed on the printout caused by reverse transfer.
- C) Streak along the feed direction appears in yellow images.

Waste toner on the ITB reverse transfers to the drum and hinders proper drum cleaning when all the following conditions are met, which is a rare case:

1. If both of the following conditions are met, set SP3-261-032 (Current Environment (Main): Abs Humidity Thresh2 (Main)) to '**3.30**' (default: 5):

- 2. Turn Off the machine power.
- 3. Disassemble the ITB lubrication unit and clean the lubricant bar and brush. See section '4. Replacement and Adjustment > ITB Lubrication Unit' of the FSM for the procedure.
- 4. Do the cleaning procedure described in section '3. Preventive Maintenance > Cleaning Points (1) > Intermediate Transfer Belt (ITB) Unit' of the FSM.
- Do the cleaning procedure or replace with a new set of drum cleaning blade and lubricant blade for the affected color(s). See section 'Appendices > 2. Appendices: Preventive Maintenance Tables' or '4. Replacement and Adjustment > Around the Drum > PCU Cleaning Unit Removal' of the FSM.
 - **NOTE:** When vacuuming the area outlined in red below, work carefully not to damage the edge of the cleaning blade.

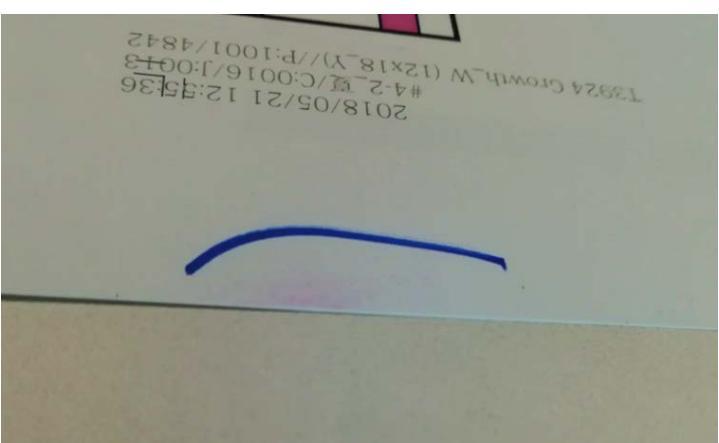
2. Magenta or Yellow toner stains appear at the front (operator side) and/or rear (non-operator side) edges of SRA3.

Example shown below is of Magenta.

Toner accumulated on the development unit drops on the ITB speed sensor or the front/rear edges of the printed paper.

For toner stains on front/rear edges, do 1 and 3 below.

- 1 Do the troubleshooting procedure announced in RTB #RM0B1052 'Toner drops and stains the front and rear edges.'
- 2 Clean the ITB unit.

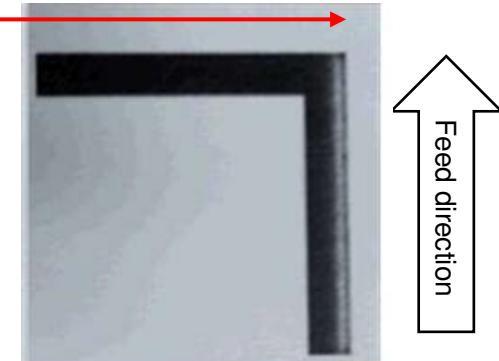
321.5mm+

The symptom also occurs with the registration detection marks, and therefore, affects the registration accuracy for jobs enabled of the auto registration adjustment function.

The registration setting in main scan direction, which is unique to each machine and adjusted at the factory, is within tolerance but too near the upper limit.

Do the below if the symptom is observed or the image is 321.5mm or longer across the feed direction.

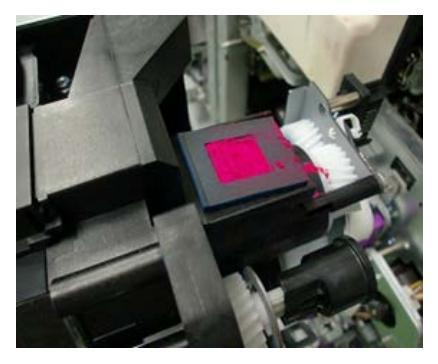
Adjustment Settings for Operators **0501-01** [Execute Cleaning Initial Setting for PCU: KCMY] or **SP3-032-001** (Cleaning Setup: Exe: Execute: All) is performed too frequently. This causes the M and/or Y developer to clog at the exit of the development unit leading to the waste toner path.

- 1. Slowly and gently remove the M and Y development units.
- 2. Vacuum the entrance of the development unit, if clogged as in below.

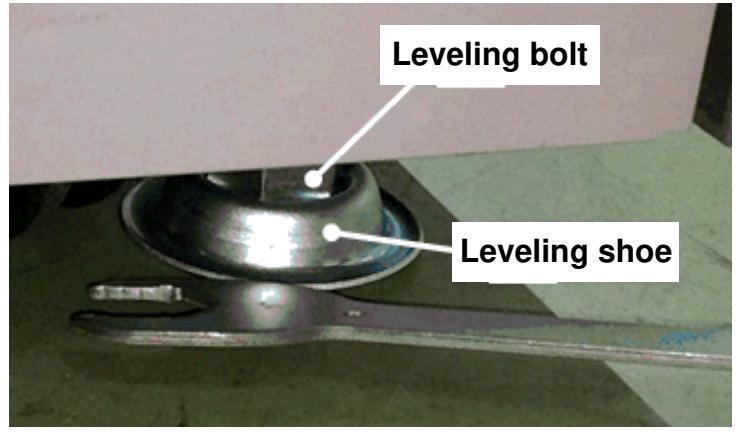
- The PTB runs off track and is eventually damaged.
- The ITB runs off track and causes the following SC:
 - SC471-00 (Belt position ready timeout)
 - > SC474-02 (ITB position error 2): front side overrun
 - > SC474-03 (ITB position error 3): rear side overrun

The FSM only documents the leveling procedure as part of the installation procedure for the main units; the Imaging section and Fusing section. However, connecting optional peripherals after leveling the main units affects the leveling of the main units. Therefore, the main units must always be leveled whenever optional peripherals are connected or disconnected, but the FSM is missing of this instruction.

3. Turn the bolt until it contacts the shoe, and further extend the bolt by making an extra half rotation so that the shoe sets firm against the floor.

* Touch the leveling shoe to check if it is in contact with the bolt.

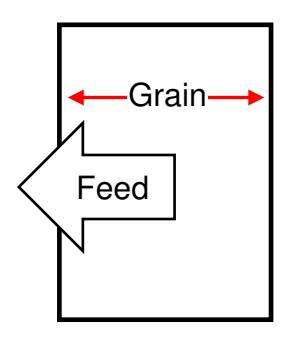
The fusing nip crumples the paper.

In addition, risk of wrinkles increases when the paper is fed along the grain direction.

• Do the troubleshooting instructions described in the following section of the FSM:

6. Troubleshooting > Image Quality > Image Quality 004: Unevenness > Wrinkles, worm tracks, creasing (page.2378)

- **NOTE:** Reducing the nip width and fusing temperature affects the fusing capability. Make sure to check the image quality as you adjust these settings.
- If the above does not work and the paper is fed along the grain direction, change the orientation or the paper stock so that the grain direction is across the feed direction.

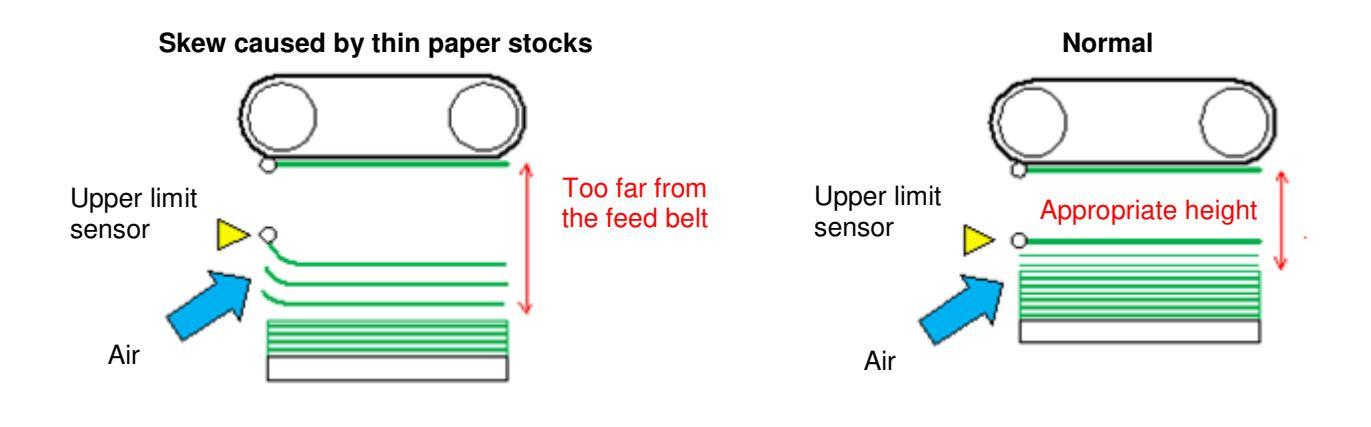
While the upper limit sensor detects the top most sheet to raise the tray to the optimal height for feeding, the tray may not rise enough with thin paper stocks. This is because the sheets tend to flutter by the air blown from the float/side fans, causing the upper limit sensor to detect the sheet and stop tray ascension too early.

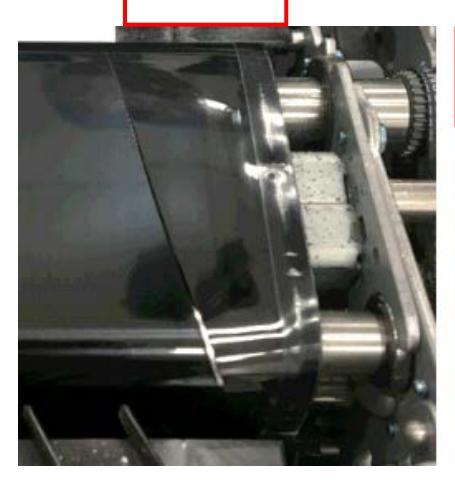
The shaft of the PTR (paper transfer roller) comes loose, causing the PTB(paper transfer belt) to tear or ride over the edge frequently. This may occur with units of the initial mass production lot.

Torn belt

Replace with the modified paper transfer roller (p/n: M0B16249).

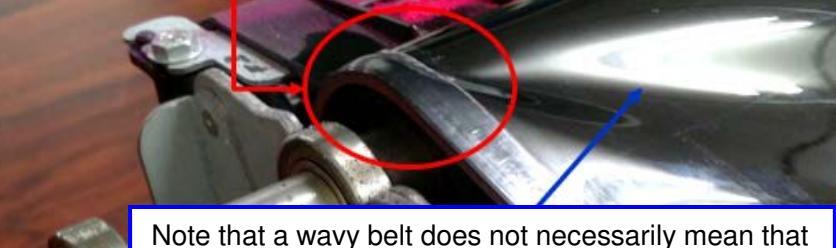
Touch with your fingers to see if the belt is level. If the difference in height is 1.5mm or more, the belt is probably riding over the edge.

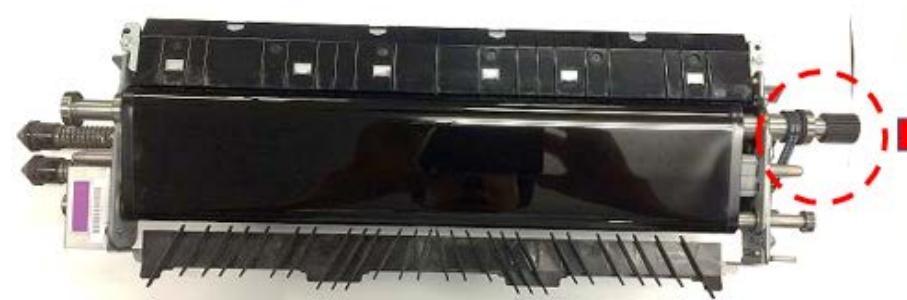
Note that a wavy belt does not necessarily mean that the belt is riding over the edge. Make sure to touch with your fingers to verify the edge of the belt track.

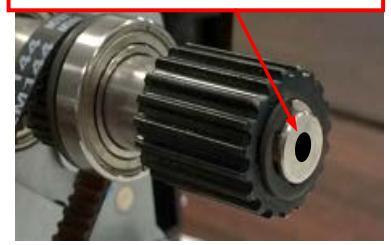
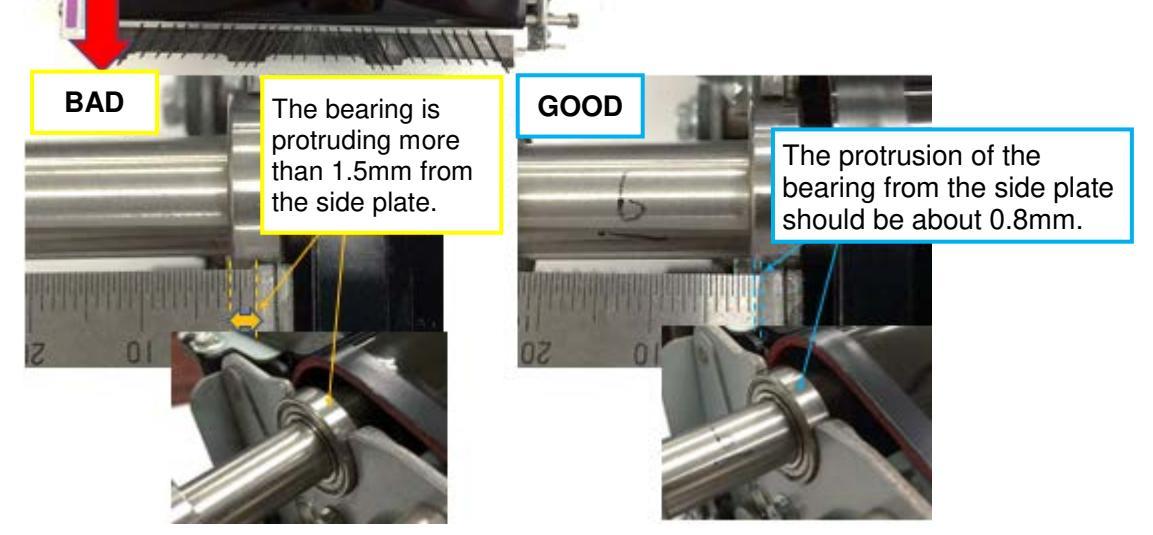
The PTR shafts of the initial mass production lot have a *white or black* marking on the edge.

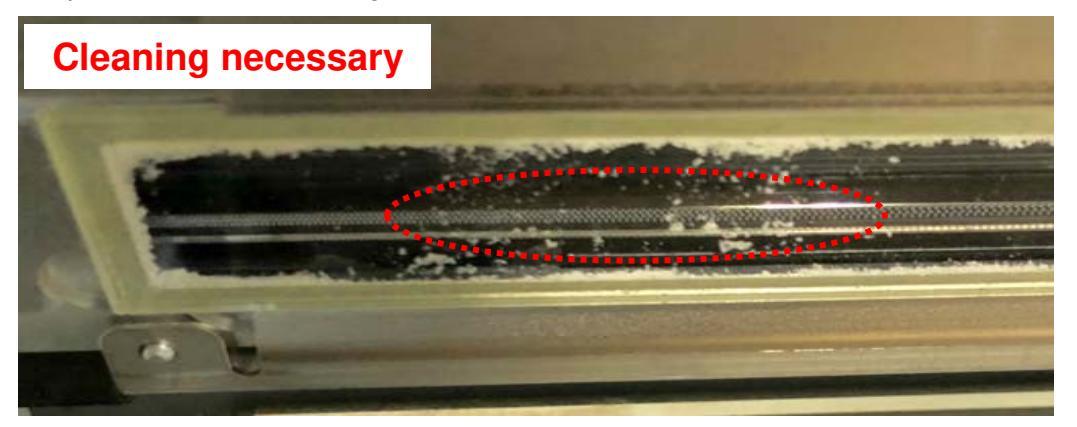
If the glass is dirty to a degree as shown below, cleaning is necessary. Continue with part two of the procedure to clean the glass.

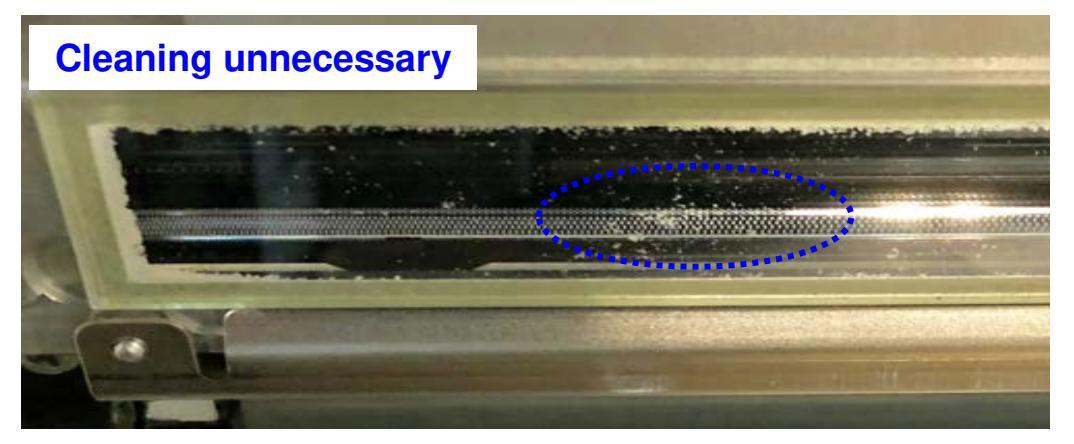
The contact glass will probably have speckle of dust as in the photo below, but this level of contamination does not require cleaning.

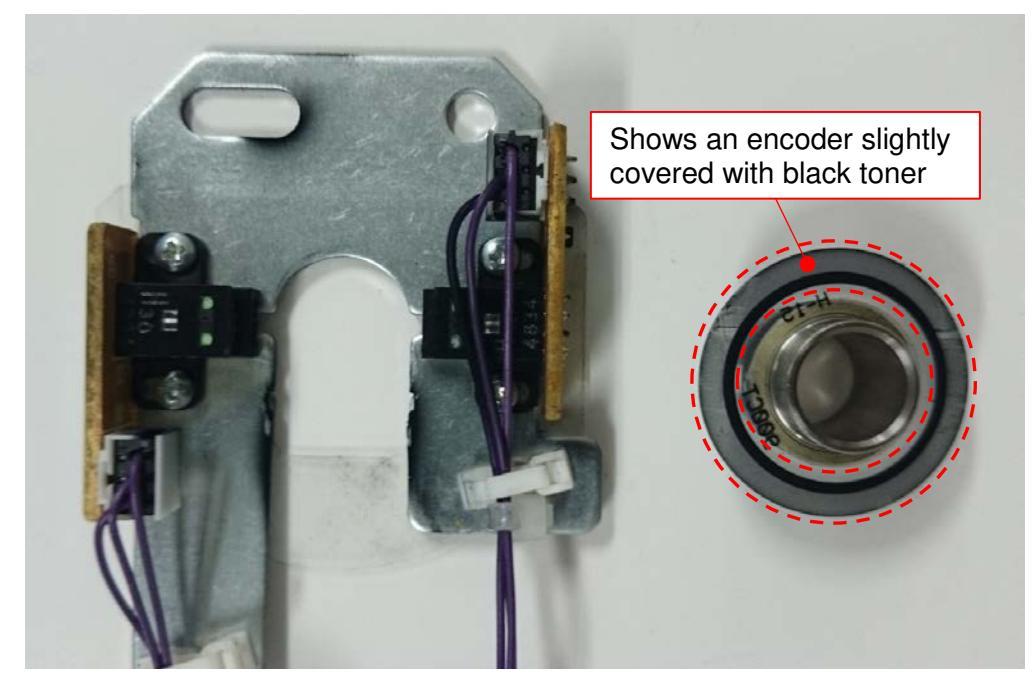
Airflow from the mainframe exhaust fan contaminates the ITB drive encoder and/or ITB motor rotation sensors with toner and affects the pulse readings.

Printing long runs and high coverage jobs increases the risk of the problem.
