Technical Bulletin

Model: Andromeda-P2		Date: 6	Jun-18	No.: RM0B1001
Subject: SP modification to change special characteristic v of the TIM-RED/MAG unit shading plates		ristic values	Prepared b	9 y : Hiroaki H Matsui
From: PP Tech Se	rvice Dept., 1st PP Tech Service S	ect.		
Classification:	□ Troubleshooting □ □ Mechanical □ □ Paper path □ □ Product Safety □	Part informa Electrical Transmit/rec Other (tion ceive) X	Action required Service manual revision Retrofit information Tier 2

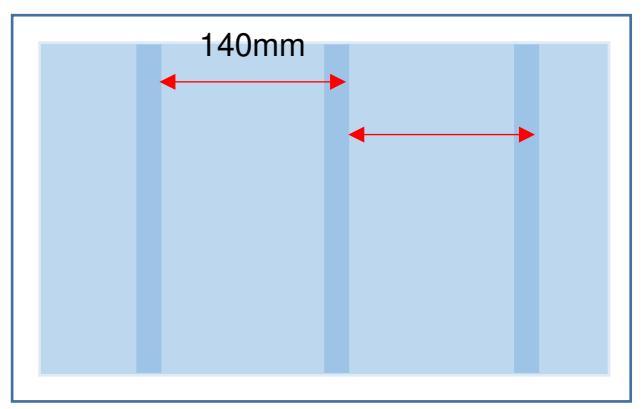
140mm-pitch banding

Toner contamination concentrated on a particular area on the surface of the encoder causes to change the ITB rotation speed, generating bands at pitch equivalent to the periphery of the ITB drive roller (140mm).

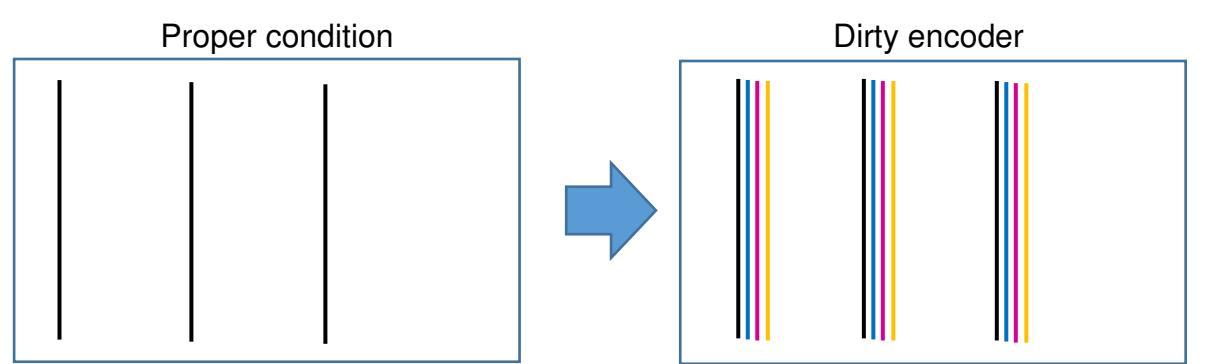
Color registration shift

When the entire surface of the encoder is contaminated with toner, the encoder readings are false detected, affecting the ITB rotation speed.

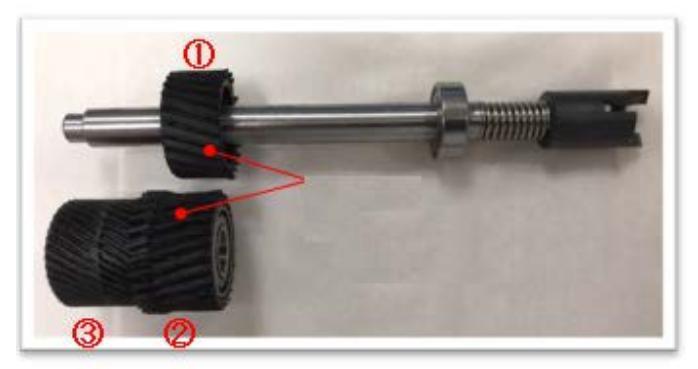
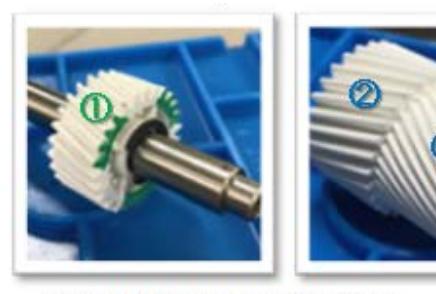
New gear

The drive gear of the drum cleaning unit wears out and causes the following symptoms:

- SC39X (Drum motor error)
- SC32X (Development motor error)
- > Drum cleaning failure

①GEAR:DRIVE:CLEANER:26Z
②③GEAR:CLEANER:IDLER:35Z/28Z

If the above symptoms occur, replace with the new set of gears using the procedures described on the following pages.

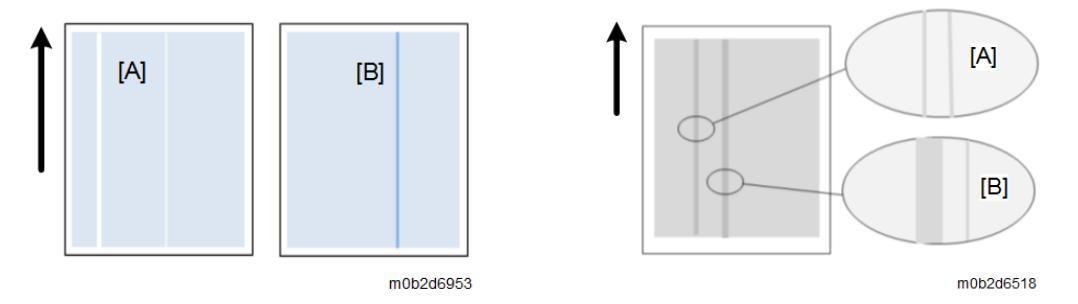
White, color or black streaks appear along the feed direction.

Dirty charge unit, foreign substance on the charge unit, dirty laser unit dust shield glass, uneven lubricant on the drum surface, dirty drum cleaning unit, scratched drum, clogged doctor gap or dirty development unit entrance film.

- The flowchart DOES NOT include the procedures to resolve problems originating in the development unit – clogged doctor gap and/or dirty development unit entrance film.
- If the problem does not resolve even after doing the flowchart, do the following as the problem is probably originating in the development unit or the laser unit dust shield glass.
 - Do the troubleshooting procedure 'Vertical white streak' described on page 2264 of the FSM.
 - > Clean the development unit entrance film.

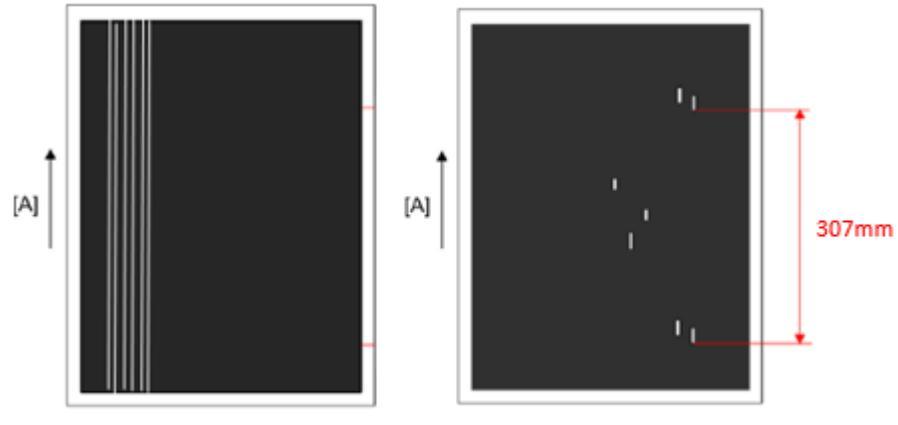
[A] Paper feed direction

White spots or white streaks appear in solid images. Spots appear at 307mm interval.

When continuously printed high coverage images, the amount of lubricant on the drum surface decreases. This causes toner additives to adhere to the drum surface and may also scratch the drum.

- 6. Replace the following parts of the affected station(s):
 - Drum
 - Cleaning unit

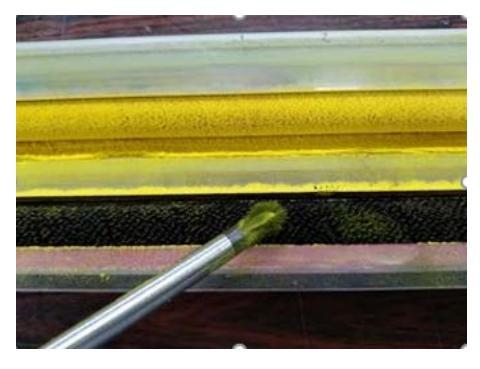
- 3. Check if the gears of the drum cleaning unit are of the modified ones or the old ones by referring to RTB #M0B1098a. If the gears are of the old type, replace with the new type for all YMCK stations.
- 4. Check if developer is adhered to the drum cleaning brush roller by touching the brush roller with a magnetic screwdriver.

If developer is present, skip step 5 and do step 6.

5. Make the following SP modifications, which will enhance the drum cleaning process.

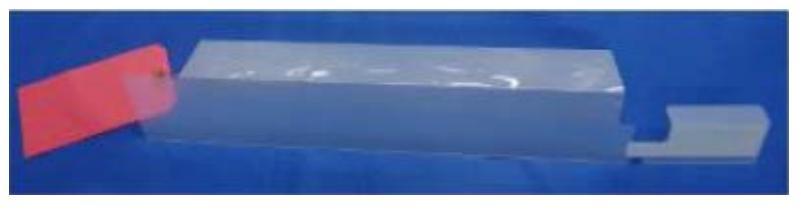
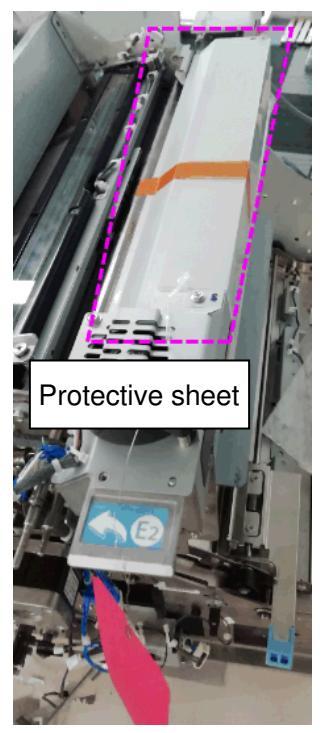
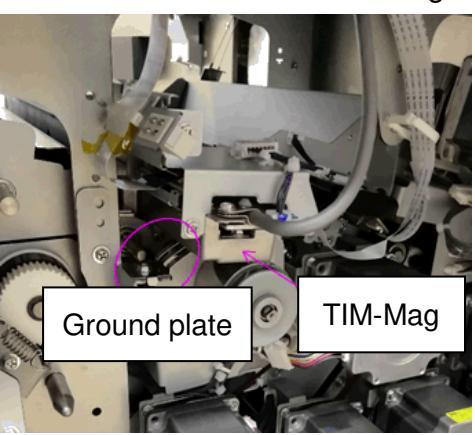
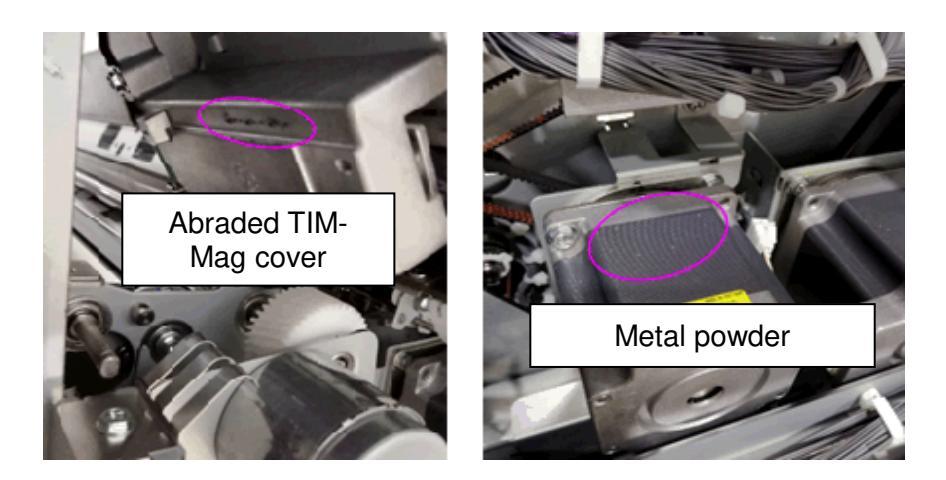
Change: A protective sheet (and bracket) was inserted between the TIM-Mag unit cover and the ground plate underneath for transport. See next page for cut-in s/n.

Reason: The above cover and plate may rub against each other during transport, causing metal powder to drop on the PSU located under the TIM-Mag unit and short circuit.
