Model: Haokan-P1		Date: 26-Oct-17	No.: RJ089001
Subject: Notes on replacing the cassette stand/carriage		Prepared by: K. Tsutsui	
From: System Strategy Dept. IP Business Center			
Classification:	<input type="checkbox"/> Troubleshooting <input type="checkbox"/> Mechanical <input type="checkbox"/> Paper path <input type="checkbox"/> Product Safety	<input checked="" type="checkbox"/> Part information <input type="checkbox"/> Electrical <input type="checkbox"/> Transmit/receive <input type="checkbox"/> Other ()	<input type="checkbox"/> Action required <input checked="" type="checkbox"/> Service manual revision <input type="checkbox"/> Retrofit information <input checked="" type="checkbox"/> Tier 2 <input type="checkbox"/> Tier 0.5

Model: Haokan-P1		Date: 11-Dec-17	No.: RJ089002
Subject: FSM correction - Finisher Firmware Update		Prepared by: Tsutsui	
From: System Strategy Dept. IP Business Center			
Classification:	<input checked="" type="checkbox"/> Troubleshooting <input type="checkbox"/> Mechanical <input type="checkbox"/> Paper path <input type="checkbox"/> Product Safety	<input type="checkbox"/> Part information <input type="checkbox"/> Electrical <input type="checkbox"/> Transm

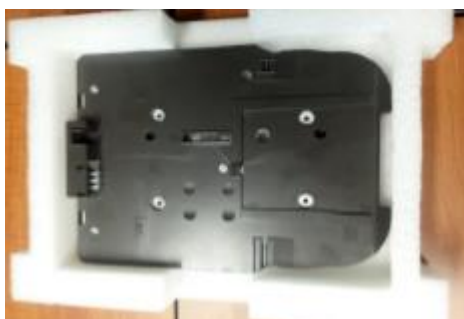
Cassette Stand

The cassette stand and carriage are registered as a service part as a set. The components are packed separately in the same box as shown below.

- When replacing the cassette stand and/or carriage, make sure to replace the two components supplied in the box together as a set, because the height and level of the stand are precisely adjusted accordingly with the carriage at the factory.

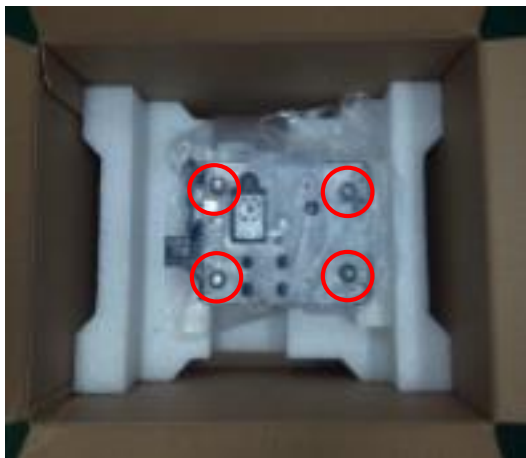
The height and level are adjusted at four points (circled in red above) on the carriage [A] with caps [B] and spacers [C].

- The position of the caps/spacers are also specified for each set of stand/carriage. Do not change the position of the caps/spacers.

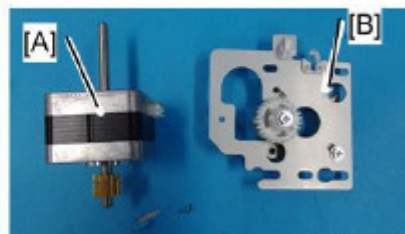
j089m190a

- Do not remove or loosen the 2 screws [A], as this will prevent accurate engagement of the gears.
