Model: Model CV-P1	Date: 18-Apr-08	No.: RM000001a
--------------------	-----------------	----------------

Subject: Firmware Release Note: Engine		Prepared by: Y.Gaman	
From: 2nd Tech. Support Sec. Service Support Dept.			
Classification:	<input type="checkbox"/> Troubleshooting	<input type="checkbox"/> Part information	<input checked="" type="checkbox"/> Action required
	<input type="checkbox"/> Mechanical	<input type="checkbox"/> Electrical	<input type="checkbox"/> Service manual revision
	<input type="checkbox"/> Paper path	<input type="checkbox"/> Transmit/receive	<input type="checkbox"/> Retrofit information
	<input type="checkbox"/> Other (       )

Model: Model CV-P1		Date: 02-Feb-09	No.: RM000003
Subject: Model CV-P1 Fuser Damage		Prepared by: Y. Gaman	
From: 1st Tech. Support Sec. Service Support Dept.			
Classification:	<input type="checkbox"/> Troubleshooting <input type="checkbox"/> Mechanical <input type="checkbox"/> Paper path <input checked="" type="checkbox"/> Other (      )	<input type="checkbox"/> Part information <input type="checkbox"/> Electrical <input type="checkbox"/> Transmit/receive	<input type="checkbox"/> Action required <input type="checkbox"/> Service

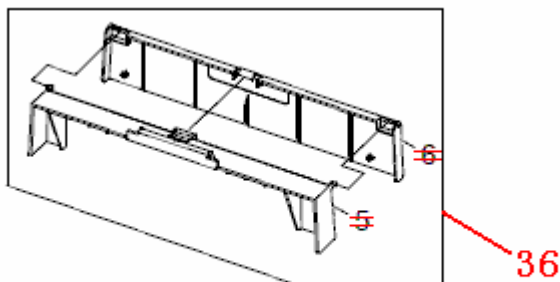
## M347

Old Part Number	New Part Number	Description	Q'ty	Int	Page	Index	Note
M0001189	M0001602	UNIT DUPLEX COVER	1	-	3	5→36	-
M0001190						6→36

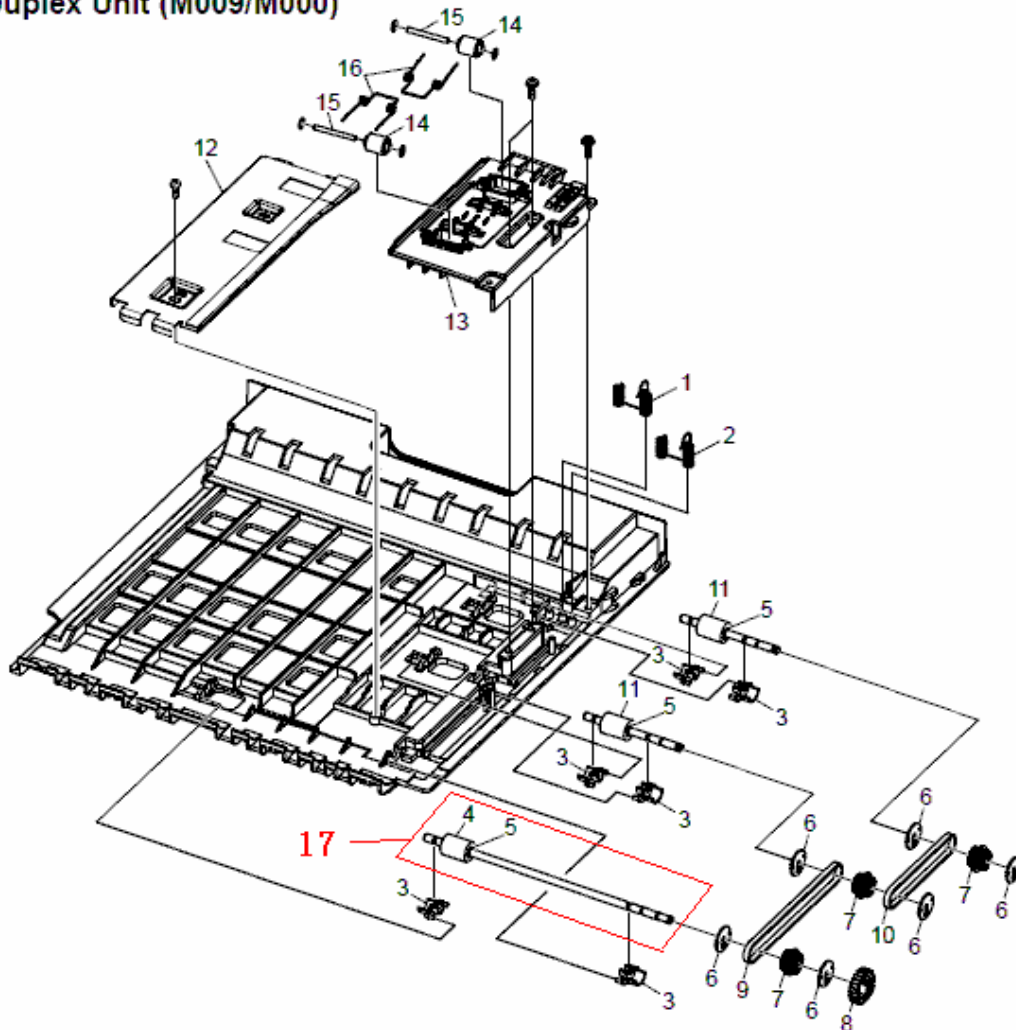
## 11.Duplex Unit (M009/M000)

**Change:** These parts were combined into one assembly.

**Reason:** The parts vendor stopped supplying P/N M0001144 as an individual part.

Old Part Number	New Part Number	Description	Q'ty	Int	Page	Index	Note
M0001144	M0001603	RZL: ELAUNIT-DUP2	1	O/O	3	4→17	-
M3071033						5→17

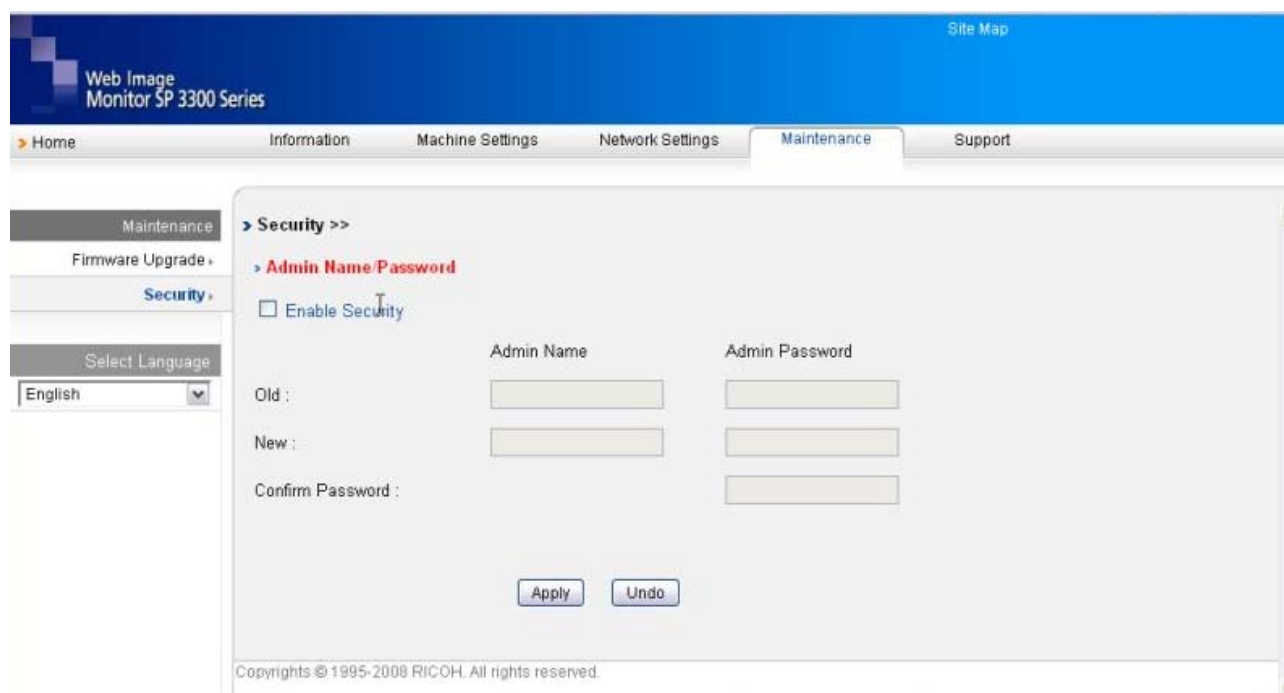
It is not possible to reset the Admin Password for Web Image Monitor.

This is a design specification (for security).

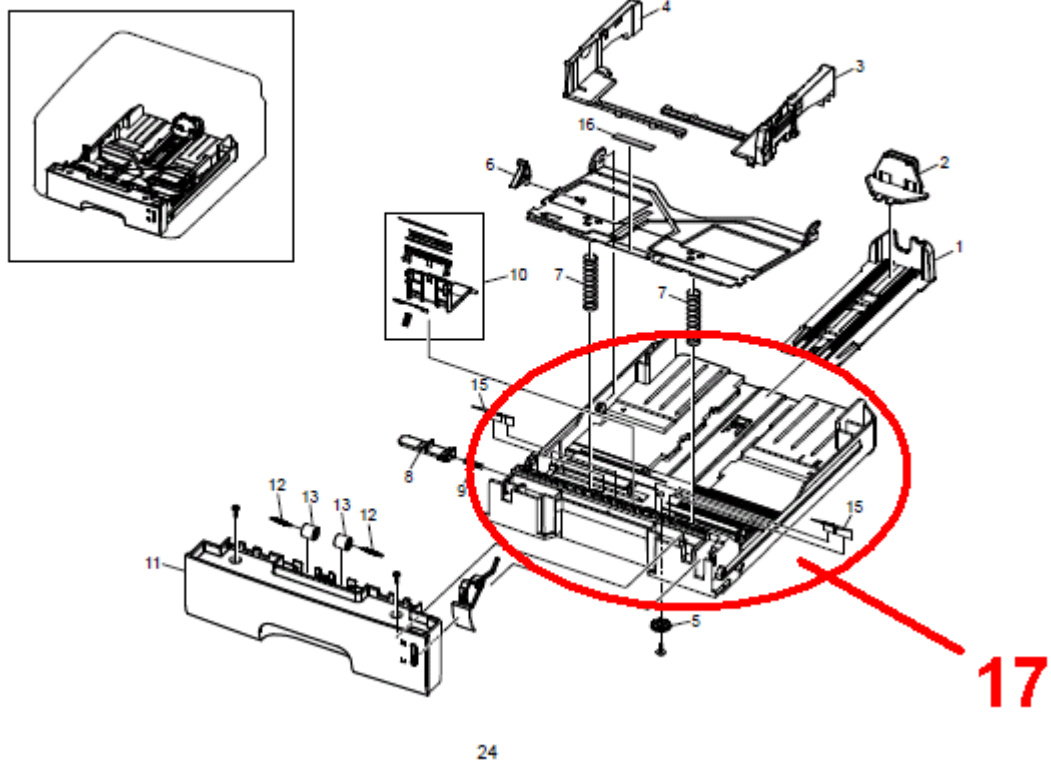
12.Cassette Unit (M009/M000)

Part No.	Description	Q'ty	Int	Page	Index	Note
M0001040	FRAME:CASSETTE:JC61-00876L	1	-	25	17	-

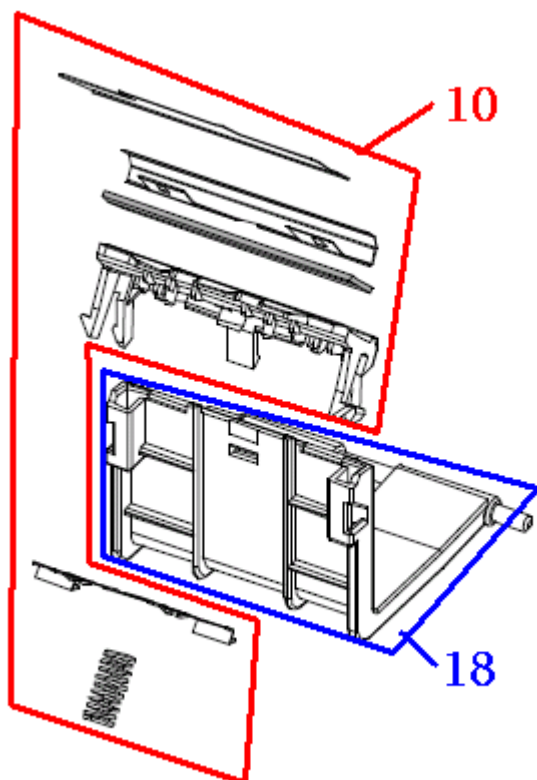
Page 24 of Parts Catalog:

Part Number	Description	Q'ty	Page	Index	Note
M0001176	Housing:Pad Holder	1	25	10	Ass'y is changed
M0001043	Pad Holder	1	25	18	Newly added.
