Model: Sh-P1	Date: 10-Aug-11	No.: RM020001a
--------------	-----------------	----------------

Subject: Firmware Release Note: Engine		Prepared by: K. Hamada	
From: 1st Overseas Tech Support Sec., 1st PQM Dept.			
Classification:	<input type="checkbox"/> Troubleshooting <input type="checkbox"/> Mechanical <input type="checkbox"/> Paper path <input type="checkbox"/> Product Safety	<input type="checkbox"/> Part information <input type="checkbox"/> Electrical <input type="checkbox"/> Transmit/receive <input checked="" type="checkbox"/> Other (Firmware)	<input type="checkbox"/> Action required <input type="checkbox"/> Service manual revision <input type="checkbox"/> Retrofit information <input checked="" type="checkbox"/> Tier 2

This RTB has been issued to announce the firmware release information for the **Engine**.

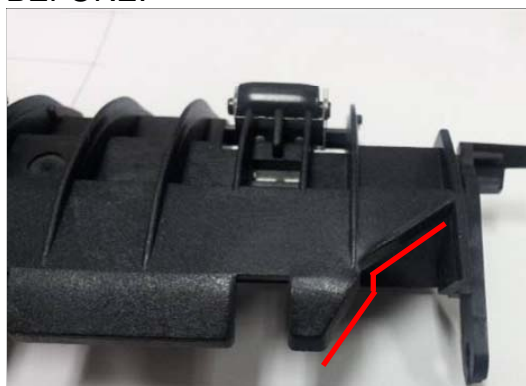
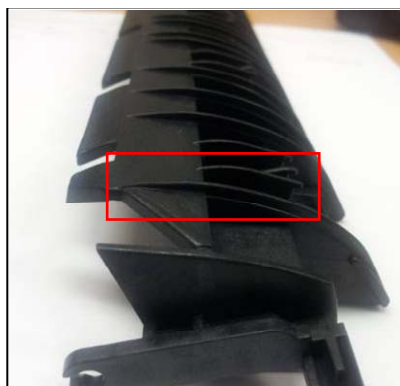
BEFORE:

- A minor change was made to the shape of the fusing exit guide (see areas outlined in red below). This was to further minimize the occurrence of “dog ear” paper jams, which may occur with some paper types.
- Since this was a minor change, the part number was not changed. It is still **M0524201** (Guide: Exit: Fusing).
- If dog ear paper jams are reported, replace the fusing exit guide with “AFTER” one by checking the shape of the part.

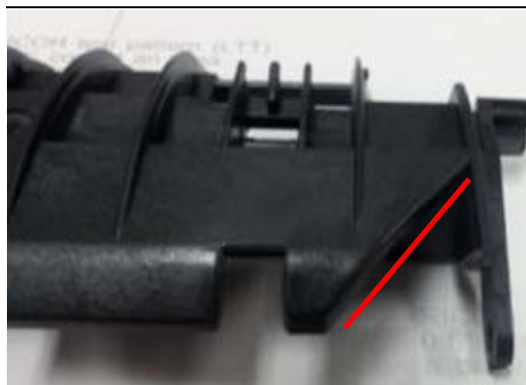
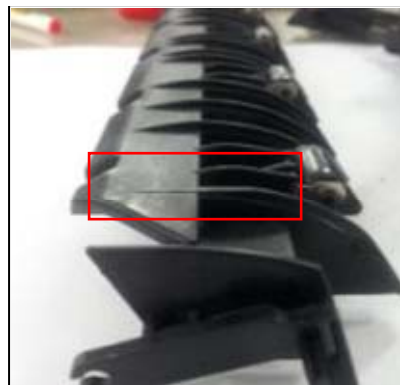
AFTER:

Note: This new fusing exit guide has been used in machine mainframes since September 2011 production.

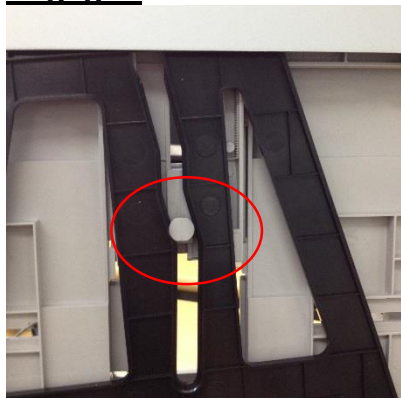
Engaged

5. Check to see whether the paper size detection mechanism in the paper tray is engaged.
 - If it is engaged, go to Step 7 (replacing the bottom plate).
 - If it is not engaged, go to Step 6.

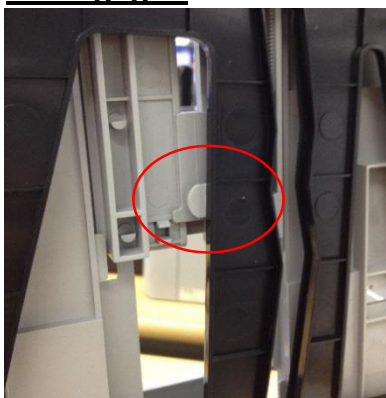
Disengaged

Note: The bottom of the end fence passes through the paper size detection rail. When the end fence is pulled up, the bottom of the fence disengages from the paper size detection rail.

6. Engage the paper size detection mechanism as follows.

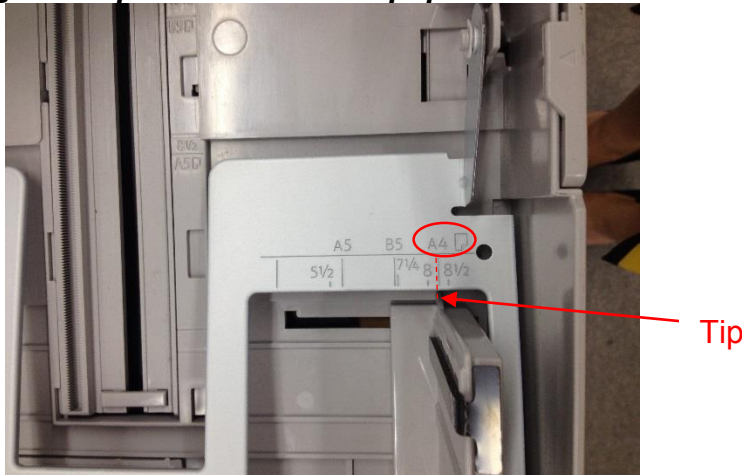
- ***Check to see whether the side fence is set too tightly.***
 - When the side fence set too tightly, the machine needs more power to feed the paper.***
 - Align the tip of side fence to paper size.***

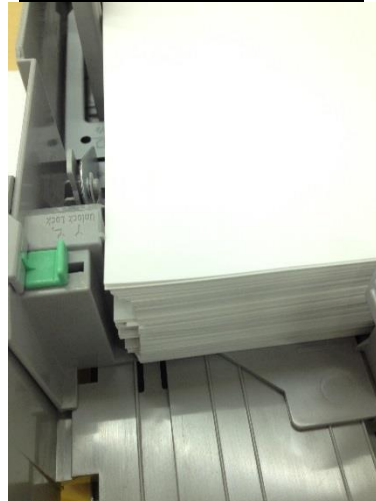
Incorrect paper loaded

- ***Check to see whether paper has been loaded neatly.***
 - If the paper is not loaded neatly, the rib may prevent the paper from being fed correctly.***

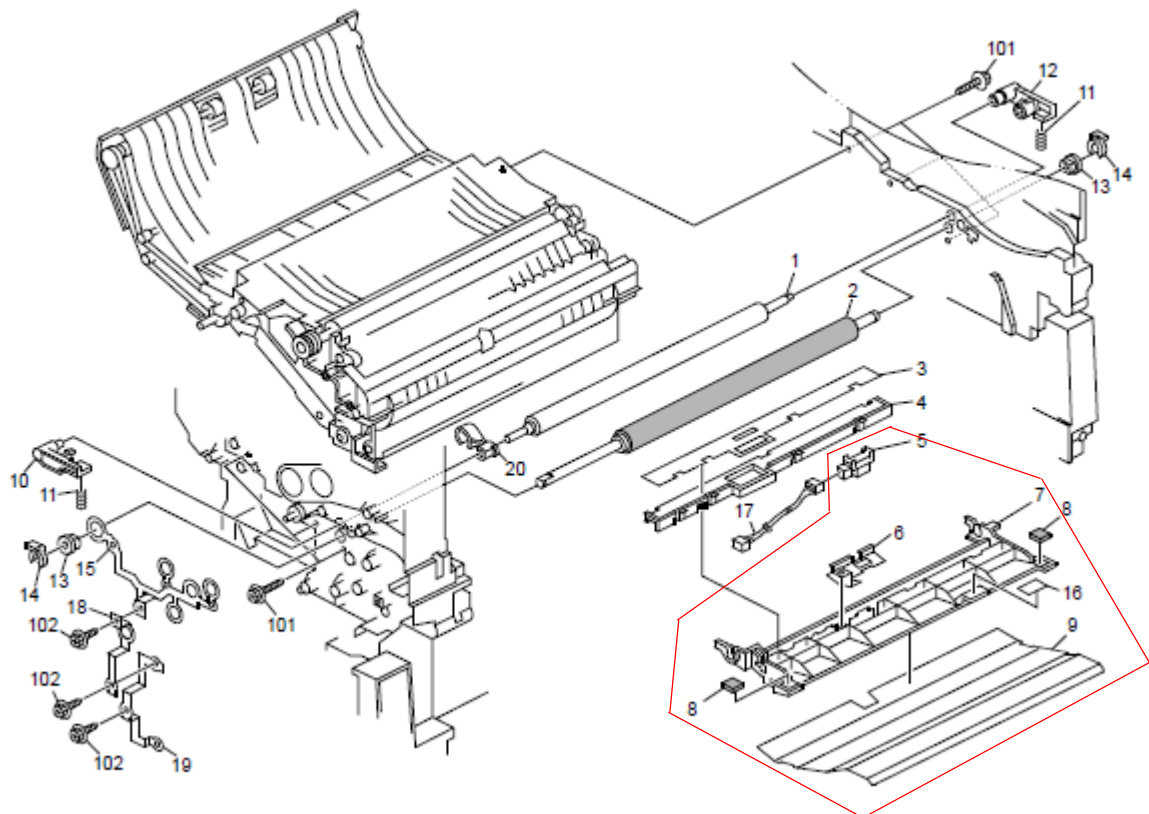
7.Paper Regist (M020/M021)

IMPORTANT: *If jams occur often, check the edge of the guide plate. Install the new assembly (M0522940) if the guide plate is shaved.*

Change: The assembly shown in the table was added as a service part.

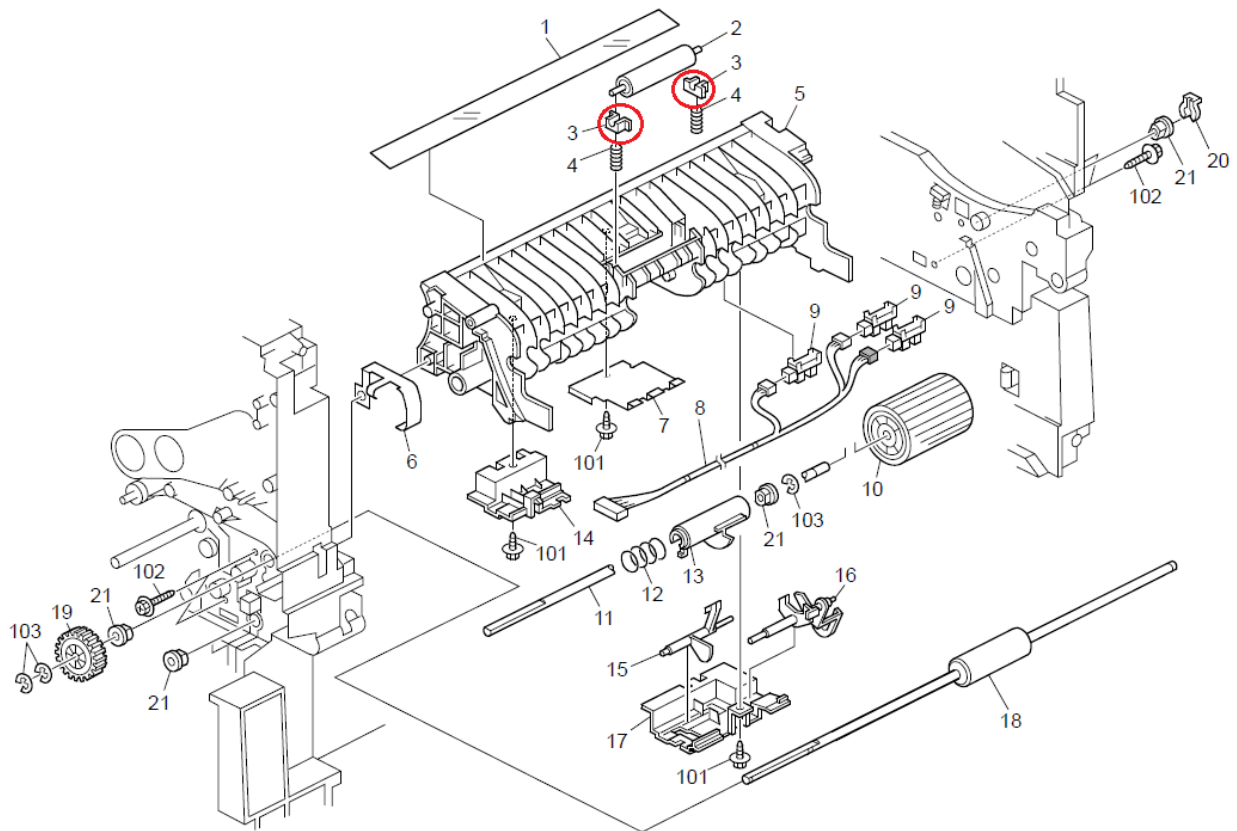
Wrong Description	Correct Description	Wrong PN	Correct PN	Q'ty	Page	Index
Bushing – 8x12x7	BUSHING - VERTICAL TRANSPORT	AA082144	AA080249	2	M020/M021: 15 M052/M053/M054: 47	3

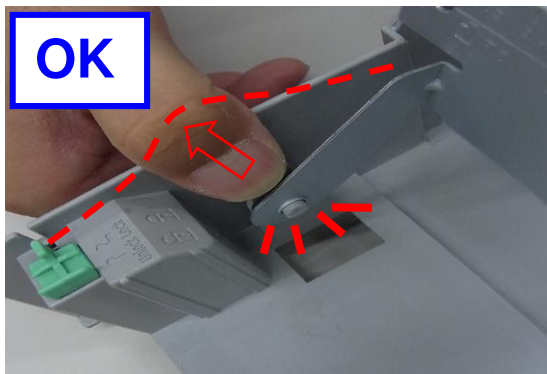
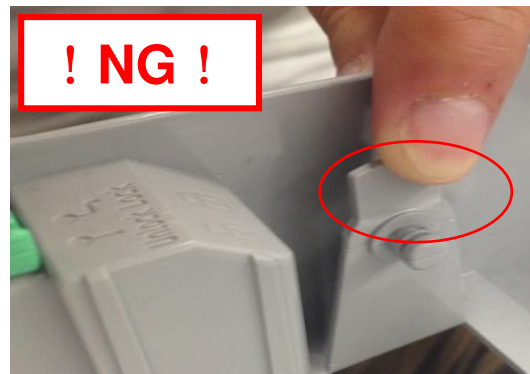
IMPORTANT: DO NOT put pressure on the bottom plate.

The 3-inch bottom plate is not as strong as those used on standard models, since the side fences can slide three inches. **Pull the outside guide outward**, as shown in the photos, while **being careful not to put any pressure** on the bottom plate. Do not press down on a small area/point too much, in order to avoid breakage.

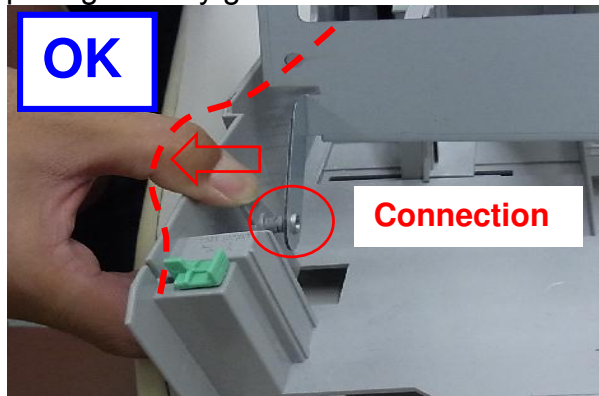
MOST IMPORTANT:

Connect the opposite side **without putting any pressure on the bottom plate** by pulling the tray guide in the direction of the red arrow.

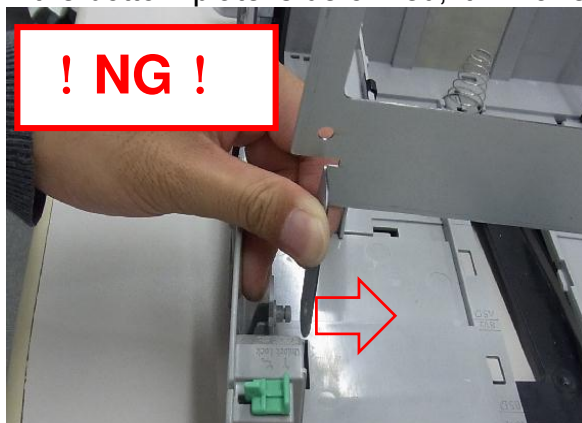
IMPORTANT: DO NOT put any pressure on bottom tray.

If the bottom plate is deformed, it will affect the feeding quality and machine operation.

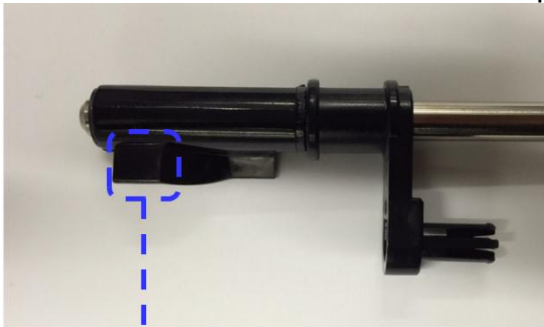
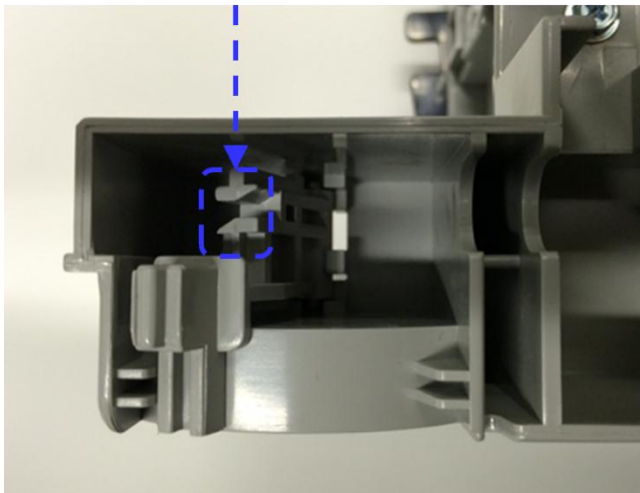
Make sure the black “fin” is locked into the opening in the gray compartment, as shown.

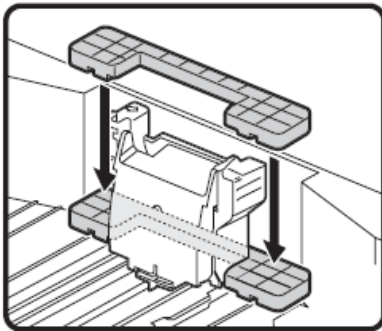
A4/Legal

If the **SOLUTIONS** above do not resolve the symptom:

1. Check whether the end fence has been set correctly.
2. Attach the spacer (P/N: M0212570) behind the end fence using double-sided tape **or**, attach the decal (P/N: M0218840) as shown.
 - If the customer uses several paper sizes in one tray, **attach the decal** instead of the spacer. Otherwise, attach the spacer.
 - Before attaching the spacer/decal, clean the attachment surface.

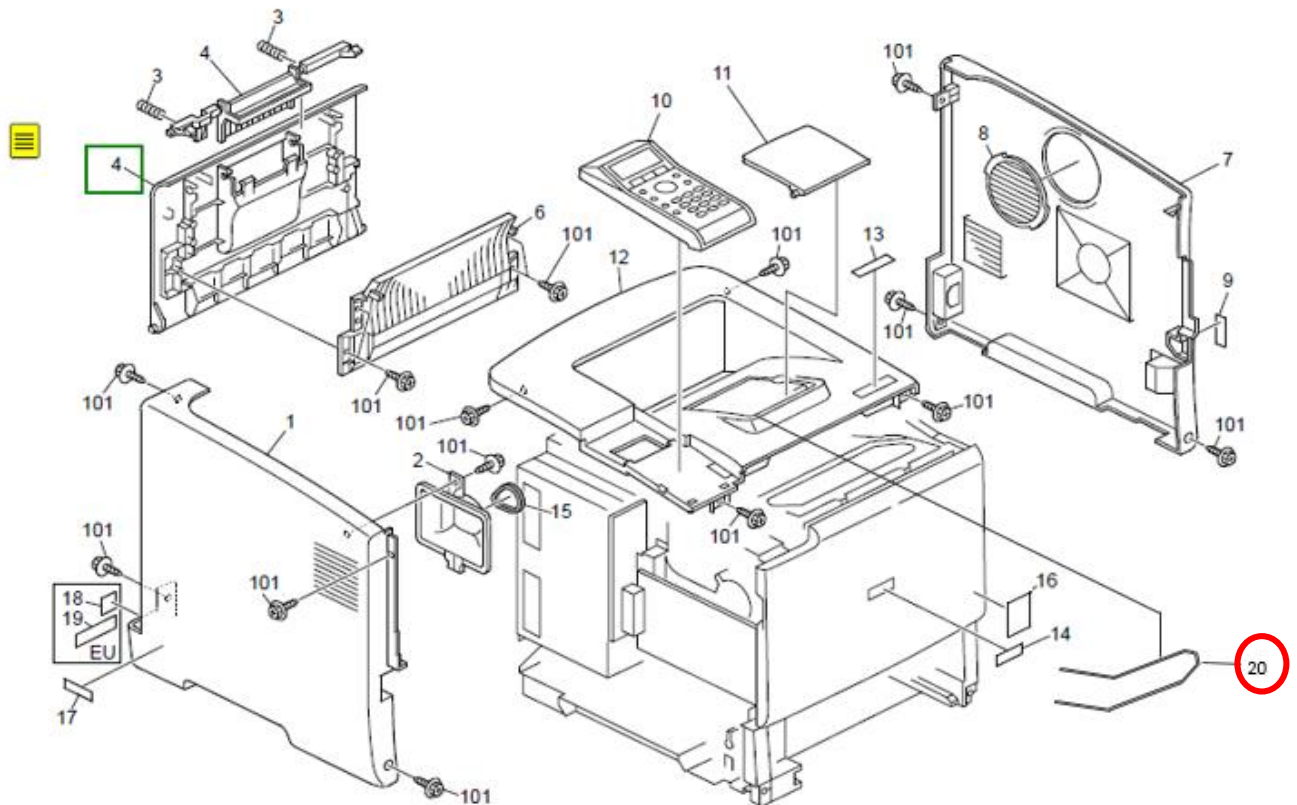
1.Exterior 1 (M020/M021)

Change: The guide plate and seal were deleted.

Old part number	New part number	Description	Q'ty	Int	Page	Index	Note
-	M0211280	EXTENSION TRAY: BAIL: EXIT	0-1	-	7	20

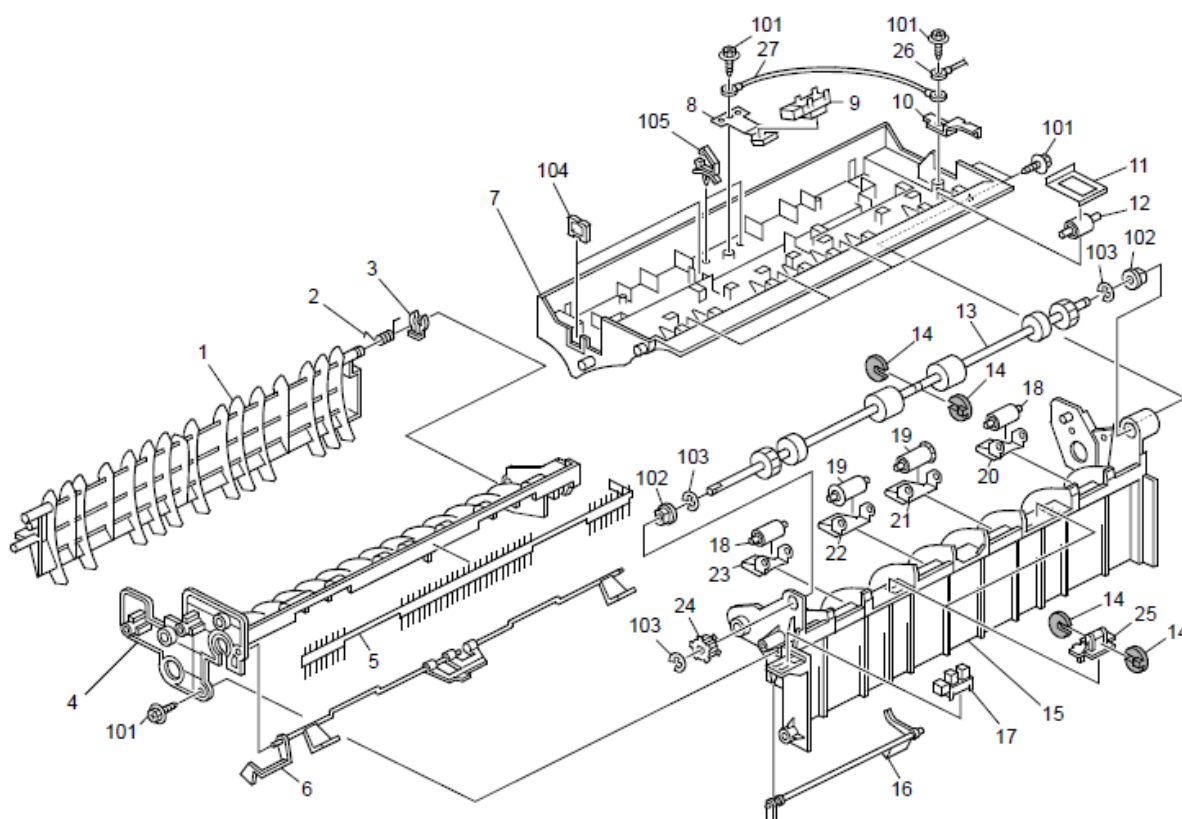
13.Paper Exit 2 (M020/M021)

Change/Reason: The following part numbers were corrected.

Wrong part number	Correct part number	Description	Q'ty	Int	Page	Index	Note
GW020020	GW010007	Photo Reflection Sensor:Exit	1	-	31	9	
GW010007	GW020020	Photointerruptor:LG248NL1	1	-	31	17
