Model: Da-P1d	Date: 19-Mar-15	No.: RM187004
----------------------	-----------------	---------------

Subject: Firmware Release Note: NetworkDocBox		Prepared by: Y. Gaman	
From: 3rd Tech Service Sect., MFP/Printer Tech Service Dept.			
Classification:	<input type="checkbox"/> Troubleshooting <input type="checkbox"/> Mechanical <input type="checkbox"/> Paper path <input type="checkbox"/> Product Safety	<input type="checkbox"/> Part information <input type="checkbox"/> Electrical <input type="checkbox"/> Transmit/receive <input checked="" type="checkbox"/> Other (Firmware)	<input type="checkbox"/> Action required <input type="checkbox"/> Service manual revision <input type="checkbox"/> Retrofit information <input checked="" type="checkbox"/> Tier 2

Model: Da-P1d		Date: 14-May-15	No.: RM187013
Subject: Squeaking Noise from Paper Exit Area		Prepared by: J. Mochizuki	
From: Field Quality Management Department			
Classification:	<input checked="" type="checkbox"/> Troubleshooting <input type="checkbox"/> Mechanical <input type="checkbox"/> Paper path <input type="checkbox"/> Product Safety	<input type="checkbox"/> Part information <input type="checkbox"/> Electrical <input type="checkbo

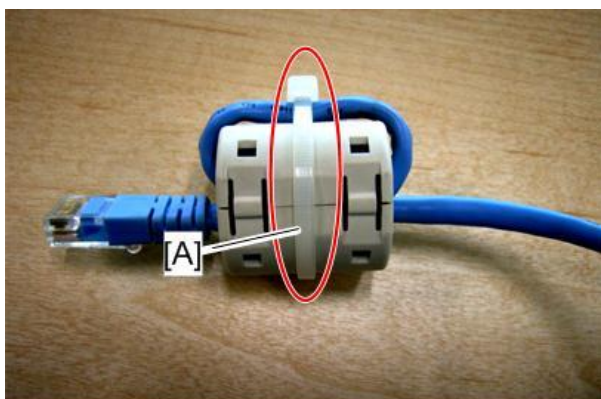
m257z0004

7. NA machines only: Bind both cores with the two bands [A], as shown below.

Important: These two binds are not included with options produced before March, 2015. Use the binds registered as service parts (P/N: 11050047) or similar ones.

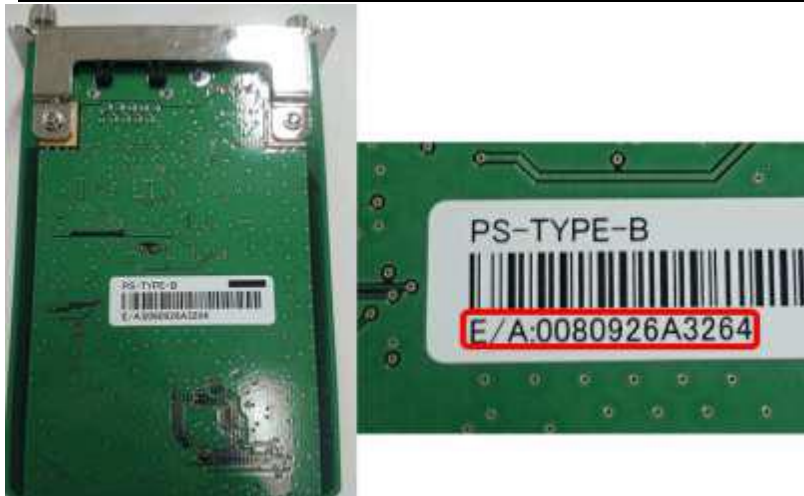
***If the IP address cannot be found (DHCP server), use the MAC address. This is the number printed on the seal affixed to the printed circuit board for the USB server.**

3. Use "RX" + the option's MAC address and access a PC browser.
Example: <http://RX0080926A3264>
4. Ping the "RX" + "MAC address" from the command prompt on a Windows PC connected to the same network as the Da-P1.
