Model: AI-P1	Date: 13-Mar-08	No.: RG179001c
--------------	-----------------	----------------

Subject: Firmware Release Note: Network DocBox		Prepared by: K.Hamada	
From: 1st Overseas Tech Support Sec., 1st PQM Dept.			
Classification:	<input type="checkbox"/> Troubleshooting	<input type="checkbox"/> Part information	<input type="checkbox"/> Action required
	<input type="checkbox"/> Mechanical	<input type="checkbox"/> Electrical	<input type="checkbox"/> Service manual revision
	<input type="checkbox"/> Paper path	<input type="checkbox"/> Transmit/receive	<input type="checkbox"/> Retrofit information
	<input checked="" type="checkbox"/> Other (      )

This RTB has been issued to announce the firmware release information for the **Network DocBox**.

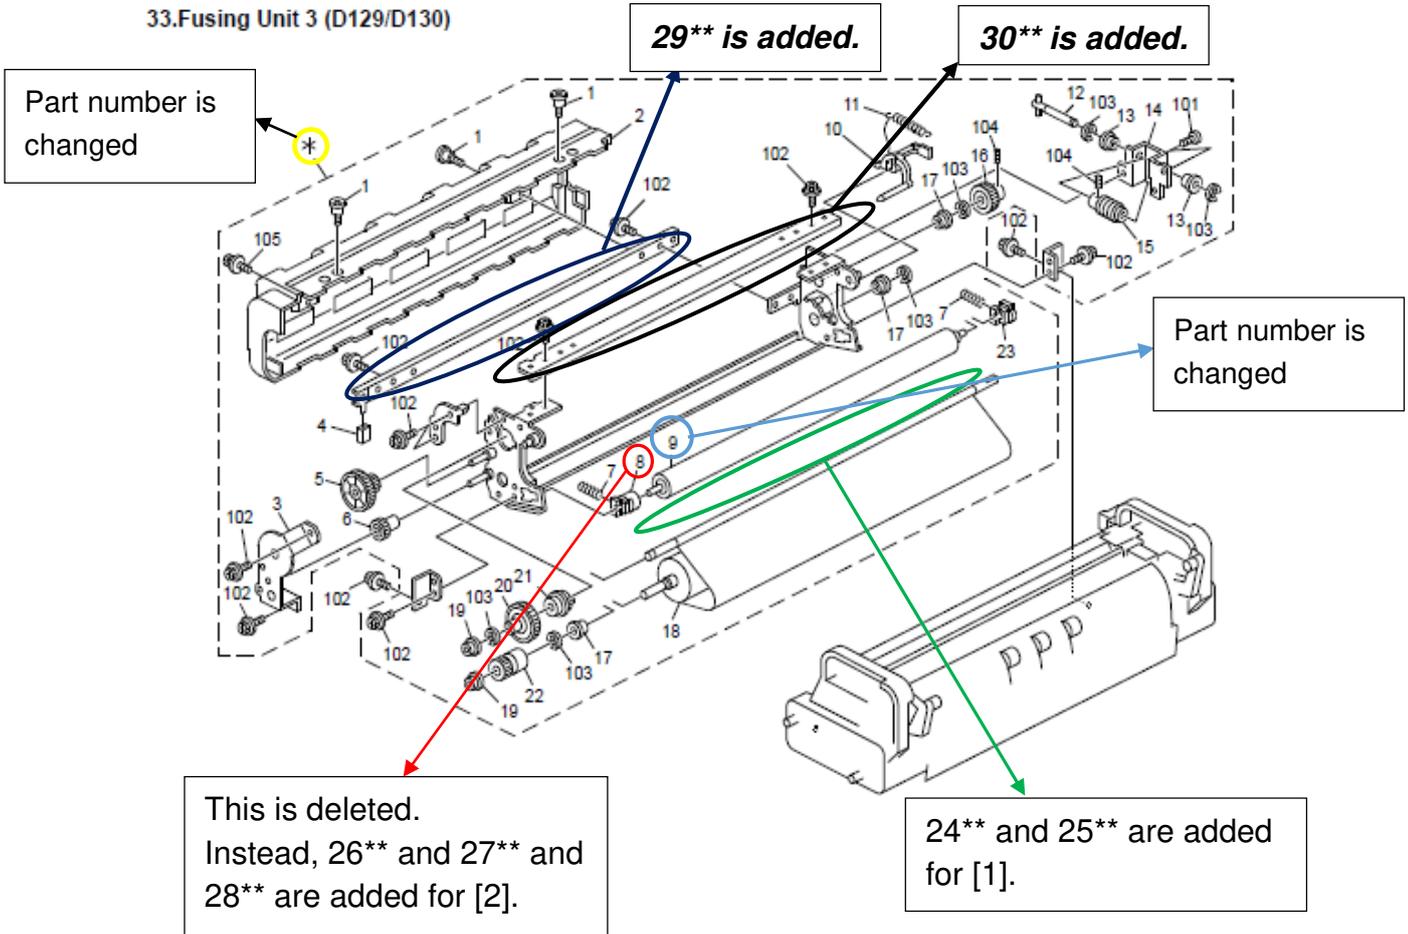
33.Fusing Unit 3 (D129/D130)

To prevent the cleaning web from coming loose, the following parts are changed or newly added to the fusing unit.

Please install a new cleaning unit (p/n: D1294304) when a cleaning web issue occurs, because individual parts are not compatible due to modification of a frame on the fusing unit. After that, individual parts can be replaced.
