Model: AI-P2	Date: 28-Sep-12	No.: RM132001a
--------------	-----------------	----------------

Subject: Firmware Release Note: Engine		Prepared by: T. Hirakawa	
From: 2nd Tech Service Sect., MFP/Printer Tech Service Dept.			
Classification:	<input type="checkbox"/> Troubleshooting <input type="checkbox"/> Mechanical <input type="checkbox"/> Paper path <input type="checkbox"/> Product Safety	<input type="checkbox"/> Part information <input type="checkbox"/> Electrical <input type="checkbox"/> Transmit/receive <input checked="" type="checkbox"/> Other (Firmware)	<input type="checkbox"/> Action required <input type="checkbox"/> Service manual revision <input type="checkbox"/> Retrofit information <input checked="" type="checkbox"/> Tier 2

This RTB has been issued to announce the firmware release information for the **Engine**.

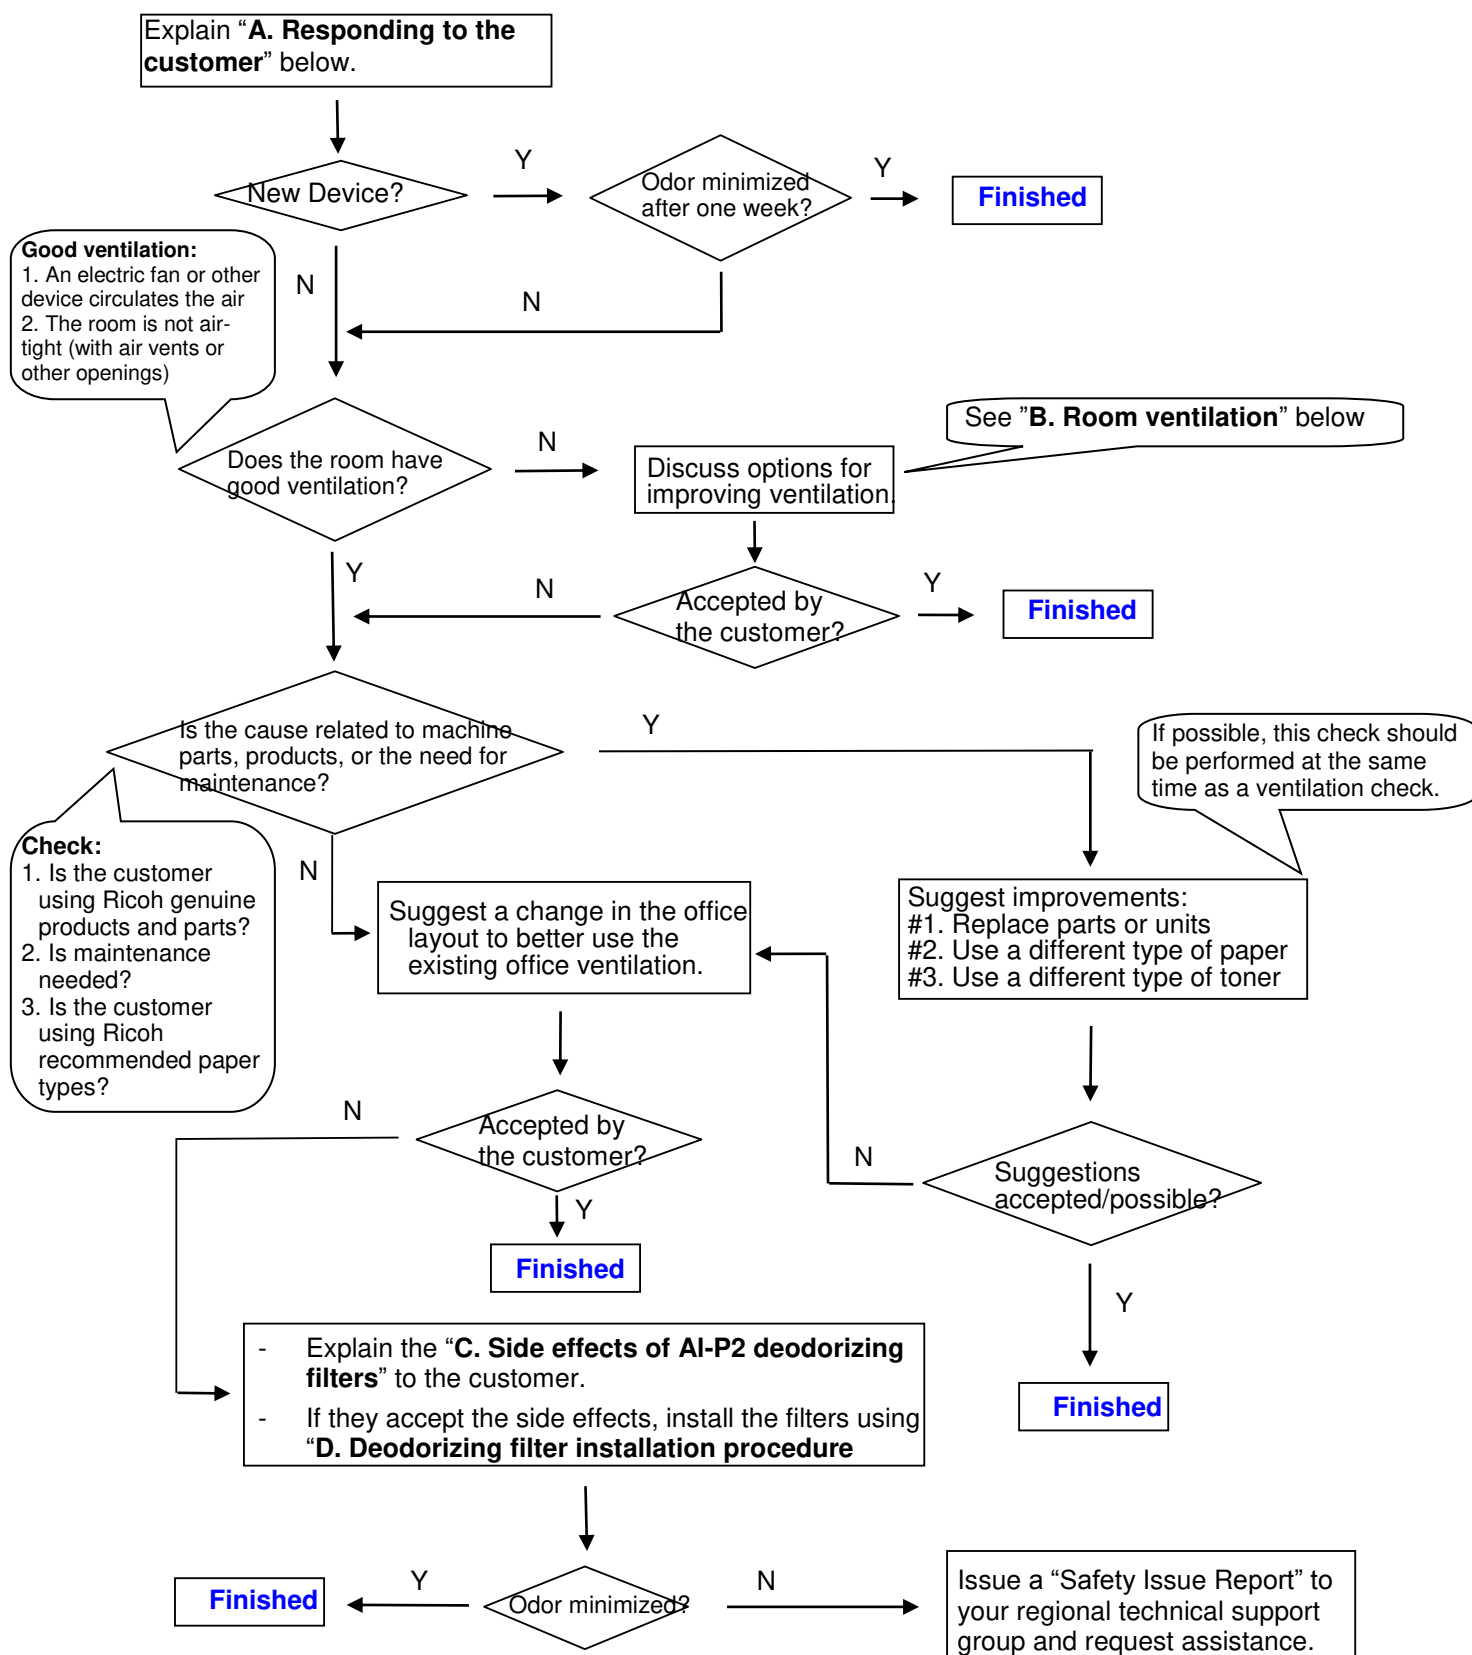
Flowchart

If a customer reports a strange odor on the machine, use the **flowchart below** to take the appropriate action.

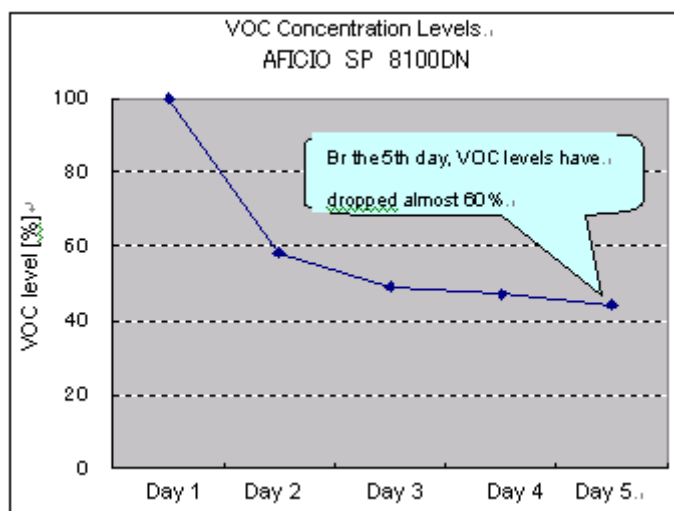
Fig. 1

- However, brand new devices have a particularly strong odor that might worry some customers. This odor is significantly reduced by the end of the **first week of use**, so please ask for the customer's patience. See Figure 1 below for an example using the Aficio SP 8100DN.

- Volatile Organic Compounds (VOC) are particles of the component materials (glues, plastics, chemicals, etc.) that Ricoh devices are built with. VOC are the primary source of the odors produced by Ricoh devices, so tracking VOC levels produced by Ricoh devices is a good indicator of the strength of the odors. Figure 1 shows the VOC levels of a brand new Aficio SP 8100DN during the first 5 days of use. As the graph shows, the amount of VOC has dropped by almost 60%.
