Model: Cor-P1.5			Date: 9	-Jun-17	No.: RM0AN001
Subject: Notice P1.5	for Mailbox CS3010 attack	Prepared I	by: Y.Taniguchi		
From: 1st FQM S	ect., 1st FQM Dept.				
Classification:					required e manual revision it information

Important Notice about Installing the Mailbox CS3010

Technical Bulletin

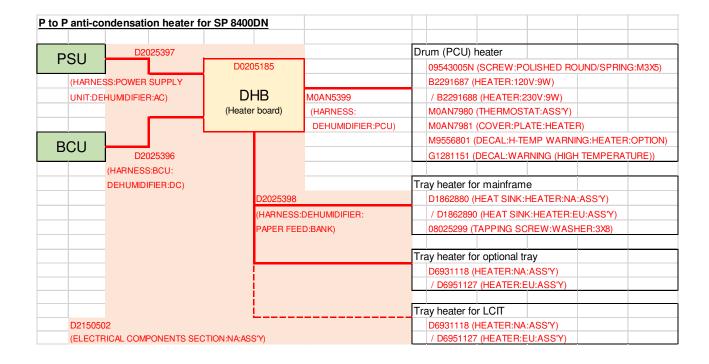
- Make sure to install the tray heater with the correct voltage for your country/region.
- If a heater with the wrong voltage is installed, it will overheat and damage the tray and/or cause carbonization (e.g., A 100V heater is installed on a 200V machine), or it will not be able to reduce enough moisture (e.g., A 200V heater is installed on a 100V machine).

IMPORTANT:
