Model: Model PE –P1/MF1		Date: 28-Dec-07	No.: RG165001a
Subject: Firmware History - Engine		Prepared by: H.K.	
From: 1st Tech. Support Sec. Service Support Dept.			
Classification:	<input type="checkbox"/> Troubleshooting <input type="checkbox"/> Part information <input type="checkbox"/> Action required <input type="checkbox"/> Mechanical <input type="checkbox"/> Electrical <input type="checkbox"/> Service manual revision <input type="checkbox"/> Paper path <input type="checkbox"/> Transmit/receive <input type="checkbox"/> Retrofit information <input checked="" type="checkbox"/> Other (Firmware History)

Model: Model PE -P1/MF1		Date: 15-Jan-08	No.: RG165002
Subject: Firmware History - Main Control Unit		Prepared by: H.K.	
From: 1st Tech. Support Sec. Service Support Dept.			
Classification:	<input type="checkbox"/> Troubleshooting <input type="checkbox"/> Part information <input type="checkbox"/> Action required <input type="checkbox"/> Mechanical <input type="checkbox"/> Electrical <input type="checkbox"/> Service manual revision <input type="checkbox"/> Paper path <input type="checkbox"/> Transmit/receive <input type="checkbox"/> Retrofit information <input checked="" type="chec

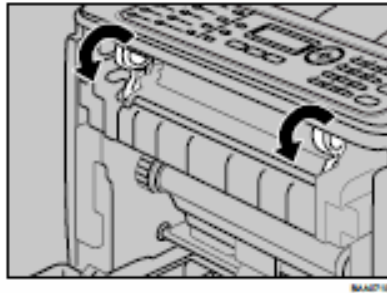
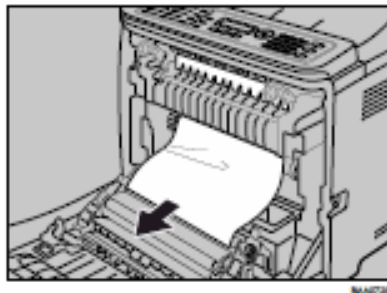
As shown in the decal below, when removing jammed paper, the operator must first pull down the fusing unit lever. Otherwise, this may damage the lower fusing entrance guide.

**2** Lower the blue fusing unit lever, and pull out the jammed paper carefully.

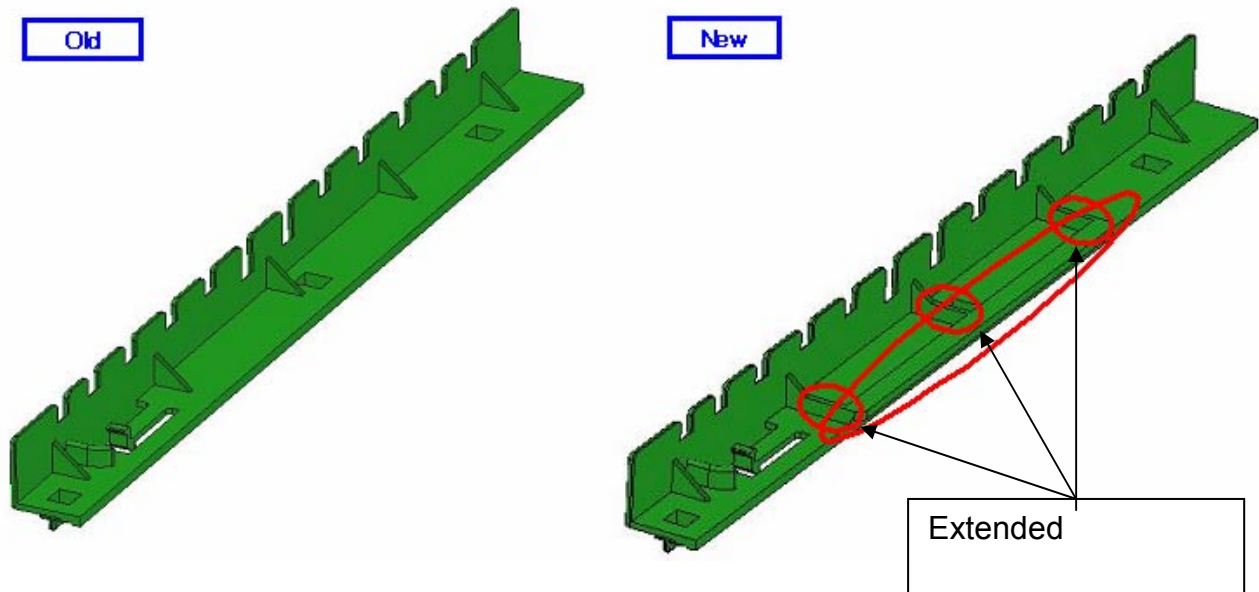
To increase the durability of the fusing entrance guide, the ribs were elongated as shown below (Applied from: July 2008 production).

If this is reported from the field, advise operators that they must lower the fusing unit lever before they removed jammed paper. If the fusing entrance guide has been damaged, replace it.

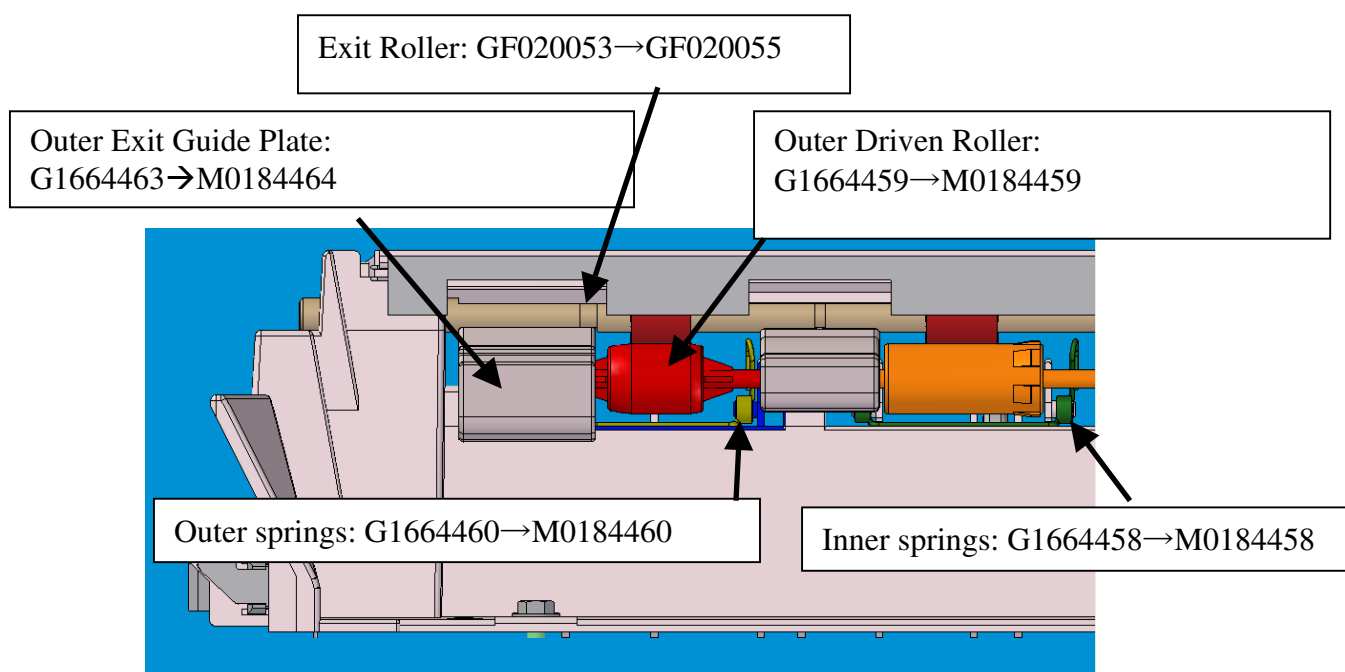
- 1) The pressure of the inner spring was decreased, and the pressure of the outer springs was increased.
- 2) The shapes of the outer exit guide plate and outer exit rollers were changed.
- 3) The shape of the exit rollers was changed (dimension [A] was lengthened, dimension [B] was shortened, and dimension [C] was shortened).
- 4) The exit guide assembly was added.

**Reasons:** Parts standardization, to improve paper stack quality, and to facilitate assembly.

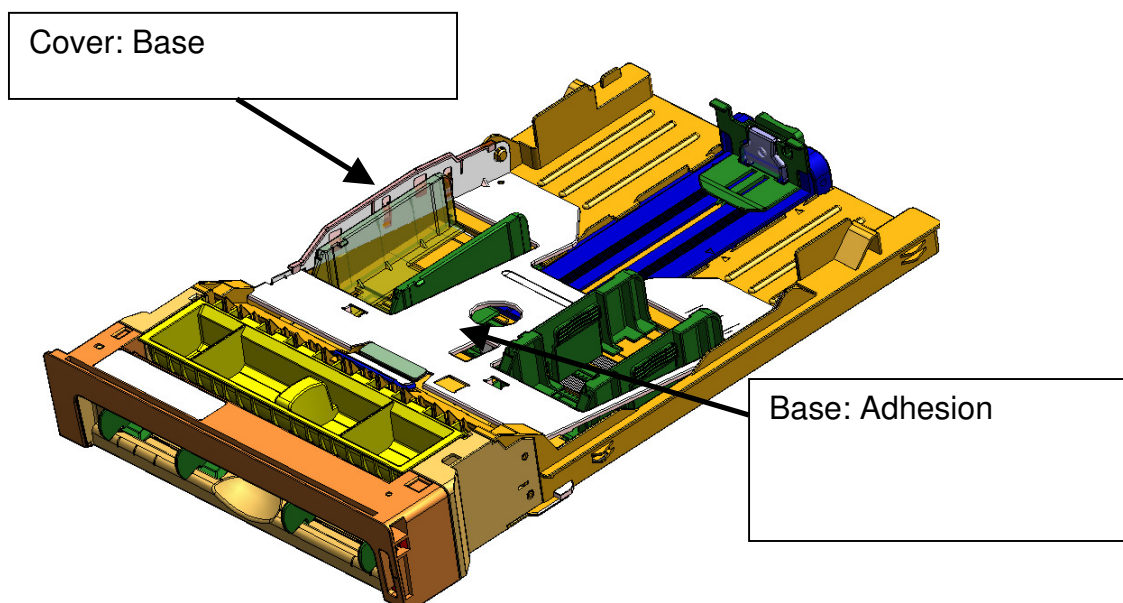
- With the new parts, even if the user forgets to push down and lock the bottom plate before pushing in the tray, the base cover makes it easier to pull the tray out.
- Users still need to push down and lock the bottom plate when loading the paper.

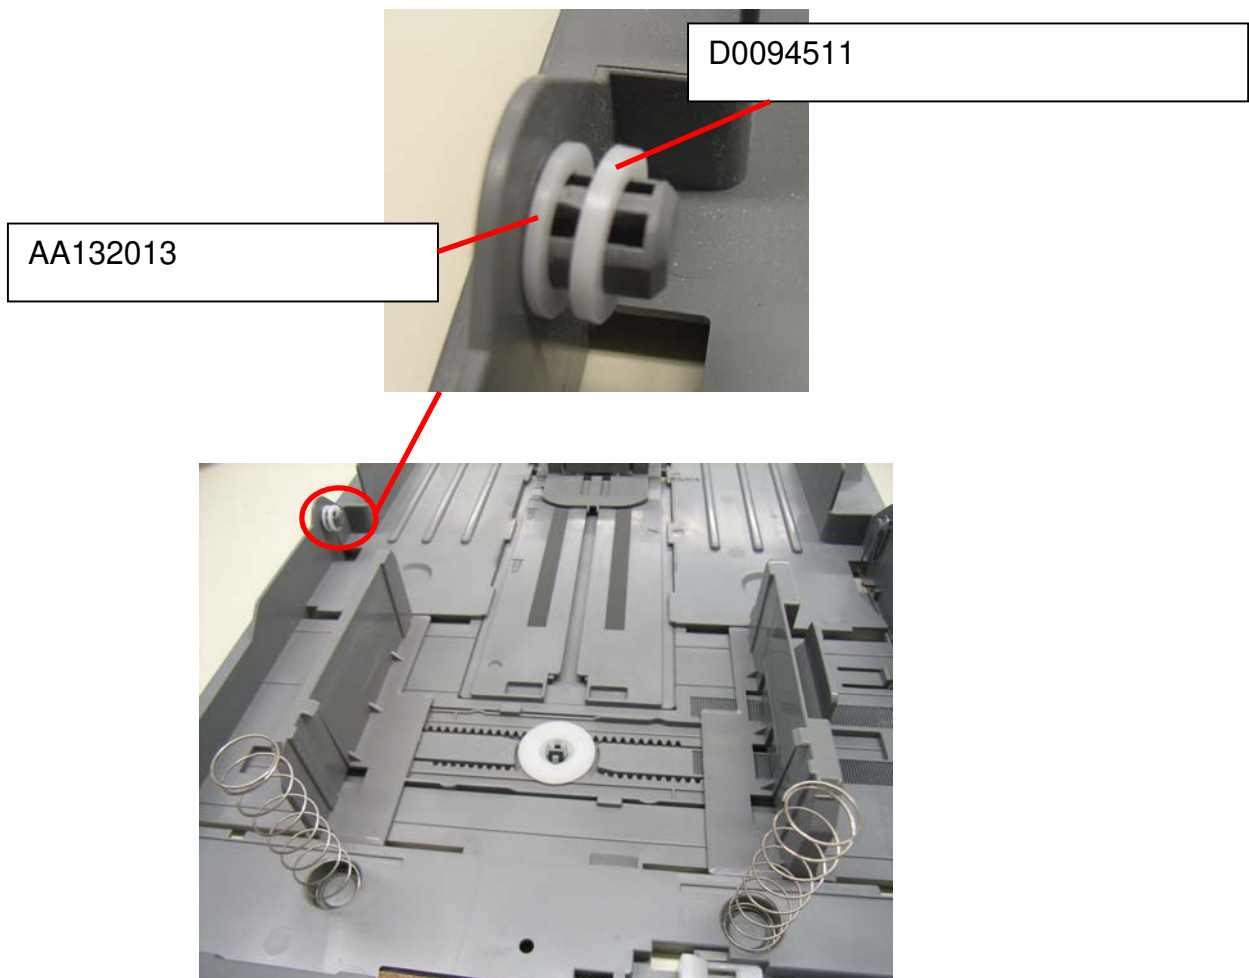
**Reason:** To further strengthen the base plate of the paper tray, minimizing paper jams.

**Note:** This was applied to the production line from March 2009.

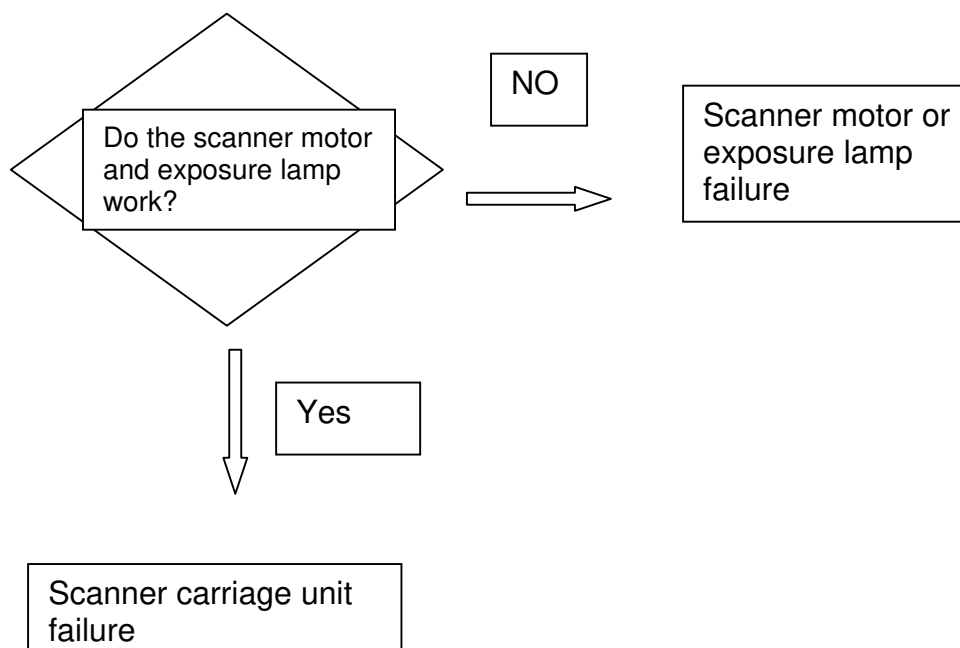
- If the scanner carriage unit does not move, the scanner motor is defective.
- If the exposure lamp does not turn on, the exposure lamp is defective.
- If the scanner carriage moves and the exposure lamp turns on, the scanner carriage unit is defective.

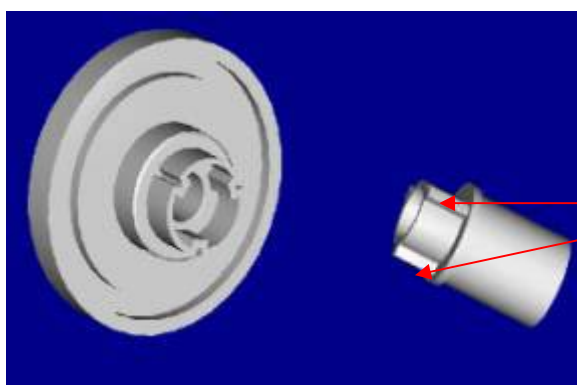
Drive AIO gear, joint gear

**Reason:** To disengage the black AIO from the drive gear when the ITB is rotated backwards (noise can sometimes be generated if they are rotated together backwards).

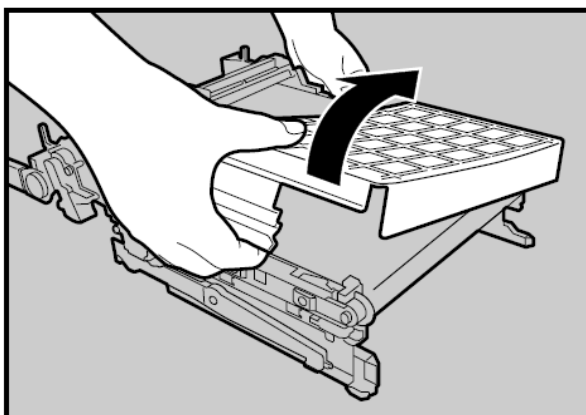
AC1442C

**Important:** Do the following whenever you replace the ITB in the field.

1. Before you install the new ITB, remove the first cover as shown.

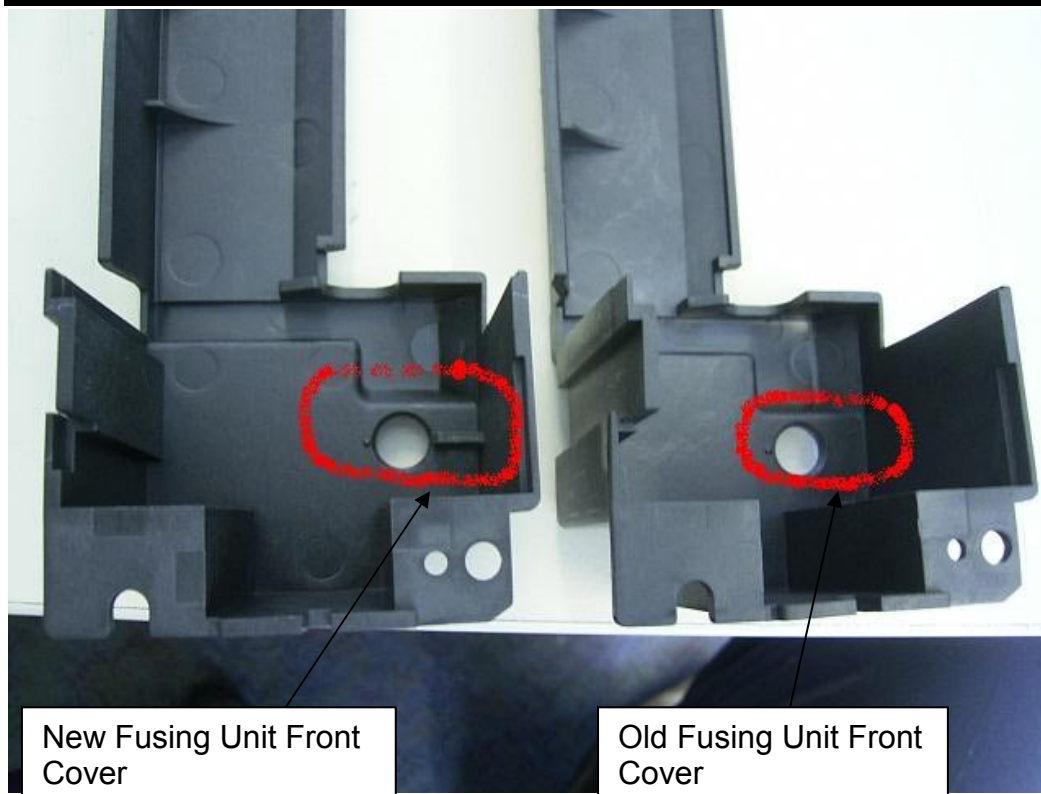
New Fusing Unit Front Cover

Old Fusing Unit Front Cover

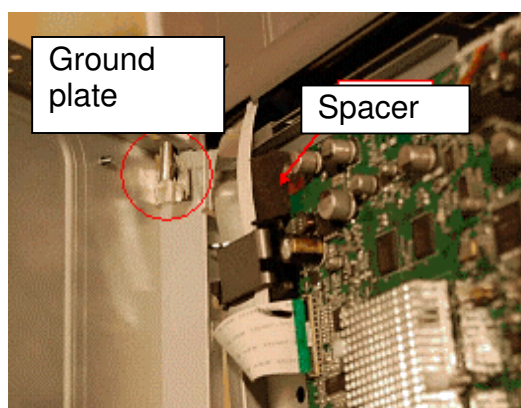
**Reason:** To increase the margin against electrical noise.

**Change:** A ground plate was extended to the control board cover and a ground spacer was added as shown.

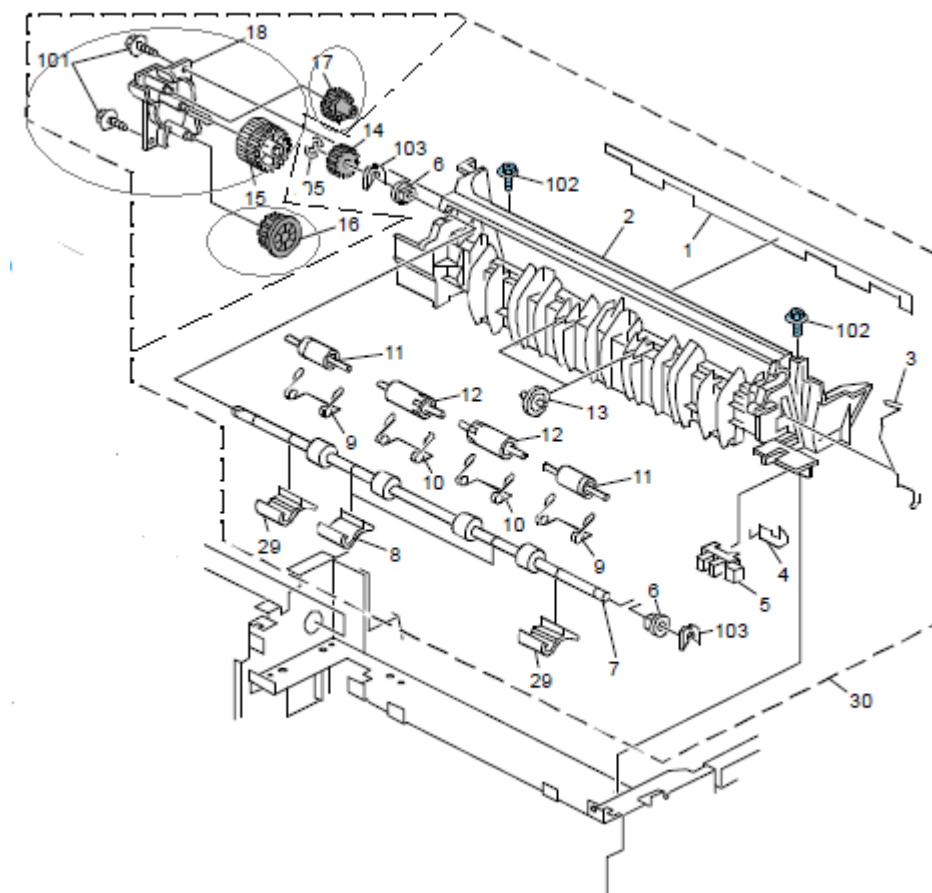
## 8. Paper Exit (G165/G166/G167/G181/G183/G184)

**Change:** The parts circled above were deleted from the illustration.

**Reason:** The Exit Guide Assembly does not contain these parts.

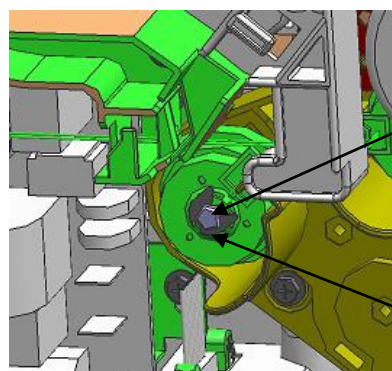
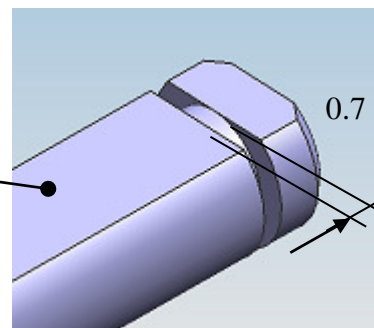
Old

G1662580 Paper Feed Roller Shaft

08050089 E-ring

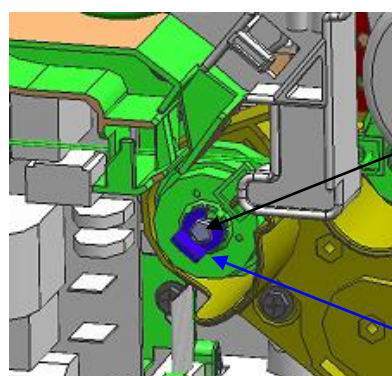
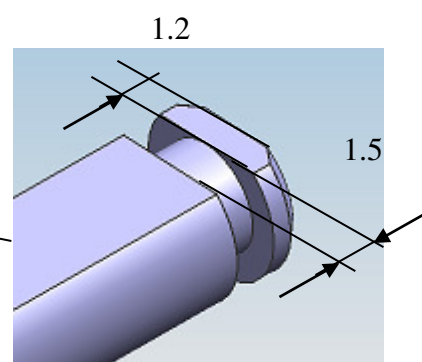
M1982580 Paper Feed Roller Shaft

H5213355 C-ring

08050089 → H5213355 New index  
27

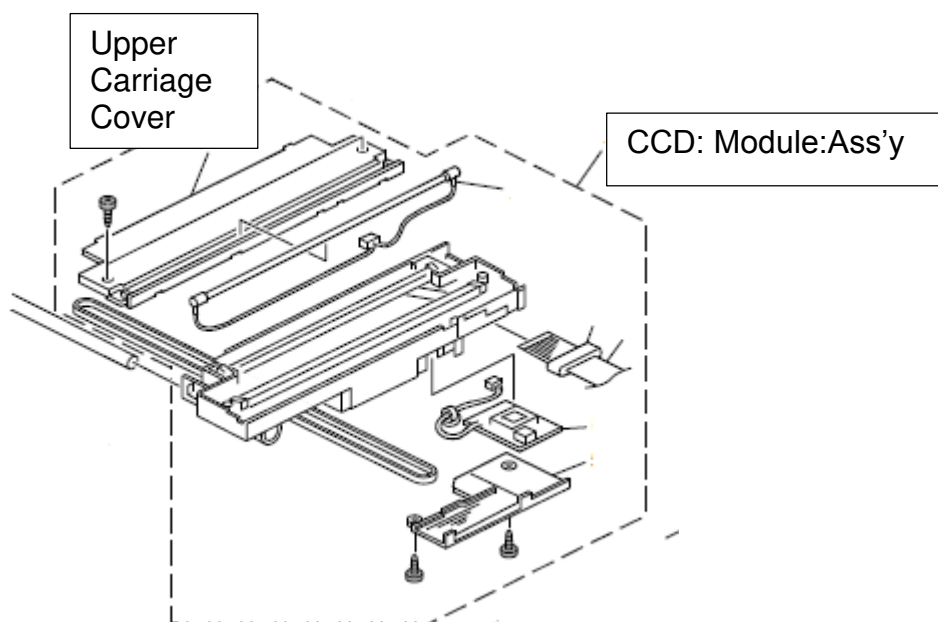
**Reason:** The manufacturer of the CCD modules has mistakenly modified the cover without notification. As a result, there is no interchangeability between the old and new covers, and both cannot be supplied.

**Change:** The Upper Carriage Cover service part was deleted and replaced with the CCD Module Assembly.
