Model: MD – P1	Date: 21-Jan-09	No.: RM040001f
----------------	-----------------	----------------

Subject: Firmware Release Note: Engine		Prepared by: H.K.	
From: 2nd Overseas Tech Support Sec. 2nd PQM Dept			
Classification:	<input type="checkbox"/> Troubleshooting	<input type="checkbox"/> Part information	<input type="checkbox"/> Action required
	<input type="checkbox"/> Mechanical	<input type="checkbox"/> Electrical	<input type="checkbox"/> Service manual revision
	<input type="checkbox"/> Paper path	<input type="checkbox"/> Transmit/receive	<input type="checkbox"/> Retrofit information
	<input type="checkbox"/> Product Safety	<input checked="" type="checkbox"/> Other (Firmware)	<input checked="" type="checkbox"/> Tier 2

Model: Model MD-P1		Date: 15-May-09	No.: RM040003
Subject: SPACER		Prepared by: H.K.	
From: 1st Tech. Support Sec. Service Support Dept.			
Classification:	<input type="checkbox"/> Troubleshooting <input checked="" type="checkbox"/> Part information <input type="checkbox"/> Action required <input type="checkbox"/> Mechanical <input type="checkbox"/> Electrical <input type="checkbox"/> Service manual revision <input type="checkbox"/> Paper path <input type="che

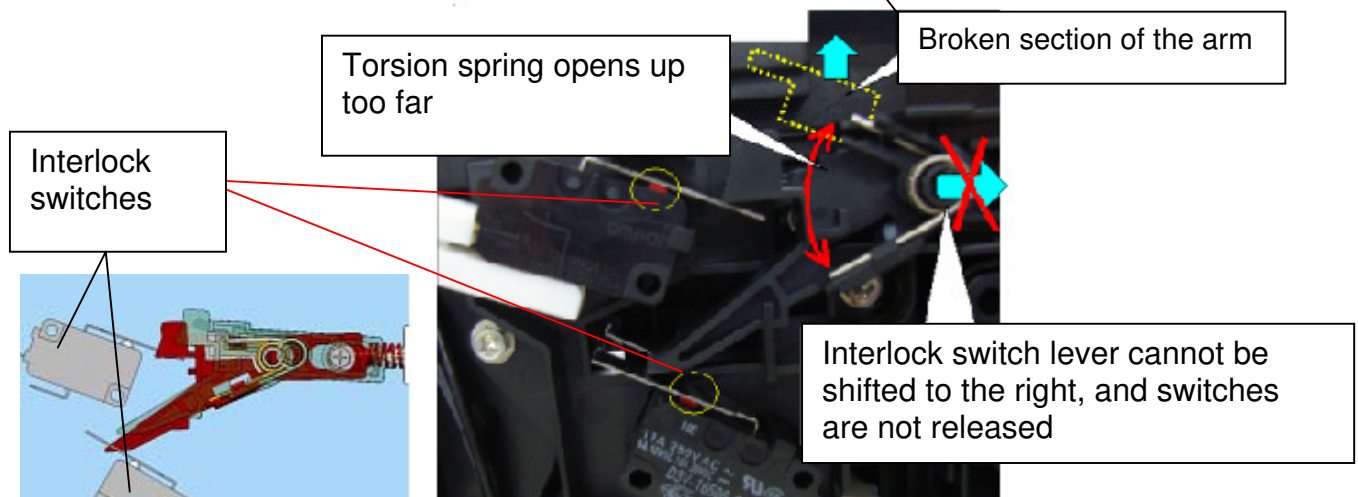
Interlock switch arm

The interlock switch arm (G1665747) breaks, which causes the torsion spring to open up too far. As a result, the interlock switch lever cannot be shifted and the interlock switches are not released, preventing the machine from detecting the cover open condition.

Replace the interlock switch arm with a new one (G1665754).

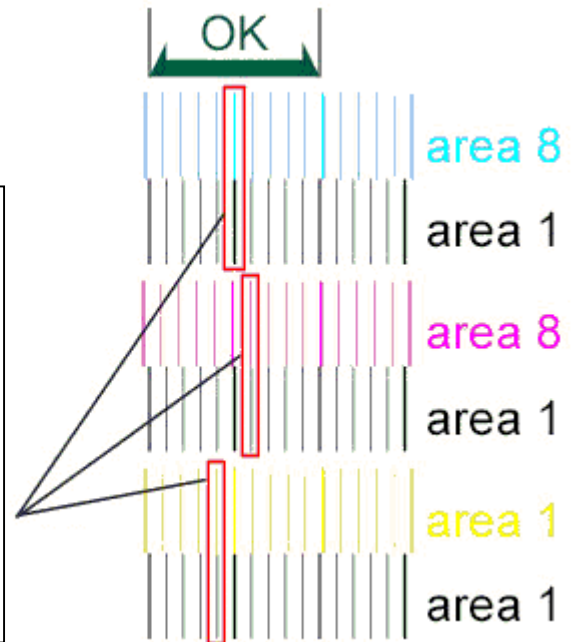
In each region/area, at least one set of vertical lines is aligned.

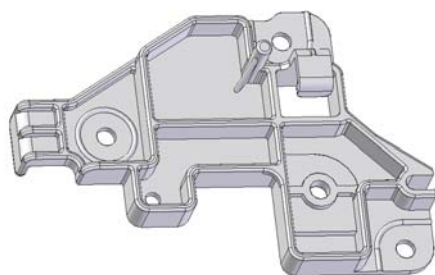
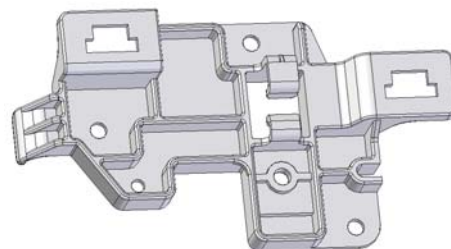
Old Holder

New Holder

- If you replace the old bracket or old holder in the field, make sure to install the new bracket and new holder **together as a set**.
- ***See other important notes about installation on the next page.***

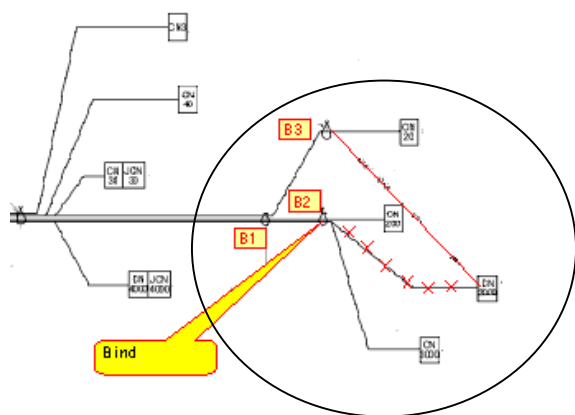
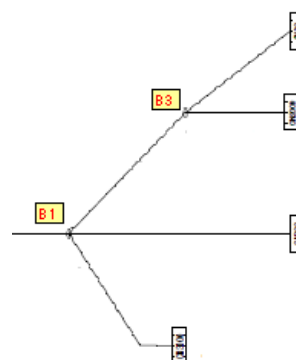
Old Harness

New Harness
