Model: G-P3	Date: 12-Mar-08	No.: RG190001e
-------------	-----------------	----------------

Subject: Firmware Release Note: Engine		Prepared by: Y. Suzuki	
From: 3rd Tech Service Sect., MFP/Printer Tech Service Dept.			
Classification:	<input type="checkbox"/> Troubleshooting	<input type="checkbox"/> Part information	<input type="checkbox"/> Action required
	<input type="checkbox"/> Mechanical	<input type="checkbox"/> Electrical	<input type="checkbox"/> Service manual revision
	<input type="checkbox"/> Paper path	<input type="checkbox"/> Transmit/receive	<input type="checkbox"/> Retrofit information
	<input checked="" type="checkbox"/> Other ()

Model: Model G-P3		Date: 4-Apr-08	No.: RG190011
Subject: Service Manual Correction		Prepared by: K. Moriizumi	
From: 1st Tech. Support Sec. Service Support Dept.			
Classification:	<input type="checkbox"/> Troubleshooting	<input type="checkbox"/> Part information	<input type="checkbox"/> Action required
	<input type="checkbox"/> Mechanical	<input type="checkbox"/> Electrical	<input checked="" type="checkbox"/> Service manual revision
	<input type="checkbox"/> Paper path	<input type="checkbox"/> Transmit/receive	<input type="checkbox"/> Ret

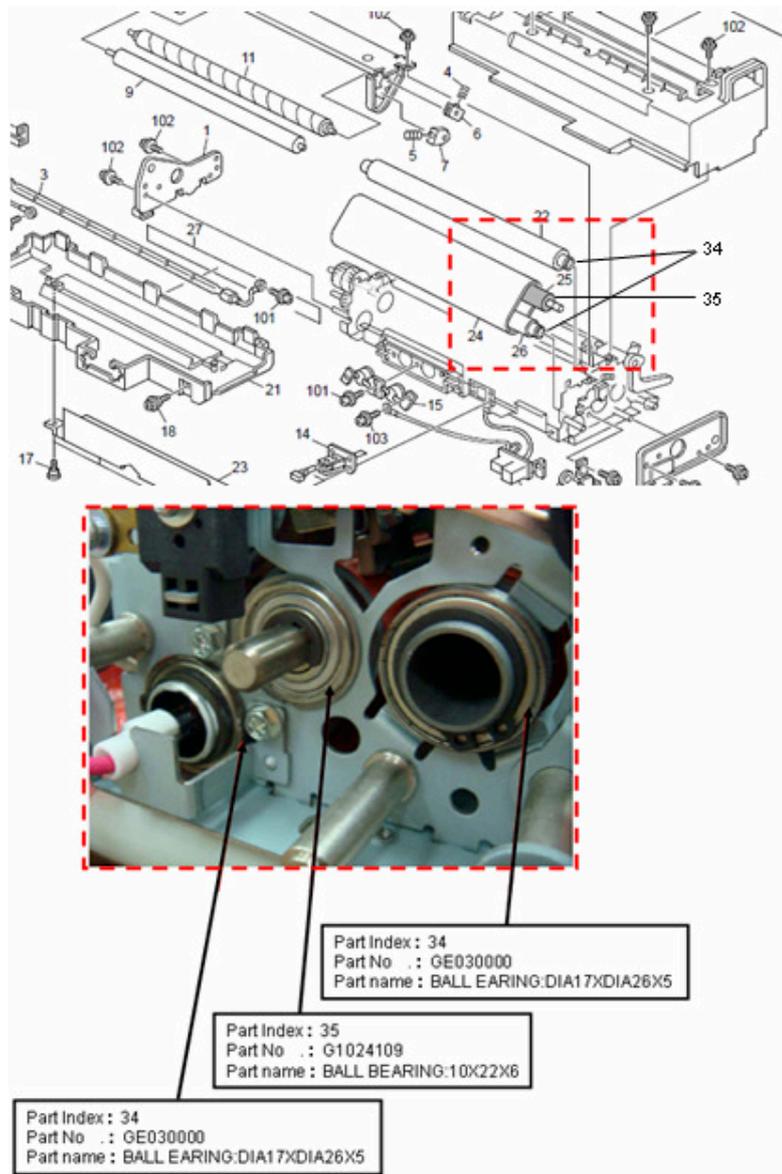
Change/Reason: These parts were missing from the Parts Catalog.

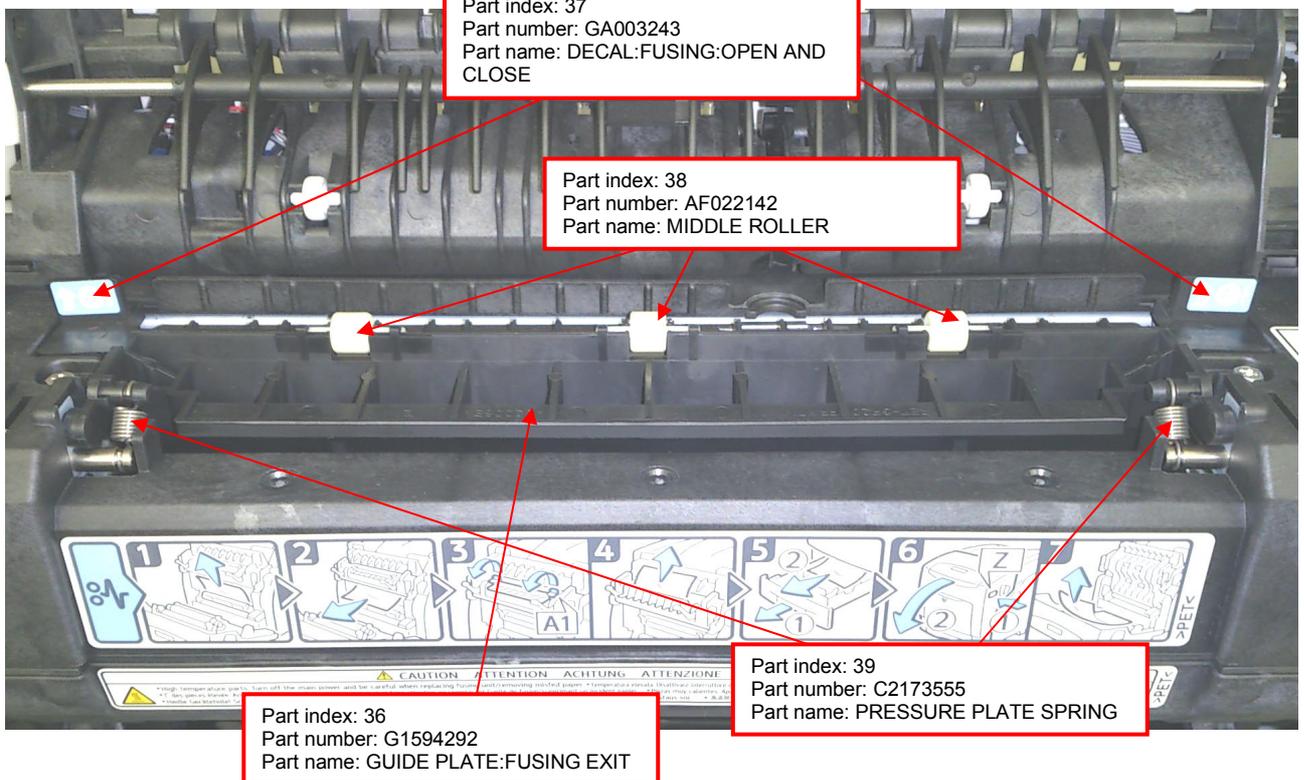
Model: G-P3		Date: 23-Jan-13	No.: RG190017
Subject: Part addition: Fuser Exit Guide		Prepared by: Y. Suzuki	
From: 3rd Tech Service Sect.,MFP/P Tech Service Dept.			
Classification:	<input type="checkbox"/> Troubleshooting	<input checked="" type="checkbox"/> Part information	<input type="checkbox"/> Action required
	<input type="checkbox"/> Mechanical	<input type="checkbox"/> Electrical	<input type="checkbox"/> Service manual revision
	<input type="checkbox"/> Paper path	<input type="checkbox"/> Transmit/receive	<input type="checkbox"/> Retrofit information
	<input type="checkbox"/> Product Safety	<input type="checkbox"/> Other ()	<input type="checkbox"/> Tier 2

Old part number	New part number	Description	Q'ty	Int	Page	Index	Note
	G1594292	GUIDE PLATE:FUSING EXIT	0 - 1		24	36*	Add
	GA003243	DECAL:FUSING:OPEN AND CLOSE	0 - 2		24	37*	Add
	AF022142	MIDDLE ROLLER	0 - 3		24	38*	Add
	C2173555	PRESSURE PLATE SPRING	0 - 2		24	39*	Add

Change/Reason: These parts were missing from the Parts Catalog.
