Model: Ti-P1		Date: 21-May-13	No.: RM109001
Subject: IEEE802.11 Interface Unit Type O Notification		Prepared by: Y. Suzuki	
From: 3rd Tech Service Sect.,MFP/P Tech Service Dept.			
Classification:	<input checked="" type="checkbox"/> Troubleshooting <input type="checkbox"/> Mechanical <input type="checkbox"/> Paper path <input type="checkbox"/> Product Safety	<input type="checkbox"/> Part information <input type="checkbox"/> Electrical <input type="checkbox"/> Transmit/receive <input type="checkbox"/> Other ()	<input type="checkbox"/> Action required <input type="checkbox"/> Service manual revision <input type="checkbox"/> Retrofit information <input checked="" type="checkbox"/> Tier 2

Subject: Firmware Release Note: Engine		Prepared by: H. Kobayashi	
From: 2nd Tech Service Sect., MFP/Printer Tech Service Dept.			
Classification:	<input type="checkbox"/> Troubleshooting <input type="checkbox"/> Mechanical <input type="checkbox"/> Paper path <input type="checkbox"/> Product Safety	<input type="checkbox"/> Part information <input type="checkbox"/> Electrical <input type="checkbox"/> Transmit/receive <input checked="" type="checkbox"/> Other (Firmware)	<input type="checkbox"/> Action

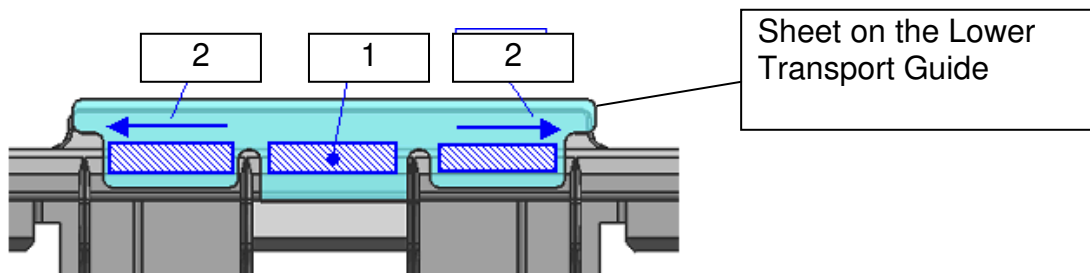
A procedure was added for attaching the sheet to the lower transport guide plate (the center is attached first, followed by the left/right edges).

- Temporary solution (from first production, June 2013)

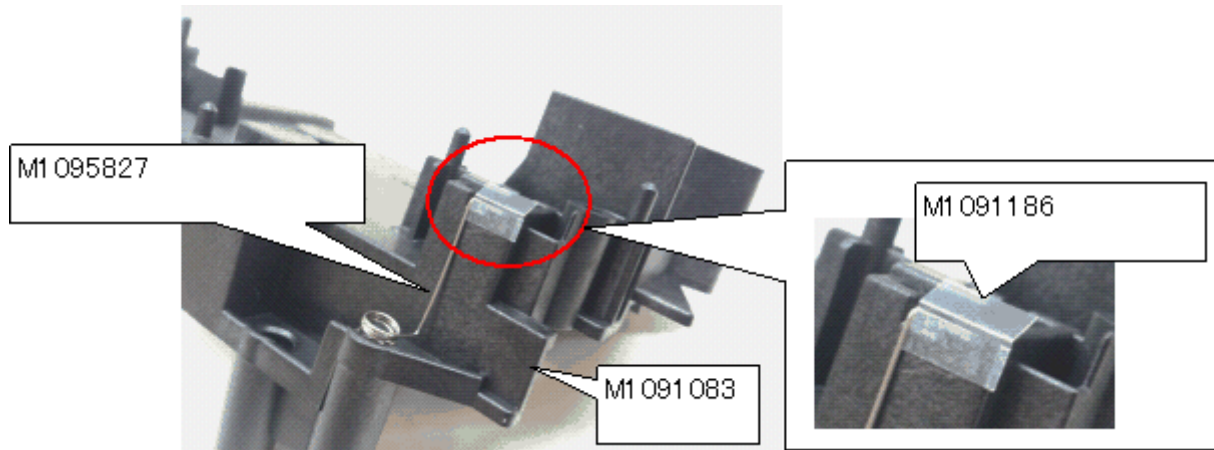
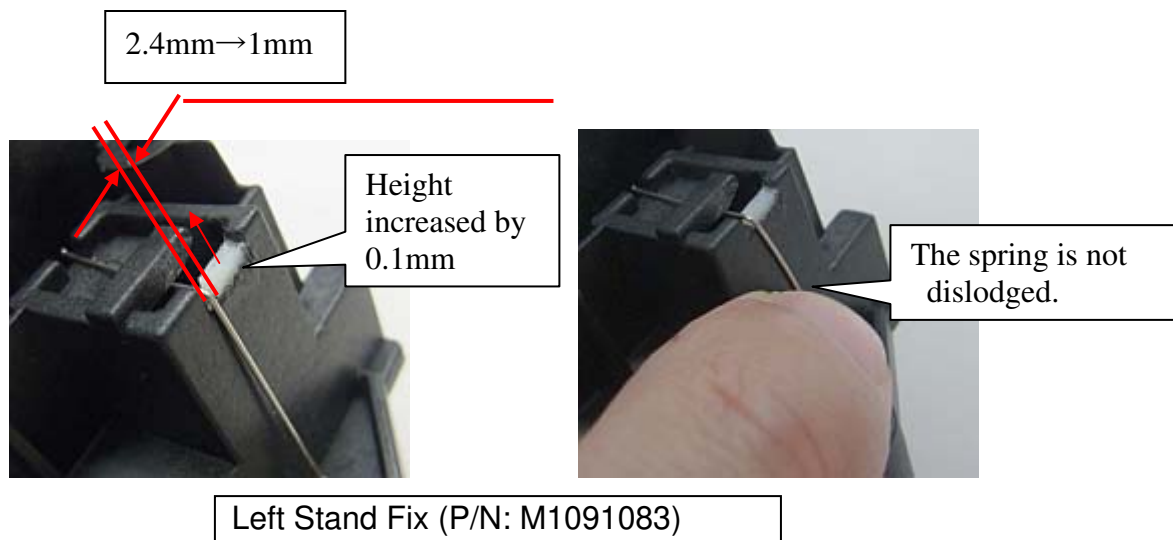
1. The width of the ditch on the Left Stand Fix for the spring was reduced from 2.4mm to 1mm.
2. The height of the white portion on the Left Stand Fix was increased by 0.1mm.

Shape change of the Left Stand Fix (P/N: M1091083):

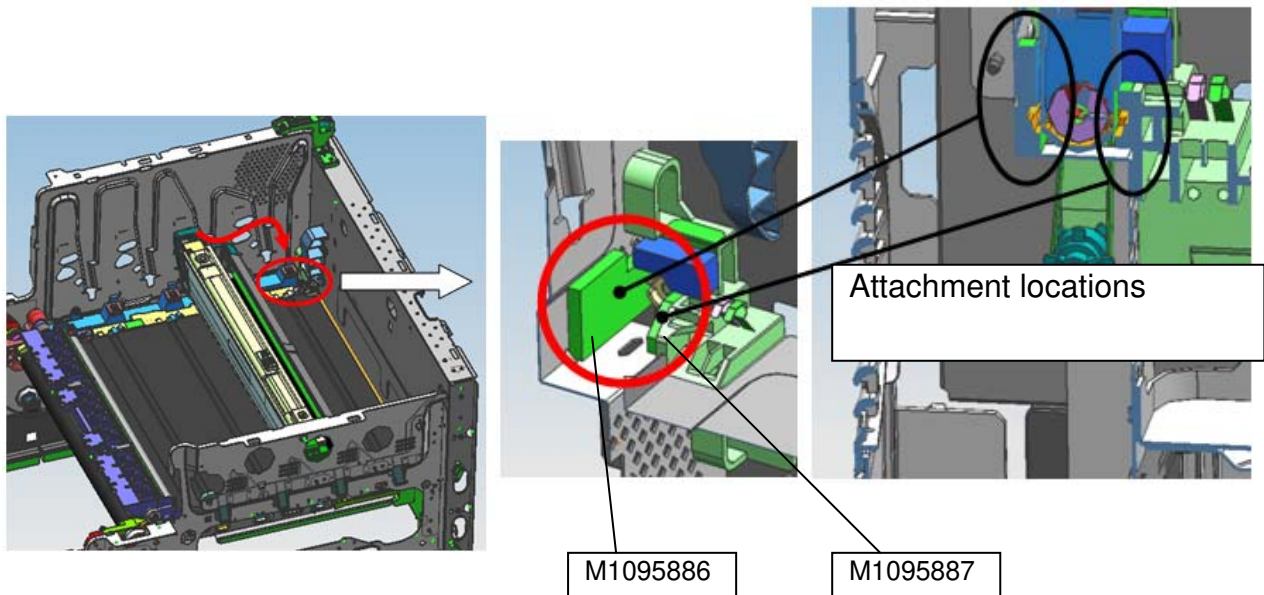
Reason: To further improve the sealing of the waste toner duct section.

Change: Two seals were added to the waste toner duct section.

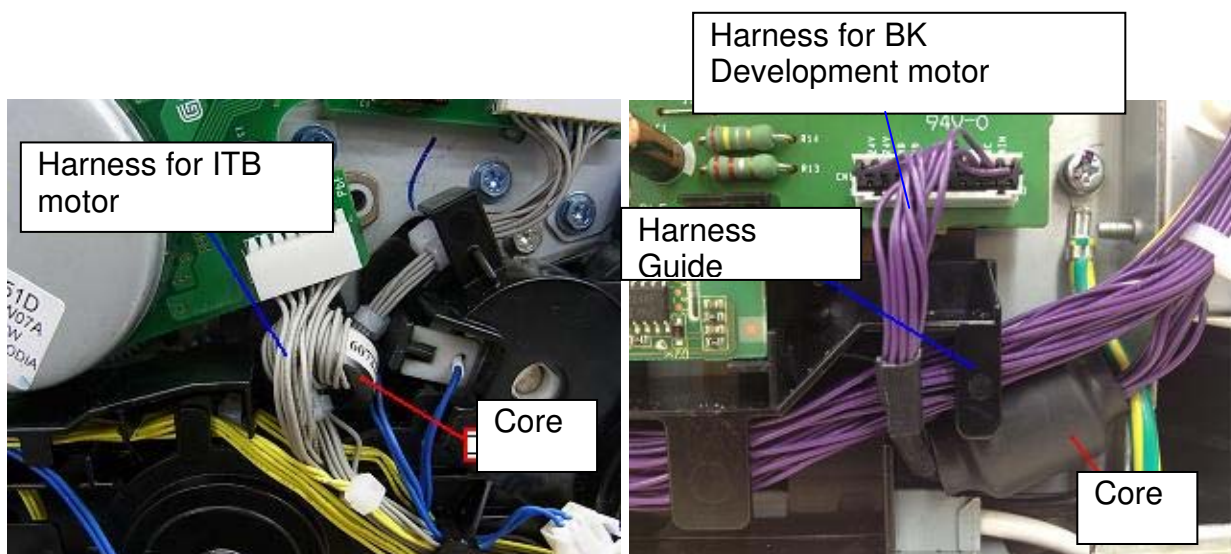
Reason: To further minimize electromagnetic interference.

Change: Two ferrite cores were added to the lower drive EGB harness.

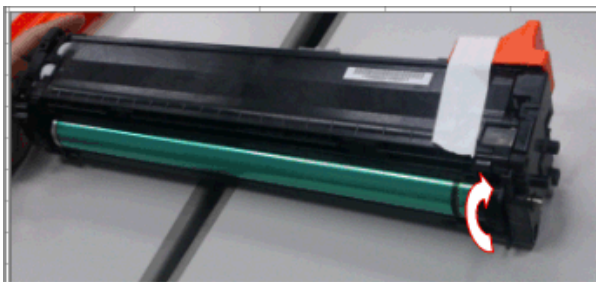
1. The above action reduces the possibility of occurrence. However, clumped toner may still form between the development blade and development roller. Please ask for the customer's understanding regarding this.
2. The clumped toner can be cleared manually by rotating the development roller in the reverse direction about 5 mm, as shown in the photo. The symptom may occur until this clumped toner is removed from the PCDU.

3. If the problem is not solved, set **SP2500-012** (Data UC2) to a value of **1**. With this setting, the machine will consume more toner than with the default setting. Advise customers that the toner and waste toner bottle will need to be replaced earlier with this setting.

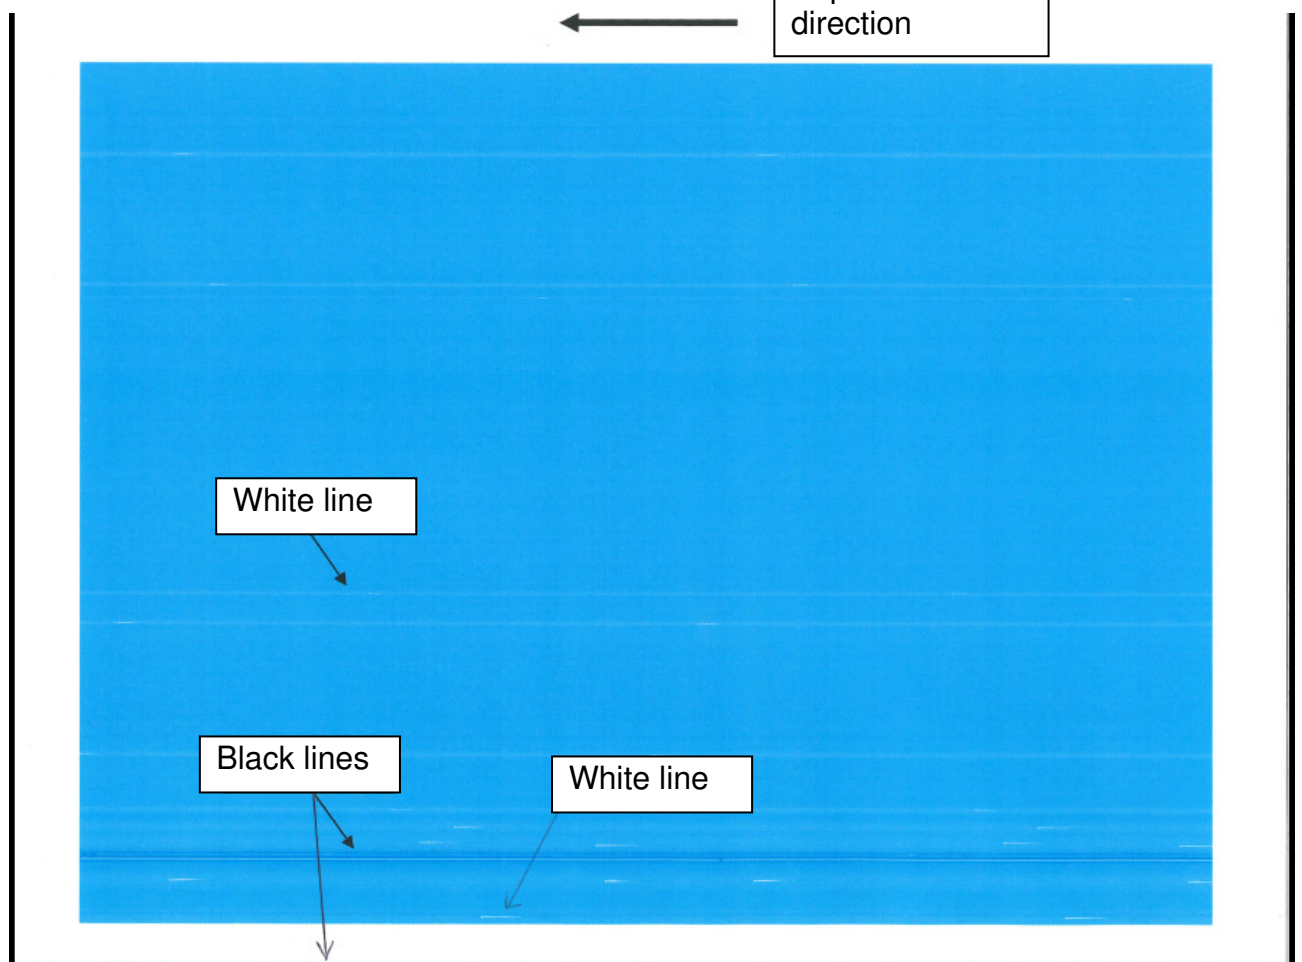
Black/ white lines appear (feed direction: Medaka)

- The Replacement alert for the PCDU can be displayed earlier with Engine firmware **Ver.1.90:16** (applied from December 2013 production). This is to prompt the customer to replace the unit before the black/white lines issue occurs. In combination with stocking units on site in advance, this will prevent service visits.
- The target yield of the PCDU is 38KP, but black/white lines (feed direction: Medaka) before 38KP have been reported from the field in Japan.
- To accomplish this, new SP modes were added from the new firmware.

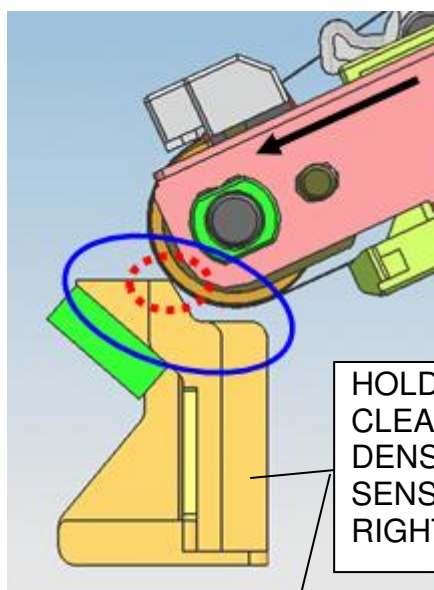
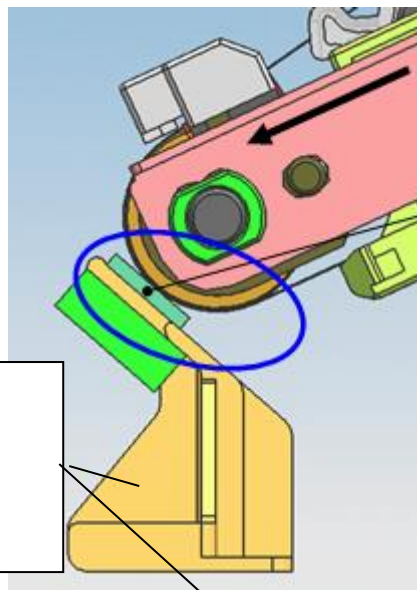
The ITB is sometimes inserted at an angle

IMPORTANT: If you need to replace the old Right Density Sensor Cleaner Holder in the field, make sure to install the new Right Density Sensor Cleaner Holder and new cushion **together as a set**.

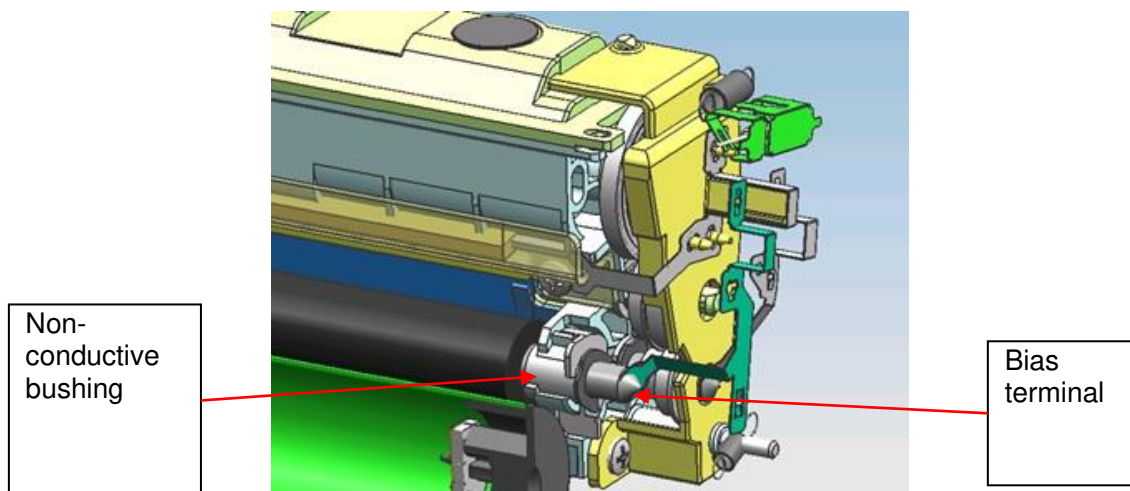
Old PCDU

Reason: To apply the development bias more consistently across the development roller surface.

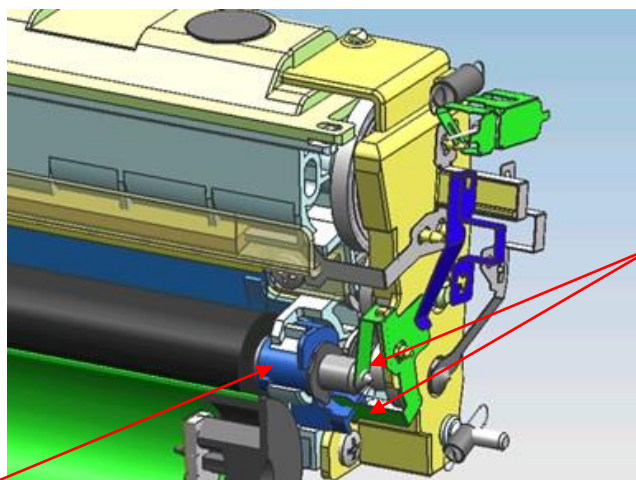
New PCDU

Conductive
bushing

Two bias
terminals

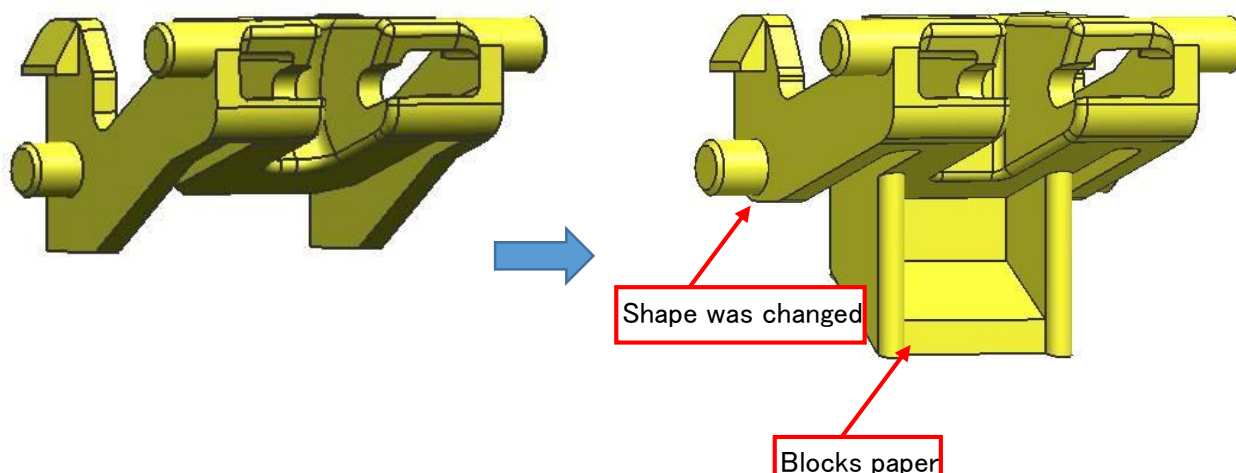
Toner in the cleaning section of the ITB unit may leak out when the user removes paper that had curled and then jammed in the unit.

Replace the paper guide holder or ITB unit with the modified one.

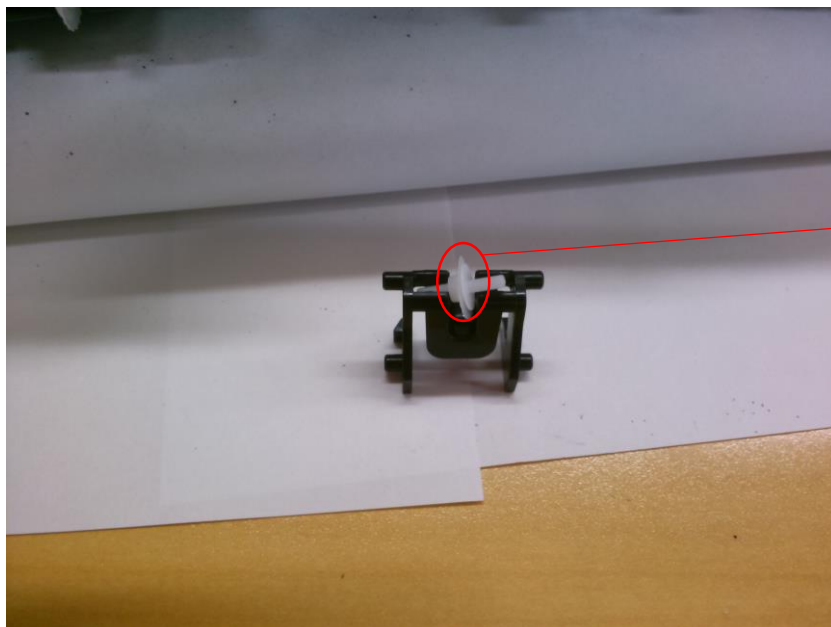
Old Paper Guide Holder

Spur

5. Remove the spur from the old Paper Guide Holder as shown and attach it into the new one.

6. Return the new Paper Guide Holder together with the spur to the ITB Cleaning Sub-Unit.

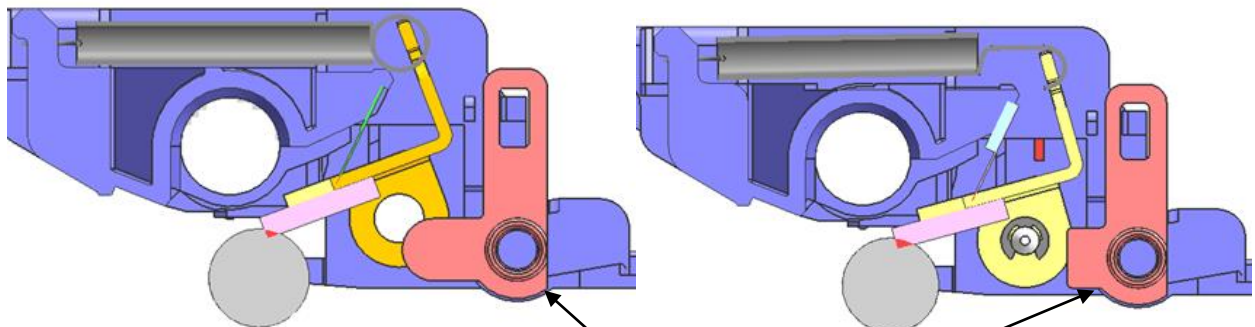
New

Plain Shaft Bearings

Right: M1096164 → M1116164

1. There is no interchangeability (**X/X**) between the old and new ITB Cleaning Sub-unit. The old part is no longer available, as a mold is not used to produce the new part. When the old ITB Cleaning Sub-unit has to be replaced, replace it with the new ITB unit assembly.
2. The old Plain Shaft Bearings are still available as a service part for older machines.

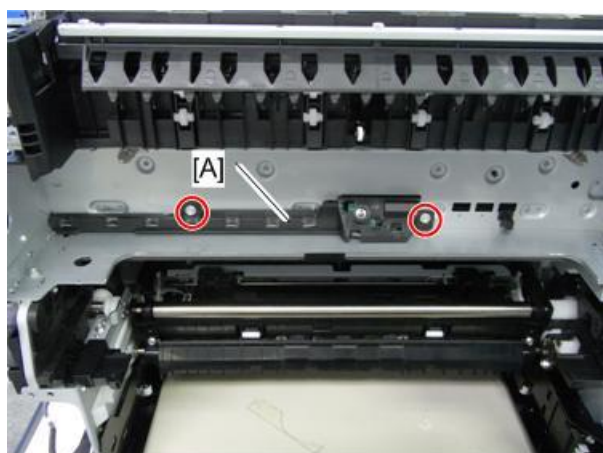
m1099065.jpg

Reason: The hooks of the thermopile Holder can be damaged in the field when the Thermopile is removed from the Holder.

1. Fusing unit (→ pg. 76).
2. Thermopile bracket (Holder) [A] (screw x2).

Note: This procedure (FSM, pg. 86) was revised as follows.

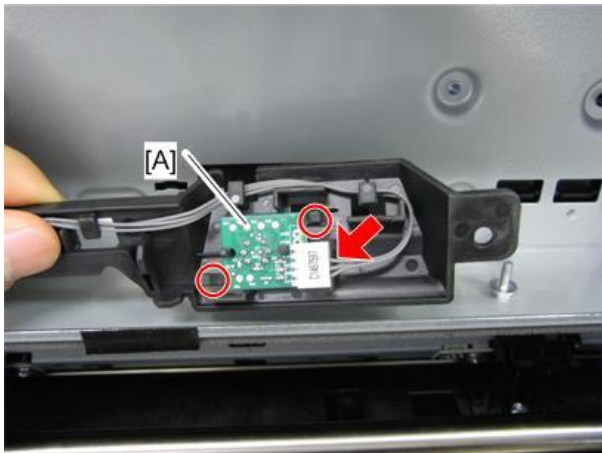
m1099066.jpg

Important: Do not remove the Thermopile [A] from the bracket (Holder). Otherwise, the hooks of the bracket (holder) will be damaged.

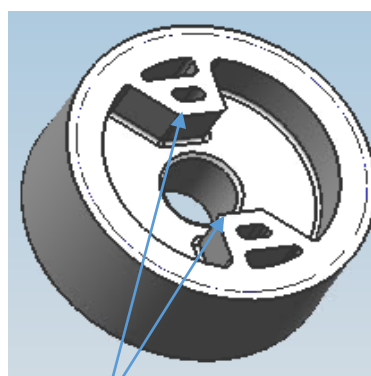
New Fusing Coupling Gear
The shape was changed.

There is no interchangeability (**X/X**) between the old and new parts. When the old part needs to be replaced, make sure to replace it with the new parts listed in the table **together as a set**.

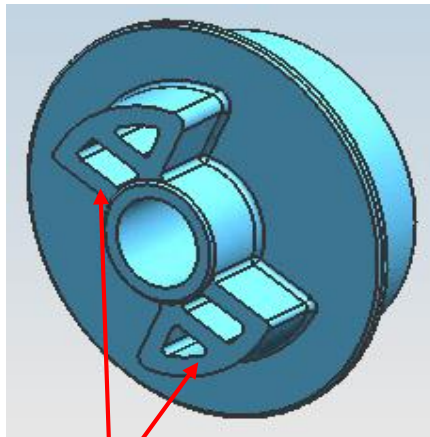
New Fusing Coupling
Pulley
The shape was changed.

Important: There is no interchangeability (**X/X**) between the old and new parts. When the old part needs to be replaced, make sure to replace it with the new parts listed in the table **together as a set**.

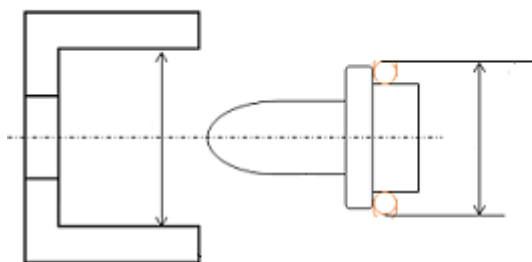
Terminal Holder:
Diameter:
 $6 +0.1/-0.1$ to
 $6.7+0.1/-0.1$

Compression
Spring:
Diameter:
 $5.8+0.1/0$ to
 $6.1+0.4/0$

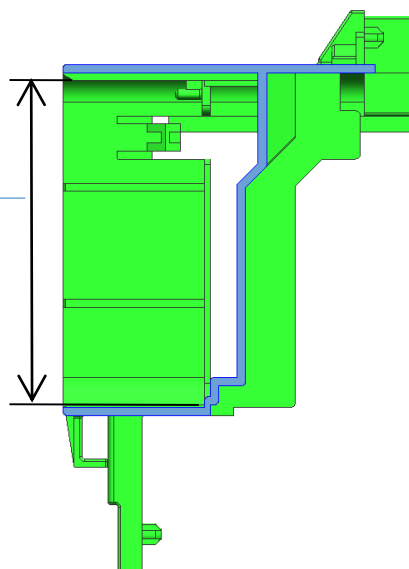
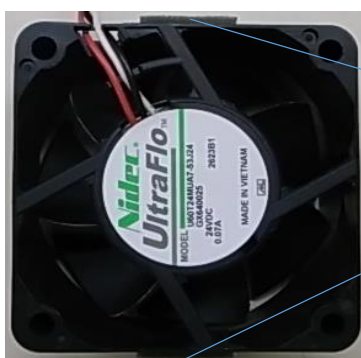
Note: The Fusing Fan Duct tended to be bent inward when the fusing fan was installed. This sometimes caused the fusing fan blade to touch the Fusing Fan Duct.

59.0 ± 0.3 to 60.8 ± 0.3

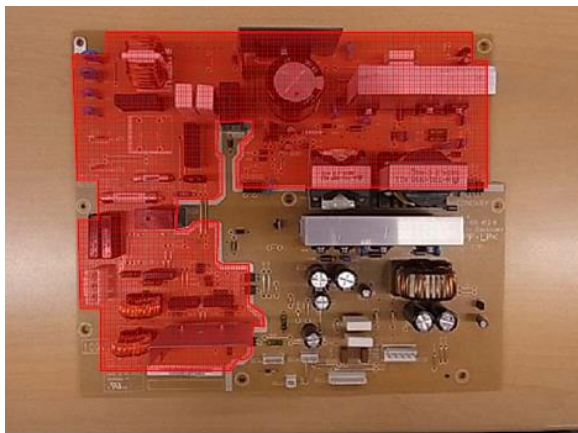
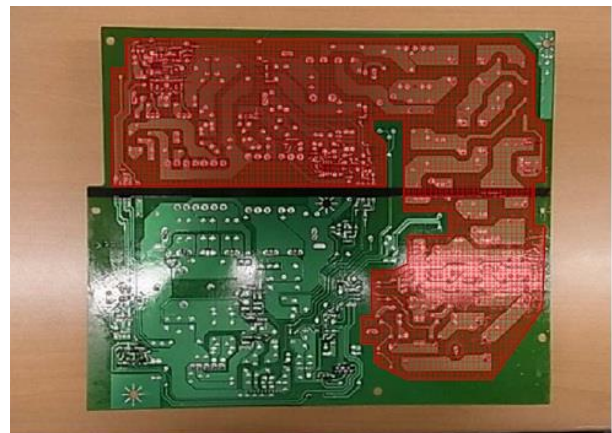
GZ230067

NEVER touch the areas outlined in red in the photos below, to prevent electric shock caused by residual charge.

The procedure to discharge residual charge from the machine by unplugging the power cord from the AC wall outlet and pressing the main power switch works only for the DC circuits on this board. Residual charge remains in the AC circuits.

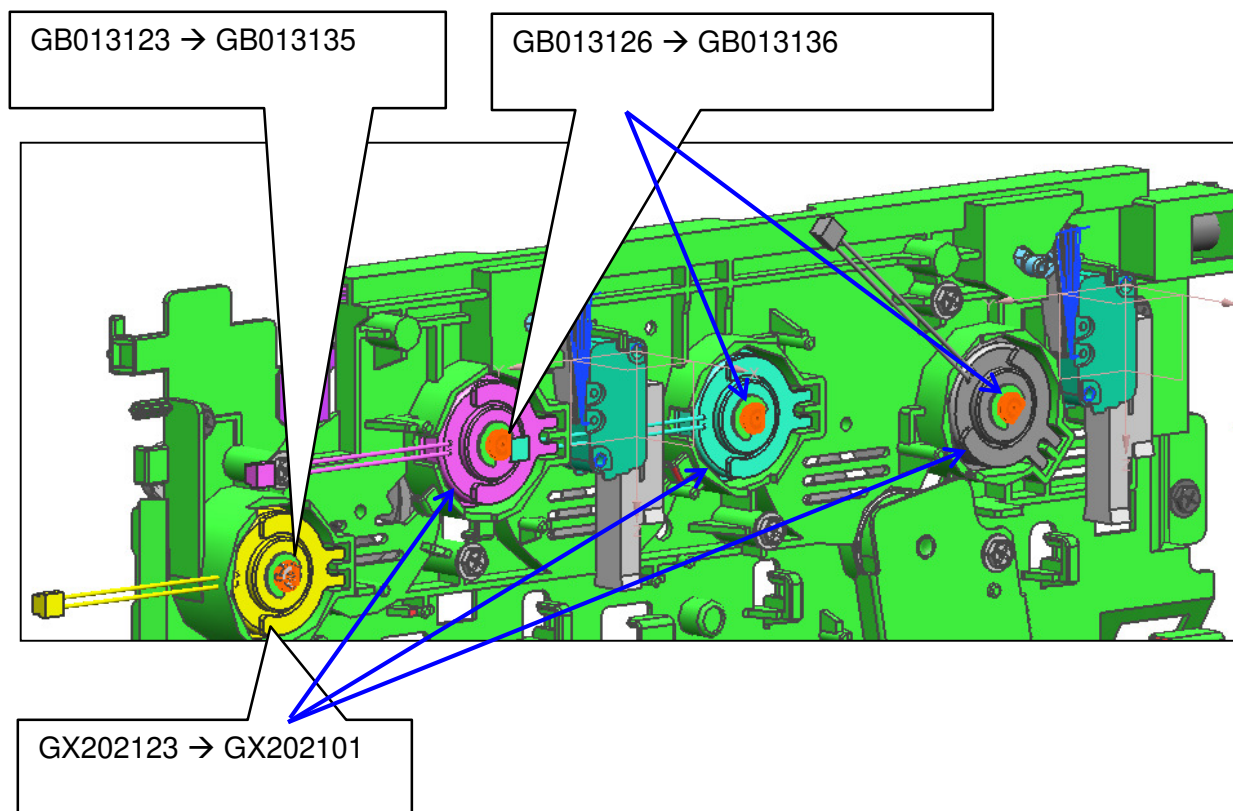
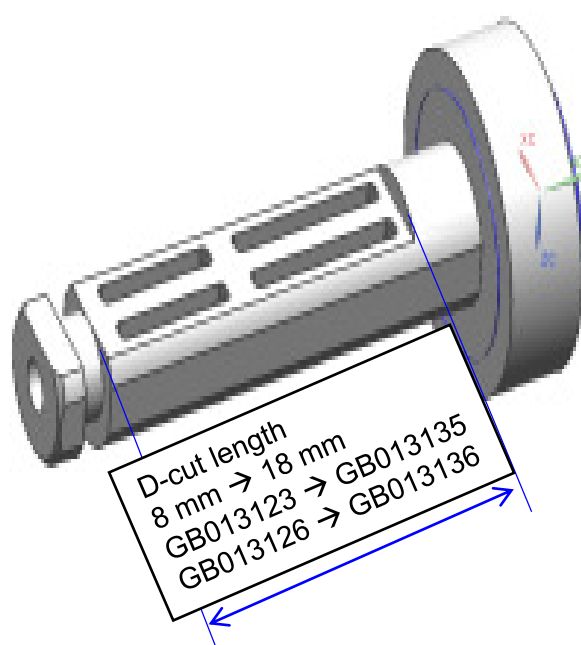
Reason: To prevent SC365 (Toner End Sensor output count error) caused by a rusted clutch, which was a problem reported from the field.

There is no interchangeability (**X/X**) between the old gear and the new clutch. When the old clutch needs to be replaced, make sure to replace it with the new clutch and new gear listed in the table **together as a set**.

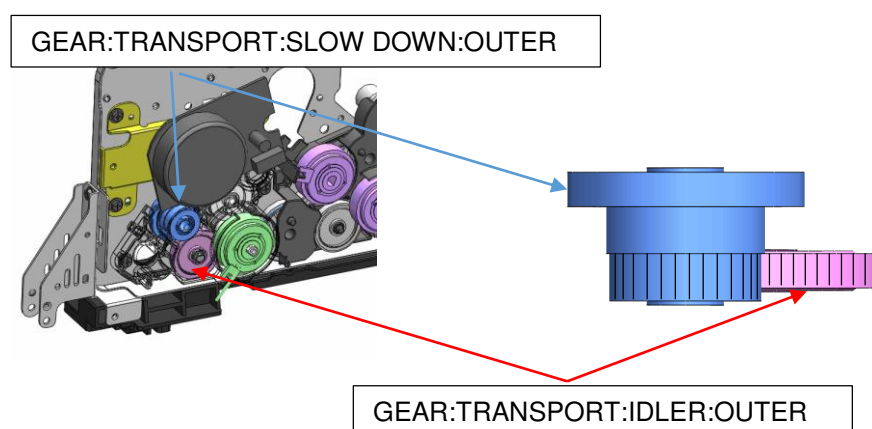
Changes: A stopper ring was added to the Connecting Transport Shaft. The height of the Outer Slow Down Transport Gear was decreased by 2 mm. The shape of the Transport Bracket was changed for assembling.

Reason: To reduce noise caused by interference between the Outer Slow Down Transport Gear and the Outer Idler Transport Gears

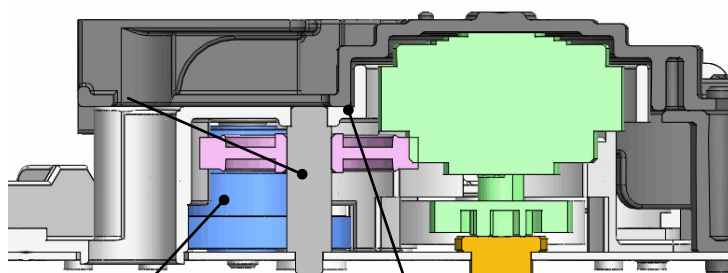
Old

SHAFT: TRANSPORT: CONNECTING

GEAR: TRANSPORT:
SLOW DOWN: OUTER

BRACKET: TRANSPORT: 2

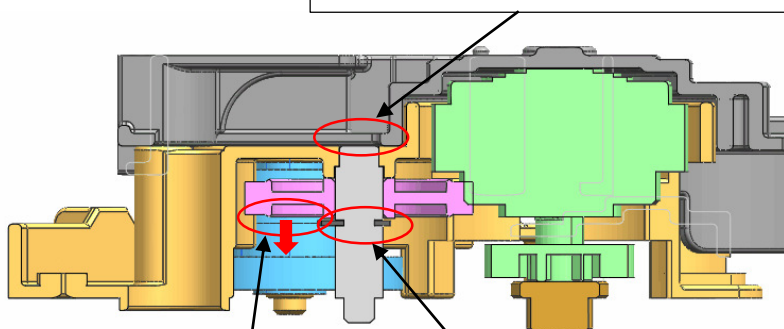
New

The shape of the Transport Bracket was changed.

A stopper ring was added to the Connecting transport Shaft.

The height of the Outer Slow Down Transport Gear was decreased by 2mm.
