Model: Model AP-P1	Date: 29-Sep-06	No.: RG133001k
--------------------	-----------------	----------------

Subject: Firmware Release Note: System		Prepared by: M.Kumagai	
From: 1st Overseas Tech Support Sec., 1st PQM Dept.			
Classification:	<input type="checkbox"/> Troubleshooting	<input type="checkbox"/> Part information	<input type="checkbox"/> Action required
	<input type="checkbox"/> Mechanical	<input type="checkbox"/> Electrical	<input type="checkbox"/> Service manual revision
	<input type="checkbox"/> Paper path	<input type="checkbox"/> Transmit/receive	<input type="checkbox"/> Retrofit information
	<input checked="" type="checkbox"/> Other ()

Model: AP-P1		Date: 5-Dec-06	No.: RG133008
Subject: Unparallel horizontal lines		Prepared by: K. Moriizumi	
From: 1st Tech. Support Sec. Service Support Dept.			
Classification:	<input checked="" type="checkbox"/> Troubleshooting <input type="checkbox"/> Mechanical <input type="checkbox"/> Paper path <input type="checkbox"/> Product Safety	<input type="checkbox"/> Part information <input type="checkbox"/> Electrical <input type="checkbox"/> Transmit/receive <input type="checkbox"/> Other ()	<input type="checkbox"/> Action required <in

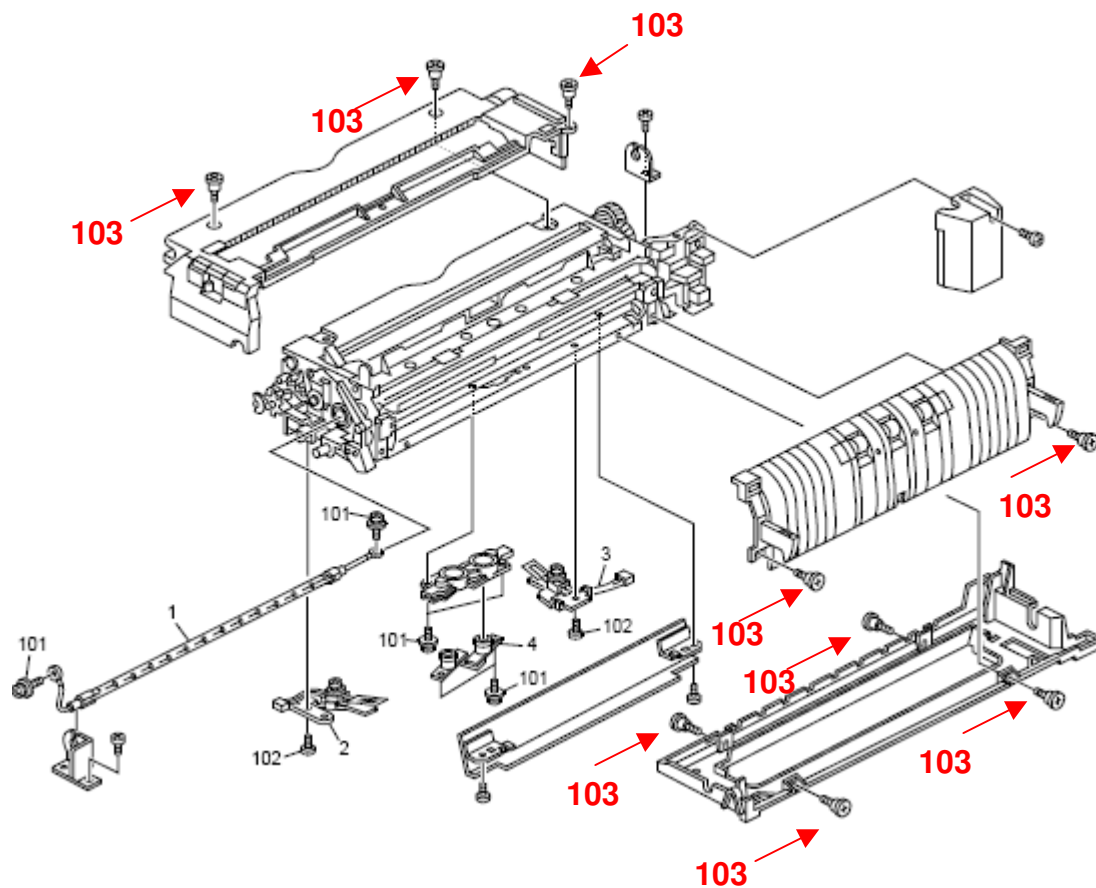
***New Index**

Change/Reason: The following part was missing from the parts catalog.

New part number	Description	Q'ty	Int	Page	Index	Note
AA143867	SCREW:DIA4:M3:FUSING UNIT	9		36	103

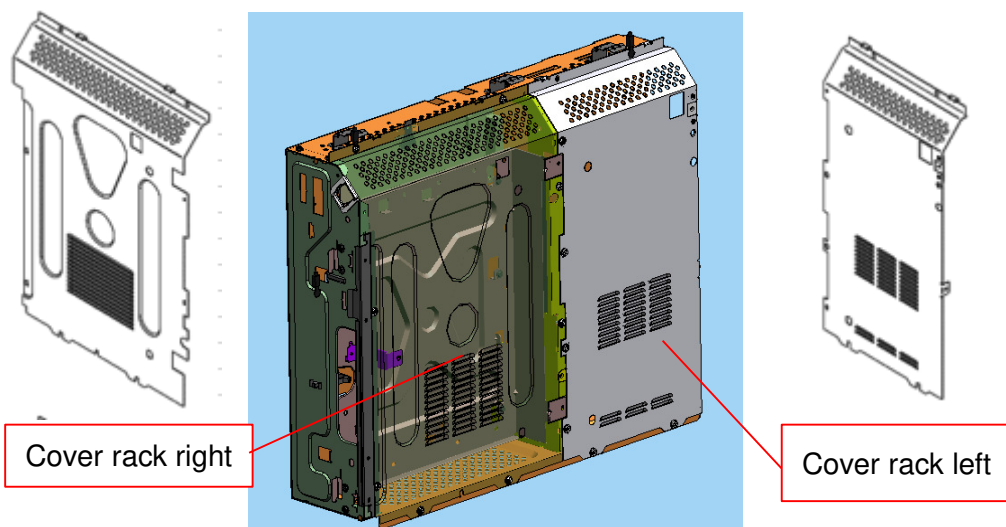
- 1) The contact finish on the push switch wears with time, causing an unstable signal from the sensor, and this causes most of the false detection errors during continuous paper feed.
- 2). Detection timing of the push switch was designed to be very short and strict, because of the situation described above in cause 1).

Cover rack right: D0295811

Cover rack left: D0295810
