Model: AP-P2	Date: 11-Dec-08	No.: RG188001e
---------------------	-----------------	----------------

Subject: Firmware Release Note: Engine		Prepared by: M. Kumagai	
From: 1st Overseas Tech Support Sec., 1st PQM Dept.			
Classification:	<input type="checkbox"/> Troubleshooting	<input type="checkbox"/> Part information	<input type="checkbox"/> Action required
	<input type="checkbox"/> Mechanical	<input type="checkbox"/> Electrical	<input type="checkbox"/> Service manual revision
	<input type="checkbox"/> Paper path	<input type="checkbox"/> Transmit/receive	<input type="checkbox"/> Retrofit information
	<input checked="" type="checkbox"/> Other ()

Model: Ap-P2		Date: 4-Sep-09	No.: RG188018
Subject: Duplex jam or Z-fold jam		Prepared by: M. Kumagai	
From: 2nd Tech Support Sec. Service Support Dept.			
Classification:	<input checked="" type="checkbox"/> Troubleshooting	<input type="checkbox"/> Part information	<input type="checkbox"/> Action required
	<input type="checkbox"/> Mechanical	<input type="checkbox"/> Electrical	<input type="checkbox"/> Service manual revision
	<input type="checkbox"/> Paper path	<input type="checkbox"/> Transmit/receive	<input type="checkbox"/> Retrofit in

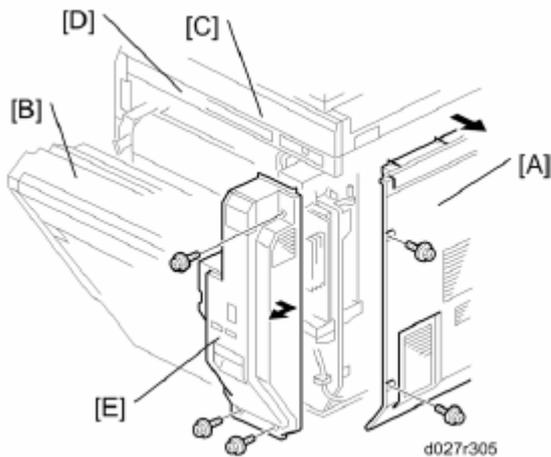
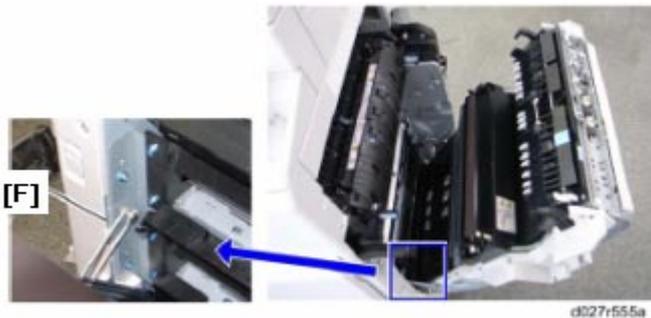
- This symptom only occurs on the Ap-P2d (50cpm model).
- This symptom has a greater tendency to occur under low-temperature conditions.
- Once the symptom occurs, it will continue to occur.

The motor torque of duplex bypass motors from a specific lot was higher than the specification maximum. This increased the level of vibration during motor rotation, which led to resonance when the vibration reached a certain frequency. Eventually, this caused the motor to disengage and rotate in idle.

Replace the duplex bypass motor with the following new part: **P/N B2232745**

1. Remove the rear cover [A] (screw x 6).
2. Open the right door [B].
3. Remove the scanner right cover [C] (screw x 2).
4. Remove the right top cover [D] (screw x 1).
5. Remove the right rear cover [E] (screw x 3).
6. Release the front link [F] (clamp x1) while the right cover is still open.

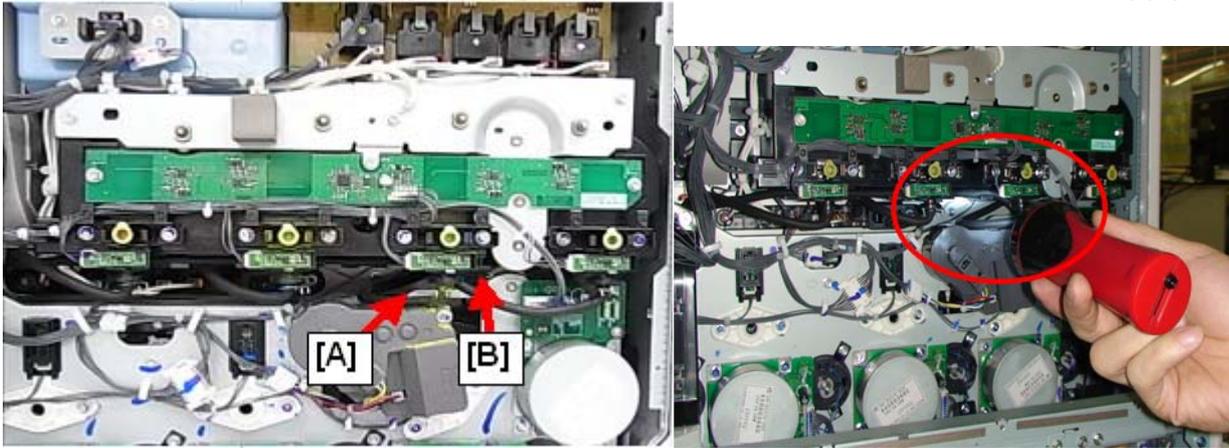
The toner supply unit was not attached correctly to the machine at the factory. As a result, the Y toner supply tube is tucked between the frame of the machine and the toner supply unit (see the picture below). Toner gets clogged inside the tube over time, eventually triggering the Toner End condition.

4. Shine a light on points [A] and [B], and check the condition of the Y toner supply tube.

Check the condition of the Y toner supply tube. Replace the Y pump unit assembly if the tube is tucked between the machine frame and the toner supply unit.

5. If the Y toner supply tube is tucked between the toner supply unit and the machine frame, shown in the photo below with [A] or [B], replace the Y pump unit (including the toner supply tube).

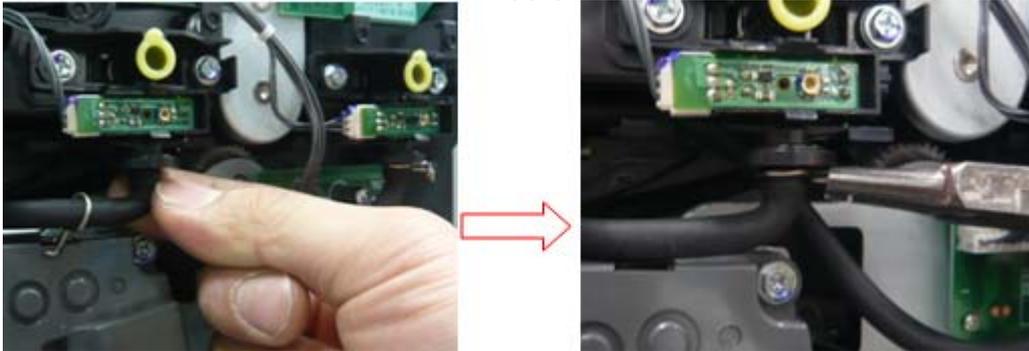
Important: Make sure that the tube is not tucked or folded. Also, make sure that the gear does not touch the tube.

19. Connect the tube to the toner supply unit, and then adjust the position.

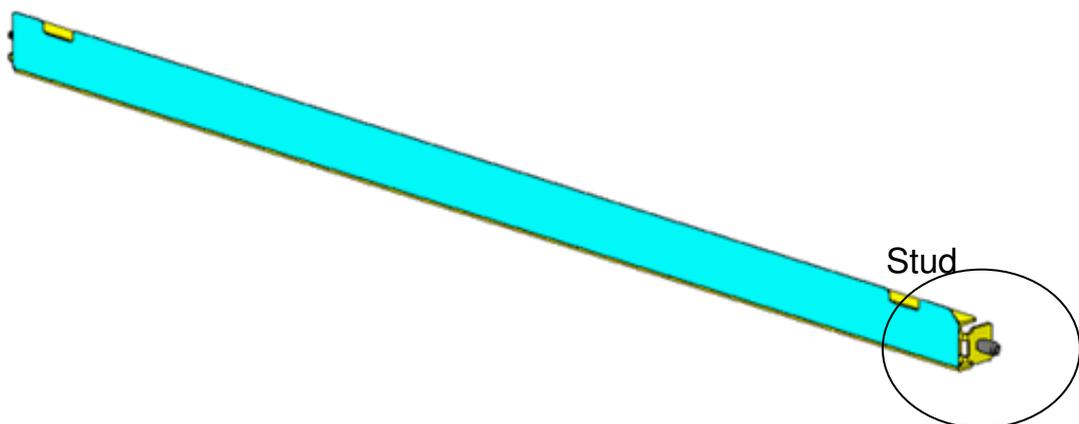
Fig. 1

Reason: To prevent paper jams by minimizing the range of motion (twisting) of the stay.

1. The bracket with a screw hole at the front side of the stay was changed to a stud fixture.
2. The torque specification for the screw (still used at the rear side) was changed from $0.7 \pm 0.1 \text{N/m}$ to $0.5 \pm 0.1 \text{N/m}$.
3. This stay is now included in the service parts assembly shown in the table above (see Fig. 2)

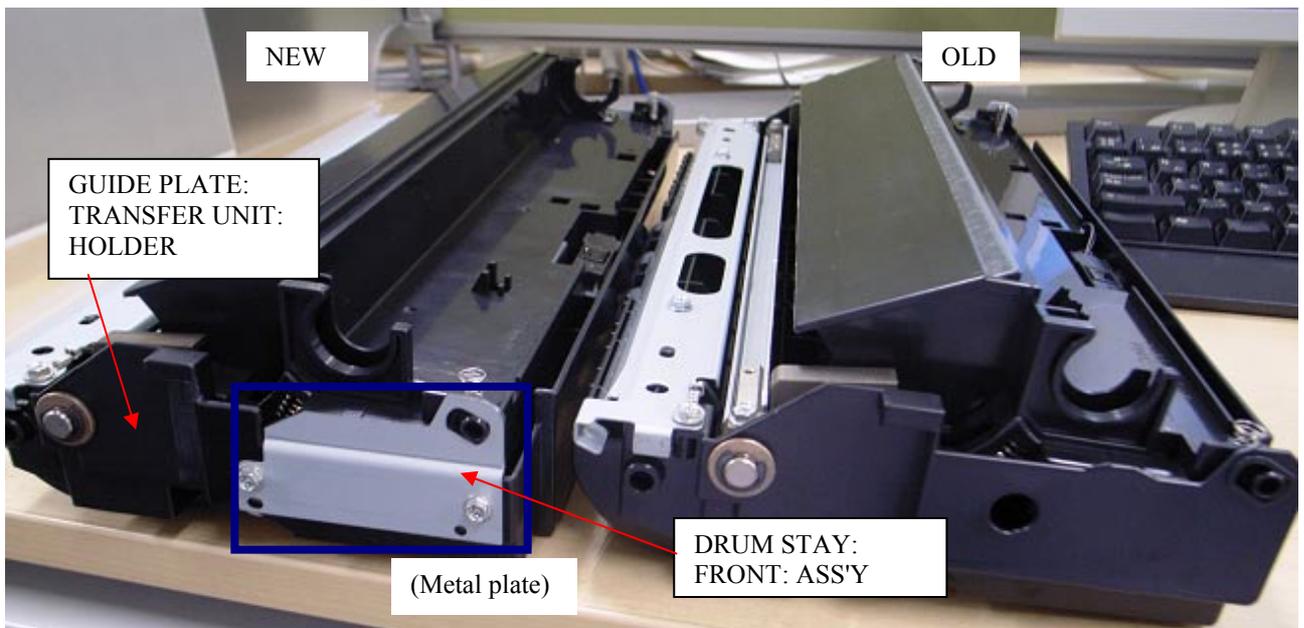
Reason: To further increase the load-bearing strength of the parts.

Old part number	New part number	Description	Q'ty	Int	Page	Index	Note
G1896286	G1896288	CASE:TRANSFER ROLLER	1	X/X	-	-	
D0894663	D0894664	GUIDE PLATE:TRANSFER UNIT:HOLDER	1	X/X			
	D0894665	SHAFT:HOLDER:REAR	1	X/X	-	-	-
	04583010N	HEXAGON HEAD TAPPING SCREW:3X10	1	X/X	-	-	-
	D0894666	DRUM STAY:FRONT	1	X/X	-	-	-
	04583008N	HEXAGON HEAD TAPPING SCREW:3X8	2	X/X	-	-	-

Important: Interchangeability is **X/O as a set** (all six parts together).
