Model: <b>AP-P3</b>	Date: 28-Sep-12	No.: RM125001e
---------------------	-----------------	----------------

Subject: Firmware Release Note: Engine		Prepared by: Y. Urushihara	
From: 1st Tech Service Sect., MFP/Printer Tech Service Dept.			
Classification:	<input type="checkbox"/> Troubleshooting <input type="checkbox"/> Mechanical <input type="checkbox"/> Paper path <input type="checkbox"/> Product Safety	<input type="checkbox"/> Part information <input type="checkbox"/> Electrical <input type="checkbox"/> Transmit/receive <input checked="" type="checkbox"/> Other (Firmware)	<input type="checkbox"/> Action required <input type="checkbox"/> Service manual revision <input type="checkbox"/> Retrofit information <input checked="" type="checkbox"/> Tier 2

This RTB has been issued to announce the firmware release information for the **Engine**.

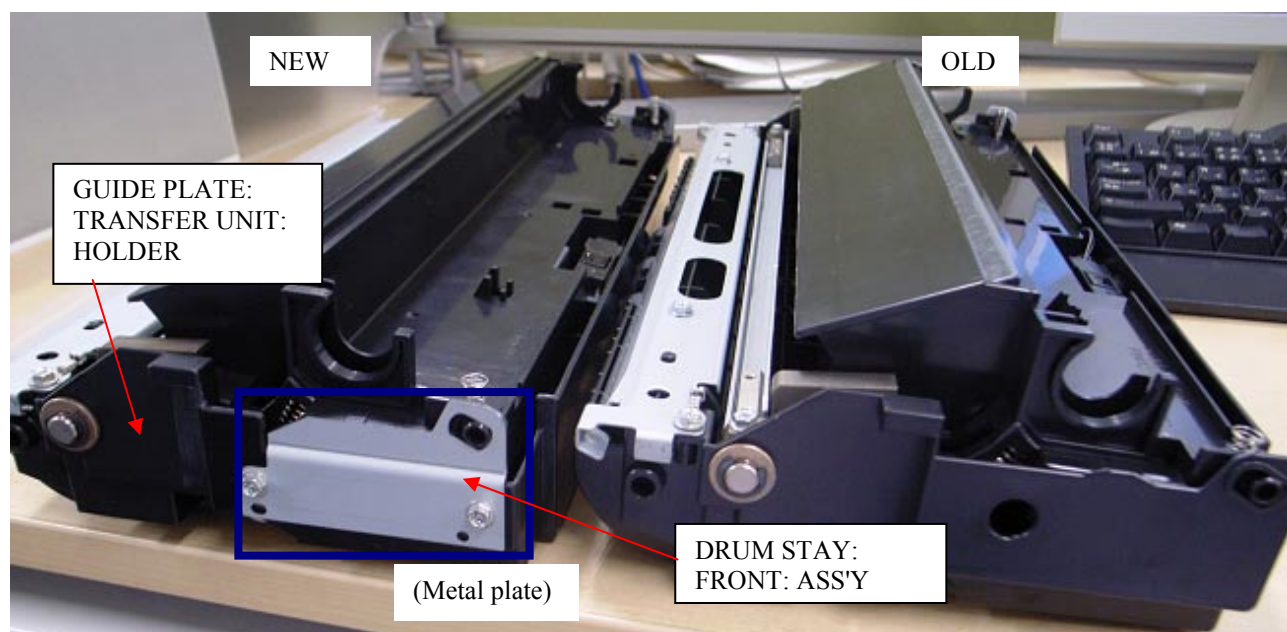
**Reason:** To further increase the load-bearing strength of the parts.

**Important:** Interchangeability is **X/O as a set** (all six parts together).

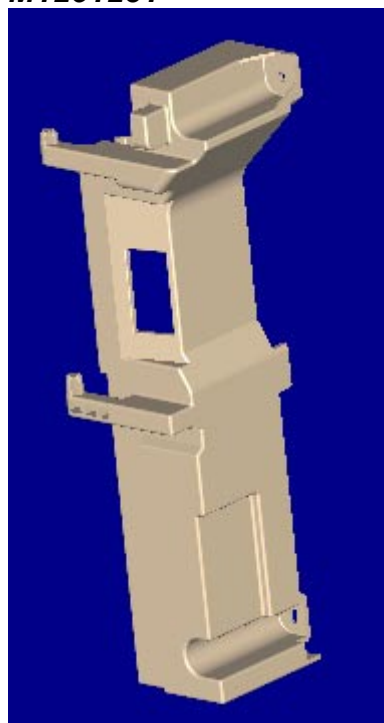
**M1251231**

Subject: SC672-10 and SC819 caused by defective switch.		Prepared by: H. Tamaki	
From: 1st Tech Service Sect., MFP/P Tech Service Dept.			
Classification:	<input checked="" type="checkbox"/> Troubleshooting <input type="checkbox"/> Mechanical <input type="checkbox"/> Paper path <input type="checkbox"/> Product Safety	<input type="checkbox"/> Part information <input type="checkbox"/> Electrical <input type="checkbox"/> Transmit/receive <input type="checkbox"/> Other (      )	<input type="checkbox"/> Action required <input type="checkbox"/> Service manual revision <input type="checkbox"/> Retrofit information <input checked="" type="checkbox"/> Tier 2

Old part number	New part number	Description	Q'ty	Int	Note
M1251230	M1251231	INNER COVER:LEFT:P3	1	X/O	-
<b>B2385821</b>	<b>M1255830</b>	<b>BRACKET:HANDLE:MAIN SWITCH:PEEN</b>	<b>1</b>	<b>X/O</b>
