Model: MET-P2	Date: 21-Oct-16	No.: RM0AL004a
---------------	-----------------	----------------

Subject: Firmware Release Note: NetworkDocBox		Prepared by: Y. Ino	
From: 1st Tech Service Sect., MFP/Printer Tech Service Dept.			
Classification:	<input type="checkbox"/> Troubleshooting	<input type="checkbox"/> Part information	<input type="checkbox"/> Action required
	<input type="checkbox"/> Mechanical	<input type="checkbox"/> Electrical	<input type="checkbox"/> Service manual revision
	<input type="checkbox"/> Paper path	<input type="checkbox"/> Transmit/receive	<input type="checkbox"/> Retrofit information
	<input type="checkbox"/> Product Safety	<input checked="" type="checkbox"/> Other (Firmware)	<input checked="" type="checkbox"/> Tier 2

This RTB has been issued to announce the firmware release information for the **NetworkDocBox**.

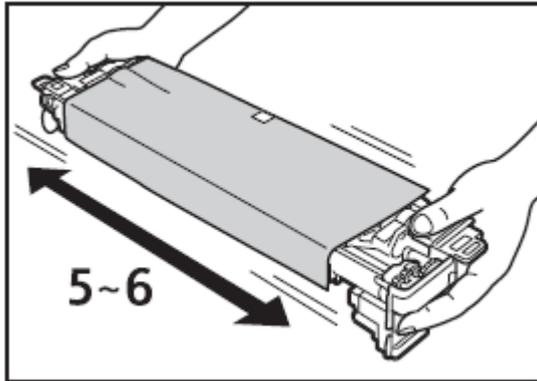
As one of the reasons that cause this symptom, the development unit was stored/transported in a position prior to its installation. This causes developer to accumulate on the gears at either end of the unit, disabling proper rotation of the development roller.

When installing a new PCDU or a new development unit, take out the unit from the package and shake it 5 or 6 times horizontally. This will reduce the chances of SC324-01 and SC324-05.

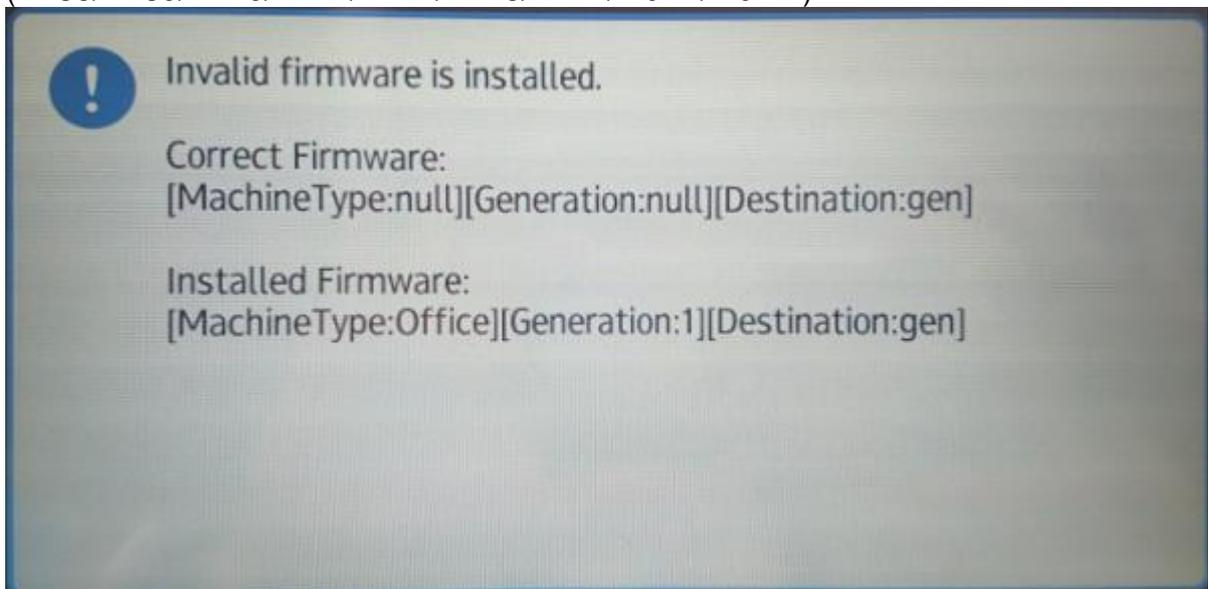
The following error is displayed at machine installation.

Corruption of the program files in the operation panel control chip.

Note: There is no damage to the hardware.

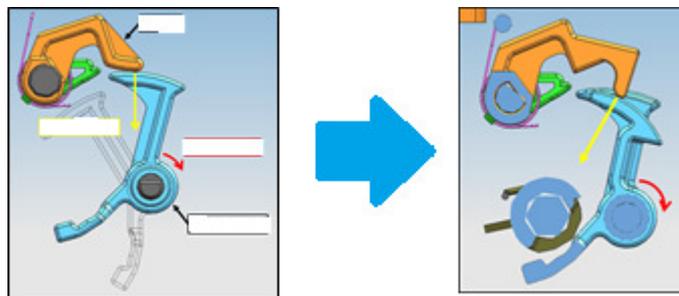
Change: The hit position of the two parts has changed because the shape of the Paper stopper and the Paper stopper link have been changed.

Old P/N	New P/N	Description	Int	Q'ty	Note
D1492638	D0BQ2638	LINK:PAPER STOPPER:MANUAL FEED	X/X	1	A
D2412638	D0BQ2637	PAPER STOPPER:MANUAL FEED	X/X	1	A

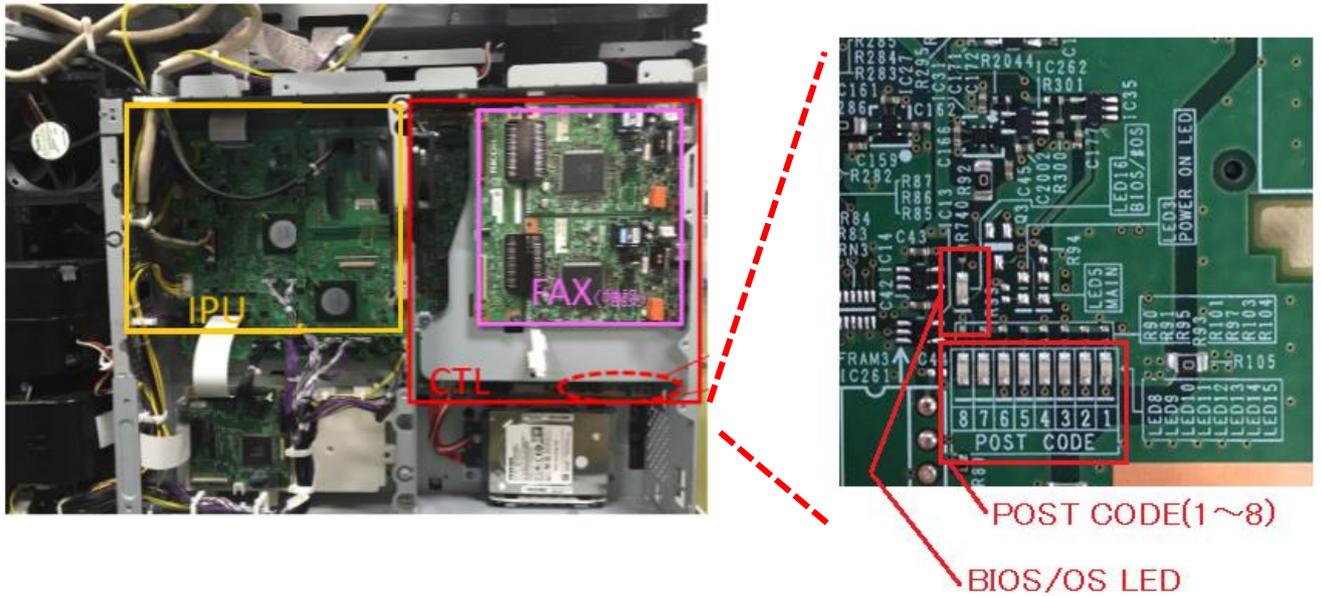
Figure 2: LED /POSTCODE AREA on the CTL

Normal situation: POSTCODE LED 8 and BIOS/OS LED blink once every second.

Note: The LEDs remain lit or are off when there is a problem with the CPU.

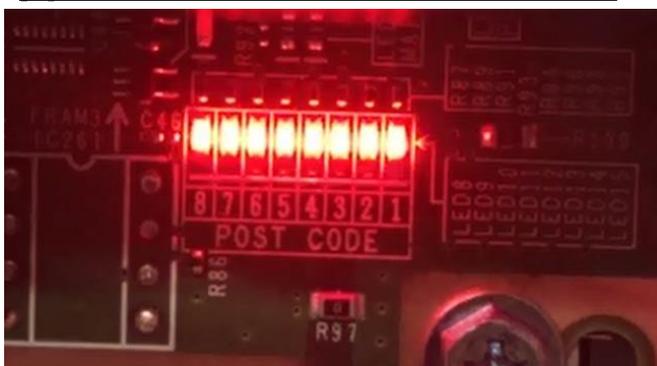
Figure 5: LEDs 1 to 8 are lit constantly

No.	Note
POSTCODE 1-8	1. For self-diagnosis code (BIOS). 2. After the BIOS starts up, LEDs 4,5,7 turn off and LEDs 1,2,3 ,6 turn on and LED 8 blinks . LED 8 remains lit or off when there is a problem with the CPU. Note: When a DIMM connection failure, defective CMOS, or defective BIOS occurs, postcode LEDs 1-8 are lit constantly.
BIOS/OS LED	- LED is lit when the BIOS is running. - LED blinks when the OS is running.

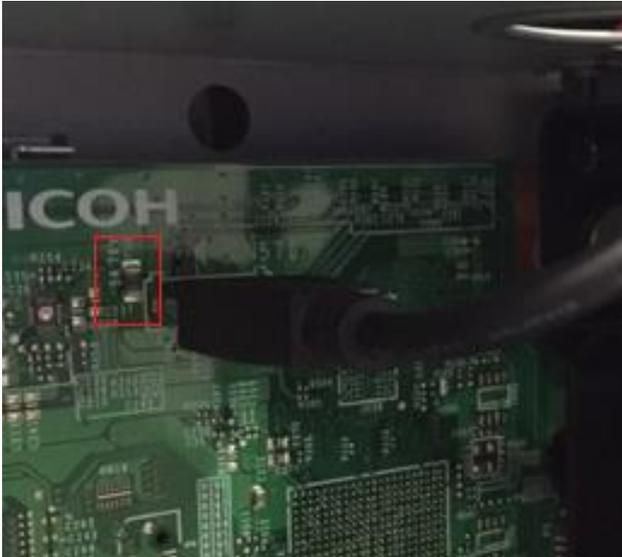
Figure 13: Fuse on the IPU

Check fuse 3 on the IPU is operating correctly.

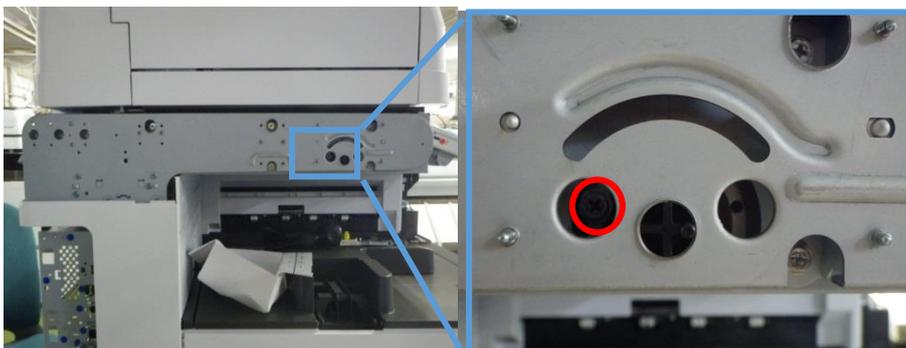
Never loosen or remove the following screw when you remove or re-attach the unit. This is because this screw fixes the scanner cam in place. If the position of the scanner cam changes, the scanner will be misaligned. This will result in image skew and other image alignment issues.

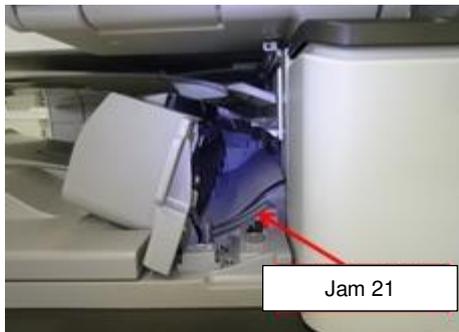
JAM21 occurs when the booklet feature is used with the Bridge Unit BU3070 and internal Finisher SR3130/3180.

The paper support guide was incorrectly installed.

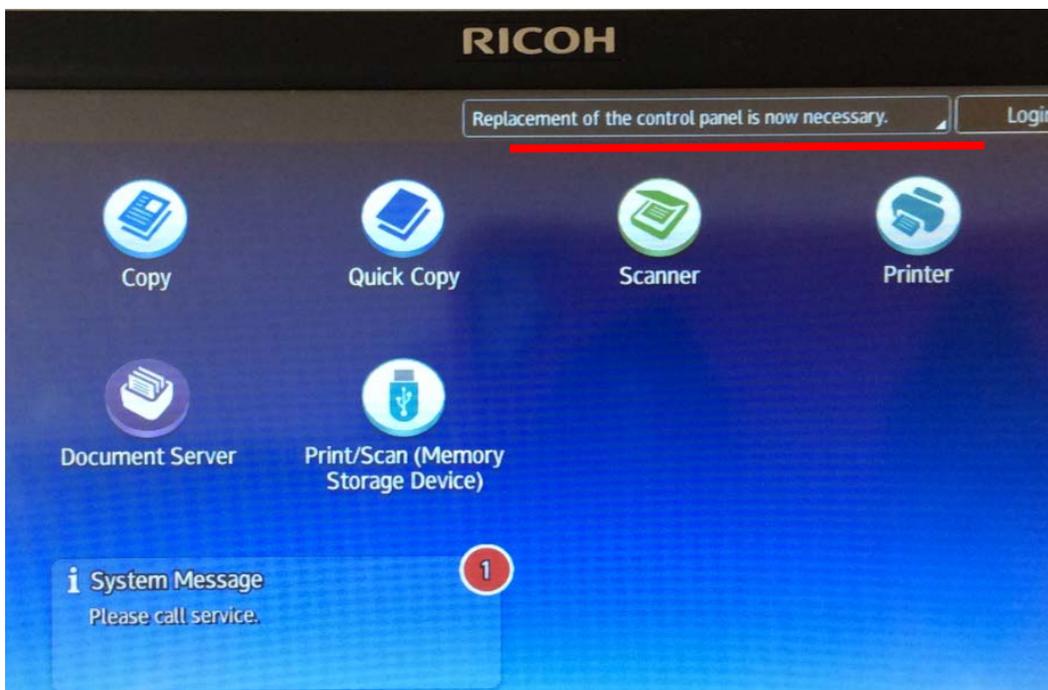
"Replacement of the control panel is now necessary" is displayed and SC843-02 occurs.

The thresholds for the data in eMMC (Cheetah System memory. please see the below block figure) overwrites is exceeded during operation or while the machine is recovering from Energy Saver mode.

Replace the PCB board for the Smart Operation Panel.

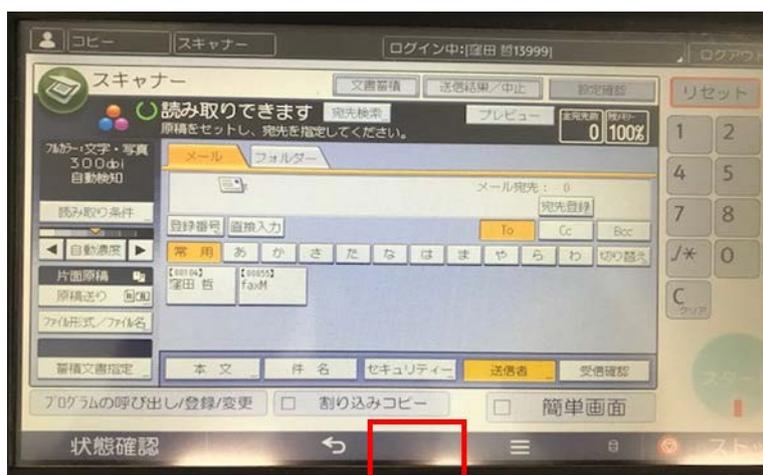
With firmware combination **#3** below, the Home button is not displayed, making it impossible to switch between applications.

Comb.	CheetahSystem	LegacyUI	Result
1	1.30 or older	1.22 or older	Good
2	1.31 or newer	1.22 or older	Good
3	1.30 or older	1.23 or newer	Problem occurs
4	1.31 or newer	1.23 or newer	Good

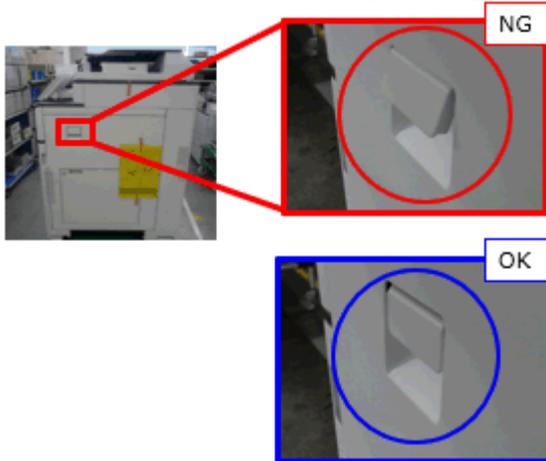
Model: Metis-P2ce		Date: 31-Jan-19	No.: RM0AL048
Subject: Duplex unit cannot be close due to the broken grip		Prepared by: T.Kiyohara	
From: MFP section, OPOS Product Quality managment Dept.			
Classification:	<input checked="" type="checkbox"/> Troubleshooting	<input type="checkbox"/> Part information	<input type="checkbox"/> Action required
	<input type="checkbox"/> Mechanical	<input type="checkbox"/> Electrical	<input type="checkbox"/> Service manual revision
	<input type="checkbox"/> Paper path	<input type="checkbox"/> Transmit/receive	<input type="checkbox"/> Retrofit information
	<input type="checkbox"/> Product Safety	<input type="checkbox"/> Other ()	<input type="checkbox"/> Tier 2

Affected models: Met-C2.1 abcde (D0AC/D0AD/D0AE/D0AF/D0AG),
Met-P2ce(M0AJ/M0AL).

Affected production: May to Aug. 2018

Lubricant contacts the shaft for the grip of the duplex unit, causing a chemical crack. As a result, the hook for the grip breaks and the spring detaches.

Replace the duplex unit grip.

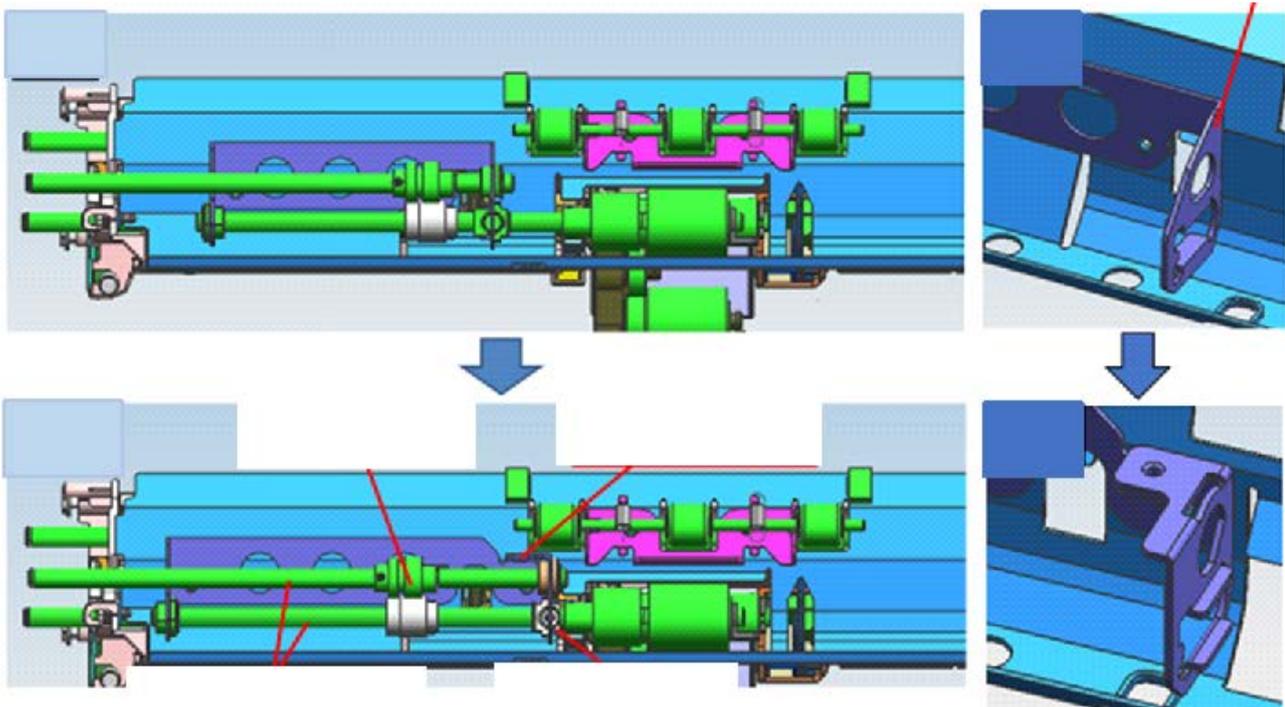
Change 3: The shape of the brackets and bearings, length of the roller shaft, and the gear position has changed. Also e-rings added.

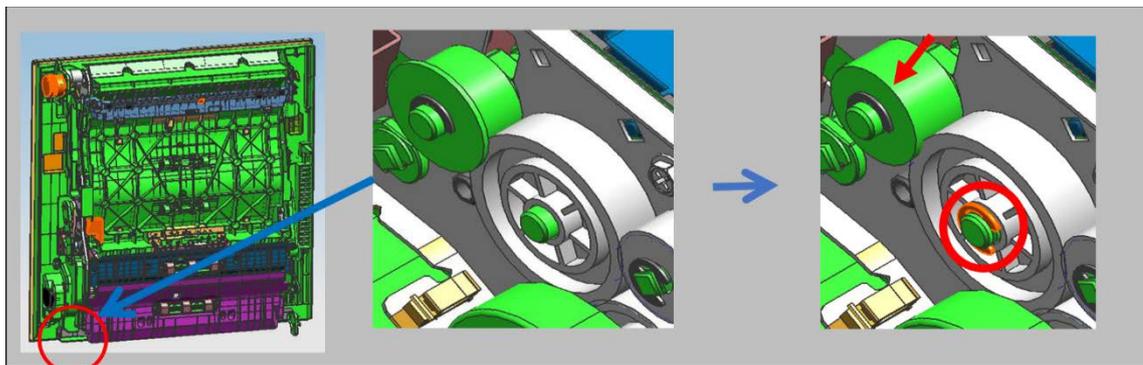
Change 4: There are no protruding parts to hold the gear. An e-ring added to stop the gear in position, and a groove added to the shaft for the e-ring.
