Model: PD-D1	Date: 12-Apr-12	No.: RC279001c
--------------	-----------------	----------------

Subject: Firmware Release Note: Main(A3)		Prepared by: Y. Kuwabara	
From: 2nd Tech Service Sect., MFP/Printer Tech Service Dept.			
Classification:	<input type="checkbox"/> Troubleshooting	<input type="checkbox"/> Part information	<input type="checkbox"/> Action required
	<input type="checkbox"/> Mechanical	<input type="checkbox"/> Electrical	<input type="checkbox"/> Service manual revision
	<input type="checkbox"/> Paper path	<input type="checkbox"/> Transmit/receive	<input type="checkbox"/> Retrofit information
	<input type="checkbox"/> Product Safety	<input checked="" type="checkbox"/> Other (Firmware)	<input checked="" type="checkbox"/> Tier 2

Subject: Exit Pawl Timing Adjustment		Prepared by: K. Yamamoto	
From: 1st Tech Service Sect., MFP/Printer Tech Service Dept.			
Classification:	<input checked="" type="checkbox"/> Troubleshooting	<input type="checkbox"/> Part information	<input type="checkbox"/> Action required
	<input type="checkbox"/> Mechanical	<input type="checkbox"/> Electrical	<input type="checkbox"/> Service manual revision
	<input type="checkbox"/> Paper path	<input typ

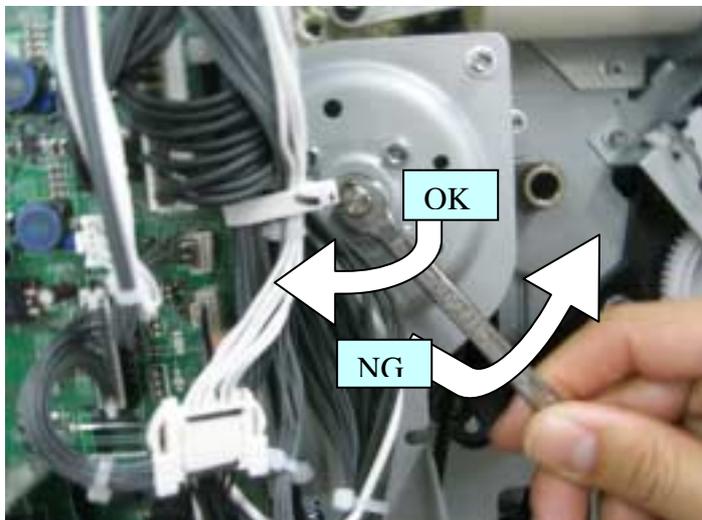
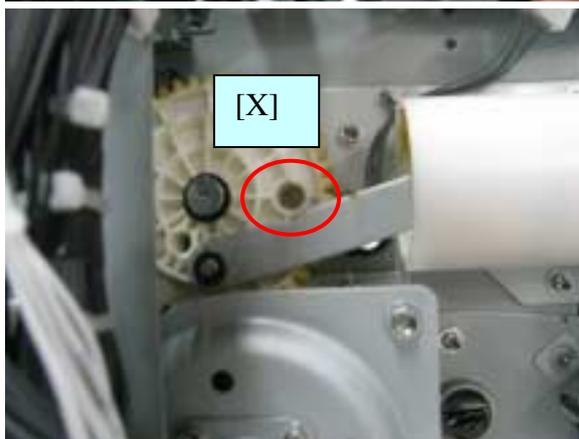
- Turn the main drive unit slowly **clockwise**, using a size 7 spanner, until the gear [X] is in the position shown in the photograph.

Important: Do not turn the drive unit counter-clockwise.

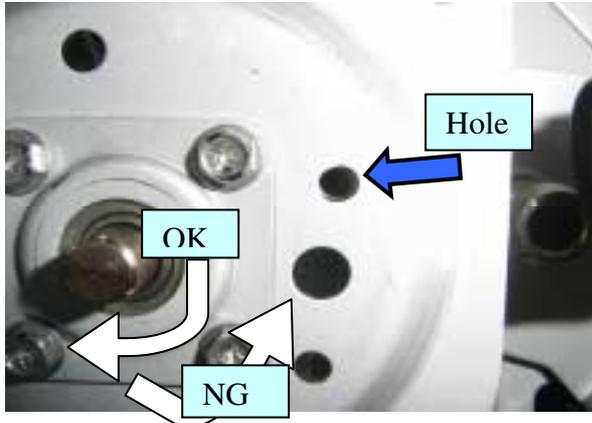
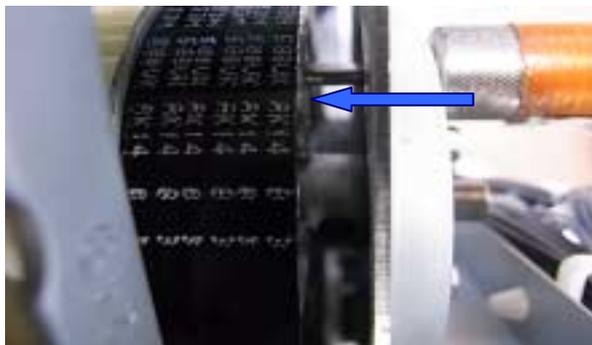
6. Insert the pin (diameter: 4mm) into the following hole.

Important: If the pin does not go through to the drive gear, turn the main drive slightly and try again.

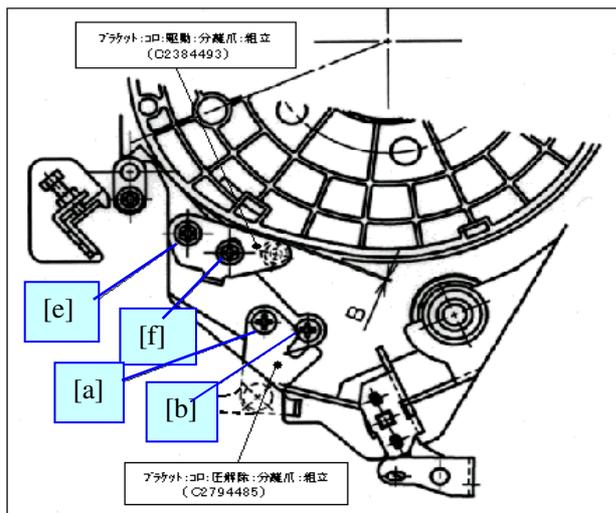
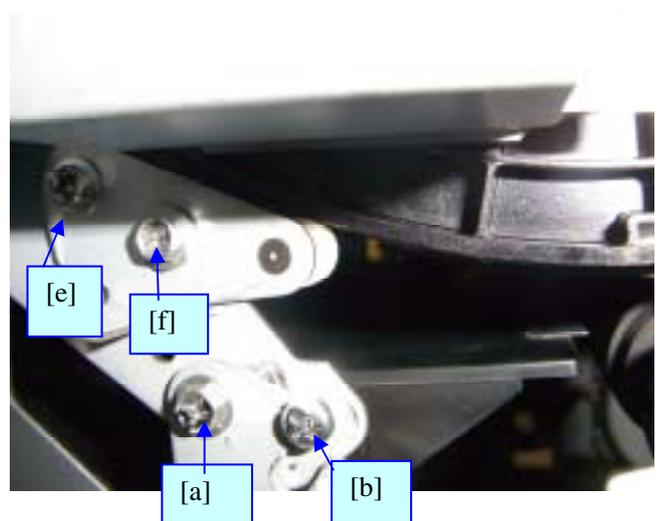
7. Loosen screws [a], [b], [e], and [f].

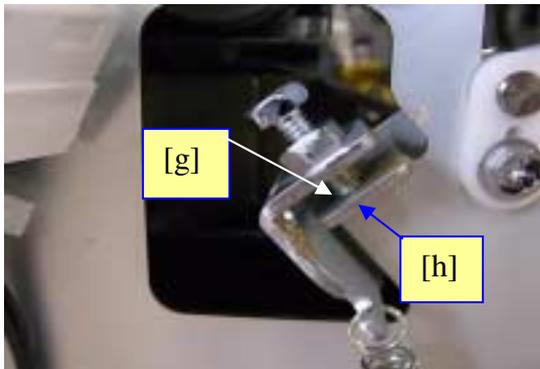
8. Make sure that the tip of the screw [g] touches the bracket [h].

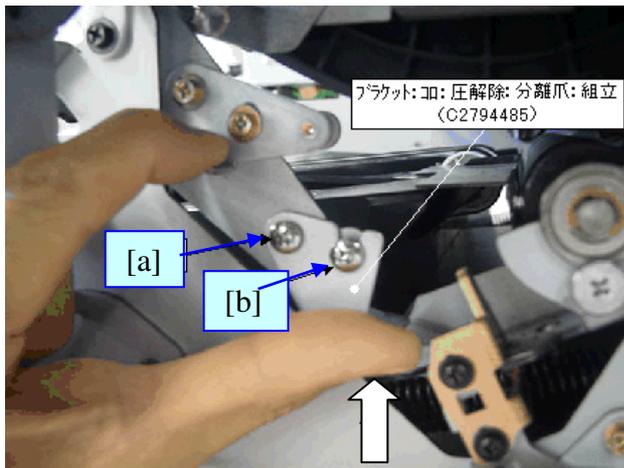
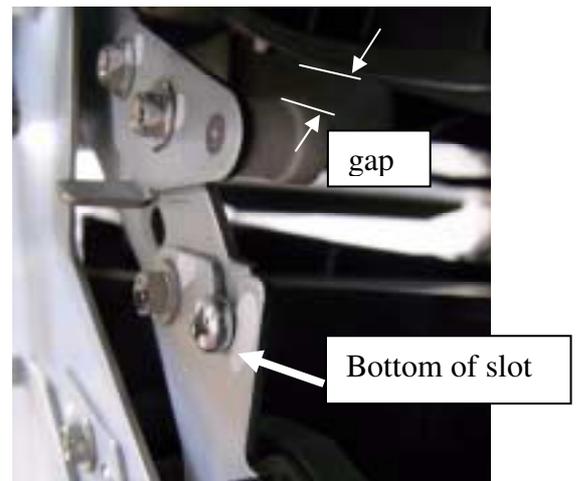
10. Push the bracket [H] up using your thumb, and tighten screws [a] and [b].

- Make sure screw [b] is touching the bottom of the slot.
- Make sure the gap between the cam flange and cam follower is wider after you tighten screws [a] and [b].

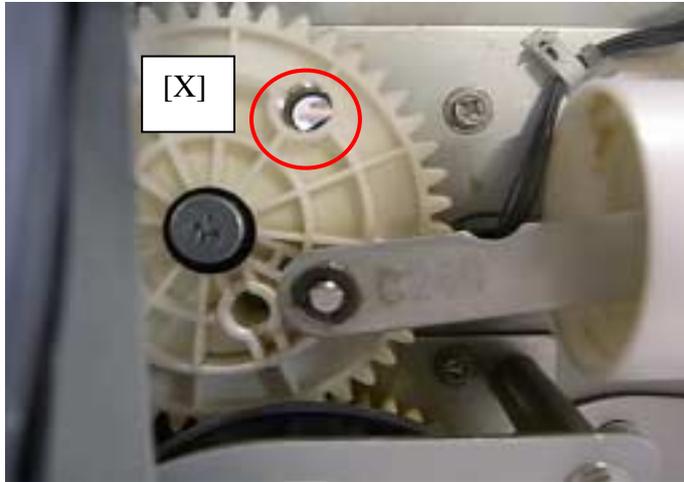
Note: The home position is the position where the hole in the gear [X] is lined up with the hole in the mainframe, as shown in the photo.

12. Turn the main drive unit slowly to its home position, using a spanner.

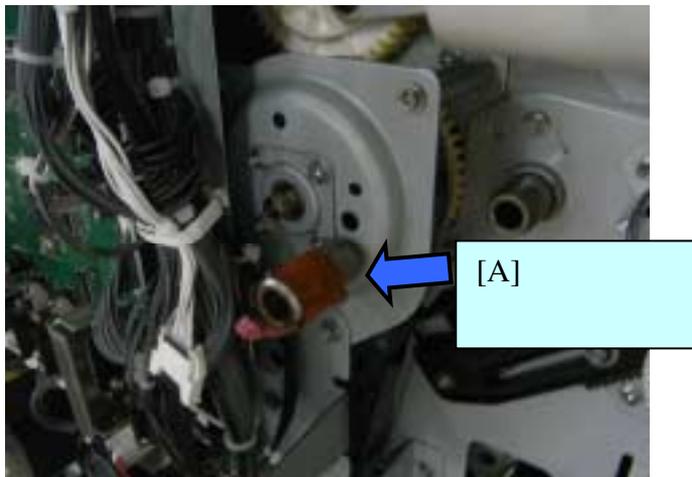
13. Insert the pin into the hole shown below [A], to check if the main drive is in the home position. Then, pull out the pin.

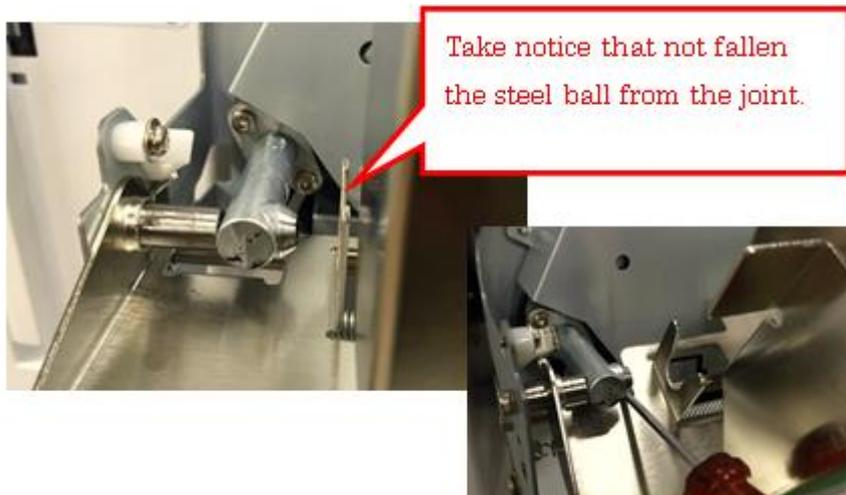
The ink nozzle is deformed, preventing a firm fit with the ink pack. As a result, air gets inside the pump and ink cannot be supplied to the machine correctly.

Replace ink nozzle (P/N C2799001).

2. Remove the nozzle and check the following parts.
