Model: PRIPORT Platinum/Platinum P/Platinum2		Date: 3-Sep-08	No: R-C267-001e
Subject: Firmware Modification History		Prepared by: K. Yamamoto, Priport Service Planning Section	
Classification:	<input type="checkbox"/> Troubleshooting <input type="checkbox"/> Part information <input type="checkbox"/> Action required <input type="checkbox"/> Mechanical <input type="checkbox"/> Electrical <input type="checkbox"/> Service manual revision <input type="checkbox"/> Paper path <input type="checkbox"/> Transmit/receive <input type="checkbox"/> Retrofit information <input checked="" type="checkbox"/> Other ()		
Model Name: Platinum: Ricoh DX3340/DX3440C/DX3240, Gestetner CP6146/DX3440/CP6300C/DX3240, Savin 3180DNP, Lanier LDD120, RexRotary DX3440/DX3240, nashuatec DX3440/DX3240, Standard SD360 Platinum P (China only): Ricoh DX3440CP, Gestetner CP6300P Platinum 2: Ricoh DX3442/DX3442C/DX3242, Gestetner DX3442/CP6301C/DX3242, Rotary DX3442/DX3242, nashuatec DX3442/DX3242

Model: PRIPORT Platinum/Platinum P		Date: 23-Oct-06	No: R-C267-002
Subject: Durability of the cloth screen is not enough		Prepared by: K. Yamamoto, Priport Service Planning Section	
Classification:	<input checked="" type="che

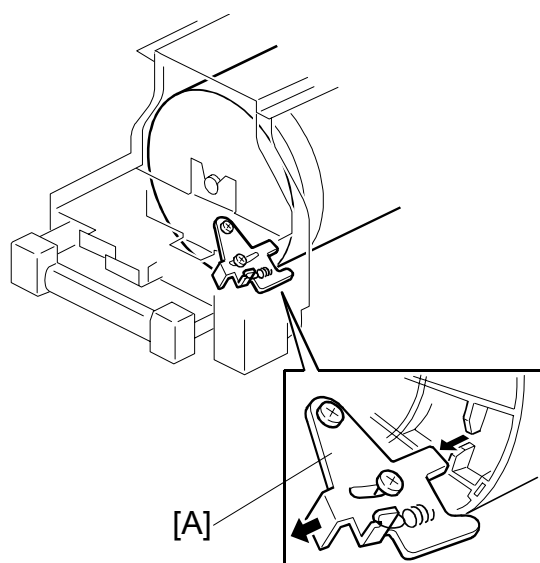
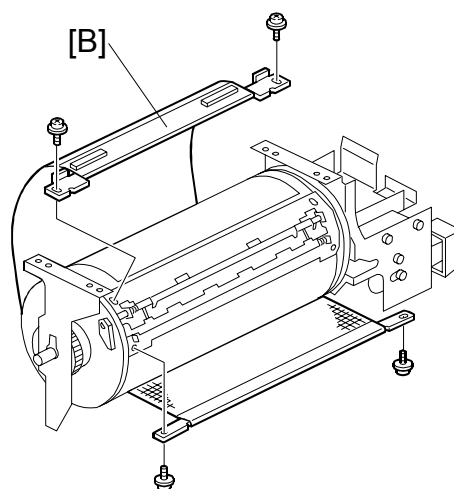
The ink leaks from the trailing edge of the cloth screen on the black drum.

The Mylar peels off the cloth screen during printing, causing the ink to leak from between the Mylar and cloth screen.

Remove the drum

1. Remove the drum upper bracket (⌘ x 4).
2. Release the stopper [A], then rotate the drum until the master clamber faces top.
3. Remove the cloth screen [B] (⌘ x 4).

- Do not scratch the cloth screen and metal screen.
- Properly insert the edge of the cloth screen [A] under the mylar [B] on the metal screen, as shown above.
Otherwise, ink will leak from the trailing edge of the master on the drum during a long printing run.
- Make sure that the correct side of the screen is facing up. In addition, make sure that the stays for securing the cloth screen are positioned correctly.
- When replacing the cloth screen, spread the screen around the metal screen while pulling the stay [C]. Adjust the stay so that it is parallel to the master clumper, then tighten the screws.
- Make sure that the cloth screen is not wrinkled while spreading it around the drum.

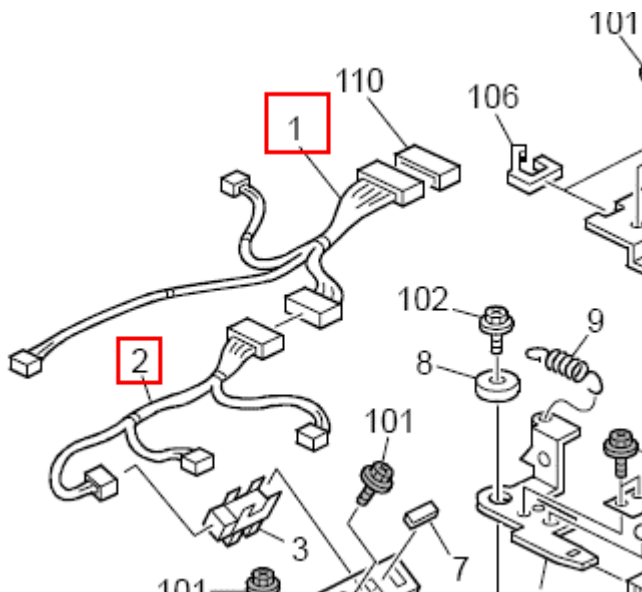
Change / Reason: The following part indexes in the parts catalog were corrected.

Old part number	Description	Q'ty	Page	Incorrect Index	Correct Index	Note
C2675273	HARNESS:CONNECTING:STAY:P LOTTER:ASS'Y	1-1	23	4	2	
C2675272	HARNESS:STAY:ASS'Y	1-1	23	2	1
