Model: PRIPORT Cats-eye	Date: 29-Mar-07	No: R-C269-002a
Subject: Firmware Modification History	Prepared by: K. Yamamoto, Priport Service Planning Section	
Classification:	<input type="checkbox"/> Troubleshooting <input type="checkbox"/> Part information <input type="checkbox"/> Action required <input type="checkbox"/> Mechanical <input type="checkbox"/> Electrical <input type="checkbox"/> Service manual revision <input type="checkbox"/> Paper path <input type="checkbox"/> Transmit/receive <input type="checkbox"/> Retrofit information <input checked="" type="checkbox"/> Other ()	
Model Name:		
Cat's-eye: Ricoh DX4640PD, Gestetner CP6340D, Savin 3585DNP2, Standard SD462, Lanier LDD350d

This RTB contains the software release information for the Cat's-eye Operation Panel.

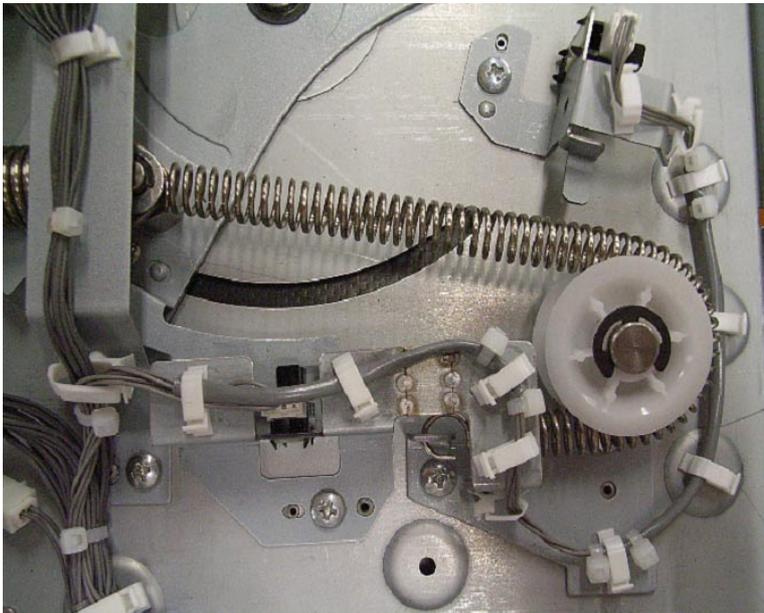
New Harness (C2695271) and Bracket (C2694822)

The edge of the duplex unit suction fan hits the harness and damages it.

Replace the harness [12] and sensor bracket [29] together as a set.

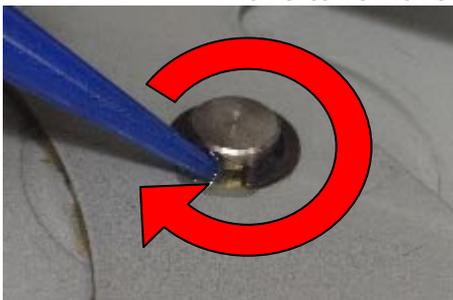
There is not enough grease on the print pressure adjustment sector gear, and as a result, the shaft is worn out.

4. Put some **oil** around the shaft, as shown in the photo.

Important: Make sure to apply this oil before you apply the grease in the next step. This is because without the oil, the grease will not stick to the shaft (you would have to remove the sector gear if you didn't apply this oil).

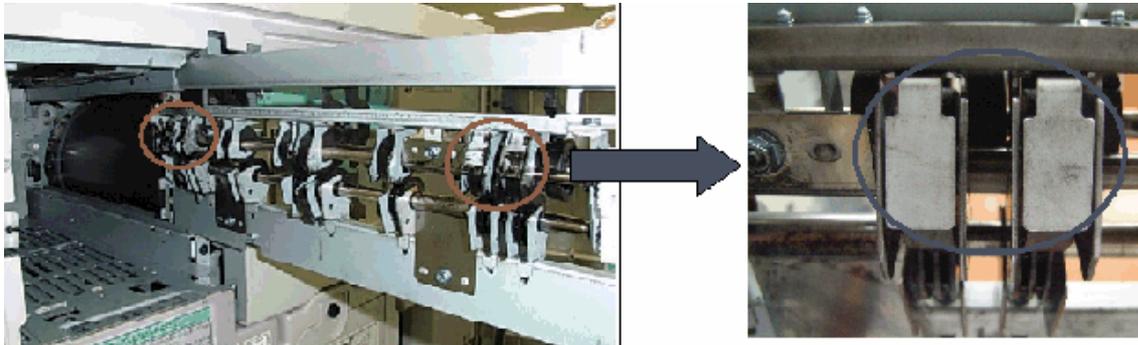
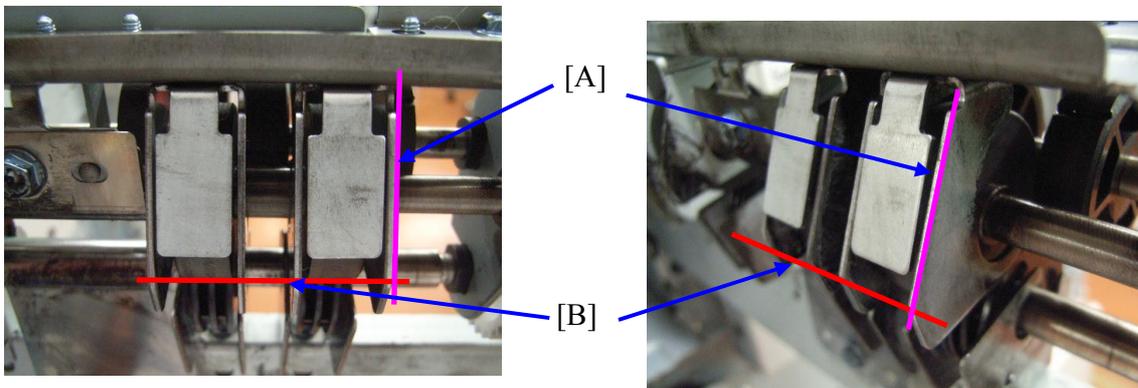
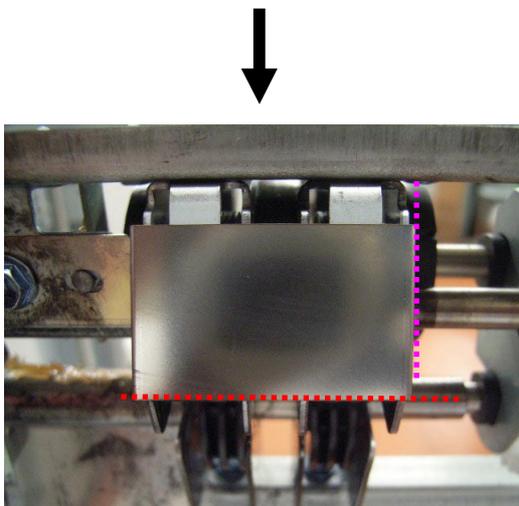
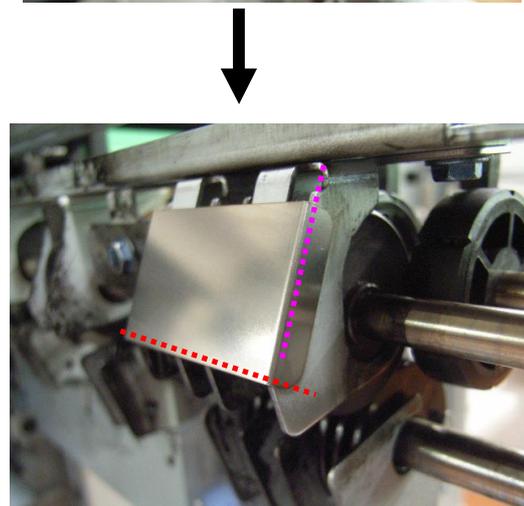
The covers of the harnesses around the registration motor are damaged, which triggers a short circuit.

Attach the two covers to the two surfaces circled in the photos below.
Important: Align the edges of the covers with lines [A] and [B].

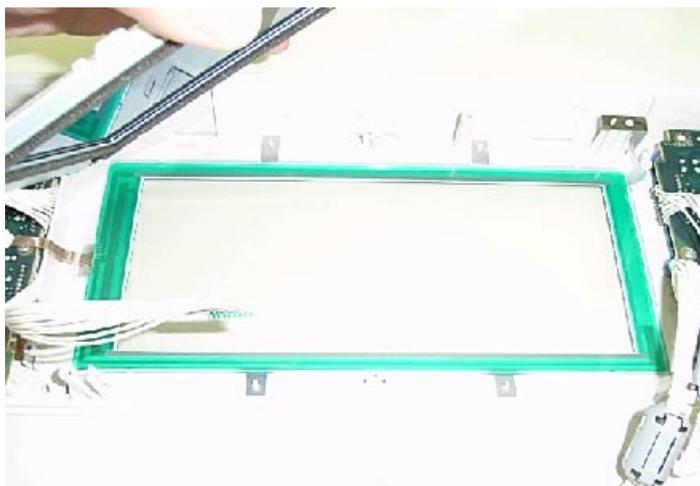
The adhesive that binds electrodes to the touch panel surface contains a polymer that tends to expand under normal office environmental conditions.

7. Remove the touch panel from the LCD and replace the touch panel.

Important: Only replace the touch panel. Do not replace the LCD.

Note: The end of the new touch panel harness is **white**.

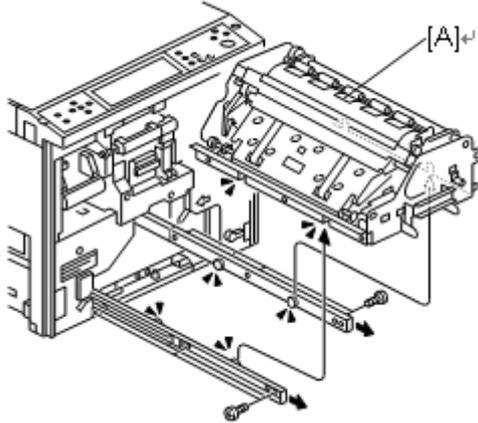
- Check the condition of the main drive shaft.
- If it is broken, replace the main drive unit with the new part (P/N C2691024) and do the adjustment procedures shown below.

1. Remove the drum unit, and then remove the duplex unit [A].

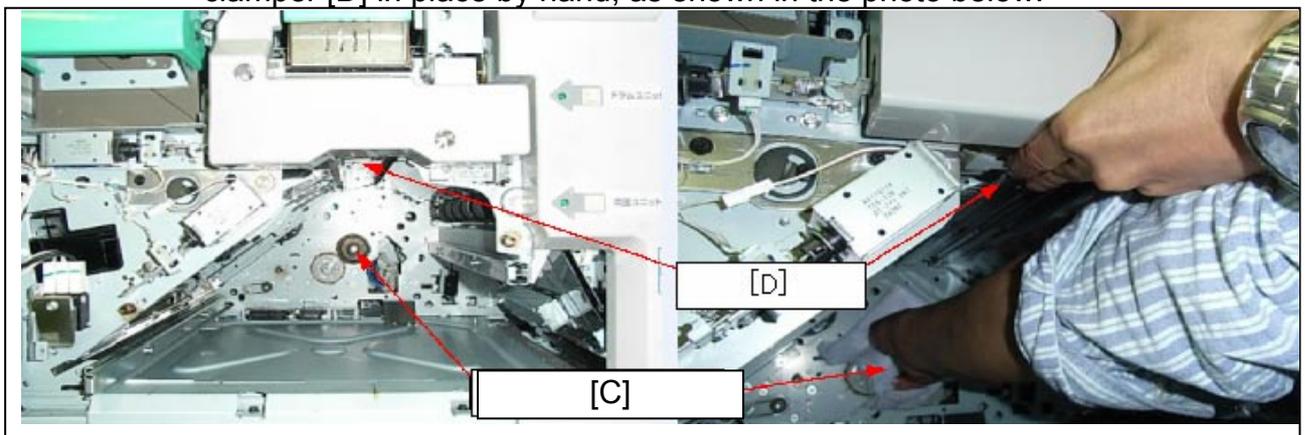
3. Try to turn the gear [C].
If there is any play in the gear (if it moves), this means the main drive shaft is broken.
Replace the main drive unit (see the procedure below).

Important: If you don't have the drum home position bracket [B], secure the master clamper [D] in place by hand, as shown in the photo below:

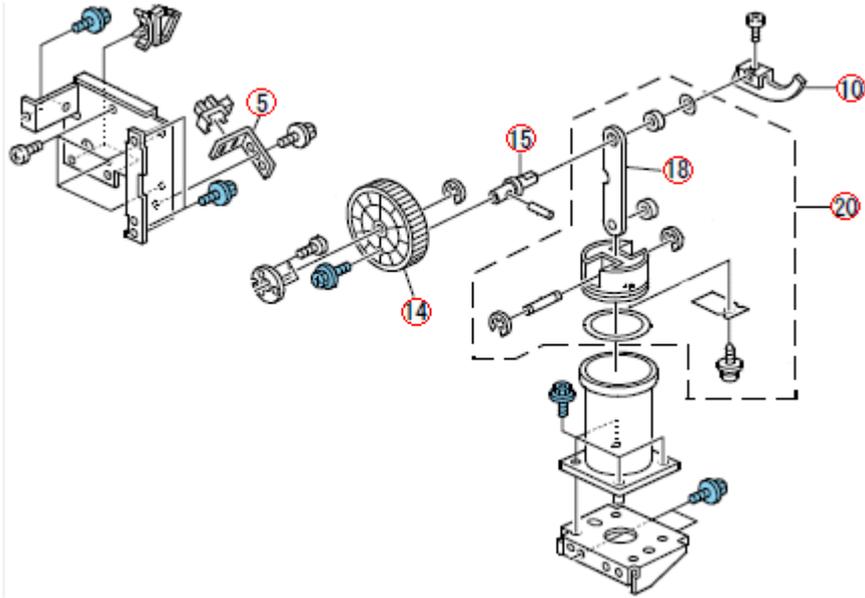
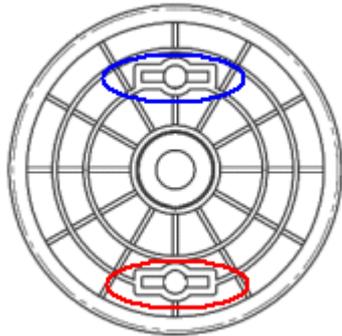
Note: P/N C2693118 in the illustration below is used in two places: on the exit pawl (pg. 17, index 10) use the hole which is circled in blue in the illustration below and on the junction gate pump (pg. 19, index 14) use the hole which is circled in red in the illustration below. The one used for the junction gate pump was modified for this symptom.

Old part number	New part number	Description	Q'ty	Int	Page	Index	Note
C2693119	C2693118	GEAR:Z66:PISTON:EXCHANGE POWL:PRESS FIT	1	O/O	17	10	
C2693119	C2693118	GEAR:Z66:PISTON:EXCHANGE POWL:PRESS FIT	1	X/X	19	14	X/O as a set
C2693056	C2693057	PISTON:PUMP:EXCHANGE POWL:ASS'Y	1	X/X	19	20	
C2693130	C2693140	GUIDE PLATE:PISTON:PUMP:EXCHANGE POWL:ASS'Y	1	X/X	19	18	
C2693124	C2693137	PIN:DRIVE:PISTON:DUPLEX: EXCHANGE POWL	1	X/X	19	15	
C2693126	C2693138	BRACKET:PISTON:PUMP:HOME POSITION SENSOR:EXCHANGE POWL	1	X/X	19	5	
C2693128	C2693139	SHIELDING PLATE:PISTON:PUMP:DUPL EX:EXCHANGE POWL	1	X/X	19	10

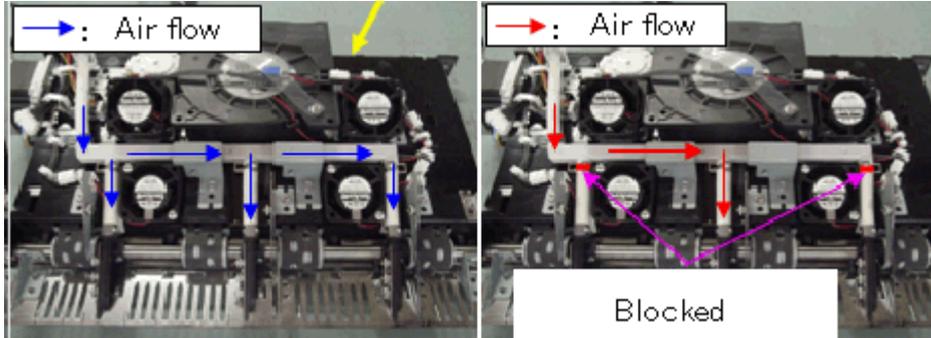
2. Two nozzles were blocked (the total number of nozzles is now one).

Old #	New #	Description	Qty	Int	Page	Index
C2693935	C2693975	PIPE:GATE:MIDDLE:ADHESION	1	X/O	41	12
C2693800	C2693801	HALE UNIT:ASS'Y (Paper delivery unit)	1	X/O	37	*

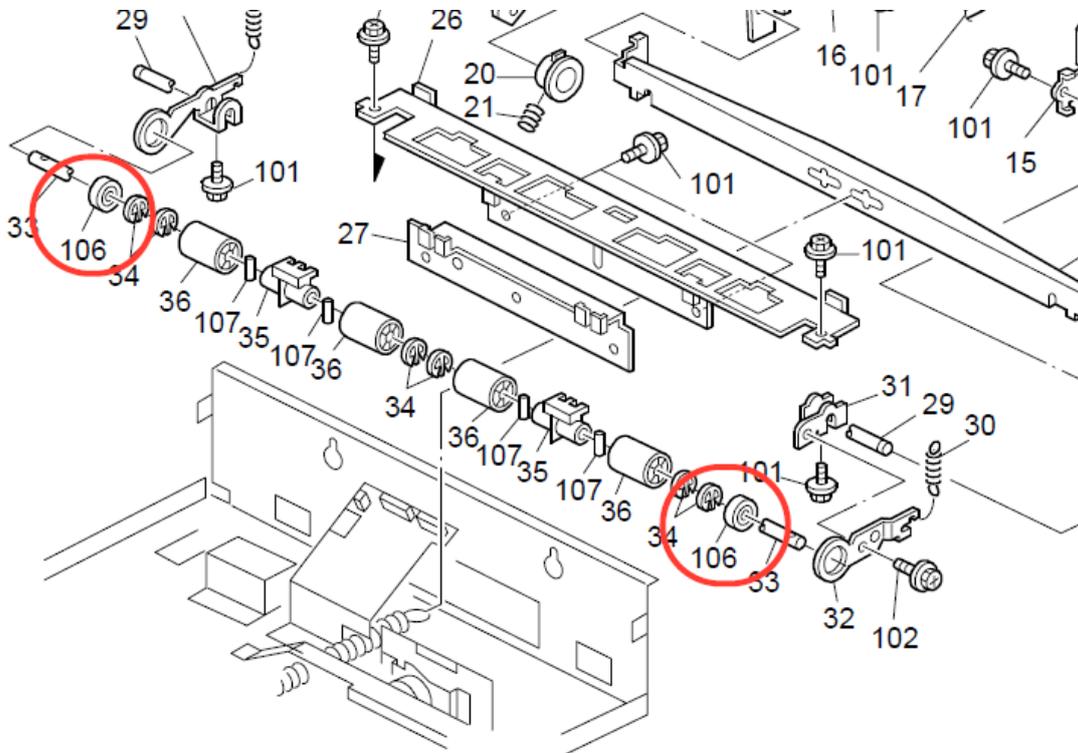
Change/Reason: The part number in the parts catalog is added.

New part number	Description	Q'ty	Int	Page	Index	Note
07413708	BALL BEARING - 8X12X3.5MM	2	-	51	106
