Model: PRIORT EMERALD/TOPAZ		Date: 1-Dec-05	No: R-C262-001
Subject: Firmware Release History (ACU)		Prepared by: K. Yamamoto, Priort Service Planning Section	
Classification:	<input type="checkbox"/> Troubleshooting <input type="checkbox"/> Part information <input type="checkbox"/> Action required <input type="checkbox"/> Mechanical <input type="checkbox"/> Electrical <input type="checkbox"/> Service manual revision <input type="checkbox"/> Paper path <input type="checkbox"/> Transmit/receive <input type="checkbox"/> Retrofit information <input checked="" type="checkbox"/> Other ()		
Model Name: EMERALD: Ricoh HQ9000, Gestetner CP6346, RexRotary CP6346, nashuatec CP6346, Savin 3590DNP, Standard SD700, Lanier LDD280 TOPAZ: Ricoh HQ7000, Gestetner CP6334, RexRotary CP6334, nashuatec CP6334, Savin 3580DNP, Standard SD460, Lanier LDD250

Model: PRIPORT EMERALD/TOPAZ		Date: 27-Dec-05	No: R-C262-006
Subject: Firmware update during USB connecting		Prepared by: K. Yamamoto, Priport Service Planning Section	
Classification:	<input checked="" type="checkbox"/> Troubleshooting <input type="checkbox"/> Part information <input type="checkbox"/> Action required <input type="checkbox"/> Mechanica

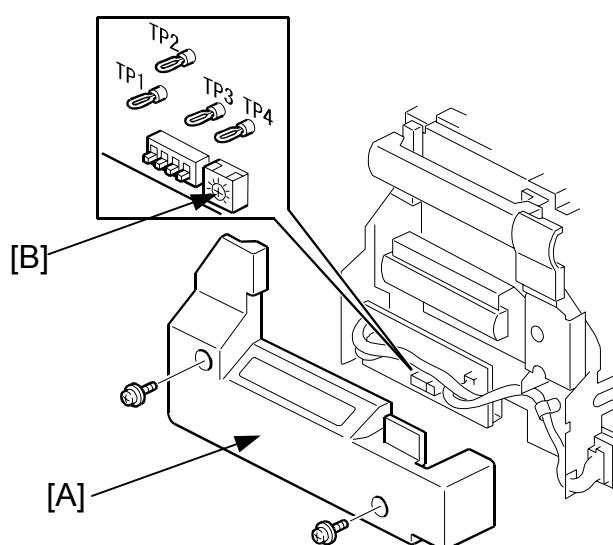
Note: This procedure is to calibrate the voltage of the ink sensor for the Ink End condition. This ensures that the sensor can correctly detect the Ink End condition. The procedure in this RTB is easier to do than the previous procedure (in the Service Manual).

1. Remove the ink around the ink roller:
 - Set SP2-2-1 (ink detection) to OFF, and then
 - Feed paper until the ink reaches the end condition
2. Pull the drum out and remove the drum front cover [A] and ink cartridge.
3. Push the drum back inside the machine.
4. Turn ON the main switch.
5. Access SP6-008-1 (Ink sensor).
6. The detection voltage is displayed on the operation panel. Turn VR901 [B] on the ink detection board until the value becomes **6.0μs**.
7. Return SP2-2-1 to **ON**.

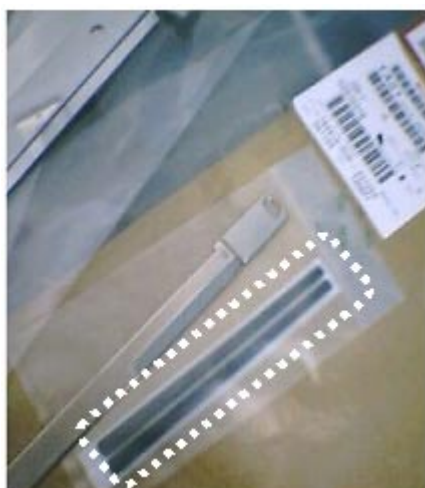
- Attach these stickers when you install the drum screen. **See the attachment procedure on the next page.**
NOTE: 1) ***These stickers are not registered as individual service parts. They are only included in the Cloth Screen service parts (2pcs).***
 2) ***These stickers are already attached on drums from the beginning of mass production.***
- Purpose: These stickers will reduce the amount of wrinkling of the master when the master is clamped. This is because the stickers increase the master clamp pressure near both sides of the drum.

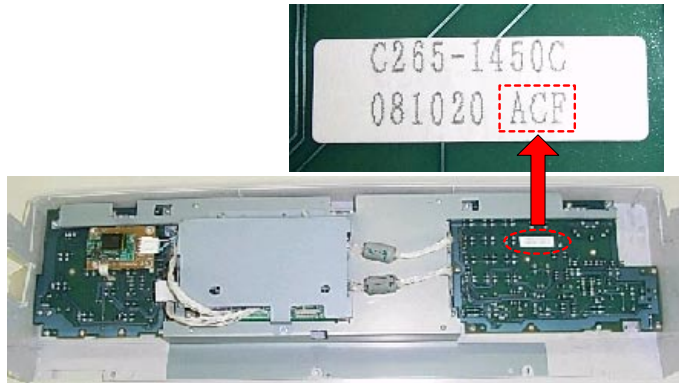
Note: Operation panels with “ACF” printed on the label (P/N H3106173) already have the modified touch panel attached.

1. Check the label on the operation panel. If “ACF” is printed on the label, **do not do this procedure.**

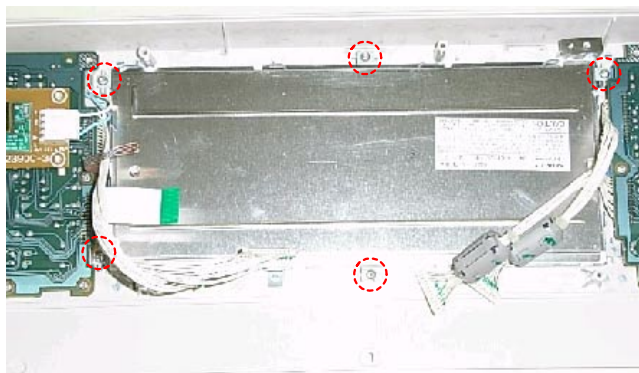
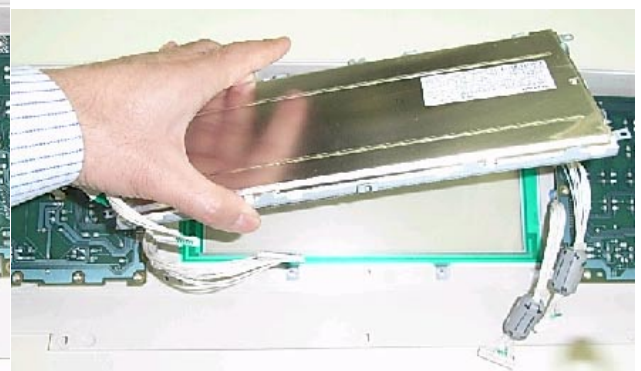
Note: The LCD cannot be completely separated from the operation panel. (There is a connector on the left side of the LCD, which is attached to the operation panel).

5. Remove the LCD (5 screws).

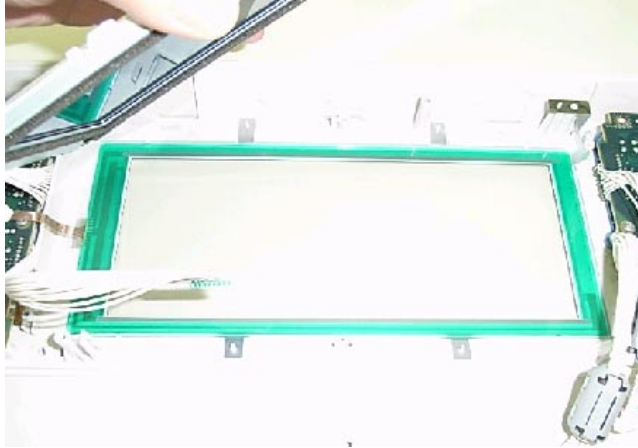
The adhesive that binds electrodes to the touch panel surface contains a polymer that tends to expand under normal office environmental conditions.

6. Remove the touch panel from the LCD and replace the touch panel.

Important: Only replace the touch panel. Do not replace the LCD.

Note: The end of the new touch panel harness is **white**.

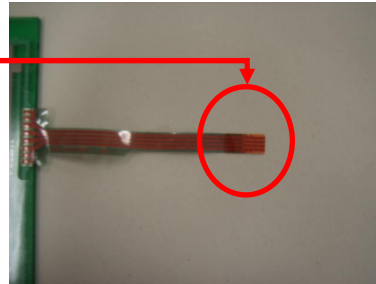
Old: B2135222

The end of the harness is brown

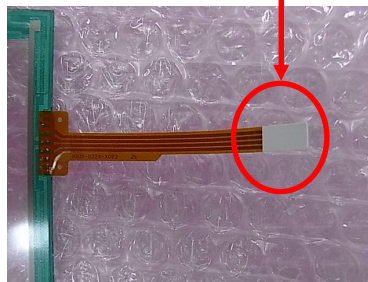
New: H3106173

The end of the harness is white.
