Model: PRIPORT SILVER		Date: 31-Dec-98	No: 01
Subject: Firmware Modification History		Prepared by: H. Kokubo,

Model: PRIPORT SILVER		Date: 15-Apr-99	No: 02
Subject: Controller Connectivity Problem (Firmware Update Information)		Prepared by: H. Kokubo,

Model: PRIPORT SILVER		Date: 15-Jun-99	No: RC231003
Subject: Paper jam at the paper delivery section		Prepared by: H. Kokubo,

Model: PRIPORT SILVER		Date: 15-Jun-99	No: RC231004
Subject: E-01 Cutter Failure, Master Misfeed		Prepared by: H. Kokubo,

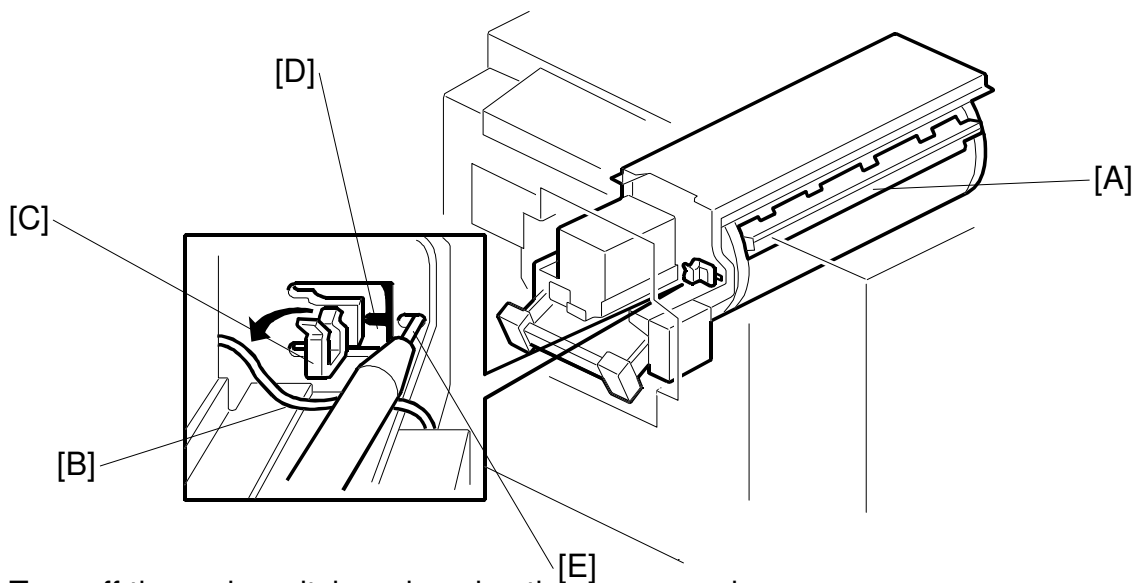
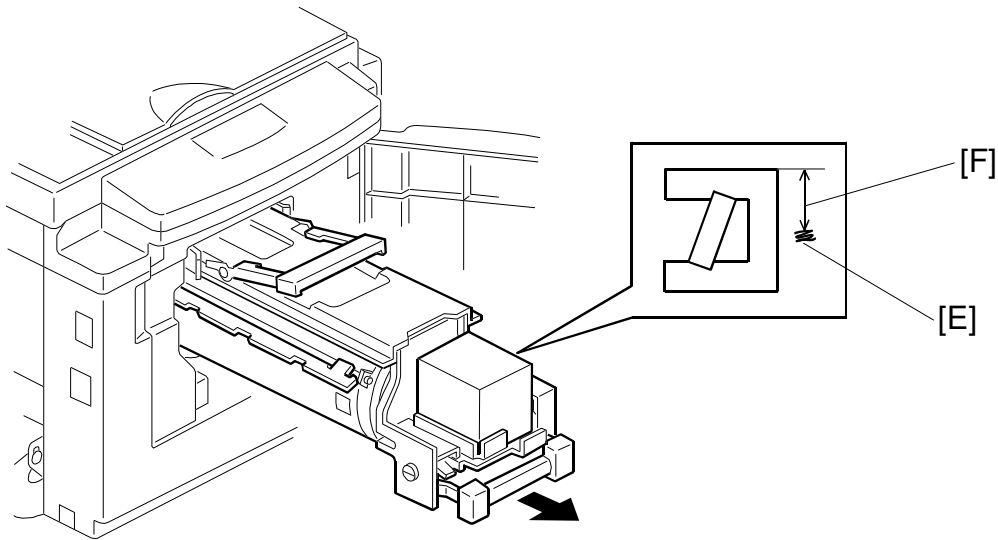
Adjustment procedure

Moving the drum to an incorrect master clamping position causes a master clamping error. This is caused when the drum turns from the home position to the master clamping position to start the master wrapping process (around the drum). Then this incorrect positioning causes the clamp to miss the master's leading edge. The master continues feeding for master making, but is not pulled while the drum turns. Consequently, the master bunches up against the cutter unit, resulting in a master cutting error.

1. Turn off the main switch and unplug the power cord.
2. Remove the front cover.
3. Turn on the test switch. (To release the cover safety functions)
- NOTE:** Don't forget to return it to the normal setting after finishing this procedure.
4. Plug in the power cord and turn on the main switch.
5. Access SP131 - 28 (Output mode - Drum Plot Stop) and press the Start key.
6. After the drum turns to the clamping position [A], look at the operation side of the drum.
7. Release the cable [B] from clamp [C].
8. Look at the drum flange spoke [D] inside the U-shaped cut out.
9. Mark a line [E] next to the spoke [D].

10. Pull out the drum and measure the distance [F] between the line marked in step 9 [E] and the top edge of the U-shaped cut out.
11. If the distance [F] is 9.5 ± 1.5 mm, the drum stopping position is correct. If it is not, reinstall the drum and change the drum stopping position for master making by using SP23 (Plot position adjustment). Then, repeat step 5 and continue until you obtain the correct drum stop position.

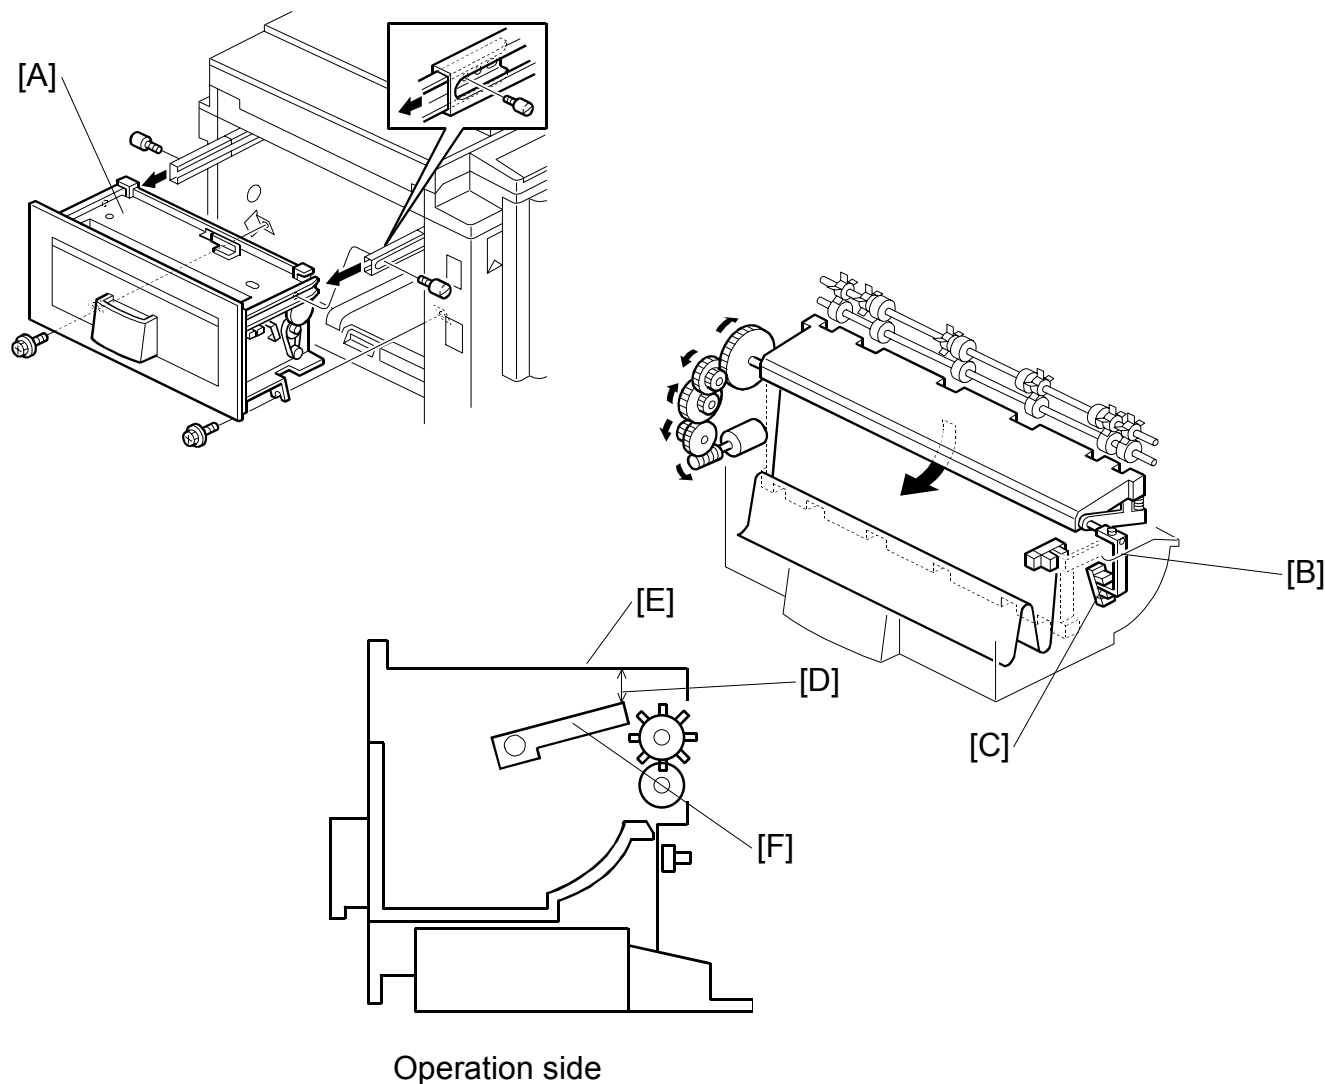
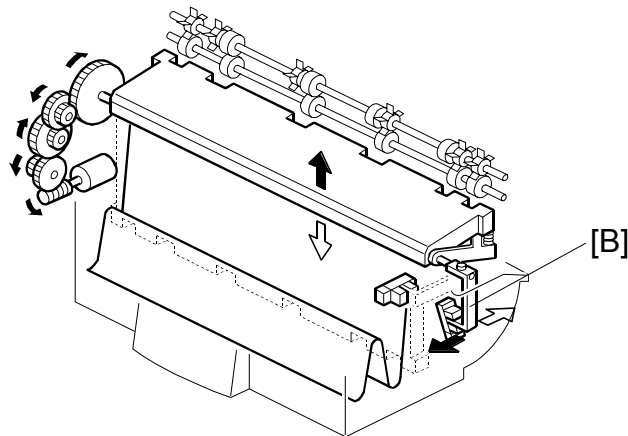
HOME POSITION CONFIRMATION

This is because the home position of the pressure plate [A] is wrong.

If the pressure plate position is slightly lower than normal, the pressure plate [A] will interfere with the ejected master [B] as shown above, causing a jam.

1. Turn the main switch on. Then, turn it off after a few seconds.
2. Remove the master eject unit [A]. (2 screws)
3. When pulling the master eject unit out (2 screws), make sure the pressure plate position feeler [B] interrupts the home position sensor [C].
4. Measure the clearance [D] between the crossbeam [E] and the surface of the pressure plate edge [F]. It should be 11.0 ± 3.0 mm.

1. Twist the pressure plate position feeler [B] (C231 3505), so that the plate moves closer to the correct home position. For example, if you want to shift the plate upwards (as shown by the black arrow), twist the feeler [B] clockwise.
2. After adjusting it, repeat the confirmation procedure on the previous page.

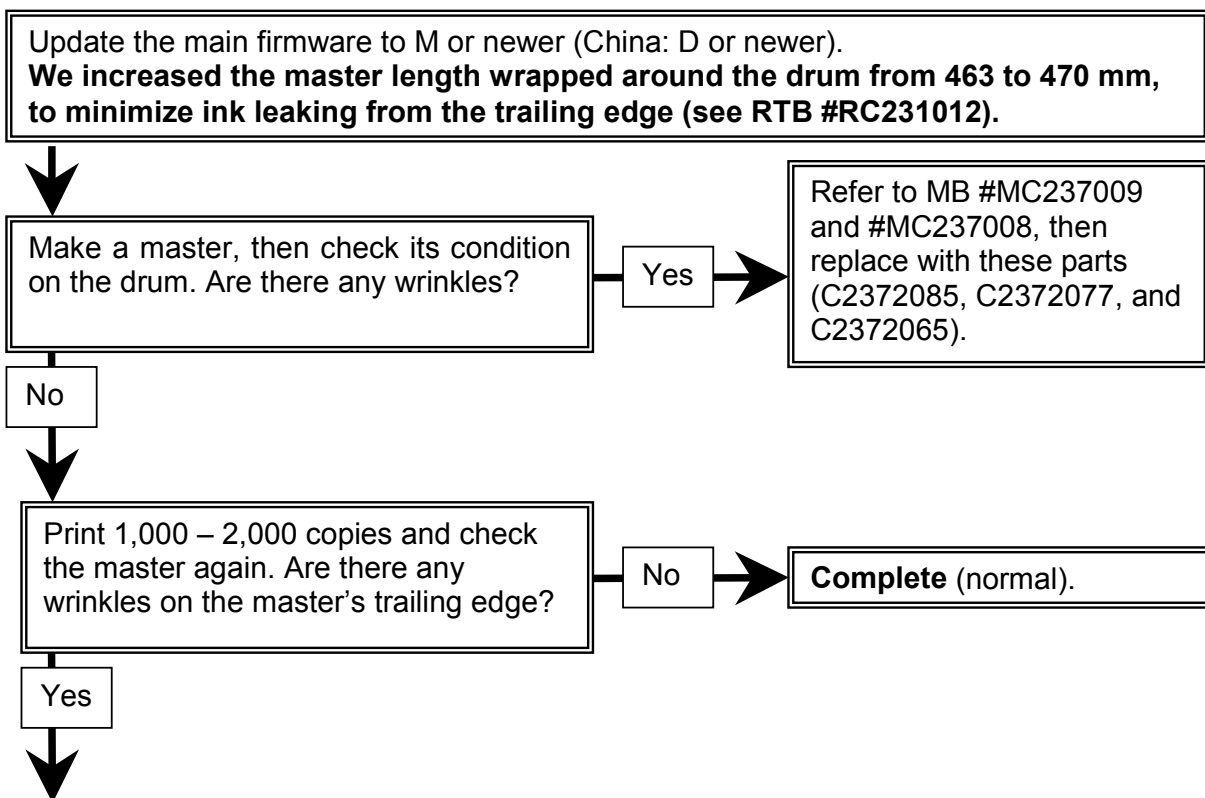
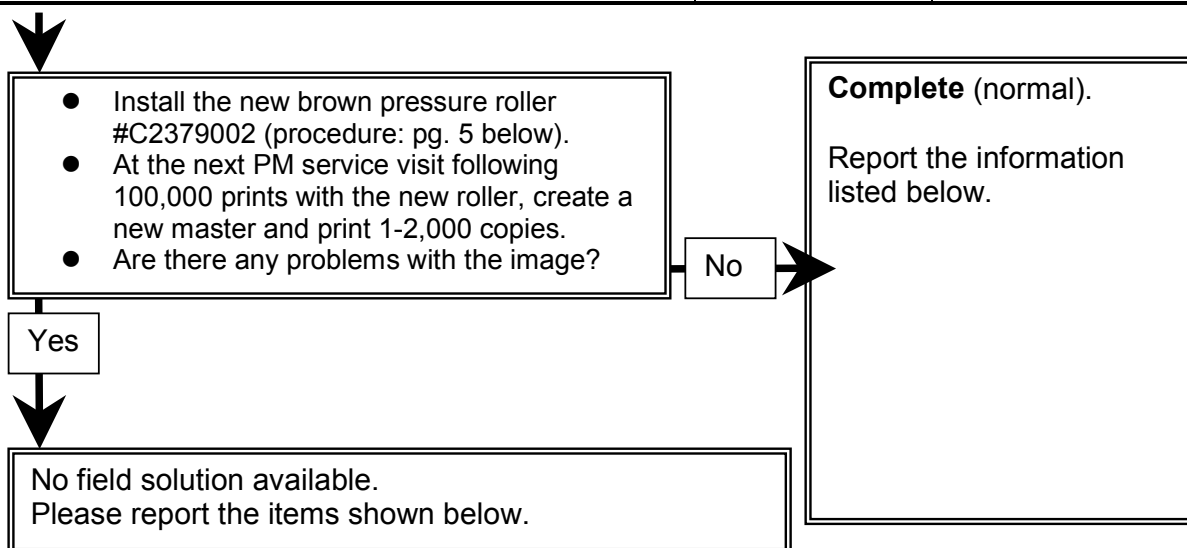
Master Wrinkling Troubleshooting Flow

Wrinkles develop in the master, which can cause the ink to leak from the trailing edge and dirty the copy images.

- Non-Ricoh production ink is used, which causes the rubber layer of the pressure roller to expand.
- A non-Ricoh master roll is used.
- 2,000 or more prints are made with the same master.

- When the symptom is reported from the field, follow the troubleshooting procedure below and install the new brown pressure roller if necessary.
 - Report the results if the roller was replaced, being sure to include the information listed at the end of the procedure below.
- Advise customers: 1) not to use non-Ricoh production ink, 2) not to use non-Ricoh master rolls, and 3) not to print more than 2,000 copies with the same master.
- Be sure to clean the roller surface using a cloth and water only. Solvents, alcohol, and other chemicals can also cause the rubber layer of the roller to expand.

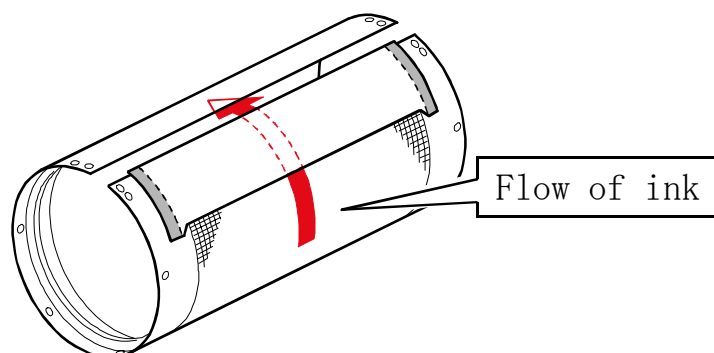
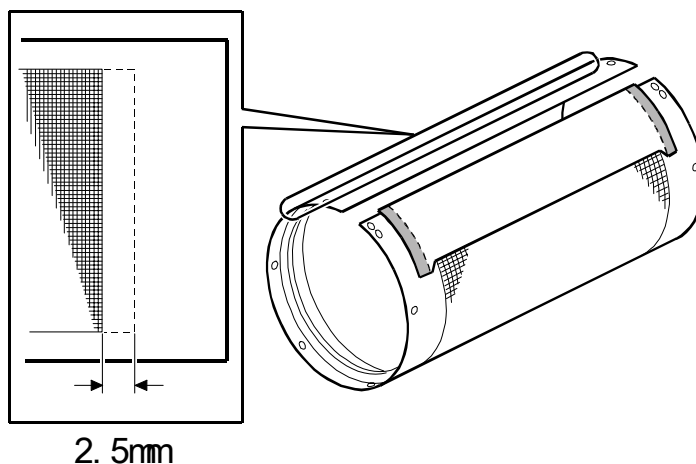
The flow of ink is shown below. The excess ink flows back into the inside of the drum from the leading edge of the new metal screen.

The leading edge of the mesh on the metal screen was increased 2.5 mm to prevent small dots at the leading edge of printing paper.

NOTE: Small dots may show if the image moves up because the mesh is closed only 2.5 mm.

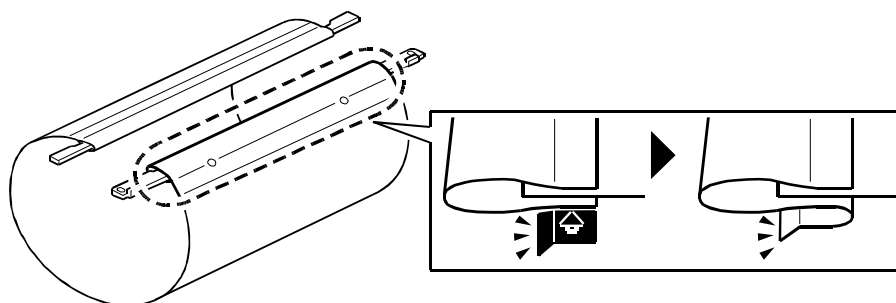
The new cloth screen is folded down the trailing edge of the screen rather than gluing it to the mylar seal.

The cloth screen was changed to an all-in-one design.

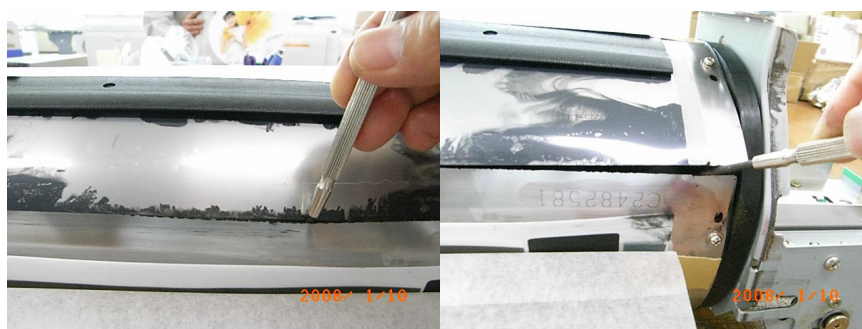
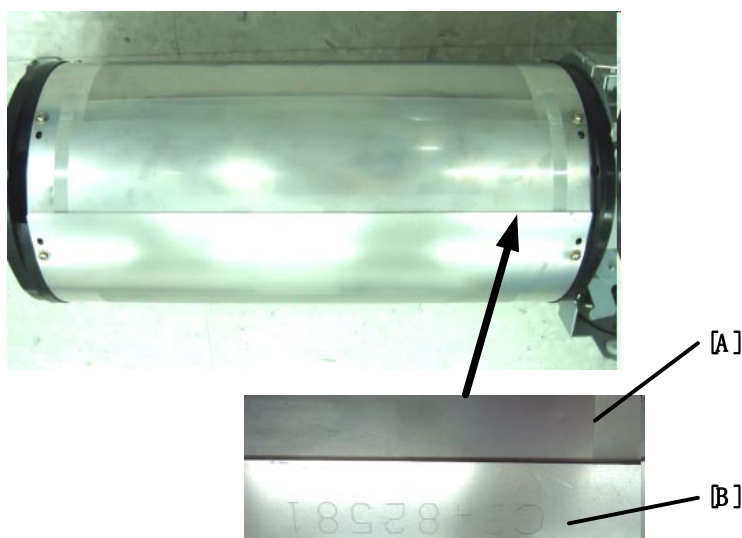
Ink leaks out from the joint of the metal screen (under the clamper).

Correct position: The trailing edge (Mylar side) [A] should be **under** the leading edge [B], so that you can see the part number printed on [B].

5. Clean the following with alcohol:
 - The area on the metal screen where the tape will be reattached in Step 6
 - The area on the Mylar where the tape will be reattached in Step 6
6. Reattach the tape to the joint of the metal screen.
7. Reattach all parts that you removed, and then reinstall the drum.
