Model: PRIORT PINKGOLD		Date: 20-May-02	No: R-C238-001
Subject: PINKGOLD firmware history		Prepared by: H. Onodera, Priort Service Planning Section	
Classification: <input type="checkbox"/> Troubleshooting <input checked="" type="checkbox"/> Part information <input type="checkbox"/> Action required <input type="checkbox"/> Mechanical <input type="checkbox"/> Electrical <input type="checkbox"/> Service manual revision <input type="checkbox"/> Paper path <input type="checkbox"/> Transmit/receive <input type="checkbox"/> Retrofit information <input type="checkbox"/> Other ()			
Model Name: Ricoh JP3000/JP3800, Gestetner 5430/5428C, RexRotary 1330, nashuatec CP430, Savin 3260DNP, Standard SD370

This bulletin is to inform you of the firmware modification history of Priort PINKGOLD.

FIRMWARE MODIFICATION HISTORY

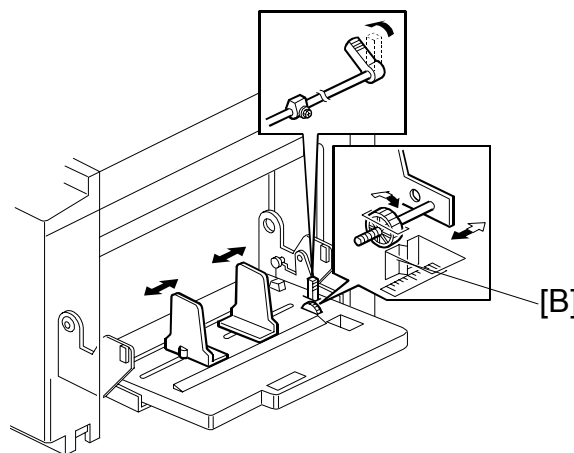
C238D056.WMF

Note: As shown in Table 1 below, a shift may still occur when using suffix D with the old pads.

Note: “Possible shift” – although the size detection range has been increased with suffix D, the width may be near the upper limit when using the old pads if the pads are not set tight against the stack, or the actual paper width is greater than the target. It is therefore not recommended to use the old pads, even with suffix D.

As stated above, the effective width of the paper + old pads is at or very near the upper limit of the suffix D detection range. Therefore, if pads need to be used, it is recommended to use the new pads together with the suffix D firmware.

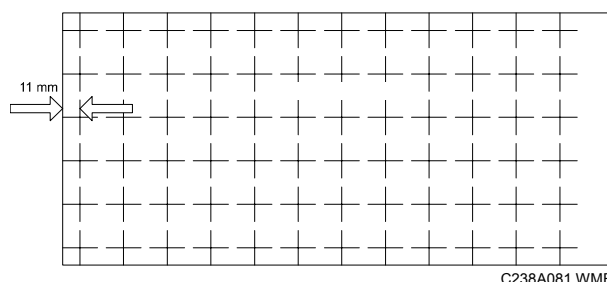
1. Set SP2-24 (Slow starting mode) to a value of "2" (print from 15 rpm).
2. Set SP8-10 (Test patterns) to a value of "6", then press the Start key.
3. Make 6 copies at speed 5 (finishing with 120 rpm). Perform the adjustment below for all 6 copies:
 - Trial print: 15 rpm
 - 1st print: 30 rpm
 - 2nd print: 60 rpm
 - 3rd print: 75 rpm
 - 4th print: 90 rpm
 - 5th print: 105 rpm
 - 6th print: 120 rpm
4. The distance between the leading edge and first line should be 11 mm, as shown below.

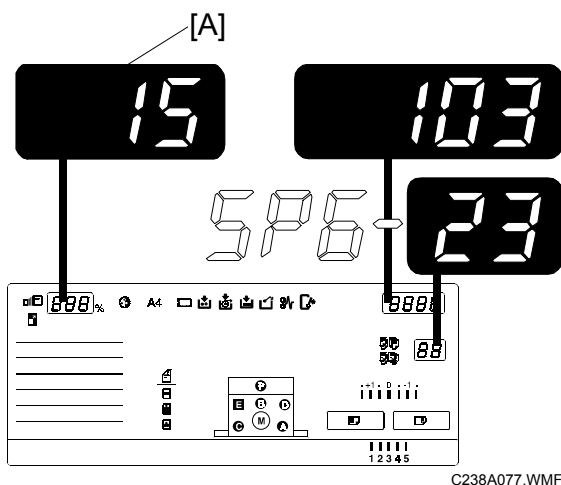
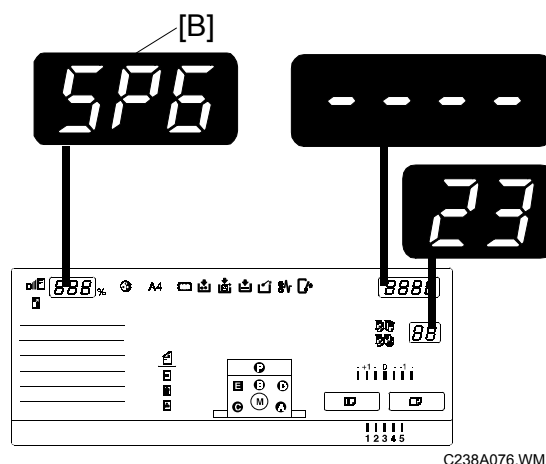
5. If this distance is not 11 mm, access SP6-23. The zoom counter [A] displays the speed. If the I/O ROM is not C2385124-G or newer, the zoom counter [B] displays "SP6", and cannot be adjusted.

6. Input a value to adjust the distance (range 0 to 255):

The higher the value, the narrower the distance between the leading edge and the 1st line becomes (and vice-versa). Also, each step corresponds to about 0.58 mm. Input the value that will bring the distance to 11 mm.

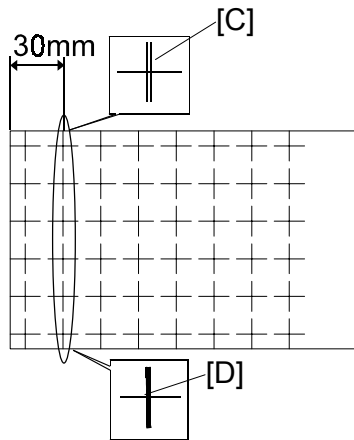
C238A082.WMF

Purpose: To adjust doubled [C] or blurred [D] images (e.g. bold lines, text) for each printing speed (15, 30, 60, 75, 90, 105, and 120 rpm), by changing SP settings.

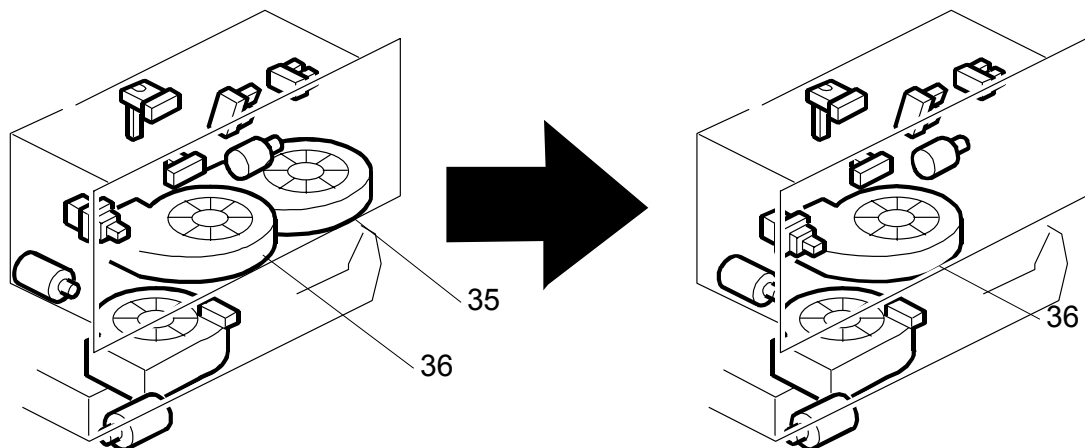
C247D001.WMF

The number of air knife fan motors has been decreased from 2 to 1, due to the decrease in size of the printable image area.

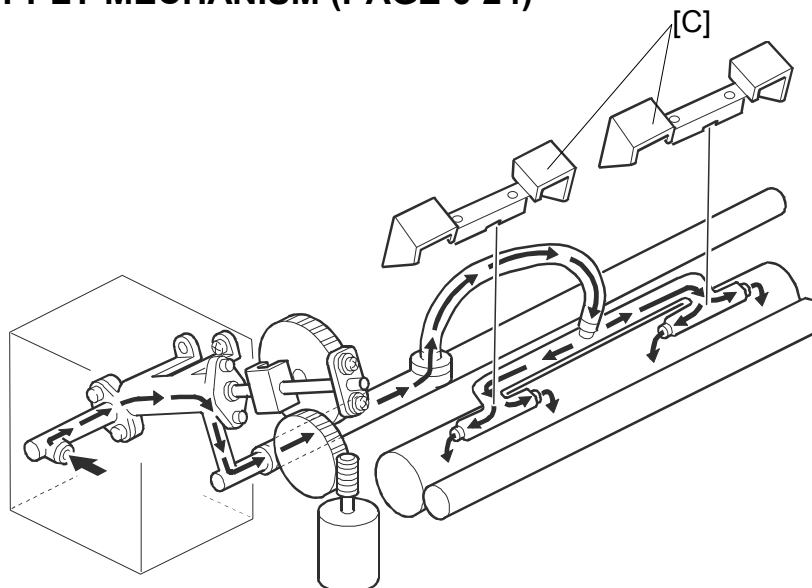
C247D005.WMF

Two ink pipe covers [C] have been added to ensure that ink from the ink distributor does not stick to the ink sensor.

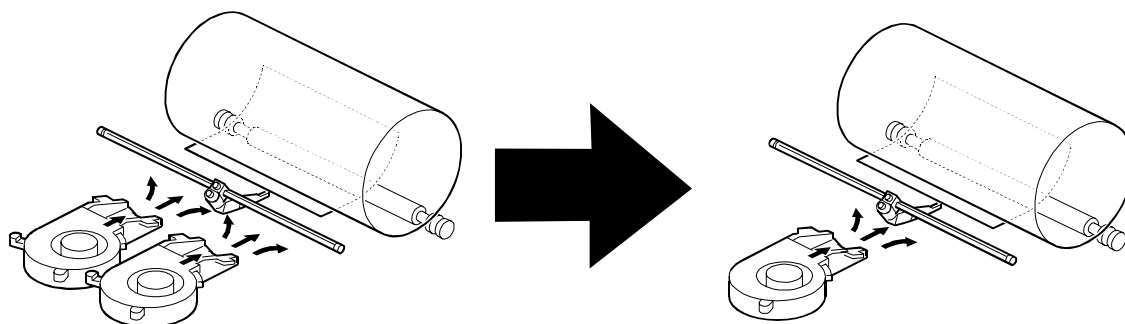
C247D002.WMF

The number of air knife fan motors has been decreased from 2 to 1, due to the decrease in size of the printable image area.

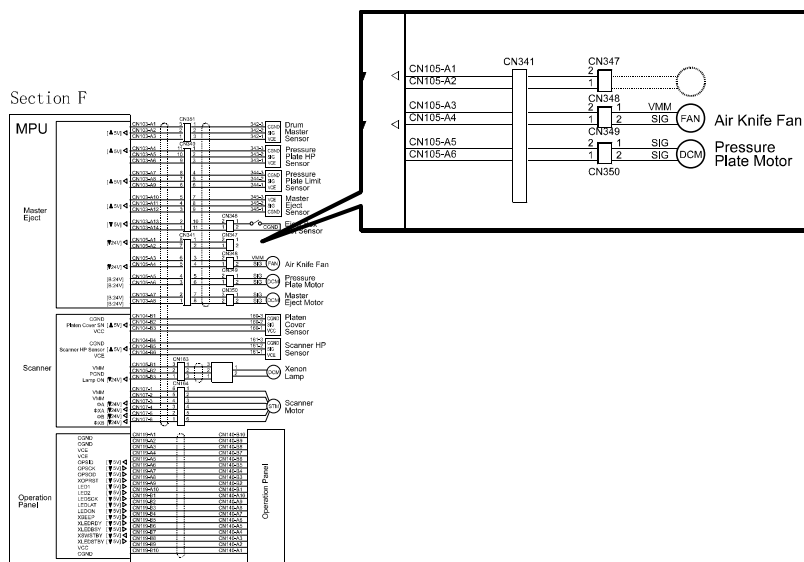
C247D003.WMF

The air knife fan motor previously connected to CN347 has been deleted (no. of motors reduced from 2 to 1).

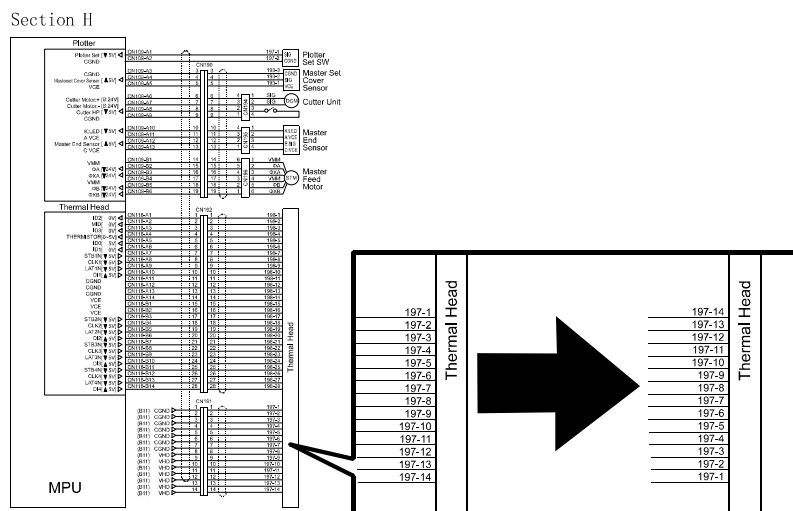
C247D004.WMF

The pin layout of the thermal head connector has been changed to conform to the new thermal head.

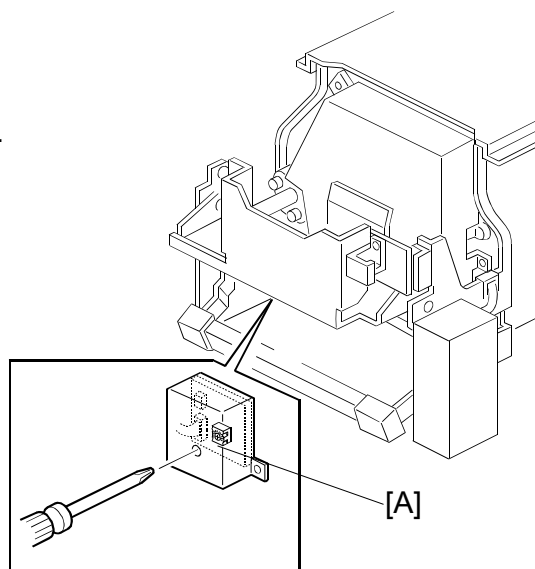
C238S013.WMF

Purpose: To ensure that the CPU detects a no ink condition.

Access SP6-40, and open the door cover, then turn the VR1 [A] on the ink detection board until the display becomes **"5.0 μ "** (5 μ s).

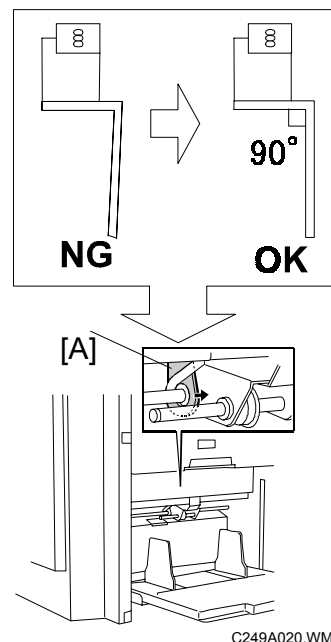
A bent retainer [A] causes extra play in the bushing/roller shaft connection, which can cause the bushing to come loose.

Bend the retainer [A] back to a right angle.

NOTE: If this does not solve the problem, replace the Sleeve with P/N #07078105B (see MB #MC238011).

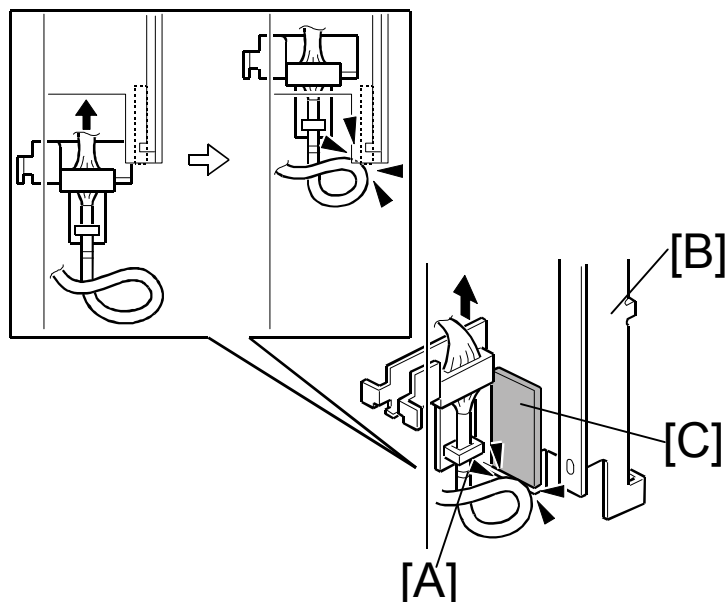
The paper tray harness (P/N: C2475237) [A] moves into a narrow space between two sides of the MPU (P/N: C2385601) [B]. This happens when the paper tray harness is curled as shown in the diagram and the paper table lifts up or down.

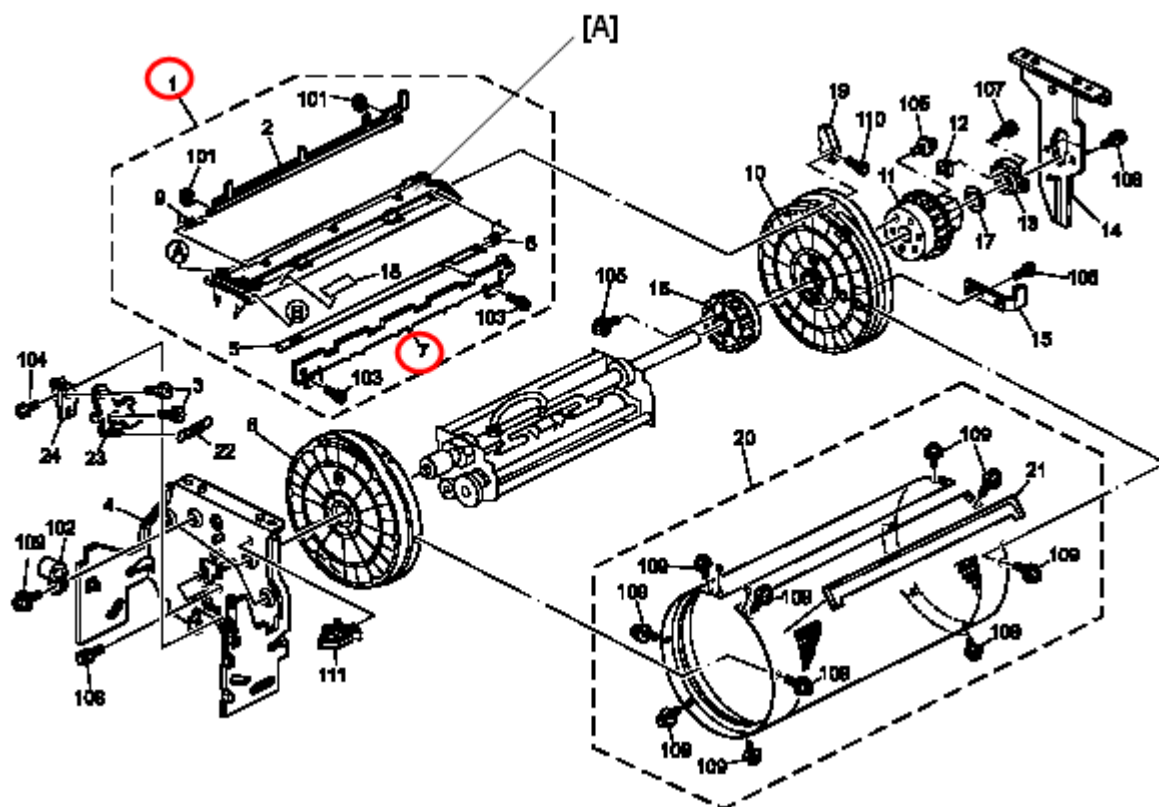
14.Drum Unit 3 (C238)

Important: If the plate clamp (index #7) needs to be replaced, replace the entire clamp assembly (index #1). This is because the new plate clamp cannot be attached to the old assembly, due to the shape change applied to the clamber base [A].
