<b>Model:</b> PRIPORT HP4/HP4P		<b>Date:</b> 30-Sep-03	<b>No:</b> R-C249-001a
<b>Subject:</b> HP4/HP4P firmware history		<b>Prepared by:</b> A. Yoshida, Priport Service Planning Section	
<b>Classification:</b> <input type="checkbox"/> Troubleshooting <input checked="" type="checkbox"/> Part information <input type="checkbox"/> Action required <input type="checkbox"/> Mechanical <input type="checkbox"/> Electrical <input type="checkbox"/> Service manual revision <input type="checkbox"/> Paper path <input type="checkbox"/> Transmit/receive <input type="checkbox"/> Retrofit information <input type="checkbox"/> Other (        )			
<b>Model Name:</b> HP4: Ricoh JP4500, Gestetner CP6244, RexRotary CP6244, nashuatec CP6244, Savin 3560DNP, Standard SD420, Lanier LDD145 HP4P (China only): Ricoh JP4510P, Gestetner 6254P

The following is the firmware modification history of Priport product HP4/HP4P.

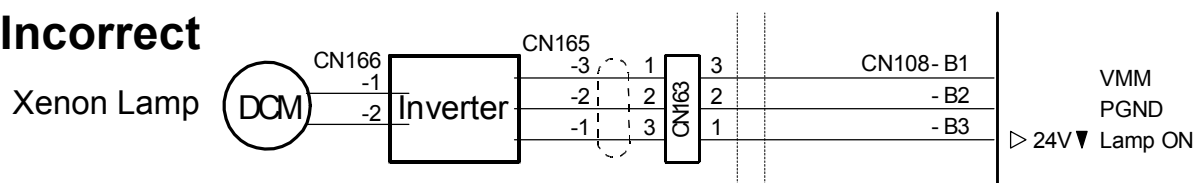
#### Incorrect

### Connector Number - Section D (pg. 7-6)

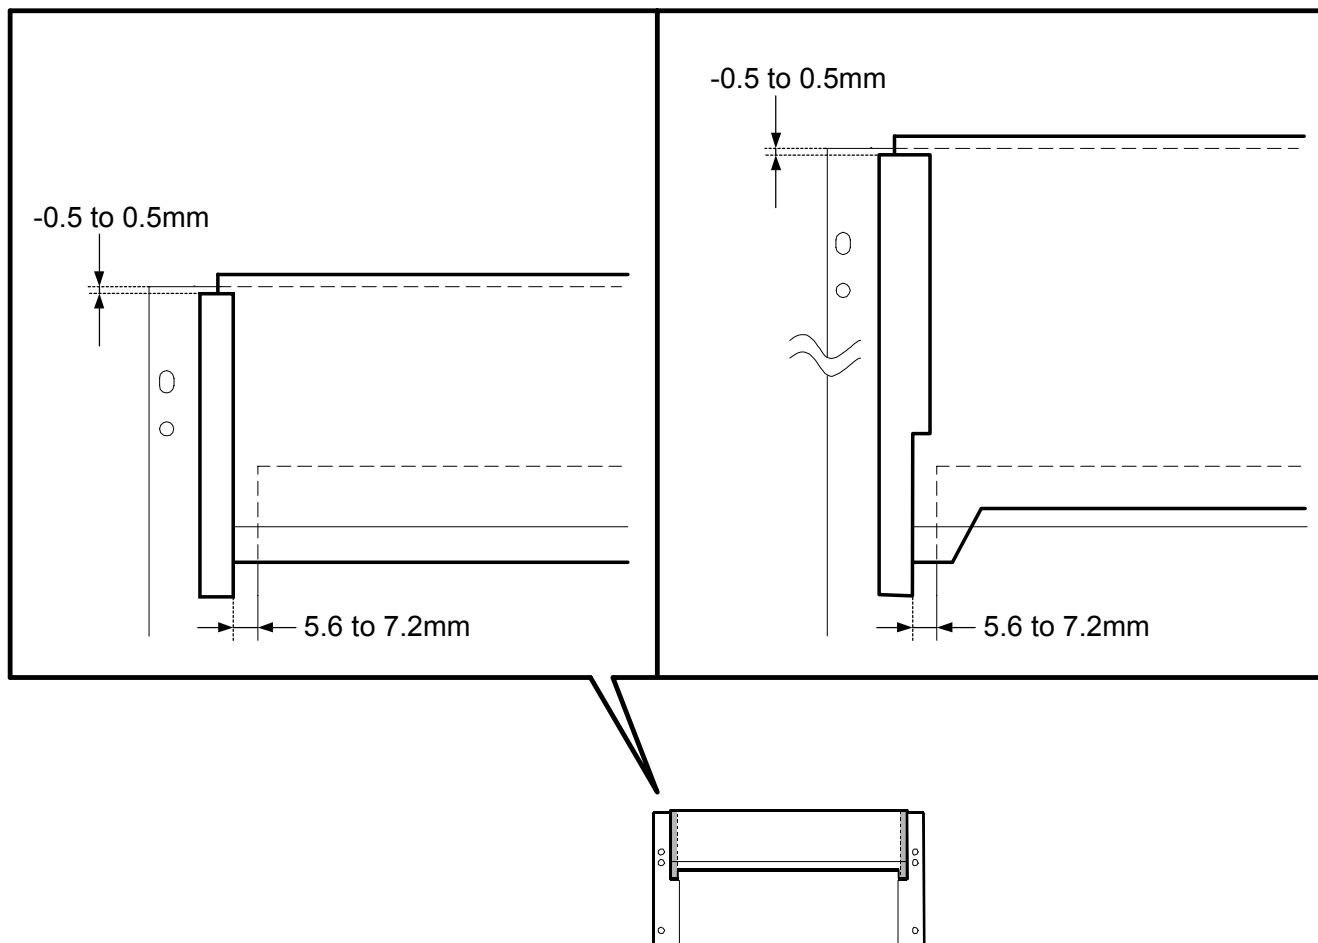
### ◆ P/N #C2492586/#C6202587

Ink leaks from the trailing edge of the metal screen.

Sometimes, the ink pressure causes part of the Mylar seal on the metal screen to peel off.

Replace the metal screen or Mylar seal when the symptom is reported.

If you replace only the Mylar seal, make sure to clean the attachment area with isopropyl before you attach the new seal.

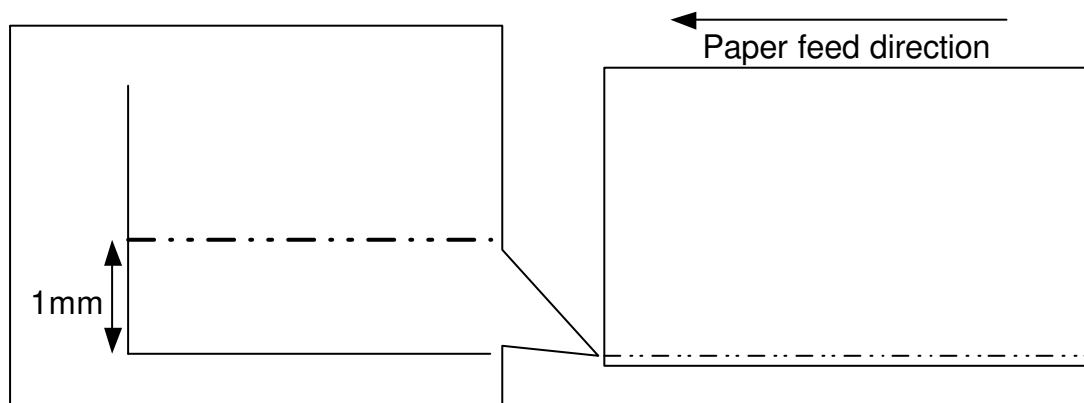
- This only happens when the image is printed out from the **VC-20** optional controller.
- See the RTB#C249018a for the firmware change history.

Image processing error in the VC-20

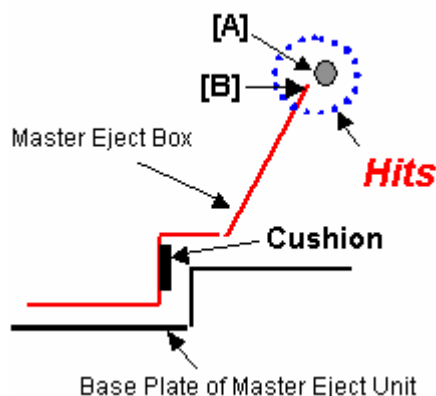
Two cushions were added to the master eject box to prevent contact between these parts.

**Note:** See MB MC264-009 for parts information.
