<b>Model:</b> PRIPORT PEARL		<b>Date:</b> 31-Dec-98	<b>No:</b> 01
<b>Subject:</b> Pressure Cylinder Maintenance Cycle		<b>Prepared by:</b> H. Kokubo,

<b>Model:</b> PRIPORT PEARL		<b>Date:</b> 31-Dec-98	<b>No:</b> 02
<b>Subject:</b> Master Feed Jams or Cutter Errors		<b>Prepared by:</b> H. Kokubo, Priport Service Planning Section	
<b>Classification:</b>	<input checked="" type="checkbox"/> Troubleshooting <input type="checkbox"/> Mechanical <input type="checkbox"/> Paper path <input type="checkbox"/> Other (      )	<input checked="" type="checkbox"/> Part information <input type="checkbox"/> Electrical <input type="checkbox"/> Transmit/receive	<input type="checkbox"/> Action required <input type="checkbox"/> Service manual revision <input type="checkbox"/> Retrofit information
<b>Model Name:</b> PEARL: Ricoh JP5000, Gestetner 5450, RexRotary 1560, nashuatec CP450, SVN 3350DNP

<b>Model:</b> PRIPORT PEARL		<b>Date:</b> 15-Sep-99	<b>No:</b> R-C229-4
<b>Subject:</b> Auxiliary Firmware Update Method - Flash memory card for updating firmware -		<b>Prepared by:</b> H. Kokubo, Priport Service Planning Section	
<b>Classification:</b>	<input type="checkbox"/> Troubleshooting <input type="che

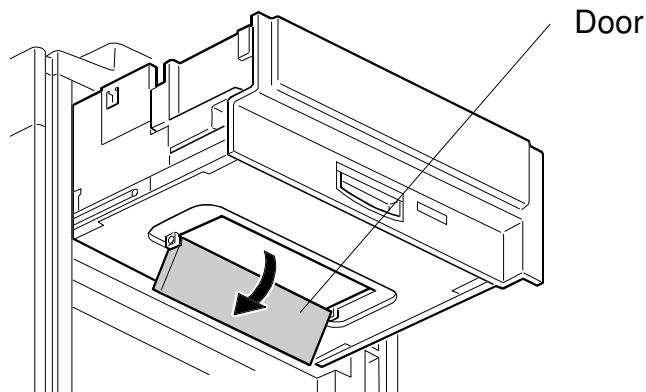
Due to heavy static electricity, the master is not guided into the buffer fans. This problem is especially likely when the master roll has almost run out and the diameter of the roll has become narrow.

1. First, slide out the master making unit and check if there is no master pieces in the buffer duct by opening the small door in the bottom of the unit.

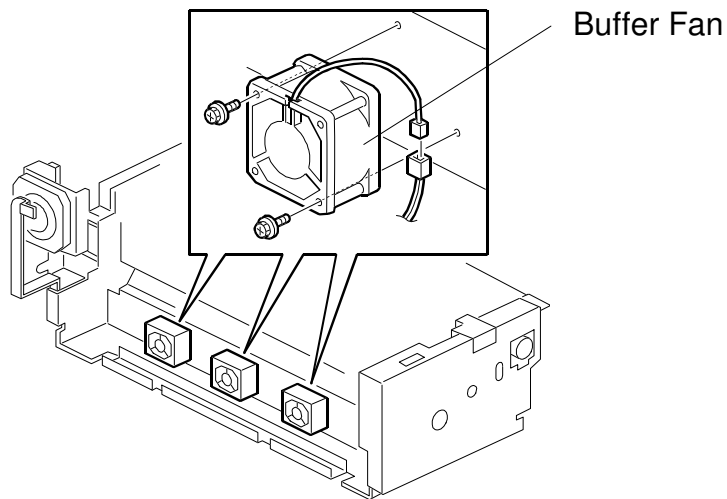
A tiny piece of master can cause the problem. Remove the three fans by loosening the screws, and check if there are any pieces of master.

2. Remove the exterior cover of the unit, and check if any master pieces are caught in the buffer fans.

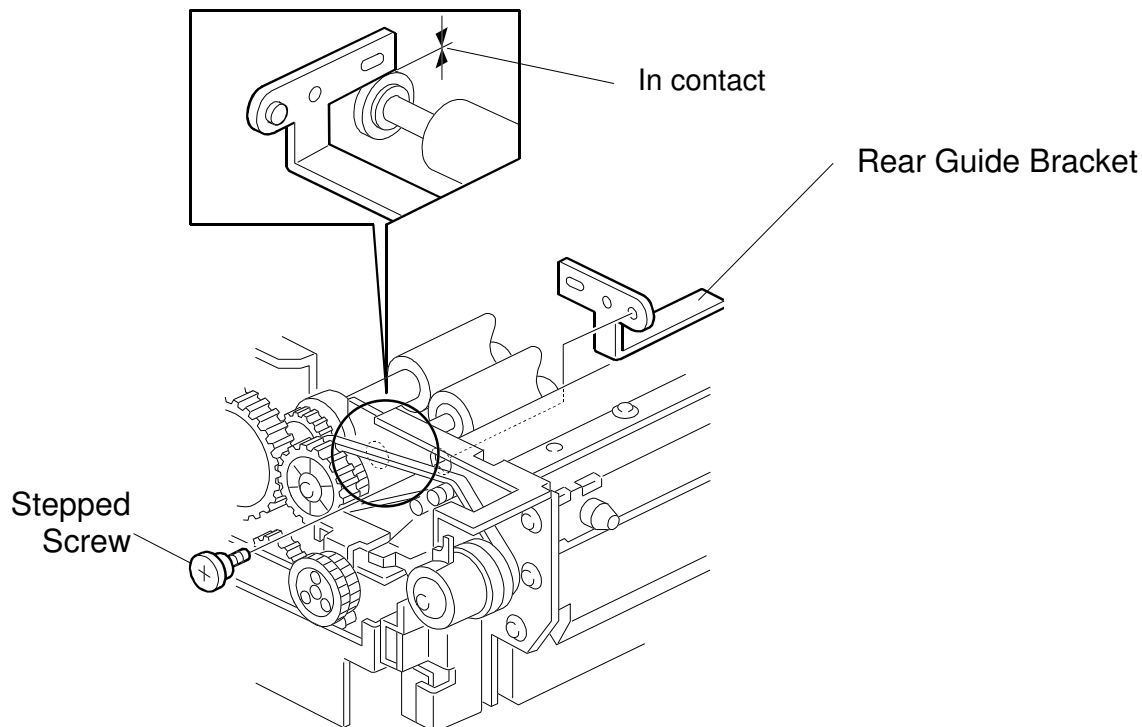
**CAUTION:** 1) The two brackets are different. Make sure to install them in the correct positions by referring to the diagrams above.  
 2) Make sure that both brackets are in contact with the flanges of the ball bearings at each end of the roller. (See diagram.)

3. Install the rear guide bracket (in the non-operation side of the unit) using the stepped screw, as shown above.

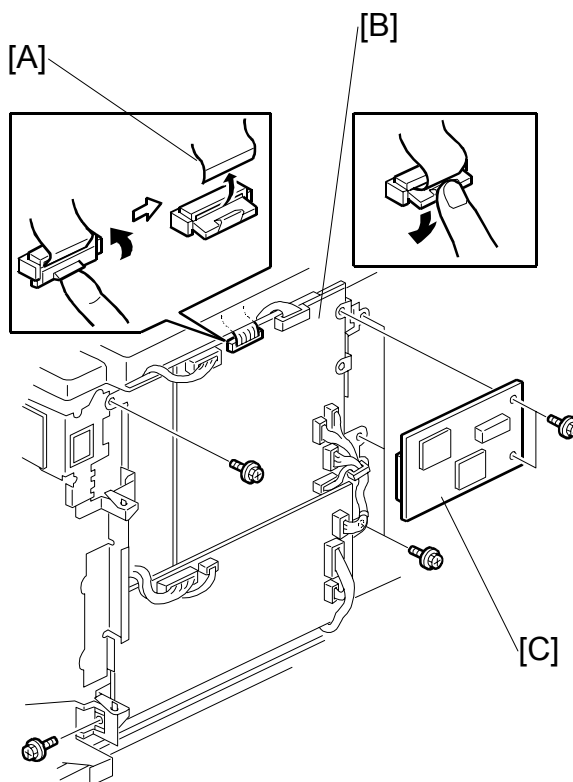
At the factory it was found that the grease applied to the sector gear shaft (in the master clamber drive unit) was insufficient. After investigating the production units, we found that this problem occurred from the December 1999 production of these machines.

If the sector gear shaft [A] wasn't greased or was insufficiently greased, the surface of the shaft [A] will gradually wear down, as the sector gear plate [B] and sensor actuator bracket [C] rotate along the shaft each time a new master is made.

If the shaft wears down (frictional wear), the sector gear plate [B] and/or sensor actuator bracket [C] will not work smoothly. This will cause the master clamber motor to lock or cause master clamping errors.

1. Turn off the main switch and disconnect the power plug.
2. Remove the rear cover.
3. Remove the flat cable [A], and open the MPU [B].  
**NOTE:** If the memory board [C] is installed, also remove it.
4. Remove screws and swing out the PSU (not shown).

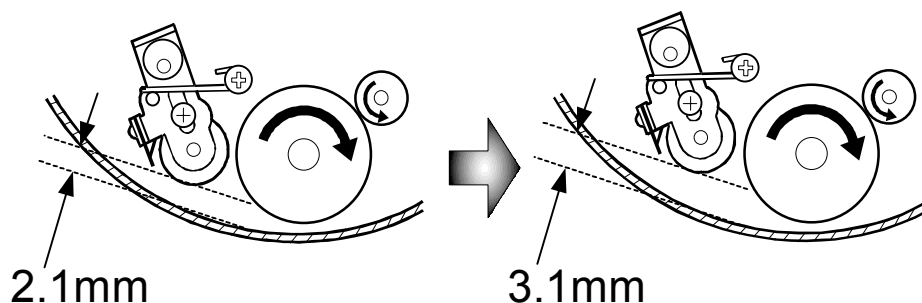
Producing over 2,000 prints with the same master causes an ink buildup to occur [A] between the inner surface of the drum metal screen [B] and the drum idling roller [C], after which the buildup is transferred to the area of the ink pump motor [D].

The home position of the drum idling roller has been increased to 3.1 mm from the drum screen, so that ink on the inner surface of the screen is applied evenly and ink leaks do not occur.

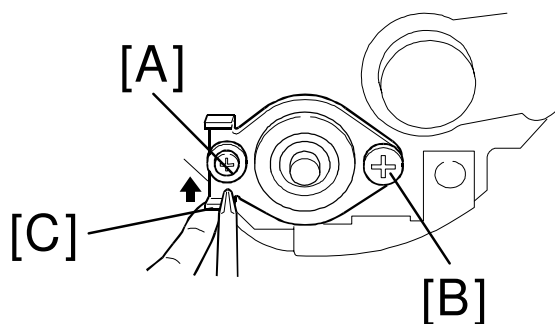
View from operator side

Producing over 2,000 prints with the same master causes an ink buildup [A] to occur between the inner surface of the drum metal screen [B] and the drum idling roller [C], after which the buildup is transferred to the area of the ink pump motor [D].

1. Remove the drum unit from the machine.
2. Remove the cloth and metal screens from the drum unit.
3. Wipe off the ink around the ink roller and the doctor roller.
4. Install the new parts, then tighten screw [B] (A2596239) and leave screw [A] (09513006Z) loose.
5. Move the lip [C] of the bearing holder up all the way as shown, then tighten screw [A].

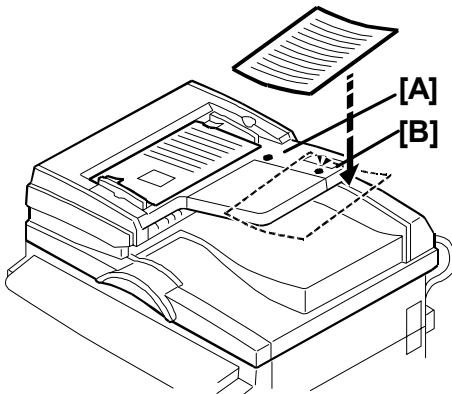
Symptom Corrected / Changes	Suffix
<p><b>1. Image shifting due to incorrect ADF paper loading:</b>  Firmware modified so that if the ADF detects a defined paper size with the left (innermost) paper length sensor [A], or neither of the sensors, it will not switch over to an "undefined size" if something is placed on top of the right (outermost) length sensor [B].</p> <p><i>Example: The machine will not switch to "undefined size" if a sheet is placed on the right length sensor after it has detected an A4 LEF sheet.</i></p>

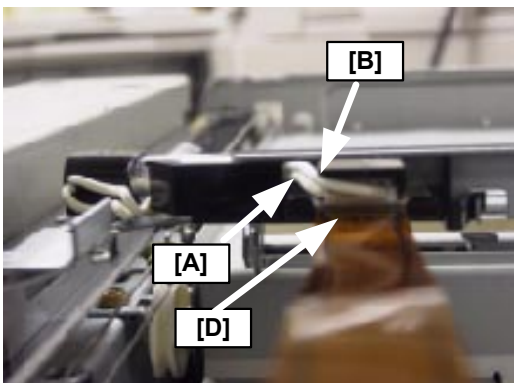
**Fig. 1: Correct**

**Correct (Fig. 1):** Wire [A] is led under wire [B], and they are not touching the flexible cable.

6. Push the pick [C] to the left to the remove the Harness Guide [E] for the flexible cable.
7. Put wire [A] and wire [B] in the same position as "Figure 1: Correct."

- Make sure wire [B] is **over** wire [A].
  - Make sure wire [A] and wire [B] are not too loose.
8. Re-attach the Harness Guide [E].
  - Put the left part of the pick [F] into the square hole [G], and then re-attach the pick [C].

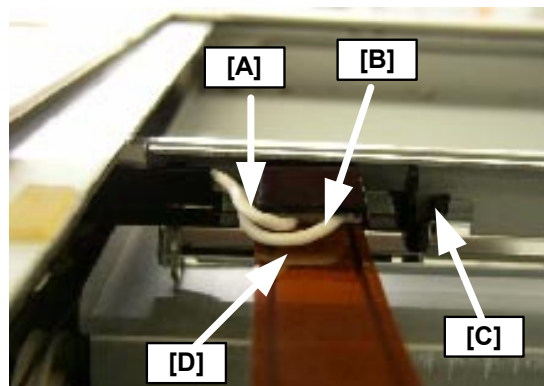
**Fig. 2: Incorrect**

**Incorrect (Fig. 2):** Wire [B] is led under wire [A], and one of them is touching the flexible cable.

- If the wires are like "Fig. 2: Incorrect", go to step 3.
3. Turn off the main switch.
4. Remove the exposure glass.
5. Check the flexible cable [D].
  - If you see any damage to the outside of the flexible cable, replace it.

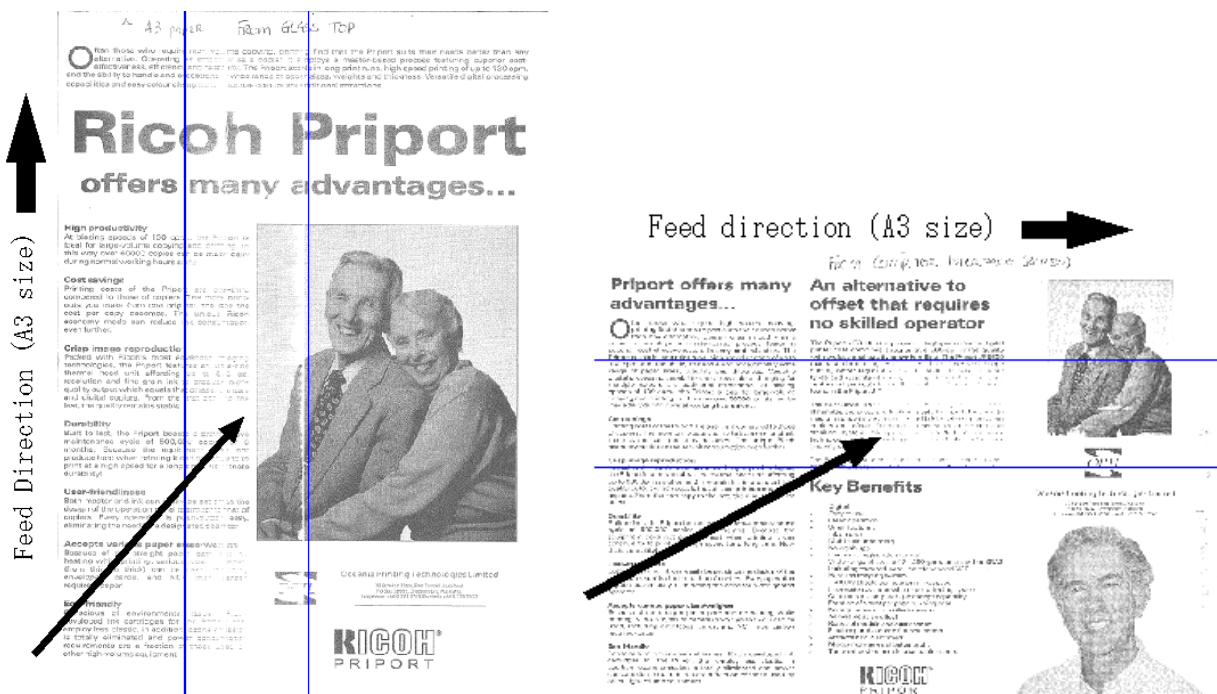
An area of the image (73mm wide) has low image density or white banding.

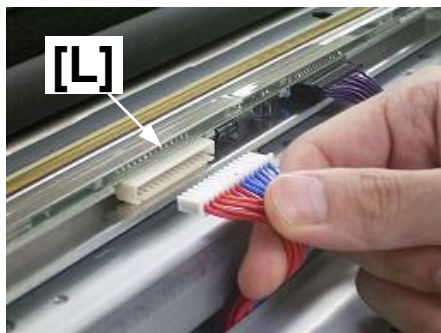
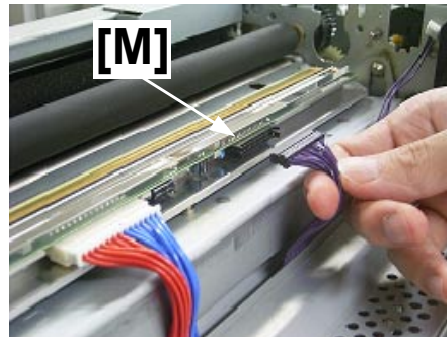
12. Disconnect the two harnesses ([L], [M]) from the thermal head.

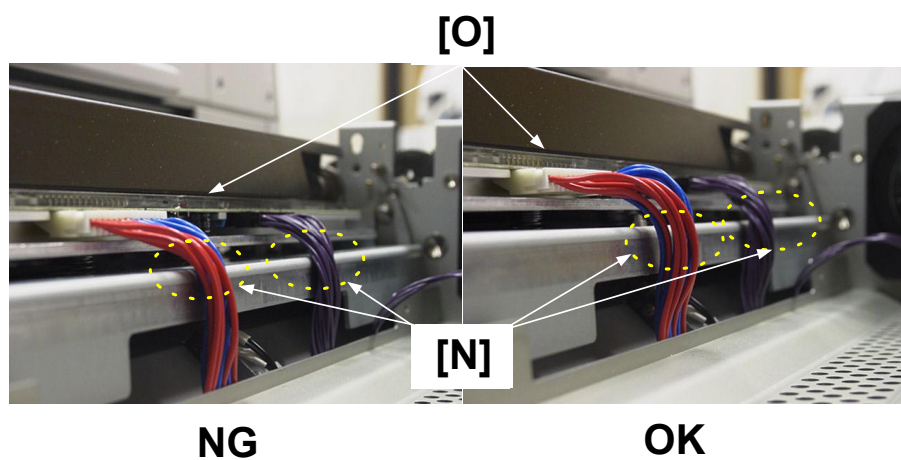
**Note:** This ensures that the harnesses are not pulled tightly when thermal head [O] moves up.

13. Pull the two harnesses very carefully and increase the slack [N].

**Important:** See the photo on the right (“OK”) for the target amount of slack.
