Model: PRIPORT TITANIUM		Date: 7-Apr-03	No: R-C252-001
Subject: Notes the model TT installation		Prepared by: M. Ohtsubo, Priport Service Planning Section	
Classification:	<input type="checkbox"/> Troubleshooting <input type="checkbox"/> Mechanical <input type="checkbox"/> Paper path <input type="checkbox"/> Other ()	<input type="checkbox"/> Part information <input type="checkbox"/> Electrical <input type="checkbox"/> Transmit/receive	<input type="checkbox"/> Action required <input checked="" type="checkbox"/> Service manual revision <input type="checkbox"/> Retrofit information
Model Name: Ricoh JP730/JP750/JP780C, Gestetner 6123lcp/5410c/6123cp, Lanier LDD 730, nashuatec 6123cp, RexRotary 6123cp

Model: PRIPORT TITANIUM		Date: 23-Oct-03	No: R-C252-003
Subject: Notes for model TT installation - revision		Prepared by: M. Ohtsubo, Priport Service Planning Section	
Classification:	<input type="checkbox"/> Troubleshooting <input type="checkbox"/> Mechanical <input type="checkbox"/> Paper path <input type="checkbox"/> Other ()	<input type="checkbox"/> Part information <input type="checkbox"/> Electrical <input type="checkbox"/> Transmit/receive	<input type="checkbox"/> Action required

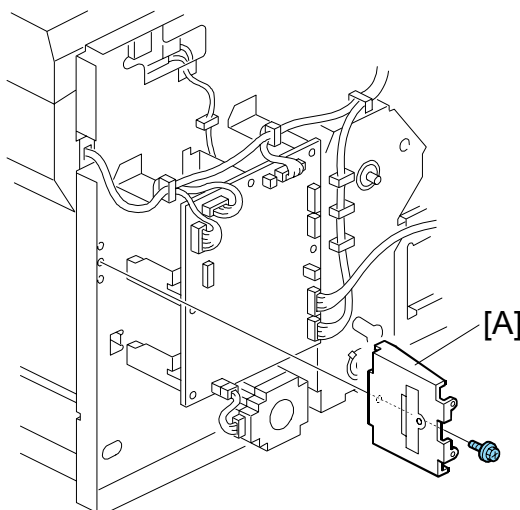
C261I002.WMF

1. Remove the bracket [A] (⌀x1).

NOTE: You do not need this bracket and its screws any more.

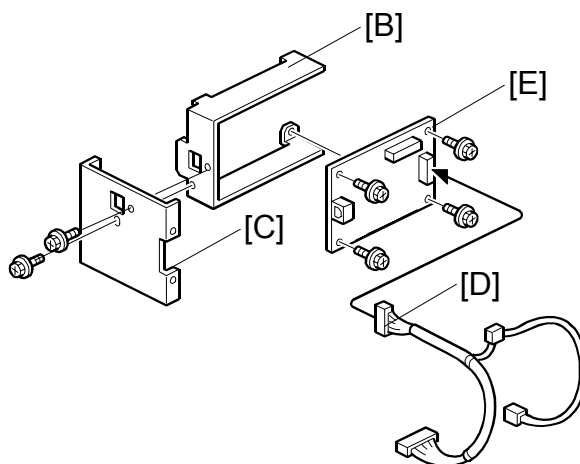
C261I003.WMF

2. Attach the printer controller board [E] to the bracket [B] (⌀x4).
3. Attach the bracket [C] to the bracket [B] (⌀x2).
4. Connect the connector [D] to the socket on the right side of the board [E].
NOTE: Make sure that the connector is securely connected to the socket.

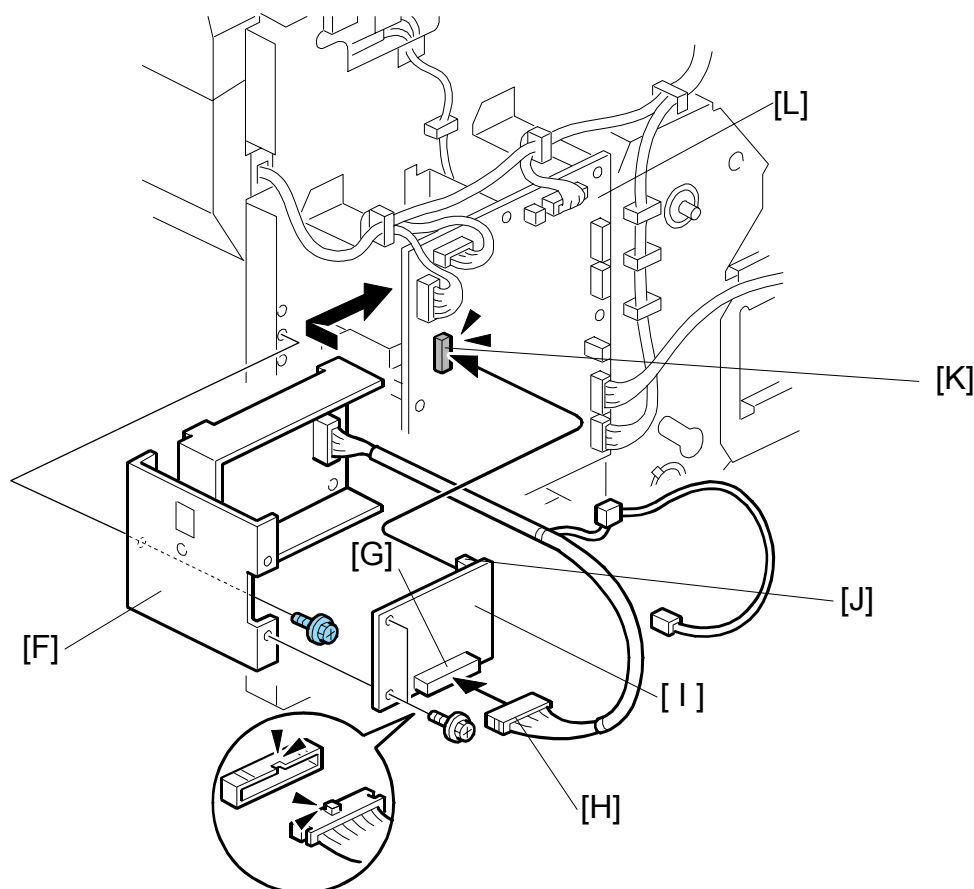
C2611004.WMF

5. Attach the bracket assembly [F] to the same place that the bracket [A] (Step 1) was installed (1 screw).

IMPORTANT: In this step, only use the M3x6 screw included with the Interface board Type 20.

6. Connect the socket [J] on the interface board to CN108 [K] on the MPU [L].

IMPORTANT: Make sure that the socket is securely connected to CN108.

7. Connect the connector [H] to the socket [G] on the interface board.
8. Attach the interface board [I] to the bracket assembly [F] (⚙ x 2).

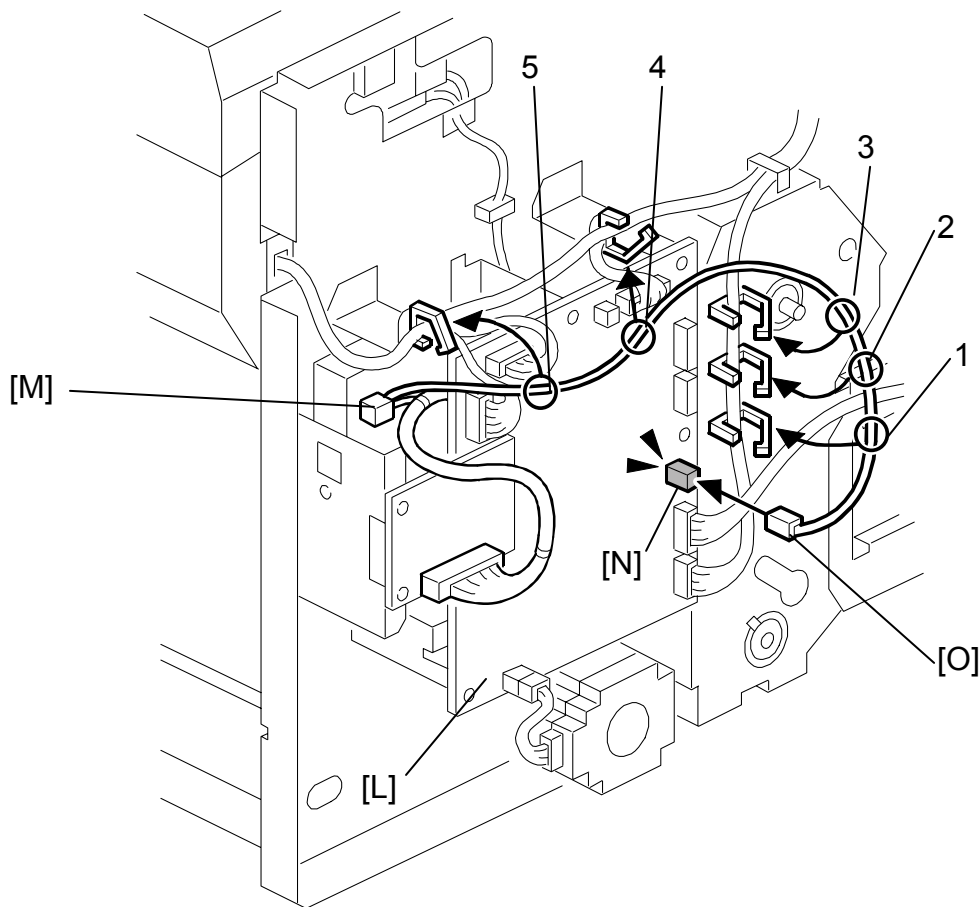
9. Connect the connector [O] to CN102 on the MPU [N].

IMPORTANT: Make sure that the connector is securely connected to CN102.
