Model: PRIORT PEARL/PEARL-MC/RUBY/SAPPHIRE/GARNET/SA2/SA2P		Date: 25-Jun-07	No: R-C235-001
Subject: Patchy image		Prepared by: M. Kumagai, Priort Service Planning Section	
Classification:	<input checked="" type="checkbox"/> Troubleshooting <input type="checkbox"/> Part information <input type="checkbox"/> Action required <input type="checkbox"/> Mechanical <input type="checkbox"/> Electrical <input type="checkbox"/> Service manual revision <input type="checkbox"/> Paper path <input type="checkbox"/> Transmit/receive <input type="checkbox"/> Retrofit information <input type="checkbox"/> Other ()		
Model Name: SAPPHIRE: Ricoh JP8000, Gestetner 5490, RexRotary 1395, nashuatec CP490, Savin 3450DNP, Standard SD630 GARNET: Ricoh JP5500, Gestetner 5450+/5455, RexRotary1560+, nashuatec CP450+, Savin 3360DNP, Standard SD450, Lanier LDD150 SA2: Ricoh JP8500, Gestetner 5490+/5499, RexRotary1395+, nashuatec CP490+, Savin 3460DNP, Standard SD650, Lanier LDD180 SA2P (China only): Ricoh JP8510P, Gestetner 5500P

Model: PRIPORT PEARL/PEARL-MC/RUBY/SAPPHIRE/GARNET/SA2/SA2P		Date: 3-Jul-07	No: R-C235-002
Subject: betterment for ink leakage		Prepared by: M. Kumagai, Priport Service Planning Section

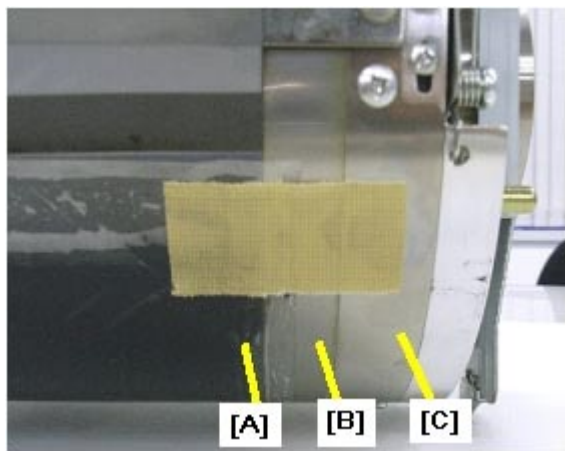
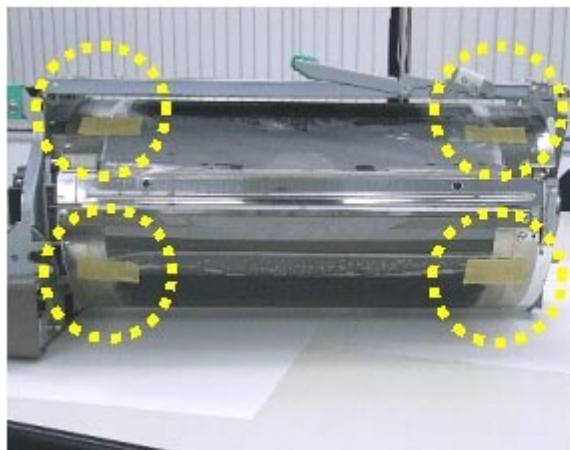
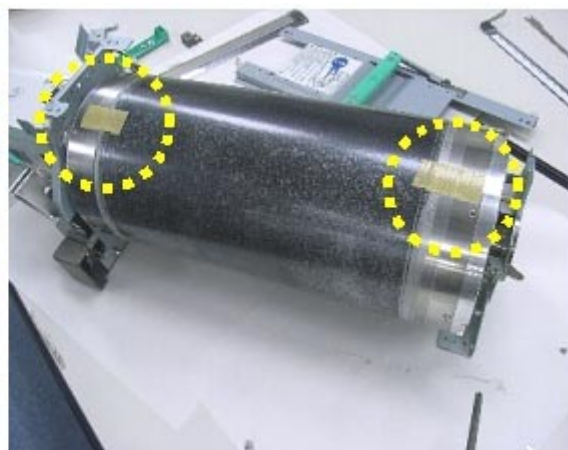
Important: Before you remove these parts, attach some tape to the three areas shown in the photo below (the master [A], cloth screen [B] and metal screen [C]). This is to prevent the cloth screen from wrinkling when it is removed or attached.

1. Remove the drum clumper, cloth screen and metal screen (see Service Manual p236).

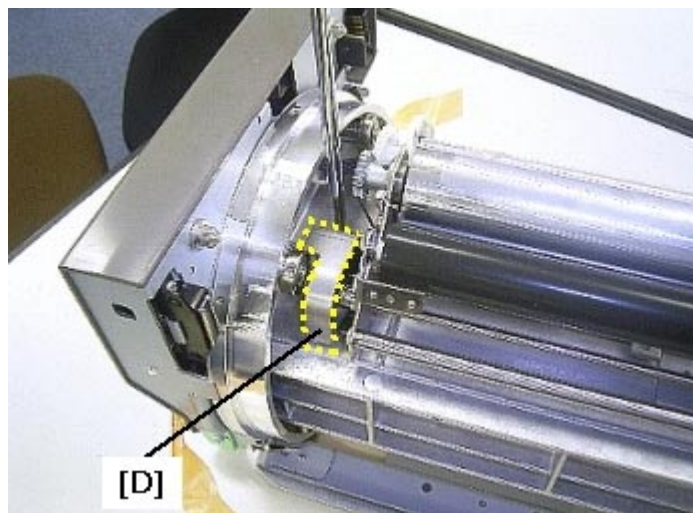
Important: Make sure that the ink does not drip out when you set the drum upside-down.

2. Remove the sensor bracket [D] (1 screw, 1 connector).

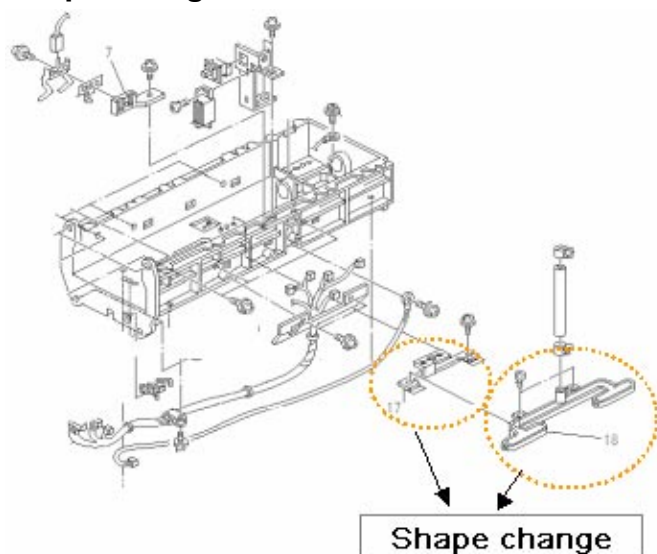
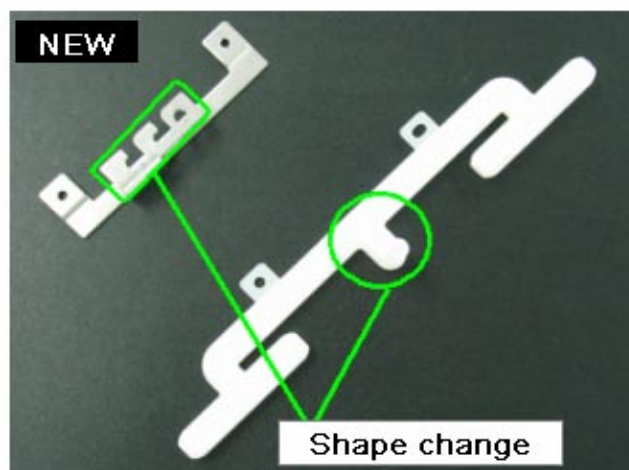
Shape change:

Ink sticks to the ink roller [C], and then builds up on the ink detection pin [A] and ink distributor.

The ink distributor and attachment bracket for the **Emerald/Topaz** are now used. The distance between the ink detection pin and ink supply port [B] is wider. Also, it is harder for ink to stick to the ink detection pin and ink distributor.

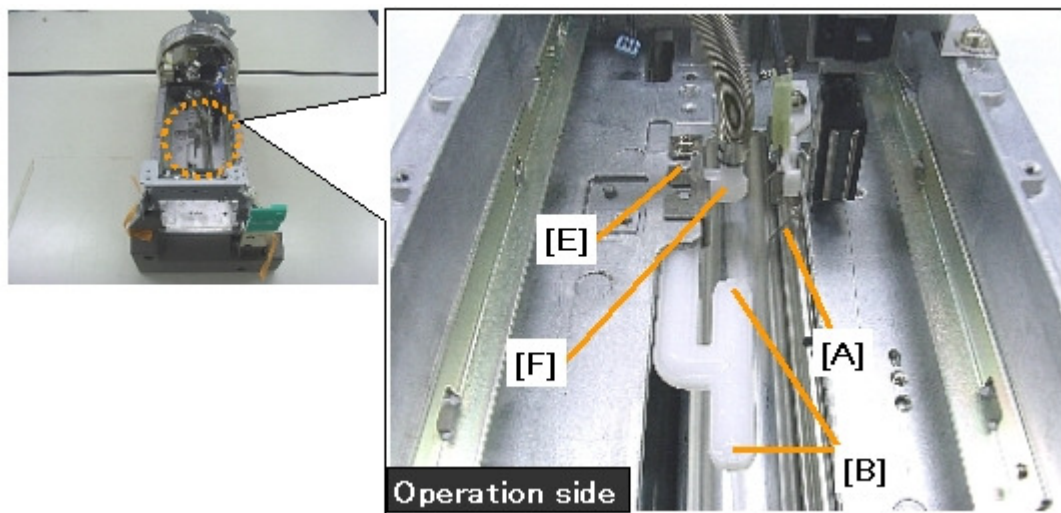
New bracket and distributor:

[A]: Ink detection pin

[B]: Ink supply port
