RIGOH	Technical	Bulletin		No. RTB-001
SUBJECT: Ink Cartridge "O" Rir	ng and Rubber Pa	d		DATE: April.30.'91 PAGE: 1 of 2
PREPARED BY: S. Asai CHECKED BY:		FROM: Copier	Technie	cal Support Section
CLASSIFICATION: Action Required Troubleshooting Retrofit Information	<ul> <li>Revision of a</li> <li>Information</li> <li>Other</li> </ul>	service manual only	MOD VT21 VT23 Ges 5 Rex 1 NSH	EL: 00/2130/2150 00/2500 5310/5315/5320/5330 240/1241/1242/1260 CP310/CP315/CP330
[Phenomenon 1]:				
There has been a problem with comes off and remains on the or it comes off and stays in the the temperature changes radic	n the "O" ring insid nozzle of the ink e cartridge cap wh ally making the "C	de the ink cartridg pump when the in the cap is ren D" ring contract.	e nozz nk carti noved.	le. The "O" ring ridge is replaced, This occurs when
[Countermeasure 1]:				
Instruct customers on how to r	eplace the ink ca	rtridge. Have ther	n follov	v this procedure:

## **Technical Bulletin**

# No. RTB-001

SUBJECT: Ink Cartridge "O" Ring and Rubber Pad

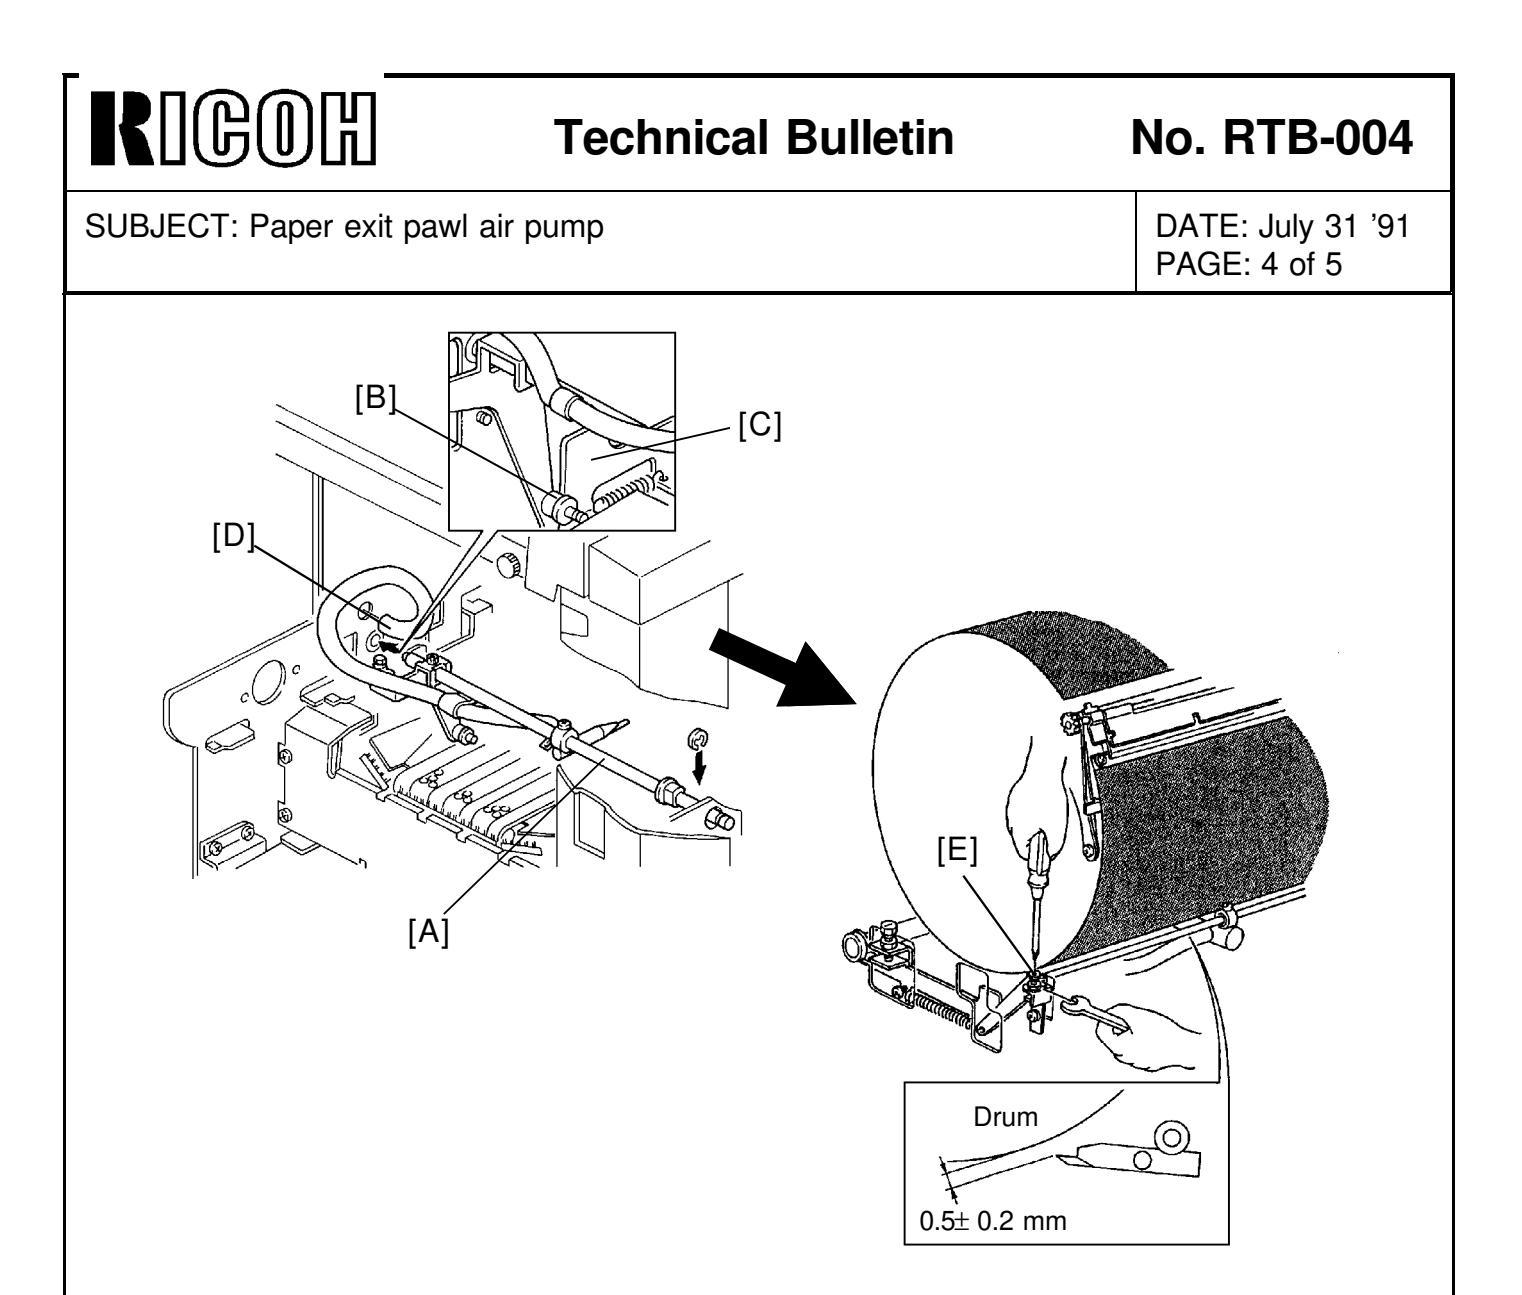
- 4. Install the new exit pawl unit [A](assembled on the previous page) to the machine (1 E-ring and 1 spring).
- **Note:** Make sure that the collar [B] on the exit pawl lever is correctly placed on the exit pawl drive cam [C].
  - 5. Insert the edge of the vinyl hose [D] into the hole on the rear side plate as shown.

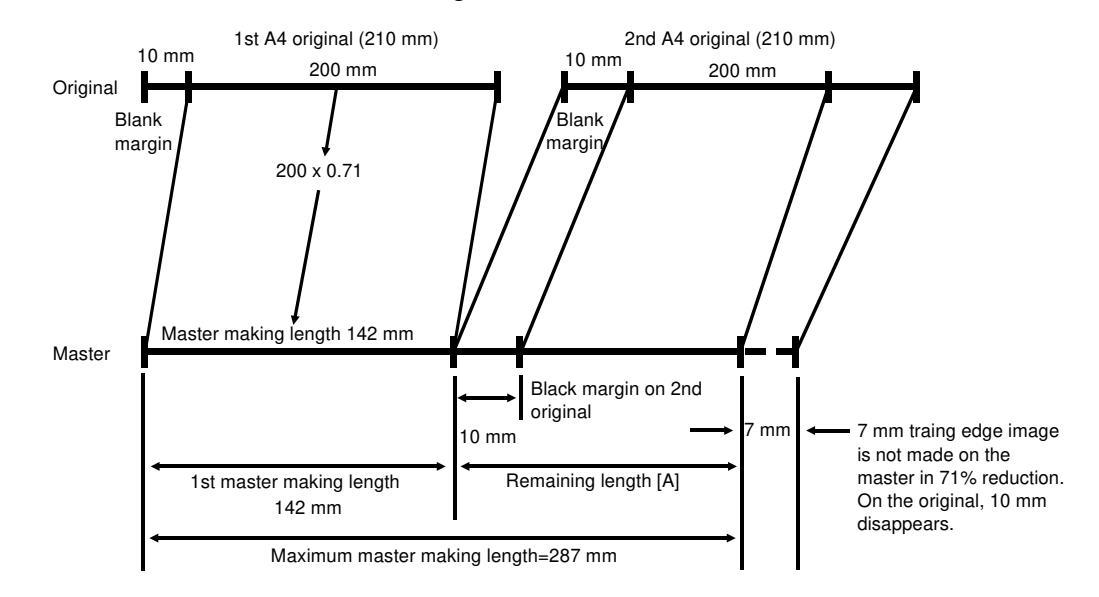
- 1. When the 1st original is fed out, the remaining master making length [A] for the 2nd original is 145 mm. (287 mm 142 mm = 145 mm)
- 2. In Combine 2 Originals mode, the ROM program detects whether the remaining length [A] (145 mm) is more than half of the maximum master making length (287 mm / 2 = 143.5 mm). If the remaining length is less than 143.5 mm, the Combine 2 Originals mode is automatically canceled before the 2nd original is fed in.

#### 145 – 143.5 = 1.5 mm (Normally, it has 1.5 mm leeway)

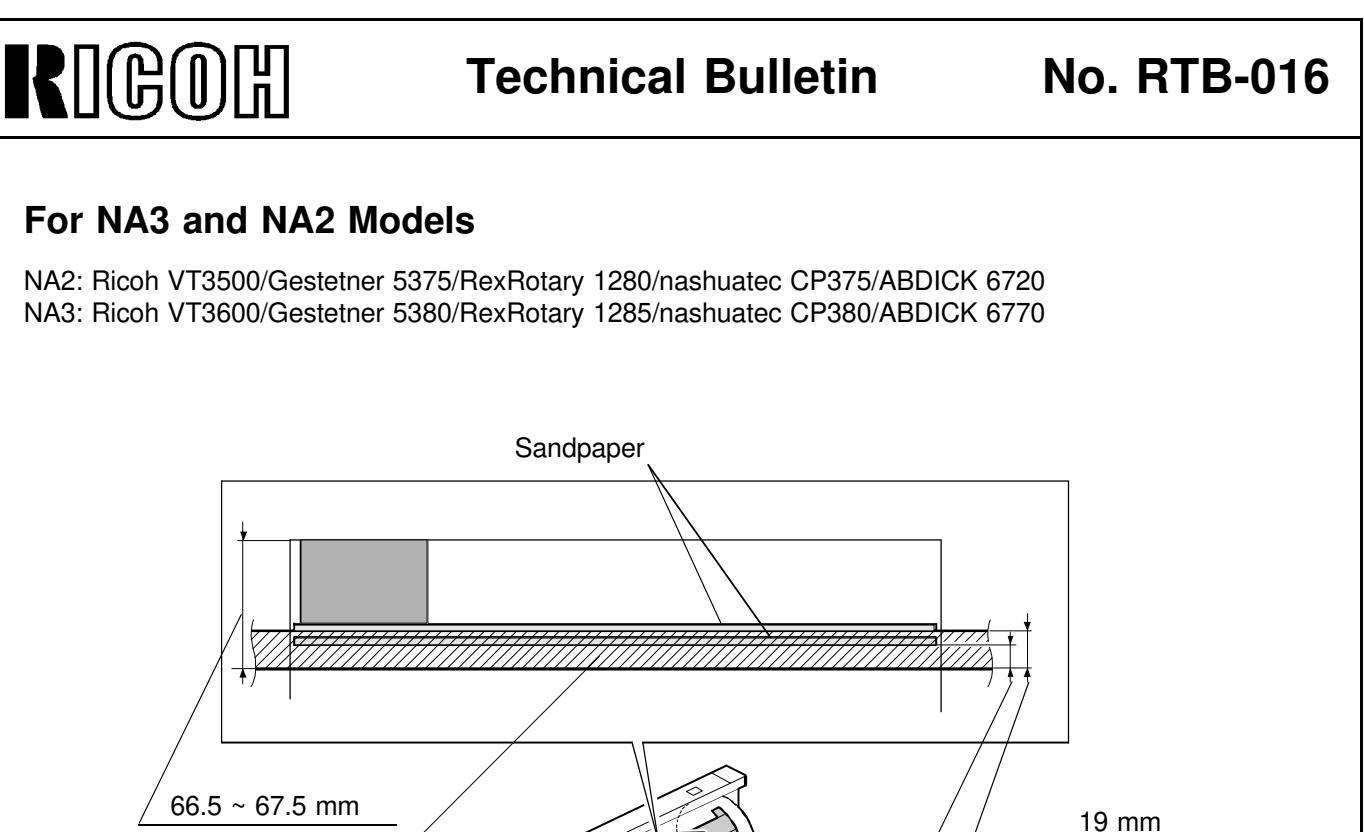
Due to the rough edges of the paper, the master wrapped around the drum becomes damaged.

3. Cover the leading edge part of the cloth screen on the drum with tape, so that ink does not leak even when the master is damaged.

- Cut the tape where it covers the upper strip of sandpaper as shown. Be careful not to damage the cloth screen surface.
- Cut both edges of the tape at the edge of the <u>metal screen</u>. Do not let the tape ride over the drum flanges.

13.5 ~ 14.5 mm

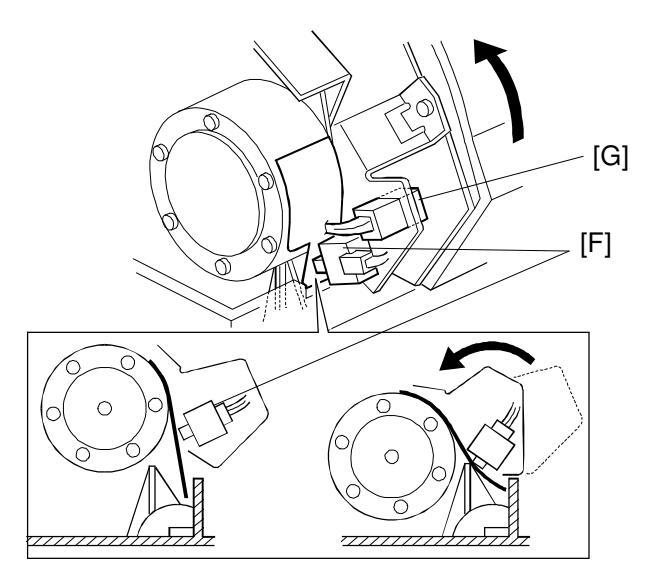
As a result, the carriage tends to be caught by the edge of the guides [C] while the carriage moves toward the original scanning position for the ADF mode. Even if the carriage is stopped on the way to the original scanning position, the master making process will happen as in the normal manner. However, as the original is not scanned properly, images will not be reproduced on the master, resulting in blank (or black) copies.

- **NOTE:** There is a switch [F] to detect whether the ADF unit is closed. Make sure that the switch is properly activated when the ADF unit is closed after installing the ADF Lower Rear Cover (see the above illustration). (Since the rib on the the ADF Lower Rear Cover would interfere with the switch [F] if you install the ADF Lower Rear Cover with the ADF unit closed, you must open the ADF unit first as explained above.)
  - The connector [G] is not used and remains open.

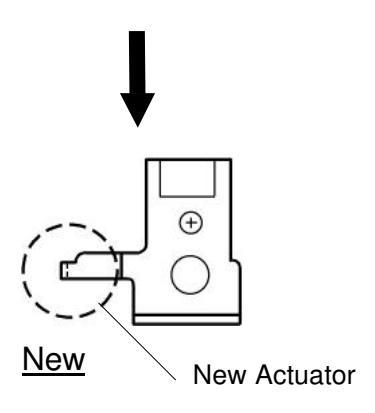
<u>Old Pressure</u> <u>Plate Arm</u>

The new part has a narrower actuation plate as shown below. This means that the full master condition will be detected earlier than before.

**NOTE:** On the production line, two of the same new part are used both on the operation and non-operation sides for part standardization purposes. For the field solution, you do not have to replace the non-operation side part.
