SUBJECT: Black Ink Cartridge Seal

FROM: Copier Technical Support Section

VT3500
Ges 5375/Rex 1280
NSA CP375

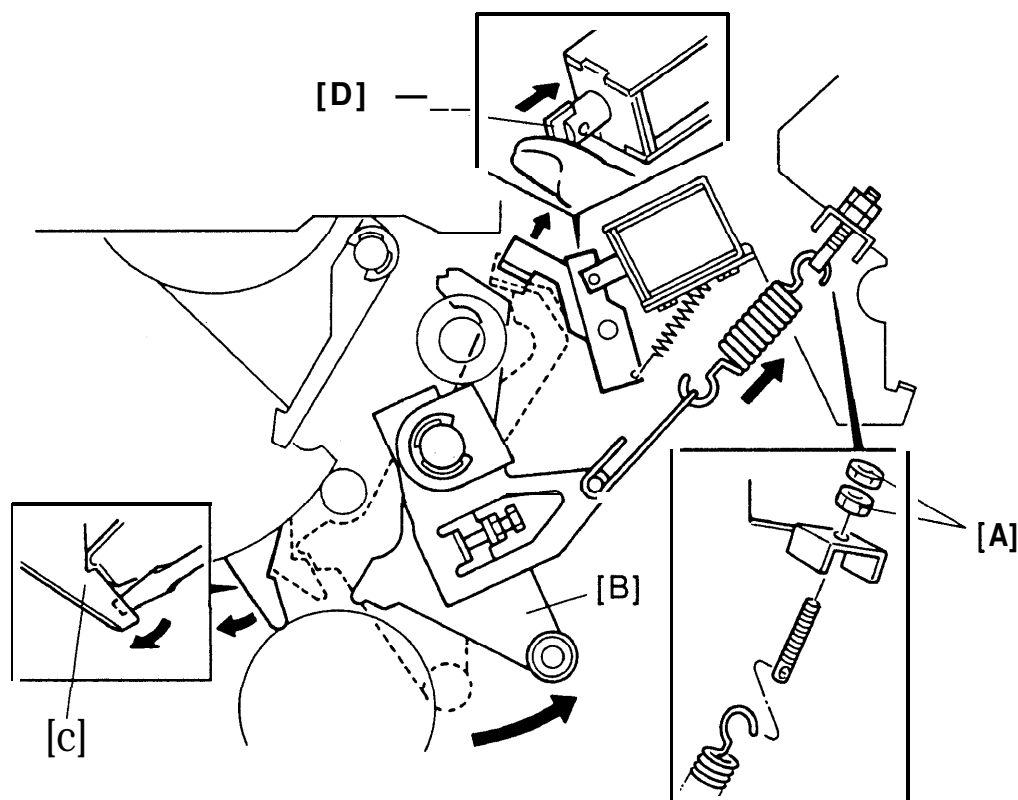
At worst, you may have to replace the A4 pressure on/off lever together with the press roller shaft if the head of the bolt is broken and the lever cannot be removed from the press roller shaft.

6. While pressing the plunger of the pressure release solenoid [D], disengage the paper detection arm [C] from the A3 pressure on/off lever [B]. Using a spanner, turn the drum shaft manually until the printing pressure is applied.
7. While the printing pressure is applied, remove the printing pressure spring by loosening the two nuts [A].

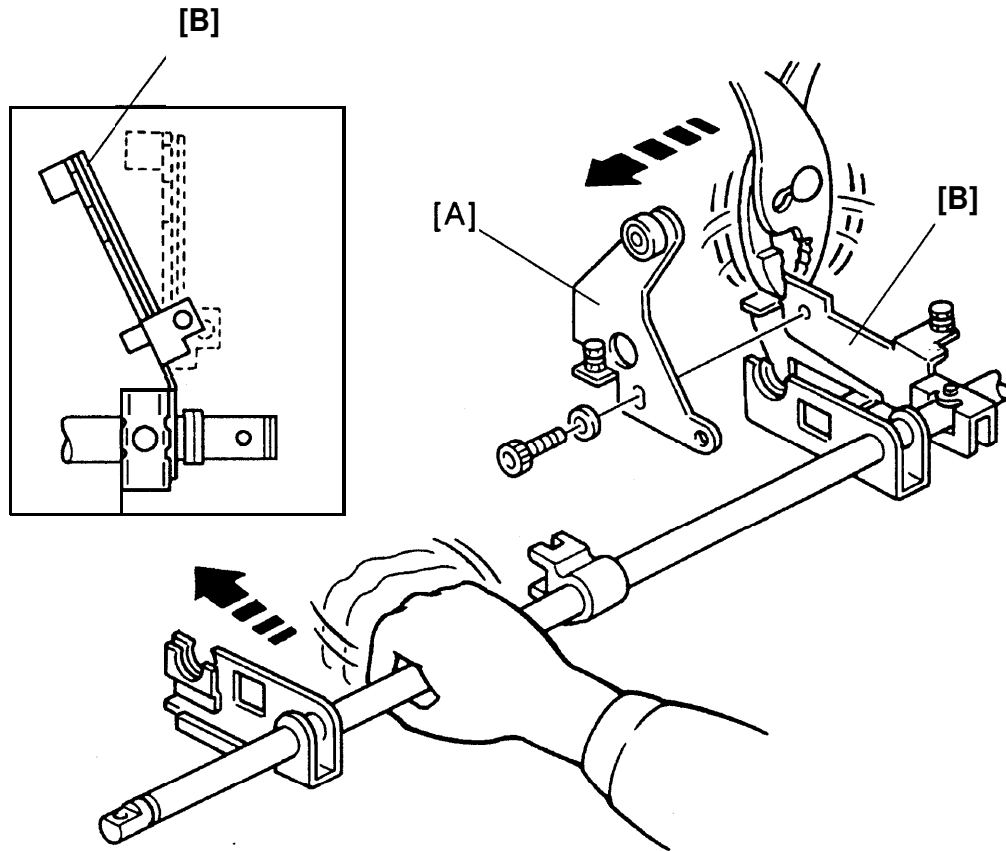
If the head of the bolt breaks and you cannot slide the A4 pressure on/off lever to the front, follow the steps below:

13. Slide the A4 pressure on/off lever to the front, so that you can remove the press roller shaft.

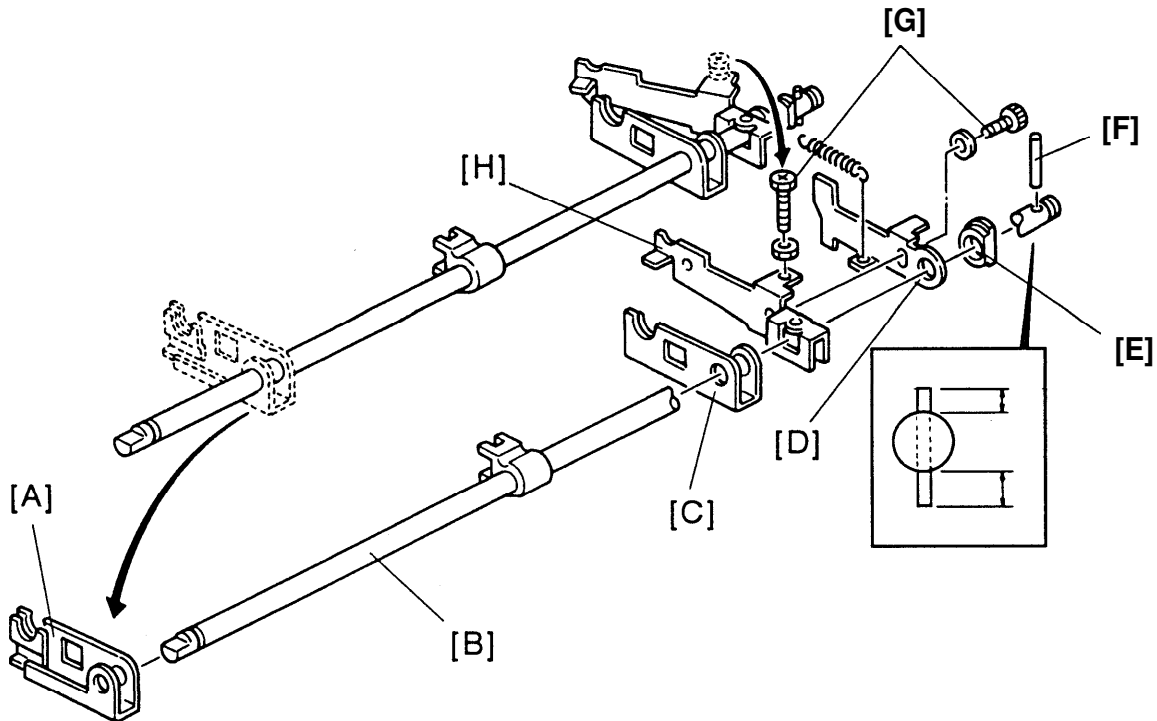
Note: To replace the A4 pressure on/off lever, you have to remove the spring pin [F] on the rear of the press roller shaft. However, it is difficult to remove it because the spring pin is firmly fitted in the hole of the shaft. Also, it may be difficult to remove the bolt from the shaft if it has broken.

14. Remove all parts from the press roller shaft. Then, replace the defective parts with new ones. If you use the press roller shaft kit (see Note below), remove the front press roller arm [A] and two bolts with the nuts [G] from the old press roller shaft, and add them to the kit.

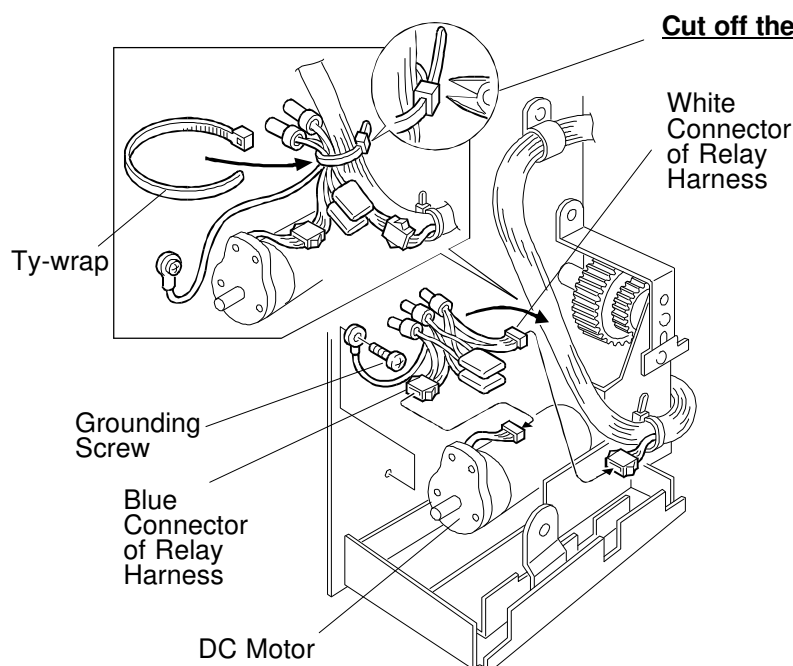
For N850

The dc motor that drives the table occasionally generates electrical noise when it starts rotating. This electrical noise is input into the ac drive board and damages IC301 on the board.

- NOTE:**
- The layout of the dc motor is slightly different between the N850 and NA33 models as shown. To prevent the relay harness from being caught by the gears, firmly secure it with the Ty-wrap as shown in the illustrations for each model.
 - Since the Ty-wrap is too long for the N850 model, cut off the excess, as shown.

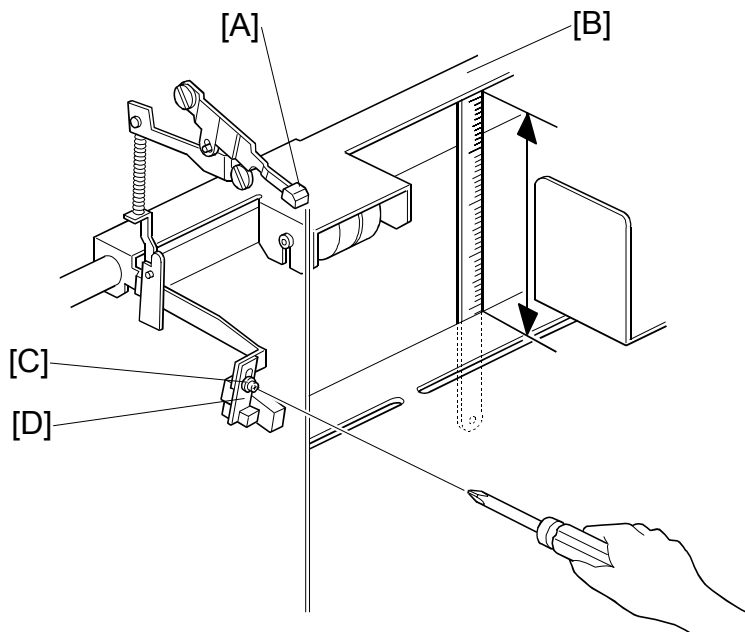
NA33 service manual Page 5-29**● 6.2 Paper Table Height adjustment**

The table height can NOT be adjusted using the procedure on Page 5-29 (because there is no lower stay at the measuring point).

Adjustment Standard: 52 ± 0.5 mm

1. Set the paper feed pressure adjusting lever [A] to the upper position.
2. Remove the right cover of the machine (5 screws).
3. Turn on the main switch and access the SP mode.
4. Select output check mode (SP131) no.19, and press the Print start key to raise the table.
5. After the paper table stops, insert a scale into the slot in the paper table. Make sure that the distance between the feed roller stay [B] and the surface of the paper table is 52 ± 0.5 mm.
6. If it is not, loosen the screw [C] and adjust the position of the actuator [D].
7. After adjusting, repeat step 5 by lowering the paper table (output No. 18) and raising the paper table (output No. 19) several times, checking the height each time.
