Model: Soleil-PJ1a/Soleil-PJ1b/Soleil-PJ2/ Altair-PJ1/ Altair-PJ2/Soleil-PJ2.5	Date: 19-Oct-12	No.: RY011003f
---	-----------------	----------------

Subject: Firmware Release Note: Backup Tool		Prepared by: A. Iwaori	
From: VC Products Support Sec., Solution Support Dept.			
Classification:	<input type="checkbox"/> Troubleshooting <input type="checkbox"/> Mechanical <input type="checkbox"/> Paper path <input type="checkbox"/> Product Safety	<input type="checkbox"/> Part information <input type="checkbox"/> Electrical <input type="checkbox"/> Transmit/receive <input checked="" type="checkbox"/> Other (Firmware)	<input type="checkbox"/> Action required <input type="checkbox"/> Service manual revision <input type="checkbox"/> Retrofit information <input checked="" type="checkbox"/> Tier 2

Model: Soleil-PJ2a/b		Date: 30-May-16	No.: RY033003
Subject: Service manual revision: Keystone Calibration & Troubleshooting		Prepared by: Takuma. Sakakibara	
From: VC Tech Service Sect., MFP/Printer Tech Service Dept.			
Classification:	<input type="checkbox"/> Troubleshooting <input type="checkbox"/> Mechanical <input type="checkbox"/> Paper path <input type="checkbox"/> Product Safety	<input typ

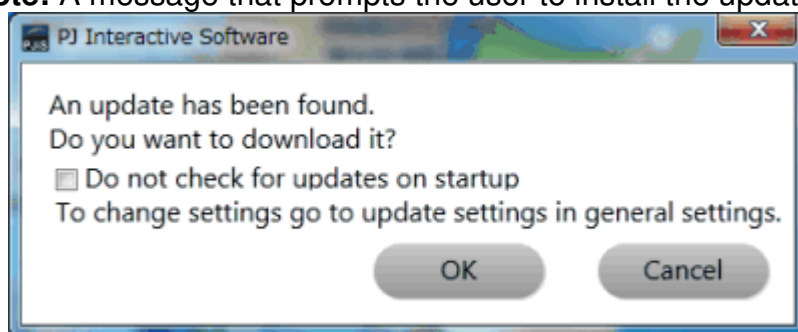
Remote whiteboard sharing does not start under the following conditions:

Update the software to **v1.2.3.0** or later.

Note: A message that prompts the user to install the update will appear.
