Model: Basil		Date: 28-Oct-05	No.: RA768001
Subject: Firmware Release History		Prepared by: Yuji Urushihara	
From: 1st Tech. Support Sec. Service Support Dept.			
Classification:	<input type="checkbox"/> Troubleshooting <input type="checkbox"/> Part information <input type="checkbox"/> Action required <input type="checkbox"/> Mechanical <input type="checkbox"/> Electrical <input type="checkbox"/> Service manual revision <input type="checkbox"/> Paper path <input type="checkbox"/> Transmit/receive <input type="checkbox"/> Retrofit information <input checked="" type="checkbox"/> Other ()

Model: Basil		Date: 7-Feb-06	No.: RA768002
Subject: RC Gate new function		Prepared by: Yuji Urushihara	
From: 1st Tech. Support Sec. Service Support Dept.			
Classification:	<input type="checkbox"/> Troubleshooting <input type="checkbox"/> Mechanical <input type="checkbox"/> Paper path <input type="checkbox"/> Product Safety	<input type="checkbox"/> Part information <input type="checkbox"/> Electrical <input type="checkbox"/> Transmit/receive <input type="checkbox"/> Other ()	<input type="checkbox"/> Action required <input checked="" type="checkbox"/> Service manual revision <input type="checkbox"/>

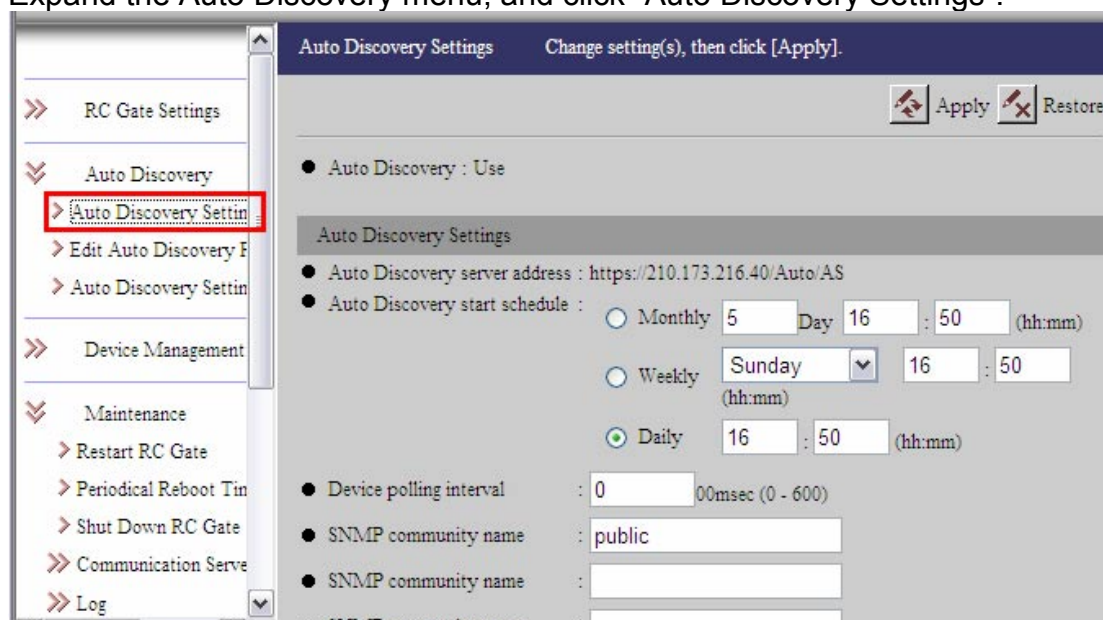
It is now possible to adjust the inter-device polling interval for Auto Discovery in CE mode. This is to reduce network traffic caused by continuous access (default: 0 ms).

- 3) Expand the Auto Discovery menu, and click "Auto Discovery Settings".
