Model: Uz-A1	Date: 22-Jan-10	No.: RD459001p
---------------------	-----------------	----------------

Subject: Firmware Release Note: Application		Prepared by: M. Yoneda	
From: 2nd Tech Service Sect., MFP/Printer Tech Service Dept.			
Classification:	<input type="checkbox"/> Troubleshooting <input type="checkbox"/> Mechanical <input type="checkbox"/> Paper path <input type="checkbox"/> Product Safety	<input type="checkbox"/> Part information <input type="checkbox"/> Electrical <input type="checkbox"/> Transmit/receive <input checked="" type="checkbox"/> Other (Firmware)	<input type="checkbox"/> Action required <input type="checkbox"/> Service manual revision <input type="checkbox"/> Retrofit information <input checked="" type="checkbox"/> Tier 2

Model: Uz-A1 (RC Gate A)	Date: 25-August-10	No.: RD459003a
--------------------------	--------------------	----------------

Subject: A failure with Auto Discovery		Prepared by: T. Takahashi	
From: : Innovation Planning Sec. S S Innovation Dep.			
Classification:	<input checked="" type="checkbox"/> Troubleshooting <input type="checkbox"/> Mechanical <input type="checkbox"/> Paper path <input type="checkbox"/> Product Safety	<input type="ch

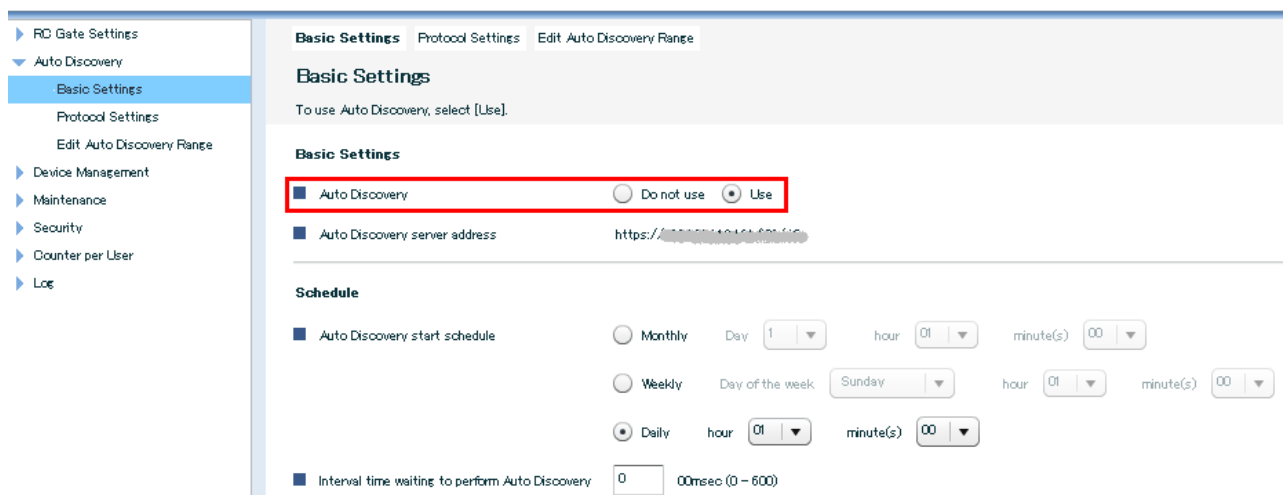
- In the Uz-A1 GUI, the AD setting is changed to "Use", then to "Do not use", and finally back to "Use". Under these conditions, only five devices are discovered.

Note: This condition can be cleared temporarily by turning the power OFF/ON.
