Model: Cor-C1.5	Date: 02-Dec-16	No.: RD2840013
-----------------	-----------------	----------------

Subject: Firmware Release Note: ProgramInfoService		Prepared by: R. Tsurumi	
From: 1st Tech Service Sect., MFP/Printer Tech Service Dept.			
Classification:	<input type="checkbox"/> Troubleshooting	<input type="checkbox"/> Part information	<input type="checkbox"/> Action required
	<input type="checkbox"/> Mechanical	<input type="checkbox"/> Electrical	<input type="checkbox"/> Service manual revision
	<input type="checkbox"/> Paper path	<input type="checkbox"/> Transmit/receive	<input type="checkbox"/> Retrofit information
	<input type="checkbox"/> Product Safety	<input checked="" type="checkbox"/> Other (Firmware)	<input checked="" type="checkbox"/> Tier 2

This RTB has been issued to announce the firmware release information for the **ProgramInfoService**.

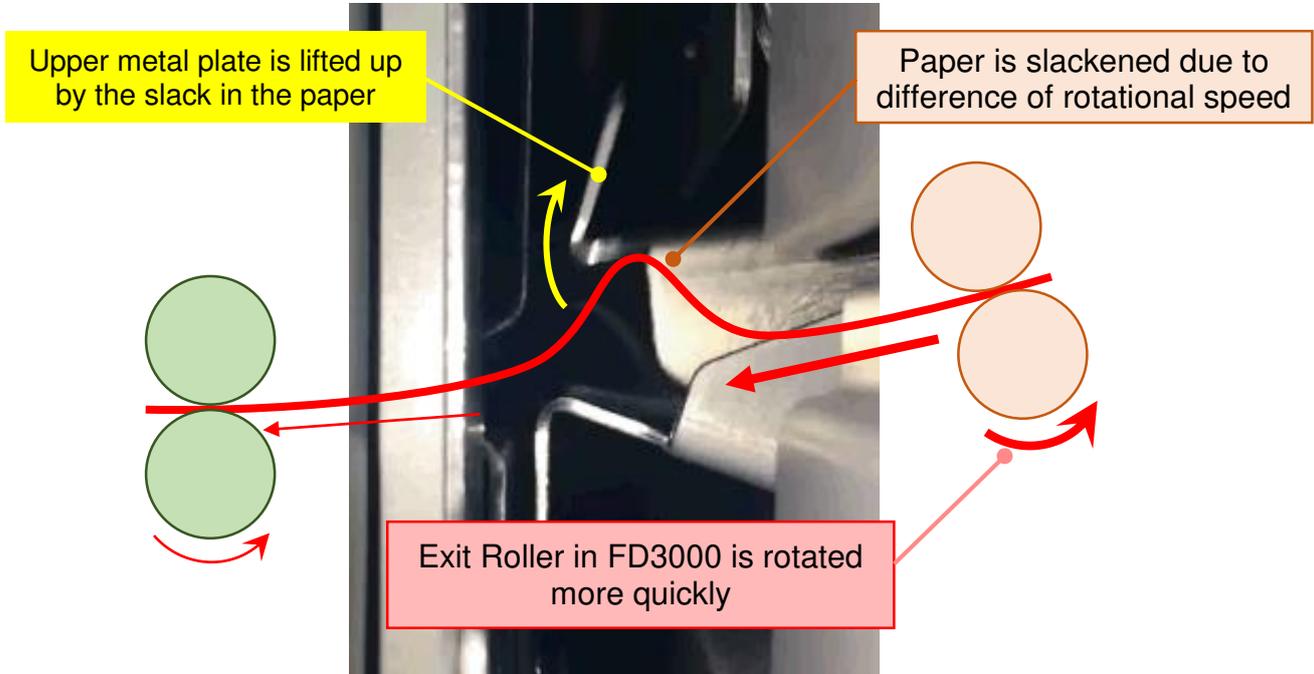
INCORRECT paper transport between FD3000 and SR3210/3220

Due to the above error, the exit roller in the FD3000 is rotated at a higher speed than the entrance roller in the finisher (Normally, these speeds should be the same). This causes slack to develop in the paper, which then lifts up the upper metallic plate. As a result, the upper plate then drops onto the lower plate. Then a metallic “clinking” noise is produced.

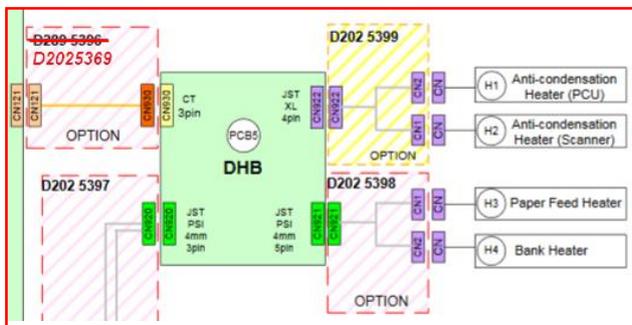
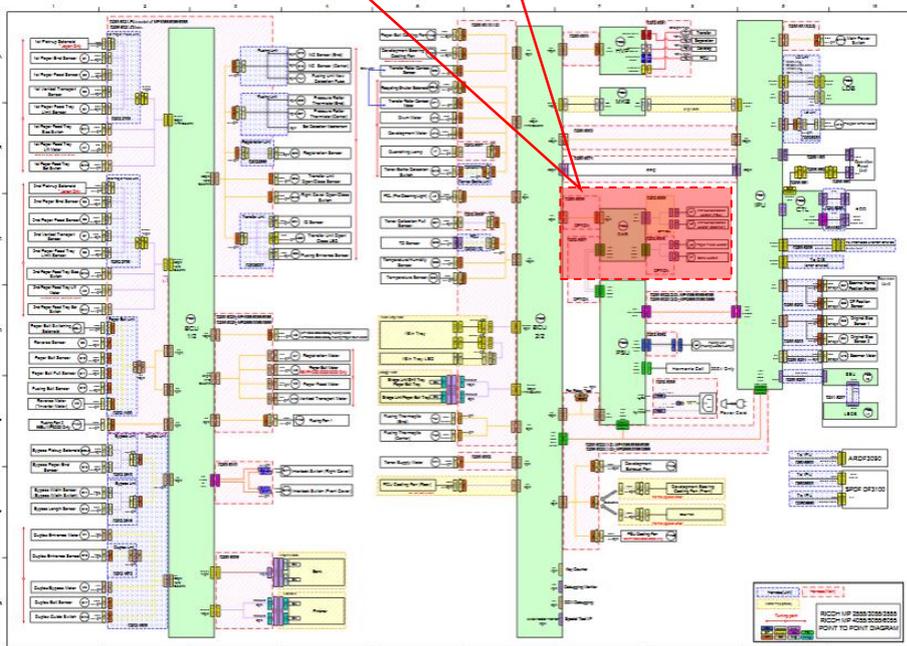
The part number of the harness between DHB and BCU (D2895396) in the P to P diagram is incorrect.

The correct part number is **D2025396**. This is the same as Cor-C1.

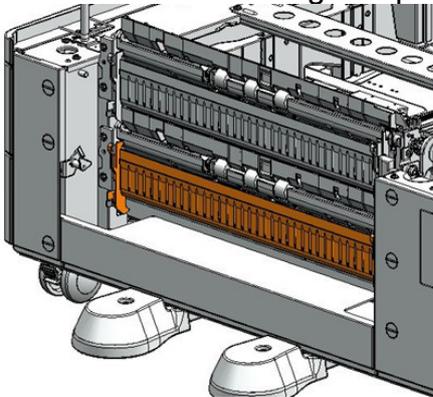
Change: Added cushions and changed the shape of the guide plate.**Reason:** To further strengthen and prevent breaking of the guide plate.**Important:** Be sure to attach the above CUSHION when installing the paper guide plates.**Procedure for LOWER GUIDE PLATE ASSYS**

1. Remove the lower guide plate.

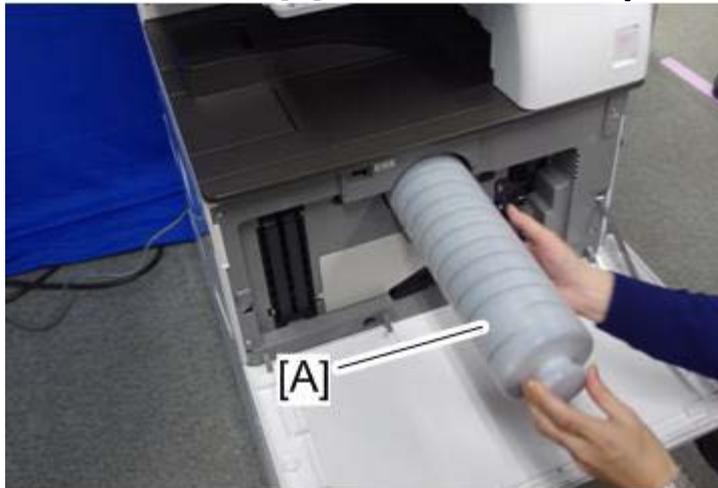
d197z1005

4. Push the toner bottle [A] into the machine slowly.

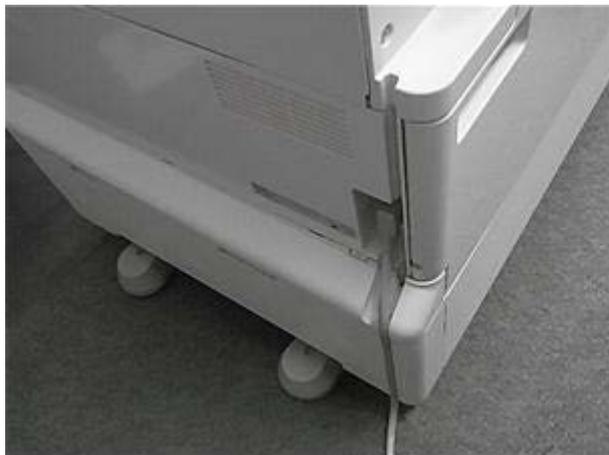
d197f0603

5. Connect the power cord to the machine.
