Model: Finisher SR3230, SR3240		Date: 26-May-16	No.: RD3BA002
Subject: Accessory trays of other models		Prepared by: Y.Ino	
From: 1st Tech Service Sect., MFP/P Tech Service Dept.			
Classification:	<input type="checkbox"/> Troubleshooting <input type="checkbox"/> Mechanical <input type="checkbox"/> Paper path <input type="checkbox"/> Product Safety	<input type="checkbox"/> Part information <input type="checkbox"/> Electrical <input type="checkbox"/> Transmit/receive <input checked="" type="checkbox"/> Other (Information)	<input type="checkbox"/> Action required <input checked="" type="checkbox"/> Service manual revision <input type="checkbox"/> Retrofit information <input type="checkbox"/> Tier 2

Subject: Poor stacking of stapled job		Prepared by: Y.Taniguchi	
From: 1st Tech Service Sect., MFP/P Tech Service Dept.			
Classification:	<input checked="" type="checkbox"/> Troubleshooting	<input type="checkbox"/> Part information	<input type="checkbox"/> Action required
	<input type="checkbox"/> Mechanical	<input type="checkbox"/> Electrical	<input type="checkbox"/> Service manual revision
	<input type="checkbox"/> Paper path	<input type="checkbox"/> Transmit/receive	<input type="check

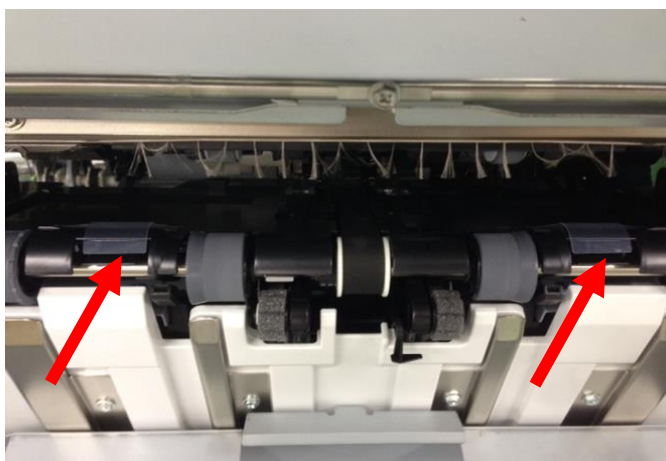
Photo

The edge of the guide Mylar protrudes over the paper exit roller.

When the affected sheet(s) are fed out to the tray late, the paper rides up on the guide Mylar. As a result, the sheet(s) are then pushed by those behind them.

Re-attach the guide Mylar (see **PROCEDURE** below).
