Model: Hadar-PJ1XGA		Date: 30-Oct-15	No.: RY088001
Subject: I/O shift issue		Prepared by: T. Takahashi	
From: 1st Tech Service Sect., MFP/P Tech Service Dept.			
Classification:	<input checked="" type="checkbox"/> Troubleshooting <input type="checkbox"/> Mechanical <input type="checkbox"/> Paper path <input type="checkbox"/> Product Safety	<input type="checkbox"/> Part information <input type="checkbox"/> Electrical <input type="checkbox"/> Transmit/receive <input type="checkbox"/> Other ()	<input type="checkbox"/> Action required <input type="checkbox"/> Service manual revision <input type="checkbox"/> Retrofit information <input type="checkbox"/> Tier 2

Affected models: Hadar-PJ1XGA (Y088)

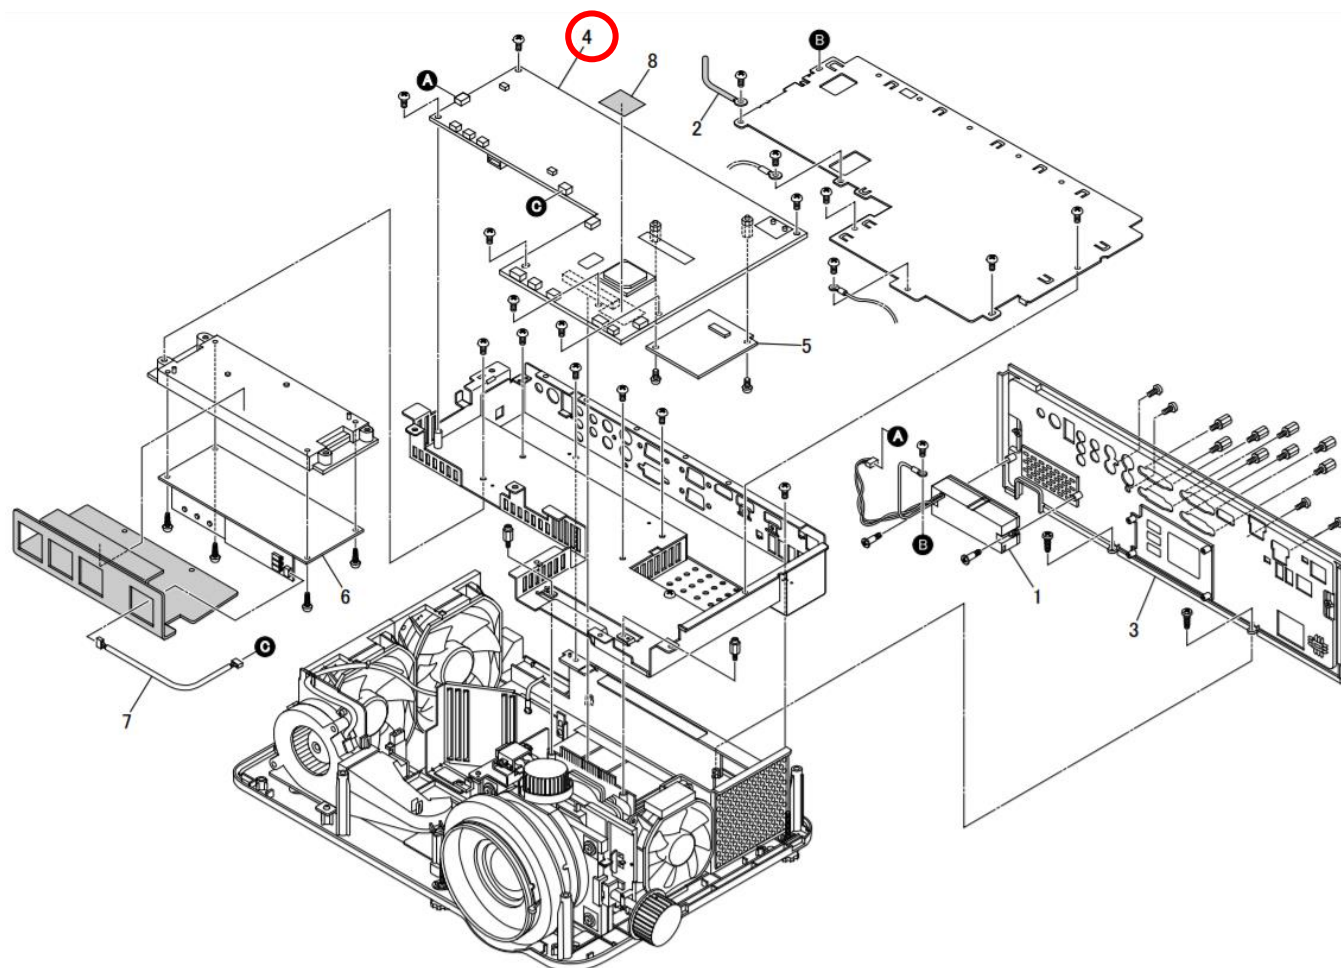
Parts Catalog update:

Part number	Description	Product name	Machine Code
Y0885101	PCB:MAIN:X:80.78401G001	PJ X5580 W1000	Y088-17/27/21 Y090-21
Y0885104	PCB:MAIN:WU:80.79601G001	PJ WU5570 W2000	Y089-17/27/21 Y091-21

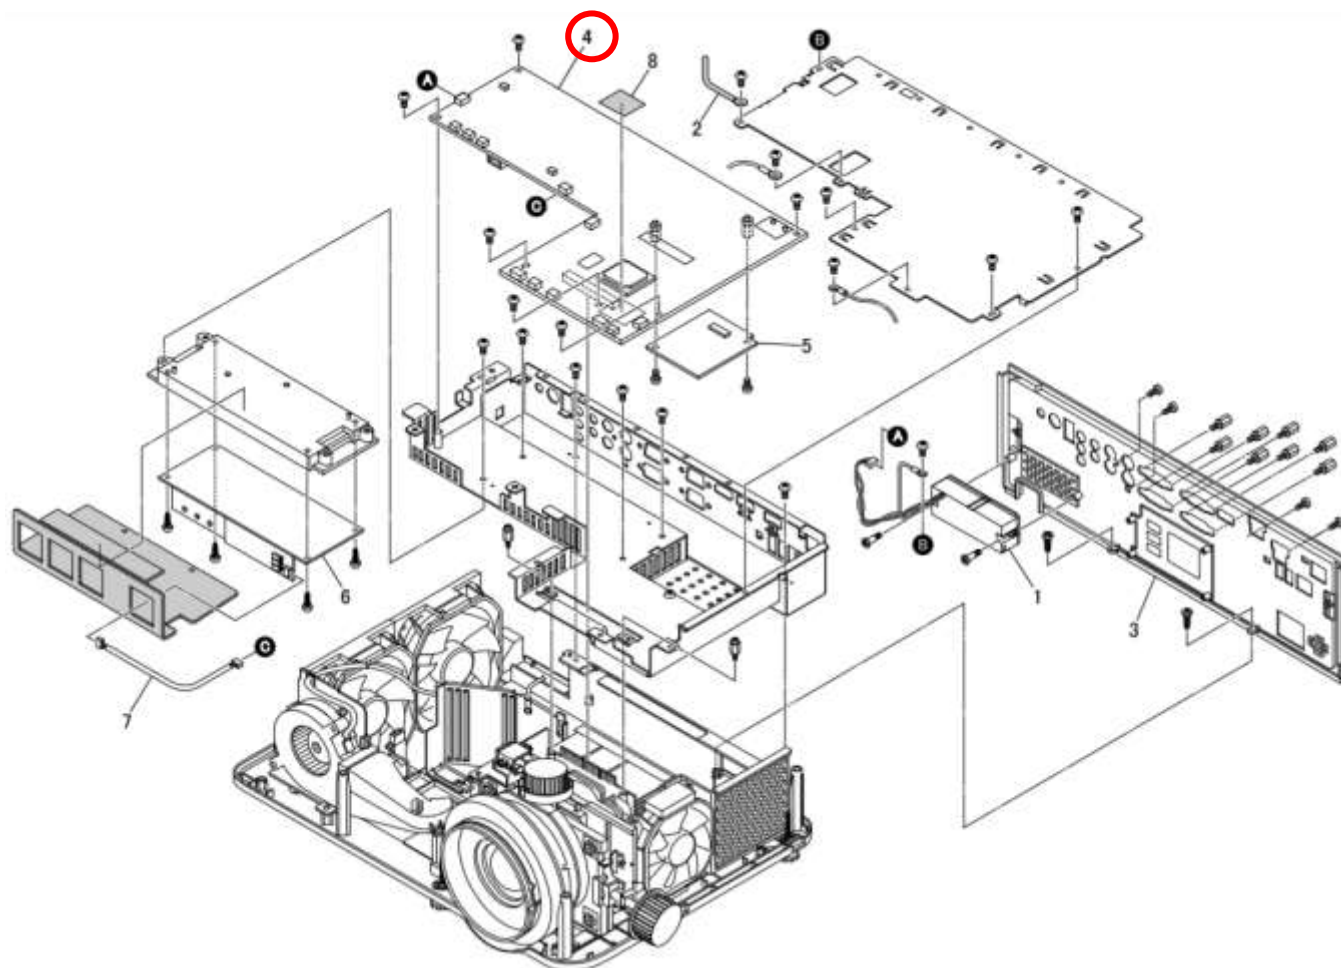
Parts Catalog update:

Part number	Description	Product name	Machine Code
Y0885101	PCB:MAIN:X:80.78401G001	PJ X5580 W1000	Y088-17/27/21 Y090-21
Y0885104	PCB:MAIN:WU:80.79601G001	PJ WU5570 W2000	Y089-17/27/21 Y091-21
