RICOH **M**odification **B**ulletin **PAGE: 1/1**

Model: Martini-C1 Printer/Scanner Kit Type 1075	Date: 17-Dec-02	No.: MG338001

Modified Article: Operation Instructions			Prepared by: K. Miura
From: Technical Services sec. Service Planning Dept.			
Reason for Modification:	☒ Parts catalog correction ☐ To facilitate assembly ☐ Part standardization	☐ Vendor change ☐ To improve reliability ☐ Other	☐ To meet standards ( )

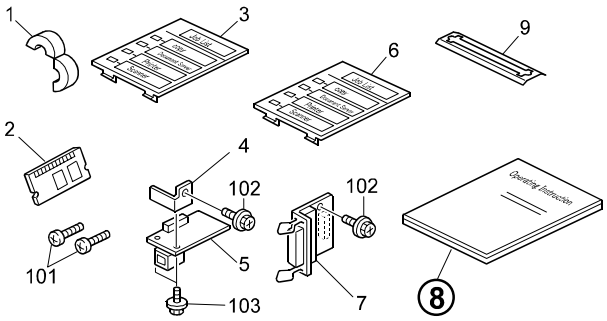
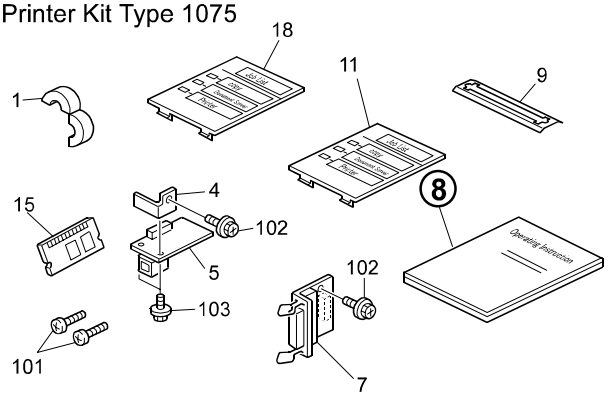
Please correct your Parts Catalog as follows:

Old part number	New part number	Description	Q'ty	Int	Page	Index	Note
G3388612	G3398609	Operating Instructions - PRN - TWN	1	_	3	8	
G3388613	G3398606	Operating Instructions - PRN - CHN	1	_	3	8

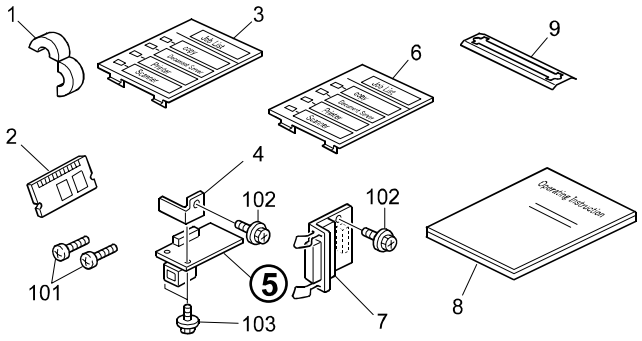
Please correct your Parts Catalog as follows:

Old part number	New part number	Description	Q'ty	Int	Page	Index	Note
B0535254	B0535166	Network Interface Board	1	_	3	5

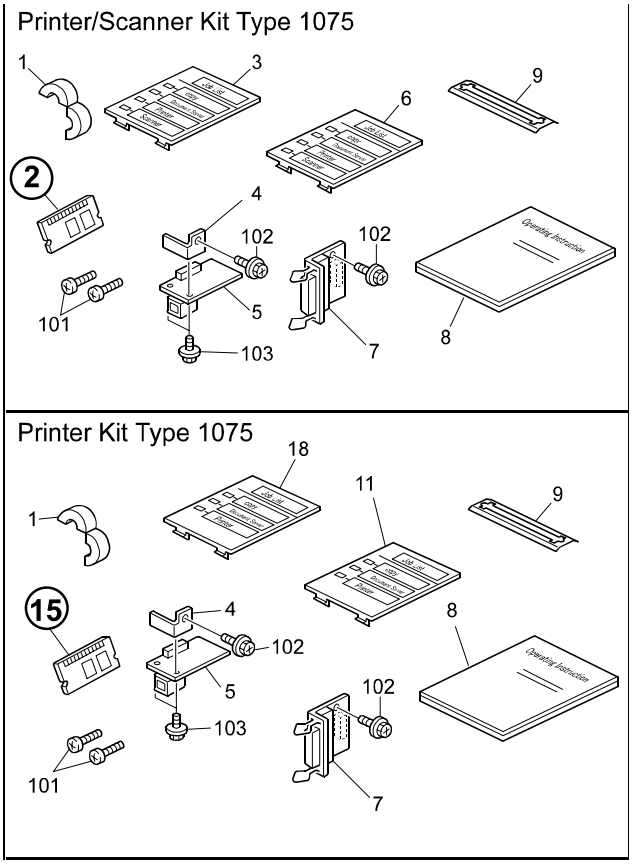
When printing with the PS driver, the Euro currency symbol is not printed out with 112 of the 136 fonts that are stored in the font ROM. To prevent this, the following parts have been changed:

Old part number	New part number	Description	Q'ty	Int	Page	Index	Note
G3385117	G3385118	Printer/Scanner DIMM	1	X/O	3	2	
G3395117	G3395118	Printer DIMM	1	X/O	3	15

For the details, please refer to RTB#Rgen011.

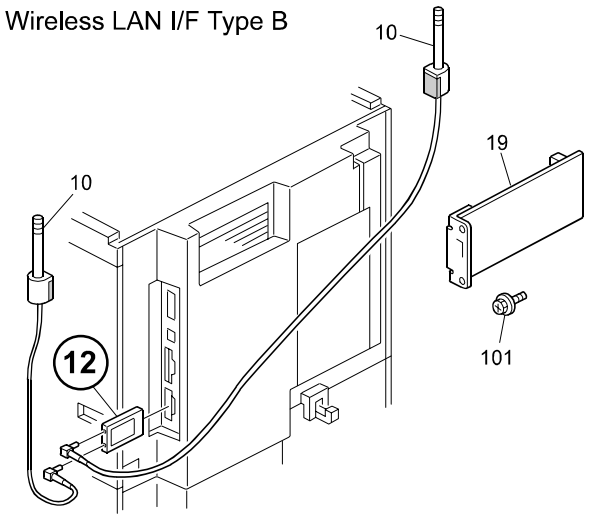
The following part has been changed due to a vendor change.

Old part number	New part number	Description	Q'ty	Int	Page	Index	Note
G6285453	G6285461	Wireless Card - US	1	X/X	3	12	
G6285454	G6285462	Wireless Card - EU	1	X/X	3	12

Note: When installing the new Wireless Card, it is necessary to upgrade the GW controller and NIB/NetFile firmware. For details, please refer to RTB #RB064019 and #RB064030.
