# Technical Bulletin

Model: Campari-MF1L(ASIA) Date			te: 04-Oct-06	No.: RB273001a_RA	
<b>RTB Reissue</b> The items in bol	d italics have been add	ded.			
Subject: Firmare	Release History(Engine)	Prepared by:	Prepared by: T.Shintani		
From: 1st Tech. S	Support Sec. Service Suppo	ort Dept.			
Classification:	Troubleshooting	☐ Part inform	nation	ction required	
	☐ Mechanical	☐ Electrical	☐ Se	ervice manual revision	
	☐ Paper path	☐ Transmit/r	eceive 🗌 Re	etrofit information

Model: Campari-MF1L(ASIA)			Date	ate: 27-Mar-07		No.: RB273002_RA	
Subject: Machine stall problem			Prepared by: T.Shintani				
From: 1st Tech. Support Sec. Service Support Dept.							
Classification:	Troubleshooting	☐ Part ir	nforma	tion			
		☐ Electrical			☐ Se	rvice manual revision	
	☐ Paper path	☐ Transmit/rec		eive	ve Retrofit informatio		
	☐ Product Safety	Other	(	)

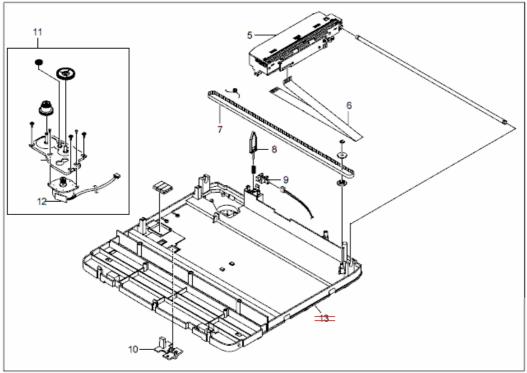
### B273/G959

**Change:** The lower scanner cover was deleted and the scanner unit was newly registered. **Reason:** The parts vendor stopped supplying the cover as an individually replaceable part.
