Model: Stinger-C1L		Date: 30-Nov-99	No.: RB001001
Subject: Differences from Stinger-C1		Prepared by: K. Miura	
From: Technical Services Dept., GTS Division			
Classification:	<input type="checkbox"/> Troubleshooting	<input type="checkbox"/> Part information	<input type="checkbox"/> Action required
	<input type="checkbox"/> Mechanical	<input type="checkbox"/> Electrical	<input checked="" type="checkbox"/> Service manual revision
	<input type="checkbox"/> Paper path	<input type="checkbox"/> Transmit/receive	<input type="checkbox"/> Retrofit information
	<input type="checkbox"/> Other ()

The new model, "Stinger-C1L (B001)" will be launched in January 2000. It is a slightly modified version of the already existing model "Stinger-C1 (Ricoh Aficio 180, Gestetner 3218, Nashuatec D418, Rex-Rotary 2818, Savin 9918DP, Infotec 4180 MF)".

This RTB clarifies the differences between the base copier and Stinger-C1L (based on the style of the service manual).

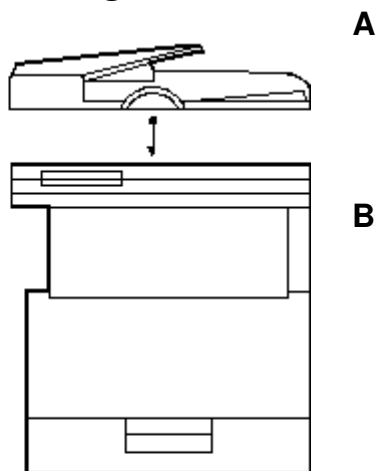
*1-2. MACHINE CONFIGURATION

Version	Item	Machine Code	No.
Copier	Copier	B001	B
	ADF (Optional)	A859	A
	Platen Cover (Optional)	A893	
	Memory 48 MB (Optional)	A887	
Printer	Printer Controller (Optional)	B305	
	PS Option (Optional)	B308	
	HDD (Optional)	G690	
	NIB (Optional)	B307	
	Memory 32 or 64 MB (Optional)	G688

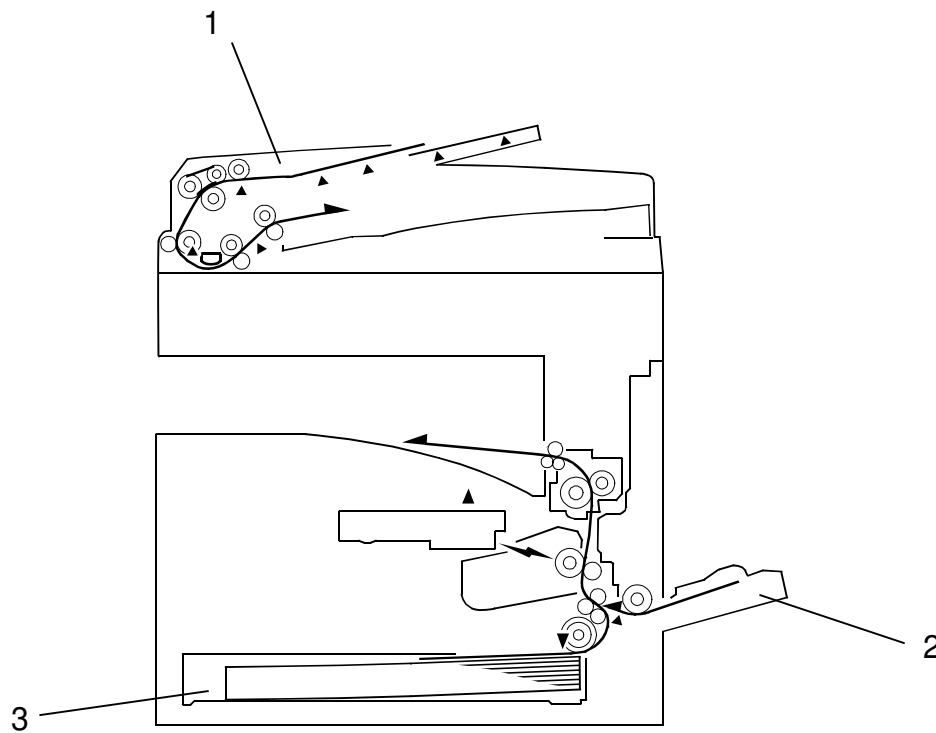
***1-3. PAPER PATH**

- 1. Optional ADF
- 2. By-pass feed tray
- 3. Paper tray

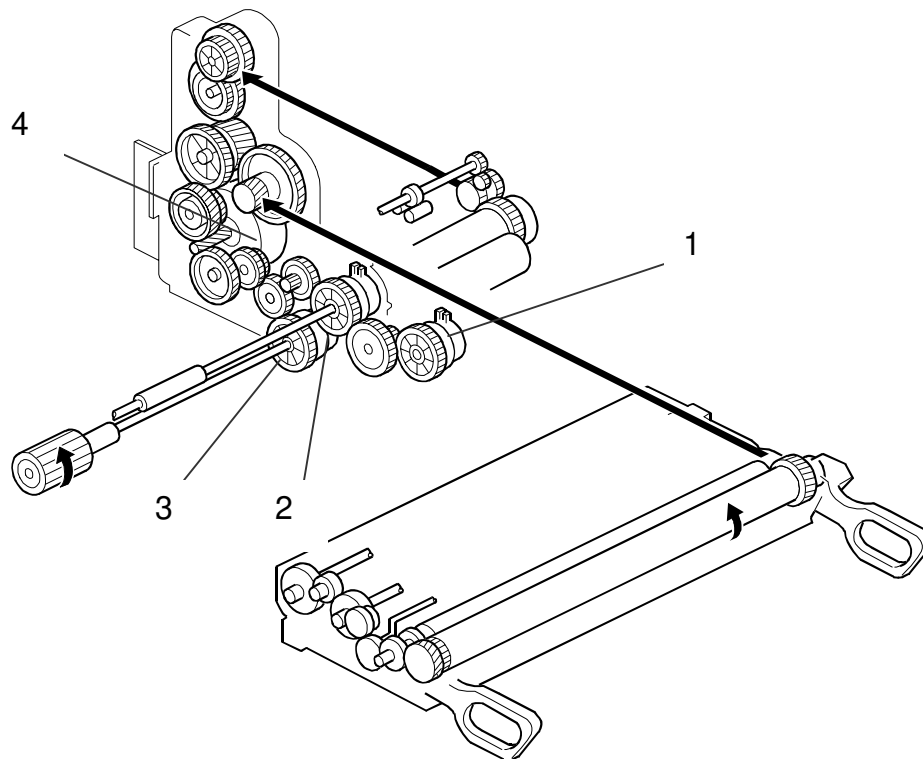
1-5. DRIVE LAYOUT

- 1. By-pass feed clutch
- 2. Registration clutch
- 3. Paper feed clutch
- 4. Main motor
