Model: R-C5.5	Date: 26-Nov-09	No.: RD084001b
---------------	-----------------	----------------

Subject: Firmware Release Note: PCL		Prepared by: T. Nihei	
From: 2nd Tech Service Sect., MFP/Printer Tech Service Dept.			
Classification:	<input type="checkbox"/> Troubleshooting	<input type="checkbox"/> Part information	<input type="checkbox"/> Action required
	<input type="checkbox"/> Mechanical	<input type="checkbox"/> Electrical	<input type="checkbox"/> Service manual revision
	<input type="checkbox"/> Paper path	<input type="checkbox"/> Transmit/receive	<input type="checkbox"/> Retrofit information
	<input checked="" type="checkbox"/> Other (Firmware)	<input checked="" type="checkbox"/> Tier 2

This RTB has been issued to announce the firmware release information for the **PCL**.

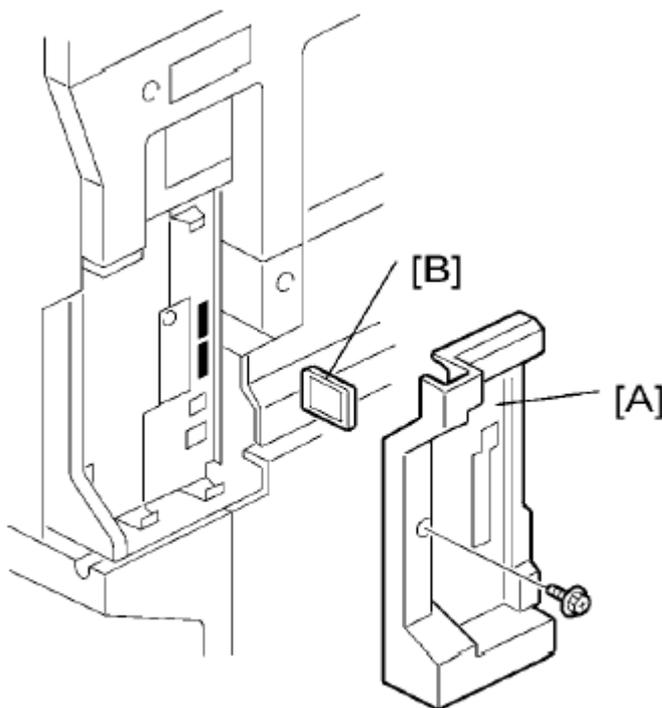
d017i502

- 3.3 Remove the plastic application cover [A]
- 3.4 Insert the SD card in SD card[B] Slot 2 (lower)

- **The encryption SD card must be installed in Slot 2(lower):**

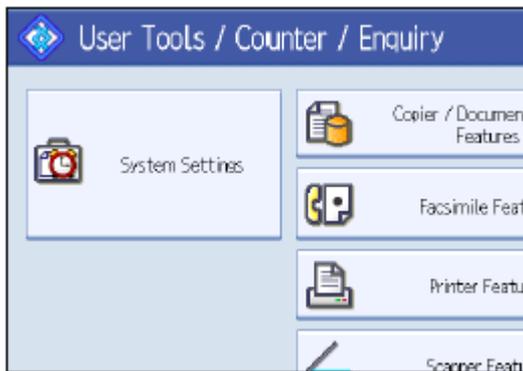
3.13 Press [System settings]

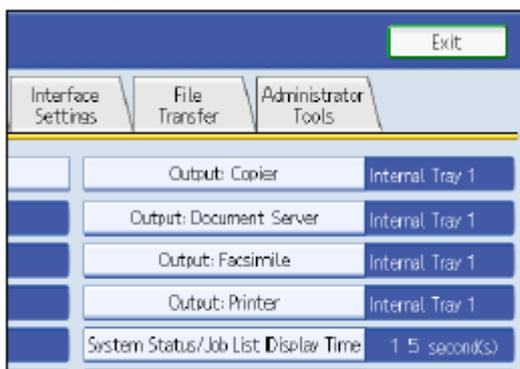
3.14 Press [Administrator Tools].

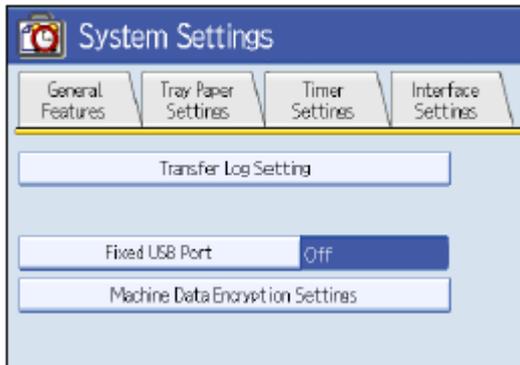
**3.15 Press [Machine Data Encryption Settings].**

If the setting to be specified does not appear, press [next].

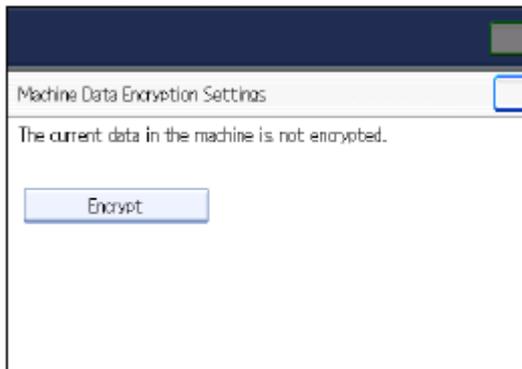
**3.16 Press [Encrypt].**

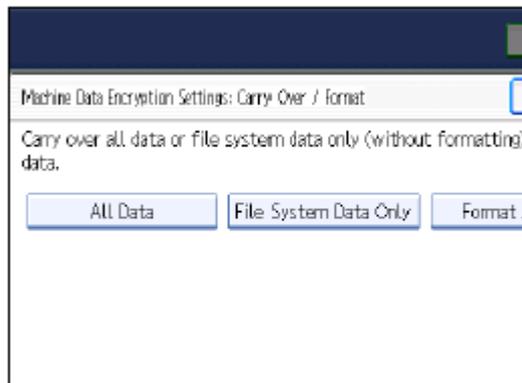
**3.17 Select the [Format All Data] to reset all of the data.****Note: It takes about five minutes to complete this operation.**

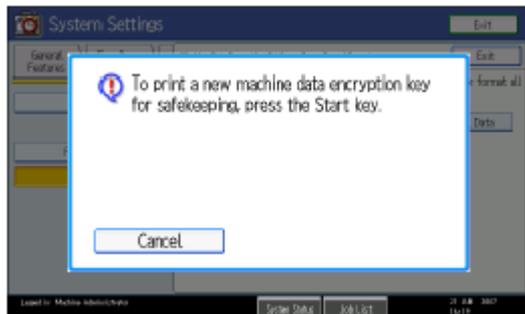
- 3.18 Press the [Start] key.  
The encryption key for backup data is printed.

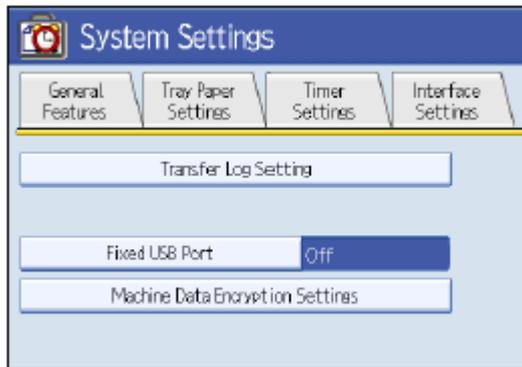
- 3.24 Press the [User Tools/Counter] key.
- 3.25 Press [System settings]
- 3.26 Press [Administrator Tools].
- 3.27 Press [Machine Data Encryption Settings].

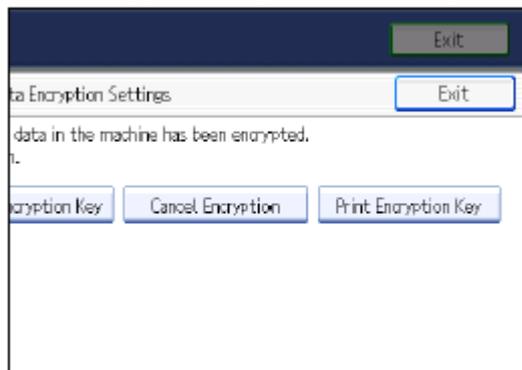
- 3.28 Press [Print Encryption Key].  
The encryption key for retrieving backup data is printed.

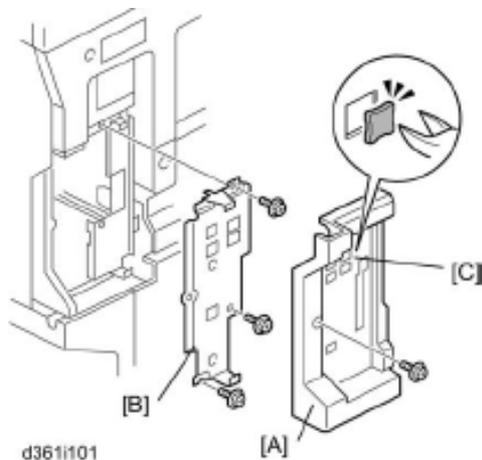
**4.1 Remove:**

[A] Application (plastic) cover

[B] Left cover plate

[C] Knockouts

- LINE 1 for Fax Unit
- If one G3 Unit will be installed, remove the knockout for LINE 1 and LINE 2.
- If two G3 units will be installed, remove the knockouts for both LINE 1, LINE 2 and LINE 3

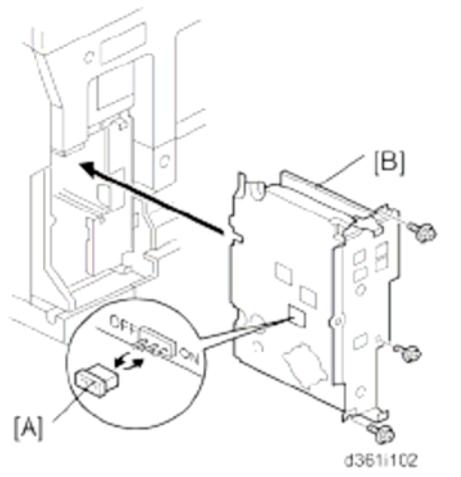
4.2. Through the window, remove the jumper [A] and set it to the ON position.

4.3 Press down the MBU.

4.4 Remove the jumper [A] (set to OFF) and set it to ON.

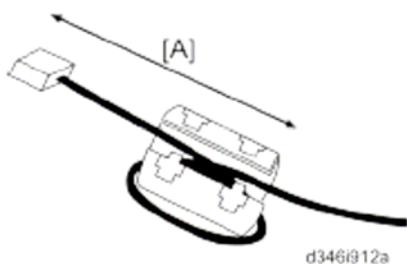
4.10 For NA models, attach the ferrite core to the telephone cord. The end of the ferrite core must be about 5cm (2.1") [A] from the end of the cable.

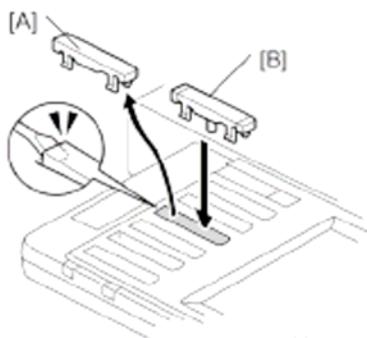
4.12 Remove the dummy keytop [A] (3<sup>rd</sup> from the top) and replace it with a facsimile keytop[B]

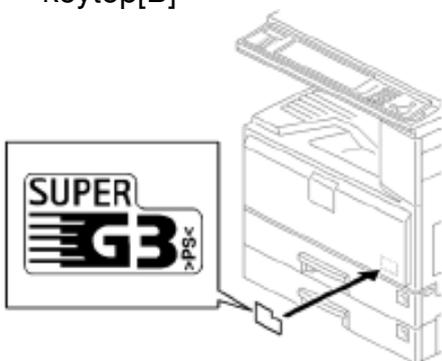
4.13 Attach the G3 decal to the front of the machine.

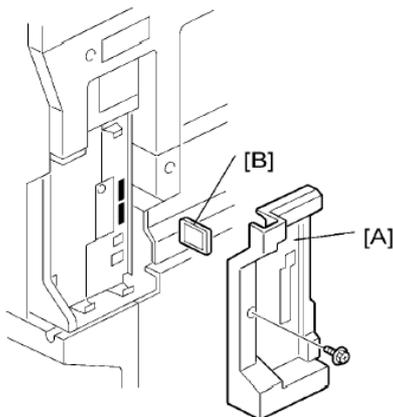
d0171502

- 3.3 Remove the plastic application cover [A]  
 3.4 Insert the SD card in SD card[B] Slot 2 (lower)

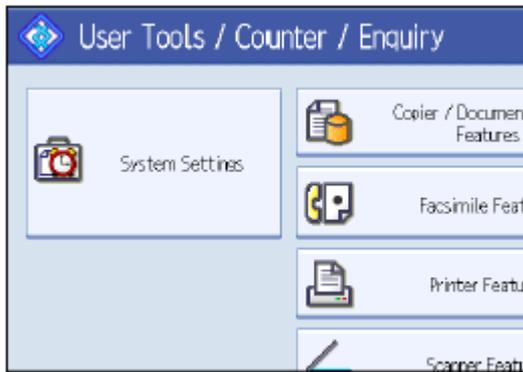
3.13 Press [System settings]

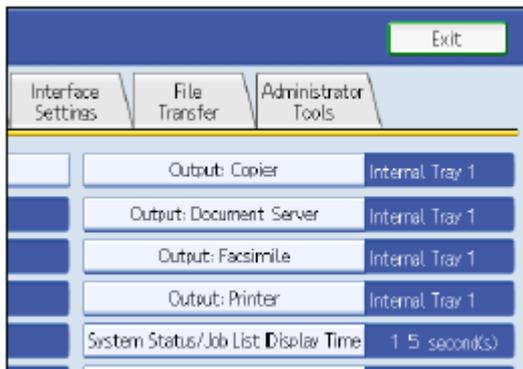
3.14 Press [Administrator Tools].

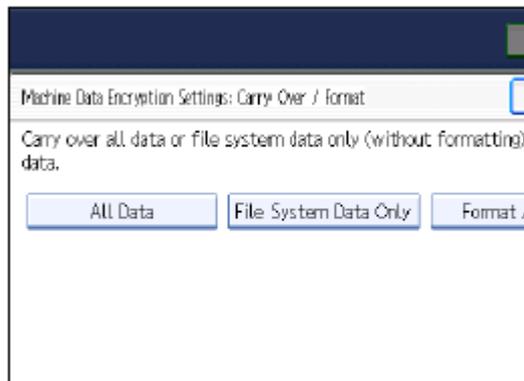
**3.17 Select the [Format All Data] to reset all of the data.****Note: It takes about five minutes to complete this operation.**

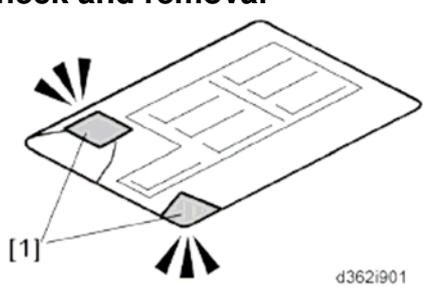
- 4.5 Check the box seals [1] on each corner of the box.
  - Make sure that a tape is attached to the each corner.
  - The surface of the tapes must be blank. If you see "VOID" on the tapes, do not install the components in the box.
- 4.6 If the surfaces of the tapes do not show "VOID", remove them from the corners of the box.

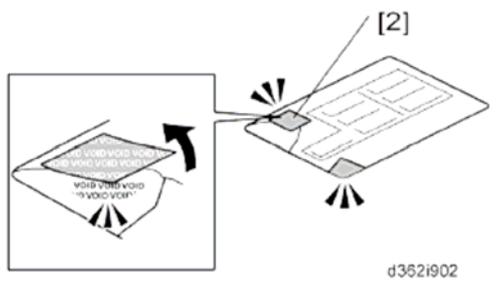
4.7 When you remove each seal, the “VOID” marks [2] can be seen. In this condition, they cannot be reattached to the box.

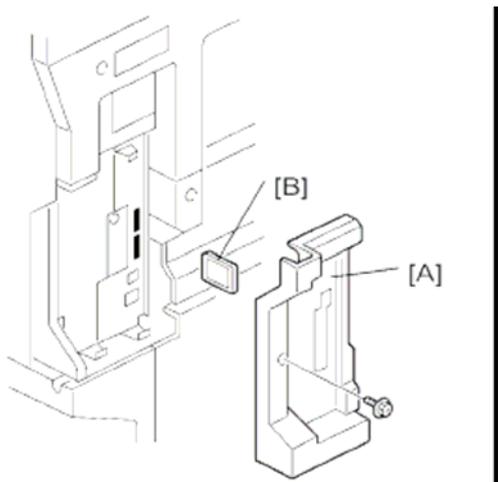
- 4.12 Remove the plastic application cover [A]
- 4.13 Insert the SD card [B] in SD Slot 1 (upper).
- 4.14 Reconnect the network cable, if the network is connected to the copier.
- 4.15 Turn the main power switch on.
- 4.16 Do SP5878-1 (Option Setup- Data Overwrite Security) and touch [EXECUTE].
- 4.17 Go out of the SP mode, turn the operation switch off, then turn the main power switch off.
- 4.18 Turn the machine power on.
- 4.19 Make sure the ROM number and firmware version in area [a] of the diagnostic report are the same as those in area [b].
  - [a]: “ROM Number/Firmware Version”- “HDD Format Option”
  - [b]: “Loading Program”- “GW5a\_zoffym”

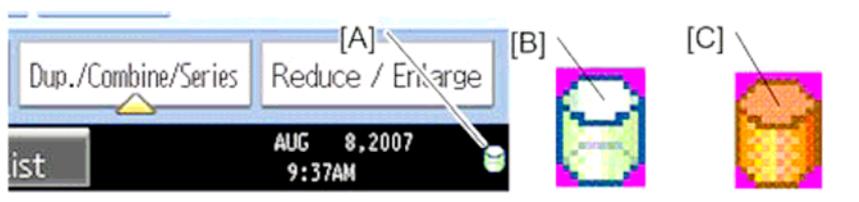
4.22 Check the display and make sure that the overwrite erase icon [A] is displayed.

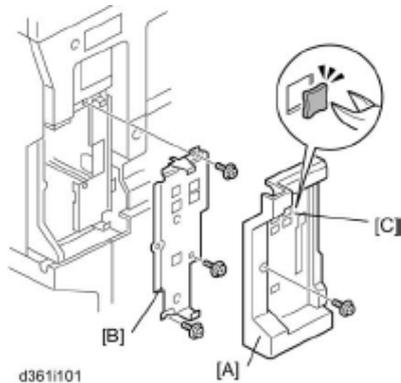
5.1 Remove:

- [A] Application (plastic) cover
- [B] Left cover plate
- [C] Knockouts

- LINE 1 for Fax Unit
- If one G3 Unit will be installed, remove the knockout for LINE 1 and LINE 2.
- If two G3 units will be installed, remove the knockouts for both LINE 1, LINE 2 and LINE 3

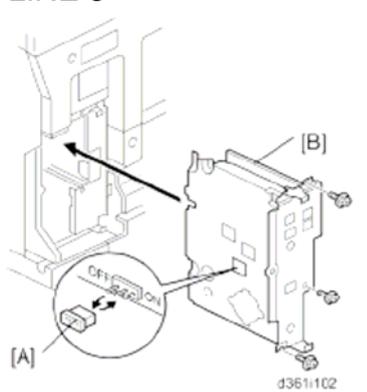
5.2. Through the window, remove the jumper [A] and set it to the ON position.

5.3 Press down the MBU.

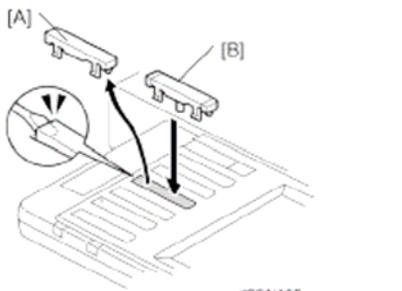
- 5.12 Remove the dummy keytop [A] (3<sup>rd</sup> from the top) and replace it with a facsimile keytop [B]

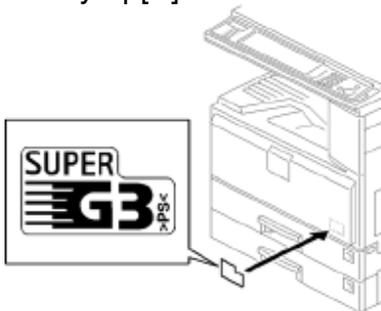
- 5.13 Attach the G3 decal to the front of the machine.
- 5.14 Connect the power cord to the machine
- 5.15 Make sure that the plug is grounded properly at the power source.
- 5.16 Switch the machine on

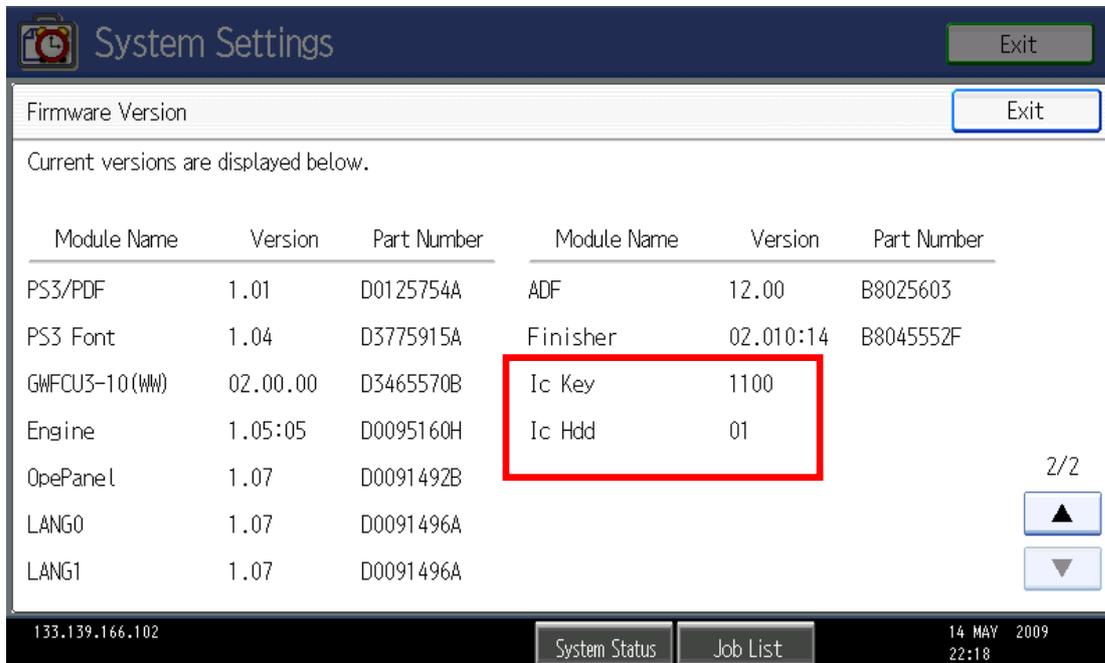
**Note:** You can check the Ic key and Ic Hdd versions in the following screen.  
(User Tools/Counter → System settings → Administrator Tools → Firmware Version)
