Pro C5100/C5110 series

Operating Instructions

Troubleshooting: TCRU/ORU

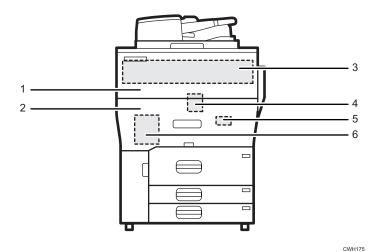
- 1. Toner Unit
- 2. Drawer
- 3. Photoconductor Unit
- 4. Cleaning Unit for Intermediate Transfer Belt
- 5. Transfer Unit
- 6. Fusing Unit

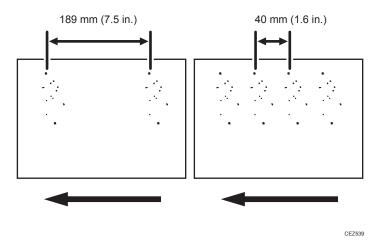
Colored Spots

Colored spots appear at 189 mm or 40 mm (7.5 inches or 1.6 inches) intervals.

(a) Colored spots appear at 189 mm (7.5 inches) intervals

The drum is scratched or stained.

The charge roller is scratched or stained.

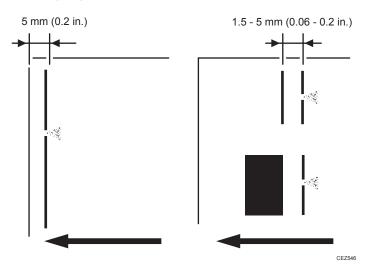
Toner Scatter (2)

Parts of a line exhibit splatter. This may occur in a line that is 5 mm (0.2 inches) or less from the leading edge, or in a line that is 1.5 to 5 mm (0.06 to 0.2 inches) from an image on the side of the image facing the trailing edge.

This may occur when printing lines on coated or other slippery paper.

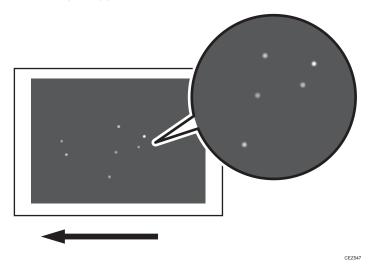
Colorless Spots

Colorless spots appear in solid-filled areas.

If the toner contains small clots, they fail to be transferred, producing colorless spots.

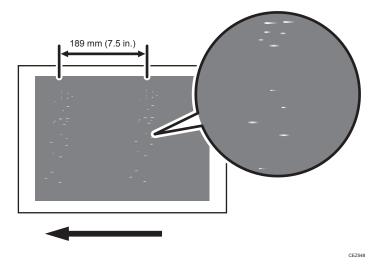
White Dots/Lines

White dots or short lines appear, spaced at intervals of 189 mm (7.5 inches) in the direction of the paper feed.

The photoconductor unit is stained.

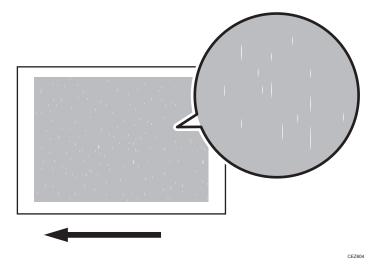
Vertical White Streaks

White streaks of 1 to 8 mm (0.04 to 0.3 inches) long and perpendicular to the paper feed direction appear.

One of the charge rollers is soiled.

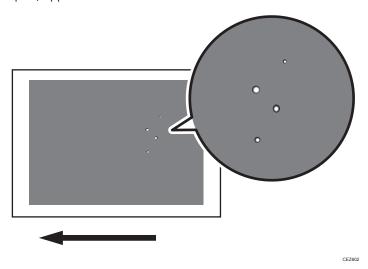
Blister-like White Spots

White spots 0.3–0.5 mm (0.01–0.02 inches) in diameter surrounded by denser spots (blister-like white spots) appear.

This may occur if a solid image is printed on coated paper, if a solid image is printed during duplex printing, or if printing is done at low temperature.

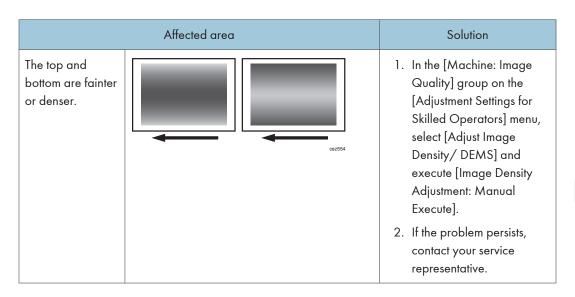
(A) The density is uneven across the entire image.

Affected area	Solution
The density from top to bottom is uneven.	cez552	1. In the [Machine: Image Quality] group on the [Adjustment Settings for Skilled Operators] menu, select [Adjust Image Density/ DEMS] and execute [Image Density Adjustment: Manual Execute]. 2. If the problem persists, see page 45 "Uneven Density from Top to Bottom".
The sides are fainter or denser.		1. In the [Machine: Image Quality] group on the [Adjustment Settings for Skilled Operators] menu, select [Adjust Image Density/ DEMS] and execute [Image Density Adjustment: Manual Execute]. 2. If the problem persists, contact your service representative.

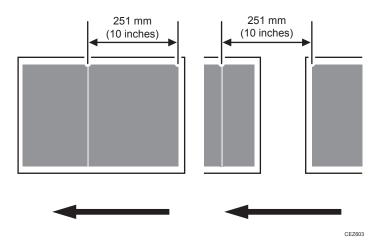
Vertical Glossy Lines

Glossy lines perpendicular to the paper feed direction appear.

Glossy lines perpendicular to the paper feed direction may appear 251 mm (10 inches) from the boundary of the margin and the solid image (in the direction opposite to the paper feed direction).

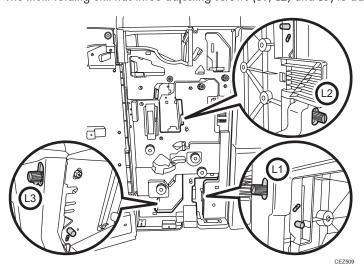
The multi-folding unit has three adjusting screws (L1, L2, and L3) to adjust deviation.

L1

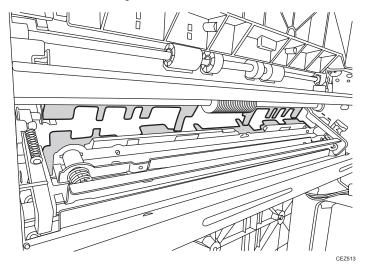
4. Wipe the tip and top of the blade with a soft dry cloth.

Be careful not to damage the blade.
