Pro C5200s/C5210s

Operating Instructions

Troubleshooting: TCRU/ORU

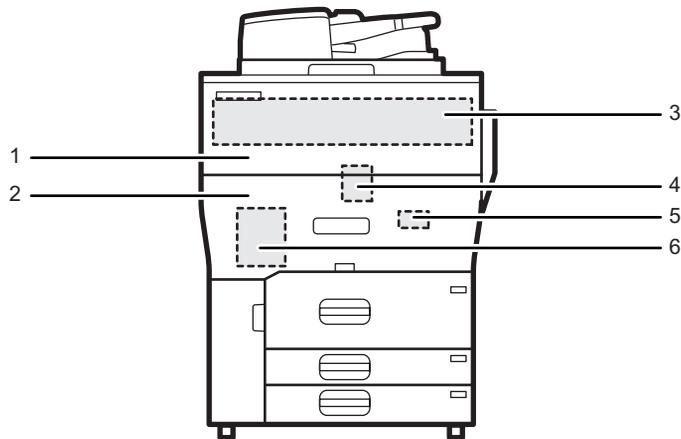
CWH175

1. Toner Unit
2. Drawer
3. Photoconductor Unit
4. Cleaning Unit for Intermediate Transfer Belt
5. Transfer Unit
6. Fusing Unit

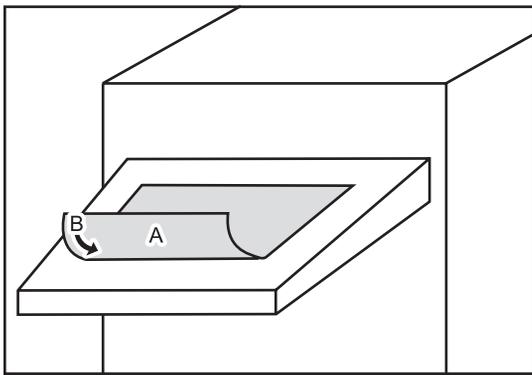
DSM008

Single-sided printing: Printed side face down

A. Side 1

B. Paper feed direction of Side 1

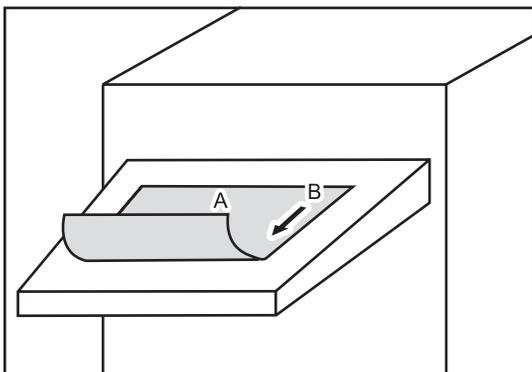
DSM009

Single-sided printing: Printed side face up

A. Side 1

B. Paper feed direction of Side 1

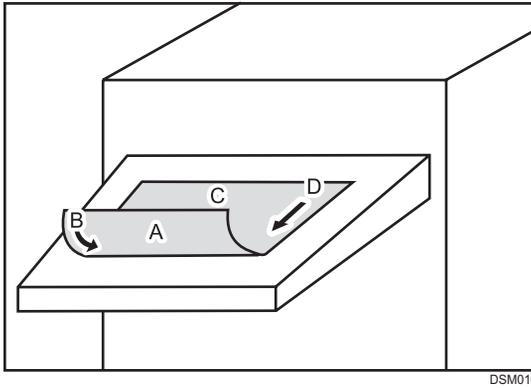
Duplex printing: Printed side face down

- A. Side 1
- B. Paper feed direction of Side 1
- C. Side 2
- D. Paper feed direction of Side 2

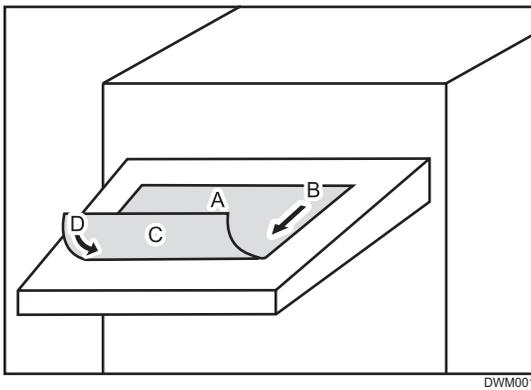
Duplex printing: Printed side face up

- A. Side 1
- B. Paper feed direction of Side 1
- C. Side 2
- D. Paper feed direction of Side 2

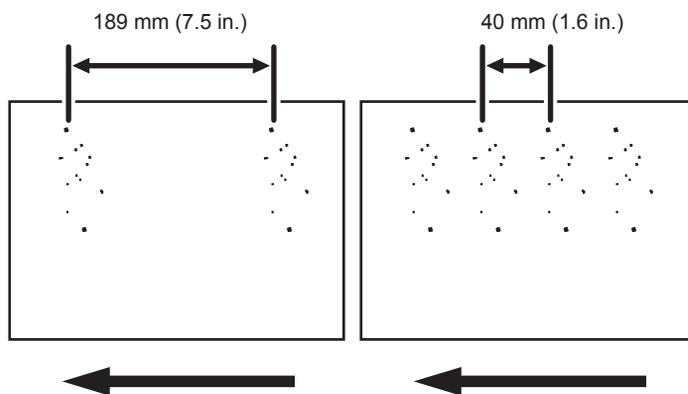
CEZ539

Colored spots appear at 189 mm or 40 mm (7.5 inches or 1.6 inches) intervals.

The drum is scratched or stained.

The charge roller is scratched or stained.

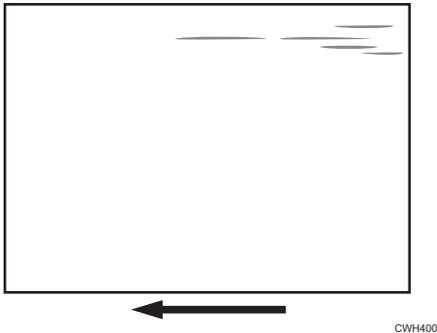
Colored streaks parallel to the paper feed direction appear.

- The charge roller is stained.
- The cleaning unit for PCU has worn out.
- The drum surface is scratched.

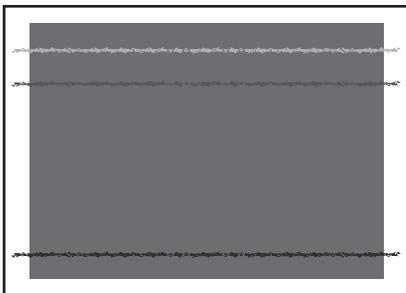
CWH401

Extended, blurred colored streaks parallel to the paper feed direction appear. The streaks also appear randomly in the margins.

If the temperature or humidity is low, remaining toner might be missed by the cleaning blade of the cleaning unit for intermediate transfer belt or transfer unit, causing streaks to appear sporadically.

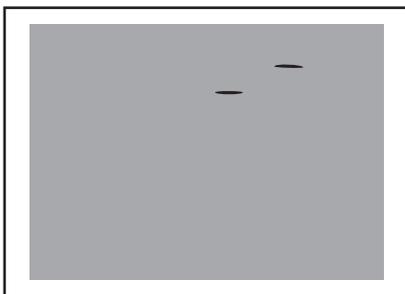
CEZ542

Colored streaks appear in solid-filled areas.

This problem may occur if the machine is left unattended for a long period or the toner bottle is kept out of its moisture-proof bag for a long period.

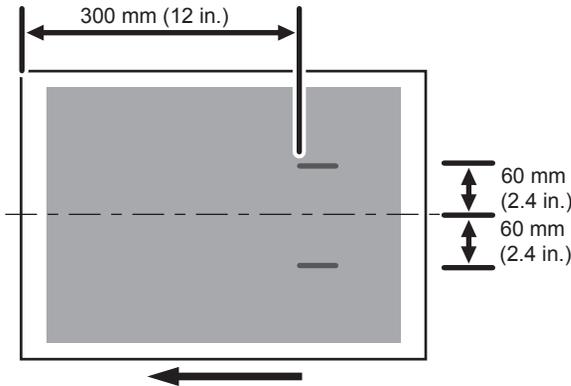
CNT004

Short black streaks appear on a black halftone image.

A sheet is bent at the entrance to the fusing unit and comes into contact with the edge of the paper delivery tank, where static electricity builds up on the sheet through friction. This causes scattering of unfixed toner on the paper surface.

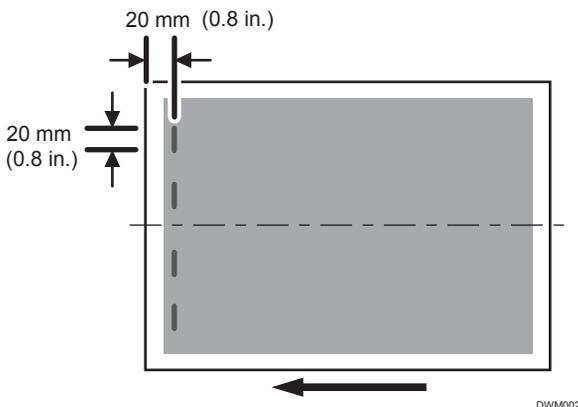
DWM002

Four 20-mm long vertical streaks appear within 20 mm (0.8 inches) from the leading edge.

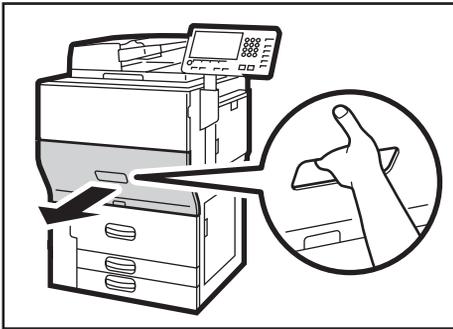
CWH001

1. **Make sure that the system is turned off and the machine power cord is disconnected from the power source.**
2. **Pull the drawer.**

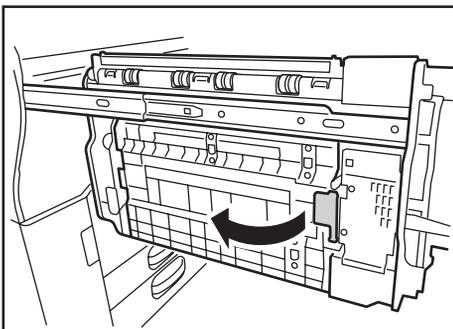
CWH414

3. **Open the cover.**

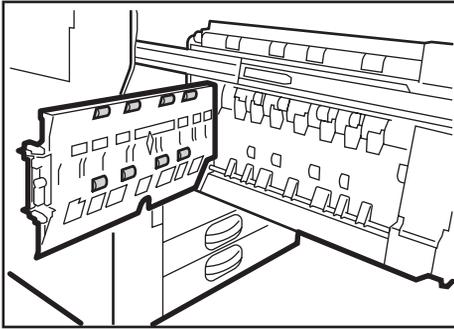
CWH410

- Turn the invert exit idle rollers to clean them using a slightly damp cloth.

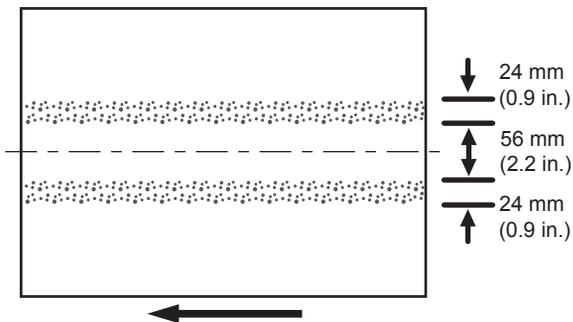
CNT006

Two 24-mm wide streaks parallel to the paper feed direction appear.

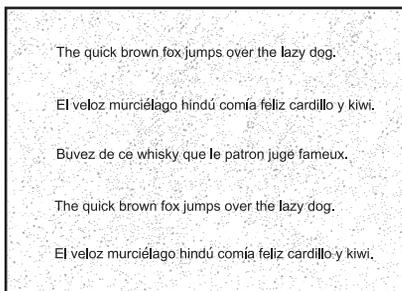
CEZ543

Completely stained background

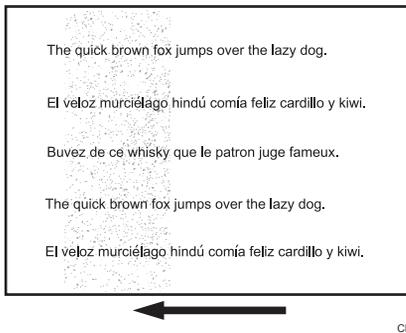
Partially stained background

This may occur because of wearing of the developer and drum unit or staining of the charge roller.

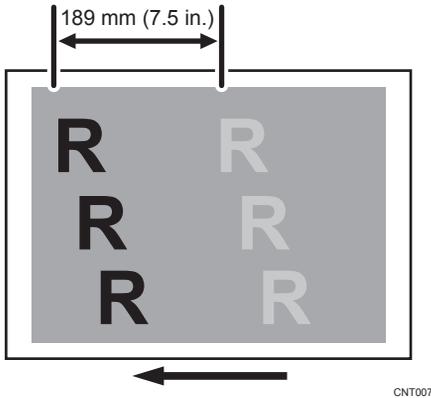
A ghost image of an image to be printed appears at a distance of 189 mm (7.5 inches) to the side of the intended image.

The image transfer current is transmitted to the drum, where a potential difference occurs between a developed area and non-developed area and causes the intended image to be reproduced.

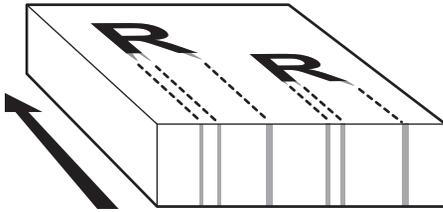
CNT008

Scratched images or soiled paper edges appear.

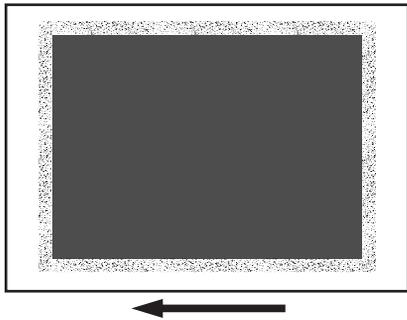
Toner is scattered around a solid-fill print.

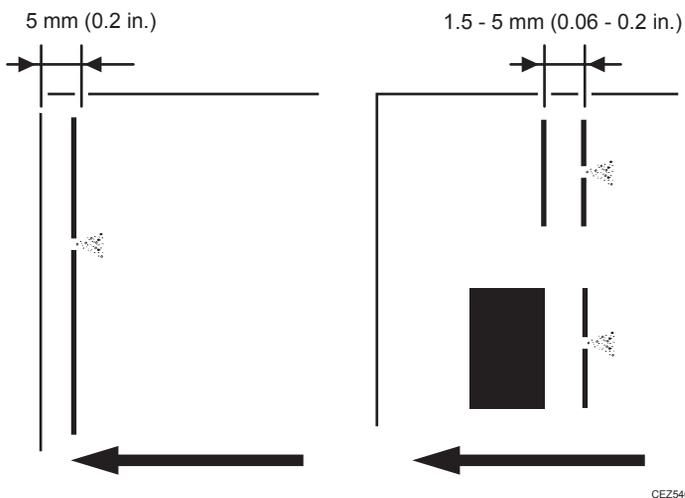
Parts of a line exhibit splatter. This may occur in a line that is 5 mm (0.2 inches) or less from the leading edge, or in a line that is 1.5 to 5 mm (0.06 to 0.2 inches) from an image on the side of the image facing the trailing edge.

This may occur when printing lines on coated or other slippery paper.

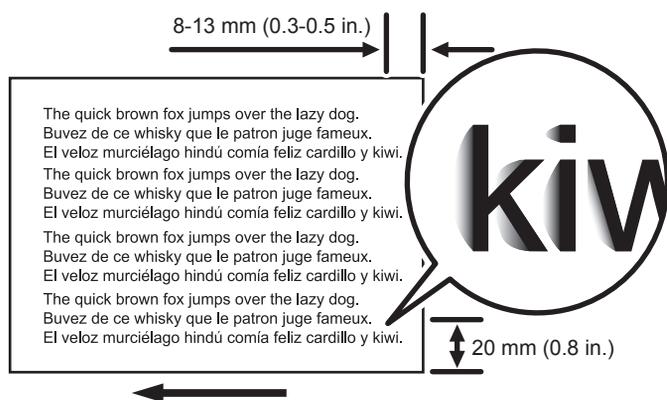
CNT009

Parts of a line or character exhibit splatter. This may occur in a line or character that is 8 to 13 mm (0.3 to 0.5 inches) from the trailing edge and 20 mm (0.8 inches) or less from the left edge facing the paper feed direction.

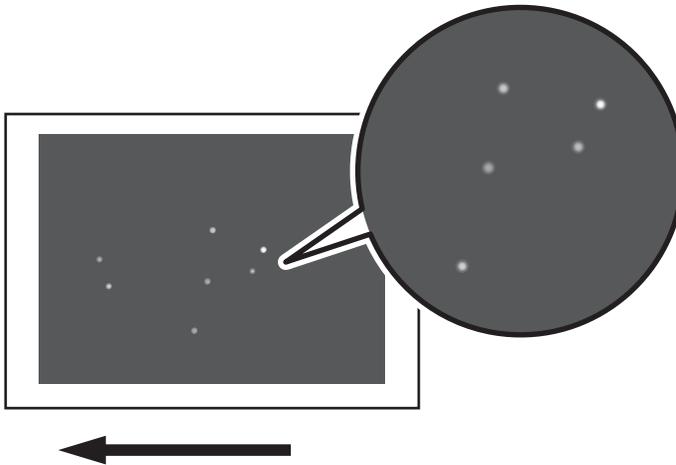
CEZ547

Colorless spots appear in solid-filled areas.

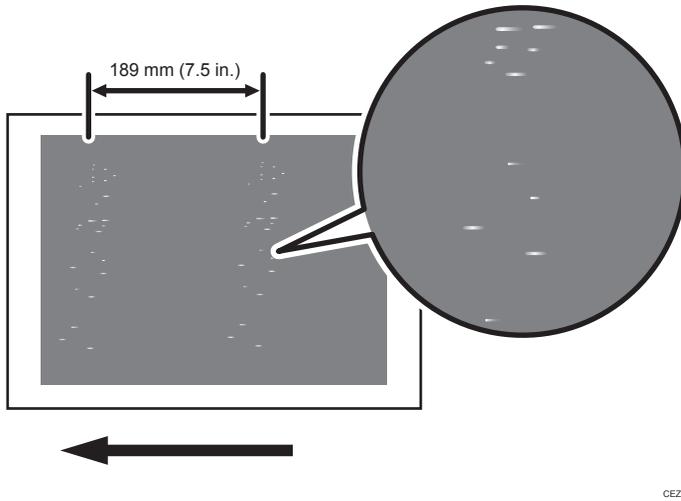
CEZ548

White dots or short lines appear, spaced at intervals of 189 mm (7.5 inches) in the direction of the paper feed.

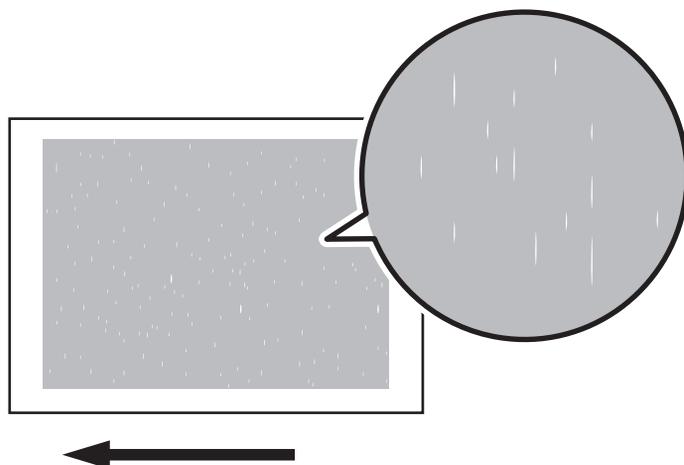
White streaks of 1 to 8 mm (0.04 to 0.3 inches) long and perpendicular to the paper feed direction appear.

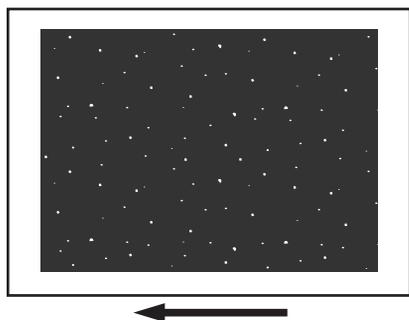
White spots of 0.2–0.3 mm (0.008–0.01 inches) in diameter appear.

This may occur if printed at low temperature or humidity.

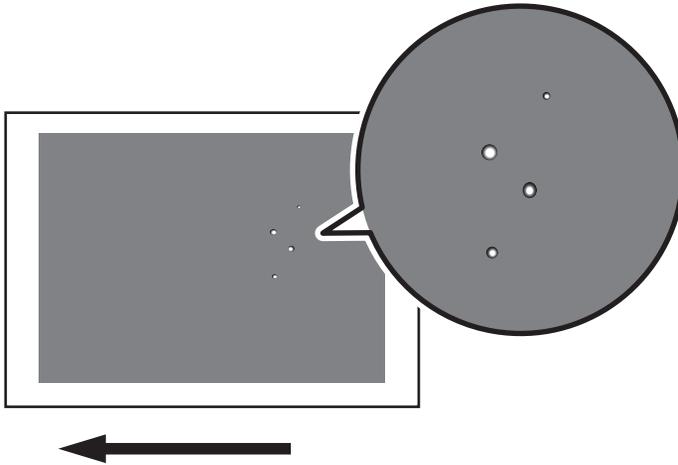
CEZ602

White spots 0.3–0.5 mm (0.01–0.02 inches) in diameter surrounded by denser spots (blister-like white spots) appear.

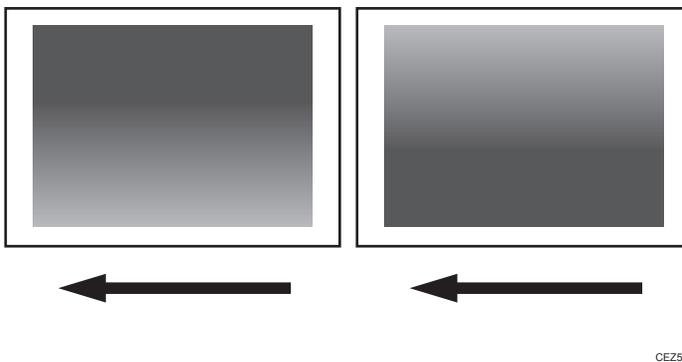
The density is uneven from top to bottom.

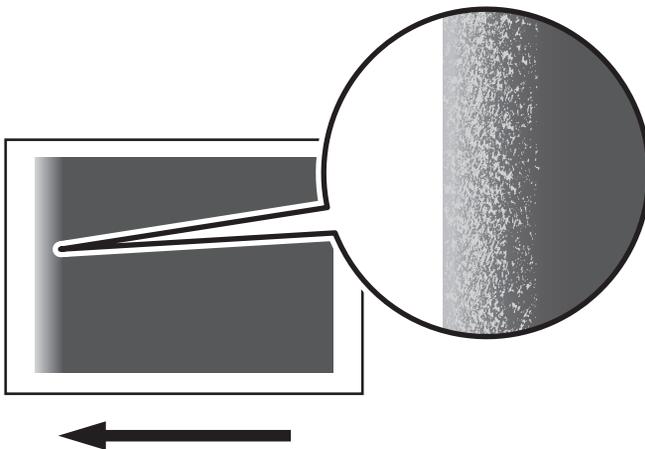
CEZ562

The leading edge is fainter.

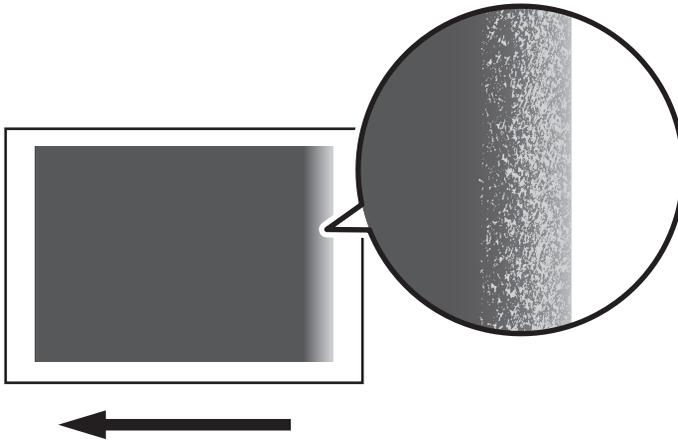
CEZ563

The trailing edge is fainter.

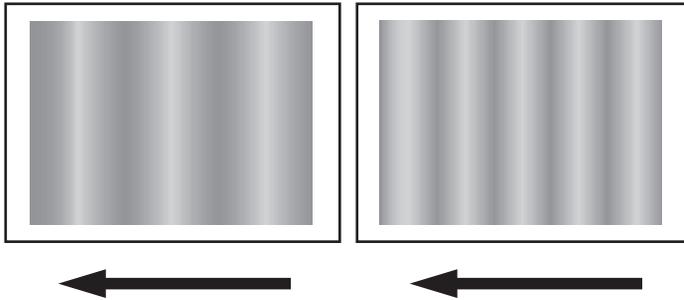
CWH407

The vertical density fluctuates periodically.

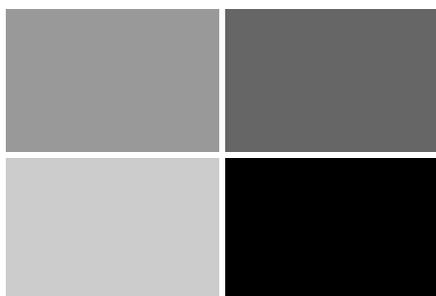
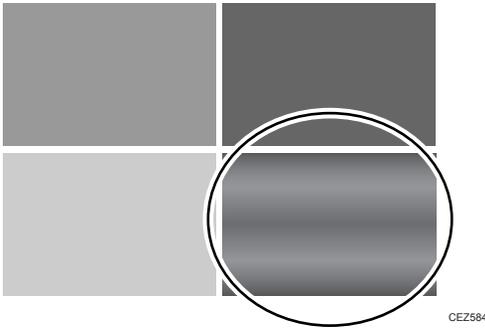
CEZ566

Black is fainter than normal during full color printing.

Normal

Black is fainter

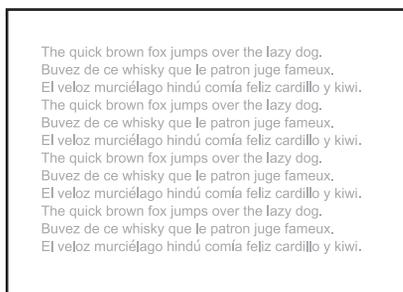
CEZ585

The entire image is fainter than normal.

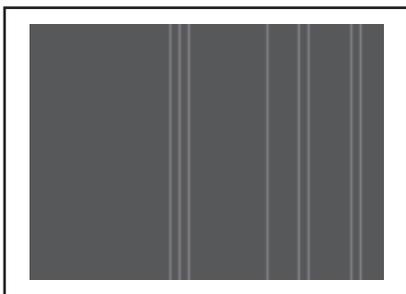
CNT001

Faded vertical streaks may appear during full color printing.

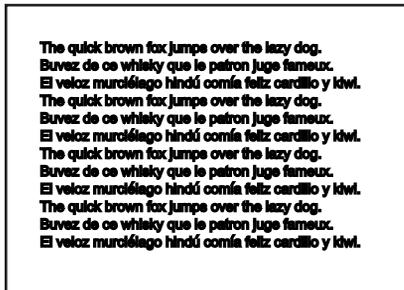
CEZ568

The entire image is denser than normal.

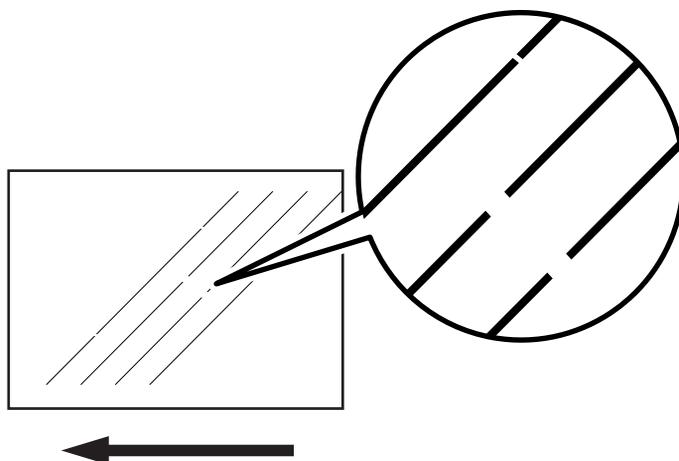
CEZ569

Broken Thin Lines

Thin lines (1 dot lines in 1200 dpi images) break.

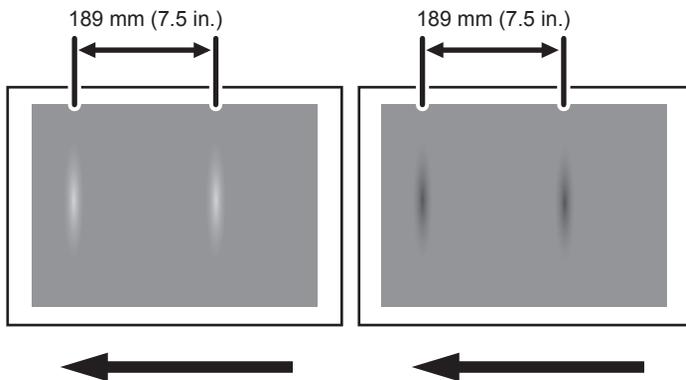
CNT002

Blurred Images

Lens-shaped blurred images appear at 189 mm (7.5 inches) intervals.

If the machine is left unattended for a long period in an environment where temperature and humidity are high, corona products on the drum absorb moisture to prevent a buildup or removal of static electricity on the drum.

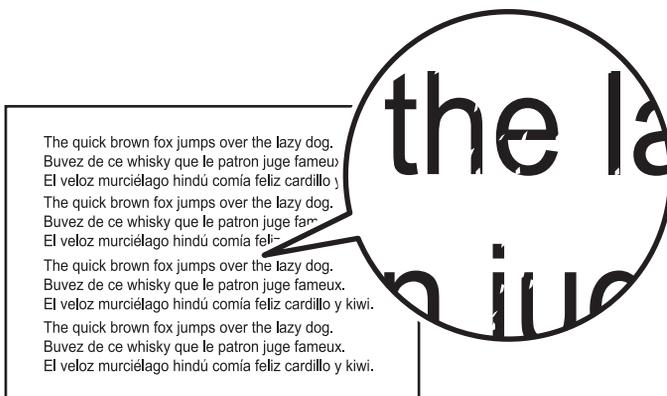
CNT003

Dropouts (character voids) occur when characters or lines are printed in black-and-white mode.

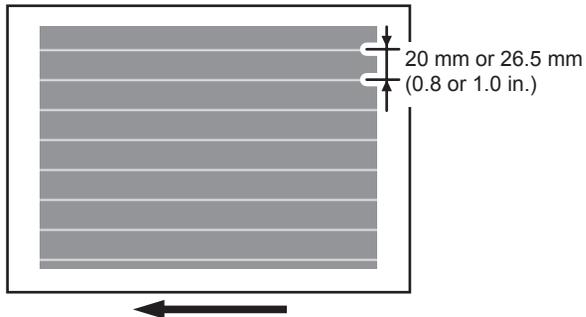
Glossy Lines

Glossy lines appear every 20 or 26.5 mm (0.8 or 1.0 inches).

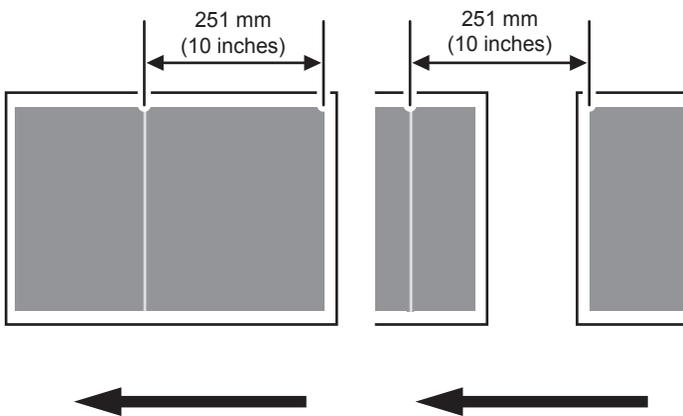
CEZ803

Vertical Glossy Lines

Glossy lines perpendicular to the paper feed direction appear.

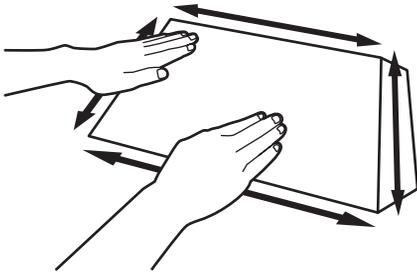
CEZ500

Flatten the envelope and all its edges to eliminate air before loading. If the envelope is curled, decurl it before loading.

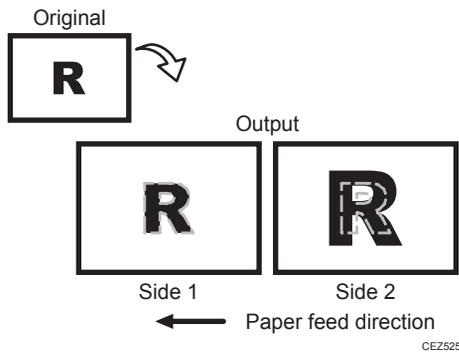
Image Scaling Error on the Side 2 of Paper

An image scaling error on the side 2 of the paper may occur because the paper expands or contracts after the image on the side 1 of the paper has been fused.

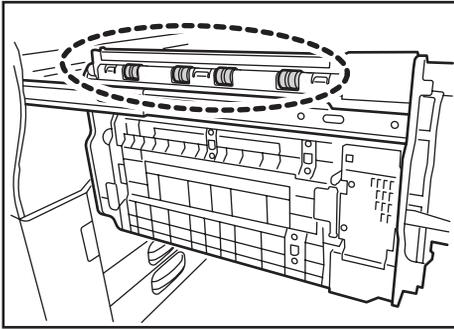
CWH412

Clean the antistatic brushes in the exit transport and inverter transport of the drawer with a blower brush.

- The antistatic brush in the exit transport

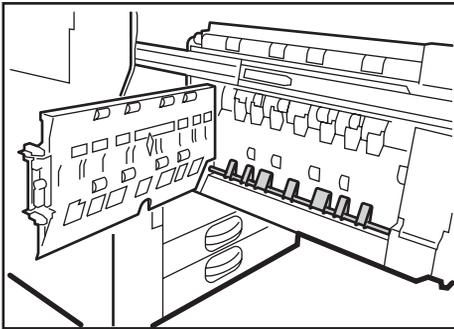
CWH413

- The antistatic brush in the inverter transport

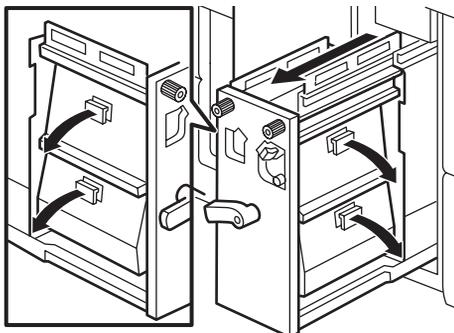
CNT016

1. Pull out the buffer pass unit and open the guide plates.

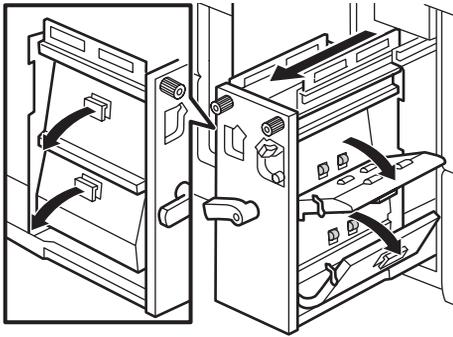
2. Wipe the rubber rollers for the transport rollers with a slightly damp cloth.

There are twenty-four rubber rollers for the twelve transport rollers.

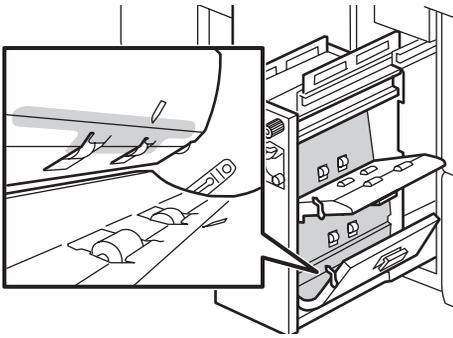
3. Wipe the guide plates (especially the ridgelines of the bends and the cut-and-bent portions) with a cloth moistened with alcohol.

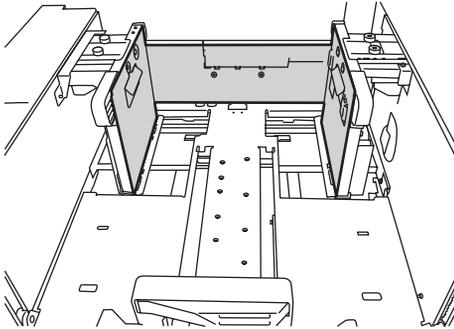
CEZ502

1. Clean the side fences and front guide.

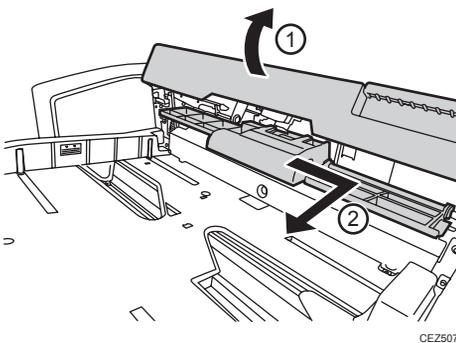
1. Remove the loaded paper.
2. Open the upper cover, and then detach the paper feed unit.

Pull it out slightly, release the metal shaft, and then detach it.

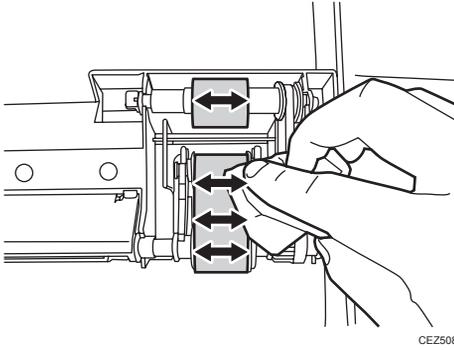
3. Clean the paper feed belt and paper feed rollers in the detached paper feed unit.

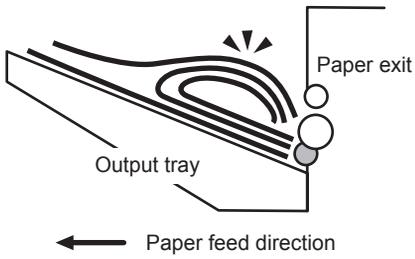
Sheet bending

The leading edge of the delivered sheet bends upward and backward.

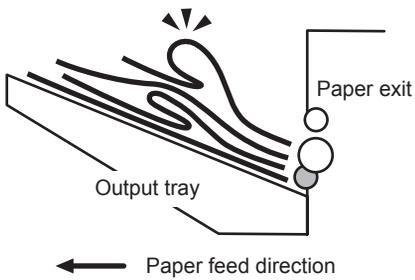
Paper deflection

Because of high paper friction, the delivered sheet may arch up and become crimped.

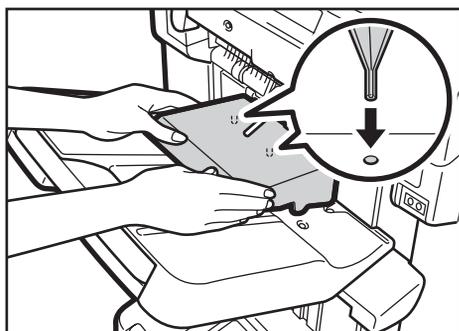
DSN012

Attach the Z-fold support tray by inserting the two protrusions on its underside into the holes on the finisher shift tray.

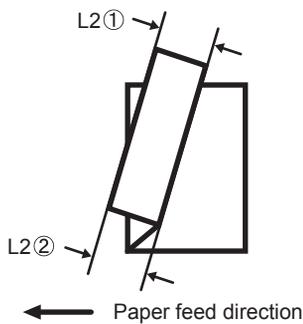
CEZ531

For example, in the following illustration, the dimensional difference between the top (L2[2]) and bottom (L2[1]) edges is a deviation.

<Folding deviation sample of L2 for Z-fold>

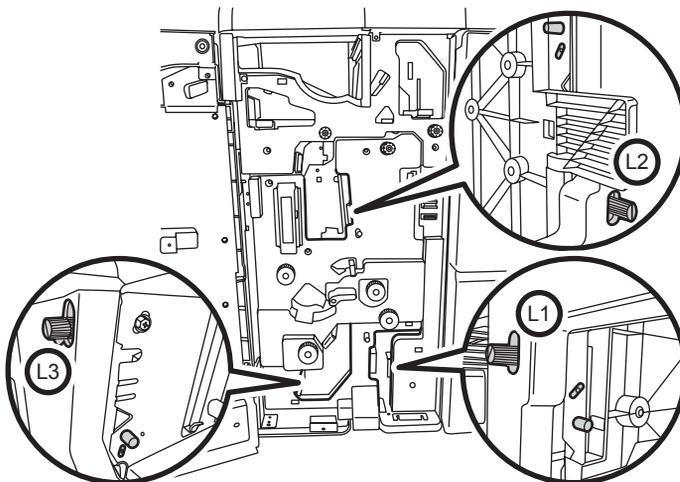
CEZ509

The multi-folding unit has three adjusting screws (L1, L2, and L3) to adjust deviation.

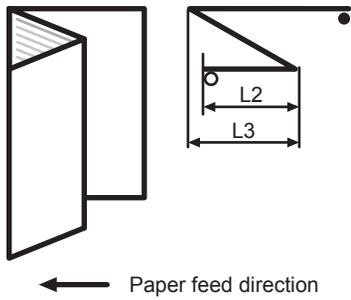
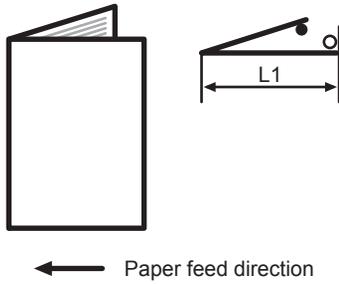
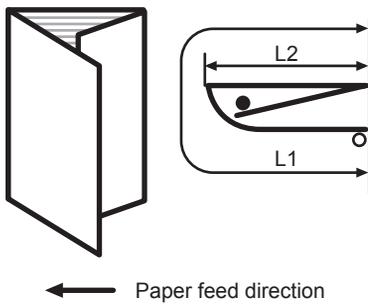
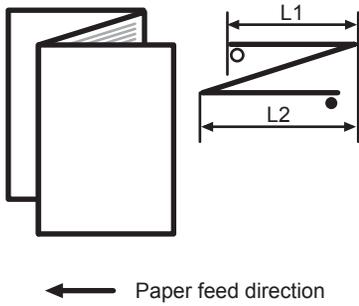
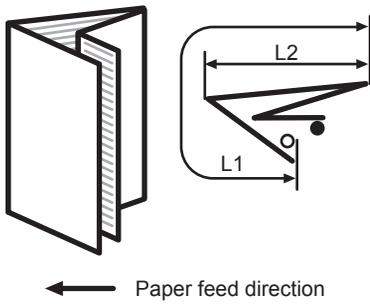
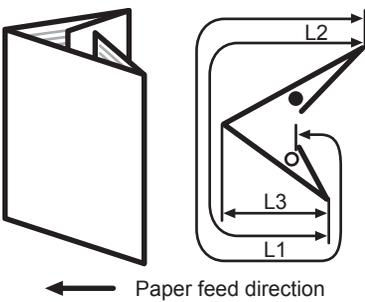
The screws adjust the folding deviations of the following parts:

The ○ mark indicates the leading edge (relative to the paper feed direction), and the ● mark indicates the trailing edge.

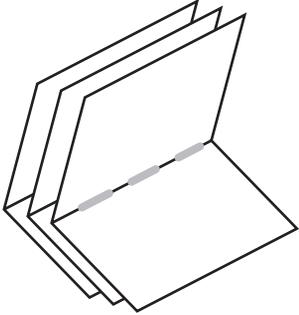
CEZ571

If multi-sheet folding is performed after a large number of Z-folds have been performed, the tip of the blade used for the multi-sheet folding may be soiled, resulting in soiled paper.

This will produce paper soil of 1-3 cm (0.4-1.2 inches) in width (equal to the width of the blade) in the fold in the center of paper.

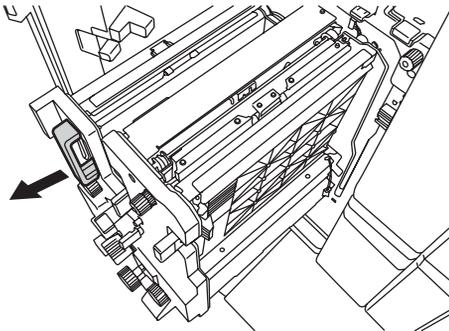
CEZ511

1. Open the front cover of the multi-folding unit.
2. Pull the multi-folding unit out.

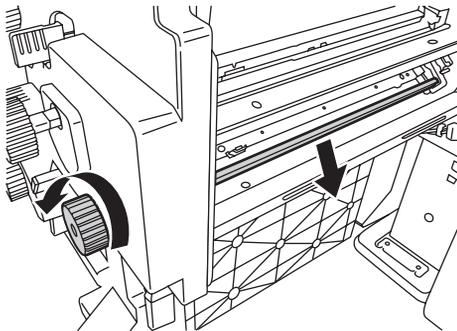
CEZ512

3. Turn the N11 dial counterclockwise until the blade appears.

The blade is located in the right part of the multi-folding unit.

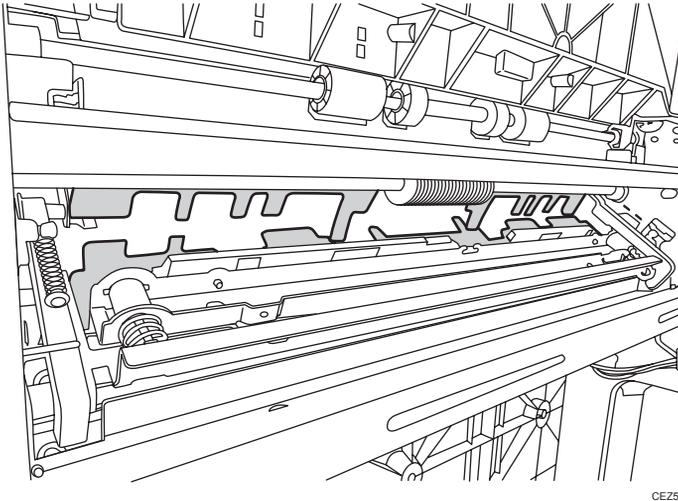
5

4. Wipe the tip and top of the blade with a soft dry cloth.

Be careful not to damage the blade.

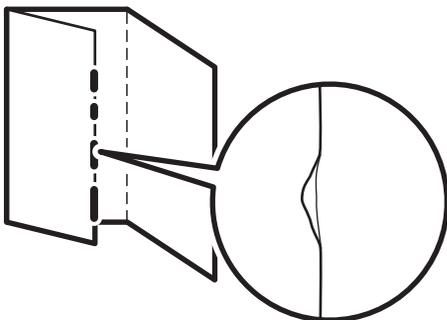
Edges of letter fold bent

When letter folding is applied, the edge of the inner flap may become bent.

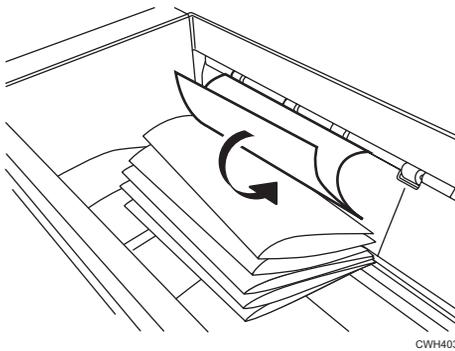
- Thick, relatively stiff paper is used.

As a bundle is delivered, its folded edge may droop and catch on the stacked bundles, causing the delivered bundle to flip over.

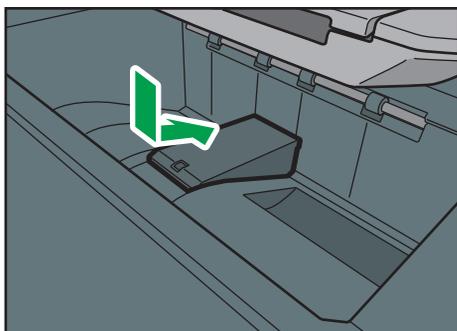
Use the Z-fold support tray for multi-folding unit.

This will reduce the angle of stacked bundles and prevent bundles flipping over as they are delivered.
