Pro 8100s/8110s/8120s Pro 8110/8120

Operating Instructions

Troubleshooting: TCRU/ORU

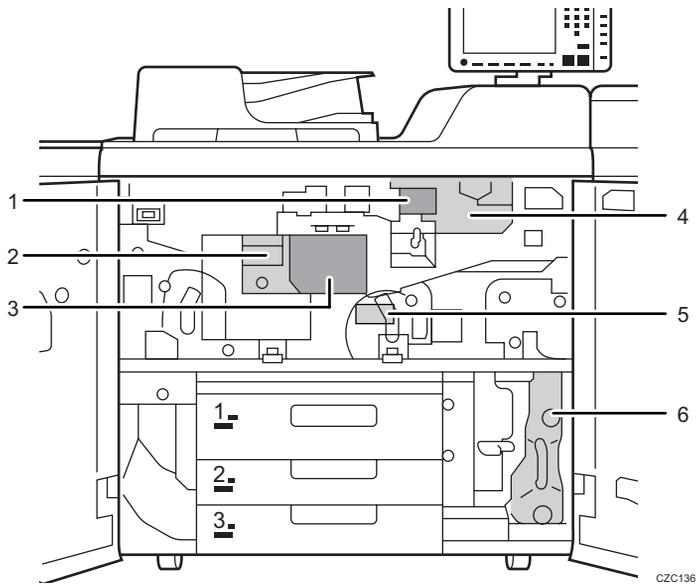
1. Developer Outlet/Inlet
2. Fusing Unit
3. Cleaning Unit for Intermediate Transfer Belt
4. Development Unit
5. Transfer Unit
6. Waste Toner Bottle

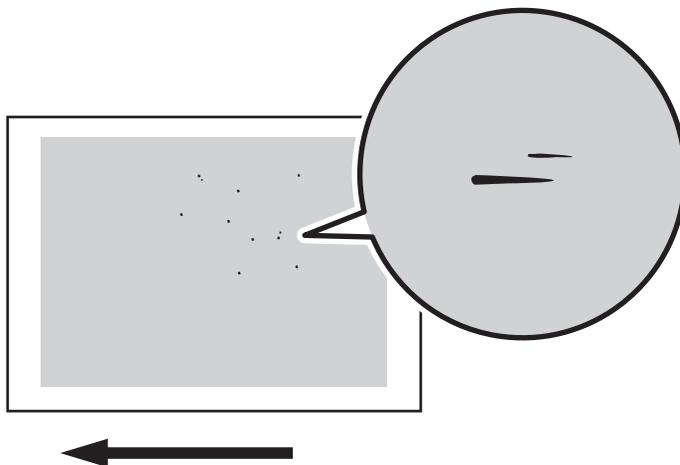
CEZ538

Toner Spotting/Staining

Paper is soiled with toner spots of 0.5–1 mm (0.02–0.04 inches) in diameter.

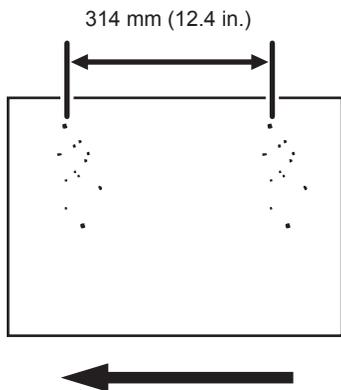
CZC307

Black Spots

Black spots appear at 314 mm (12.4 inches) intervals.

The drum is scratched or stained.

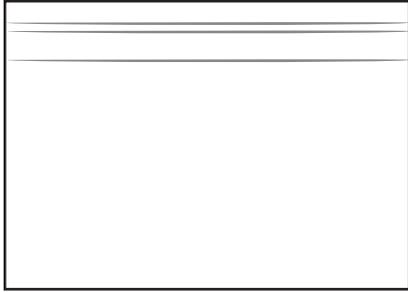
CZC346

Streaks (1)

Streaks parallel to the paper feed direction appear.

- The charger is stained.
- The cleaning unit for PCU has worn out.
- The drum surface is scratched.

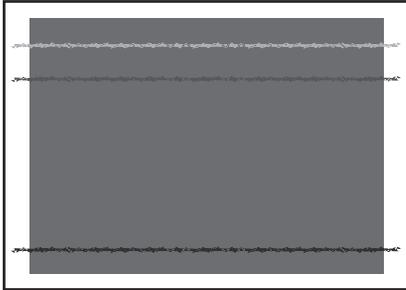
CWH401

Streaks (2)

Extended, blurred streaks parallel to the paper feed direction appear. The streaks also appear randomly in the margins.

If the temperature or humidity is low, remaining toner might be missed by the cleaning blade of the cleaning unit for intermediate transfer belt or transfer unit, causing streaks to appear sporadically.

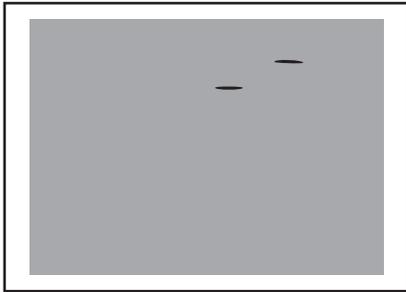
CEZ542

Streaks (3)

Streaks appear in solid-filled areas.

If the toner contains small clumps, they disintegrate in the development unit, producing streaks. This problem may occur if the machine is left unattended for a long period or the toner bottle is kept out of its moisture-proof bag for a long period.

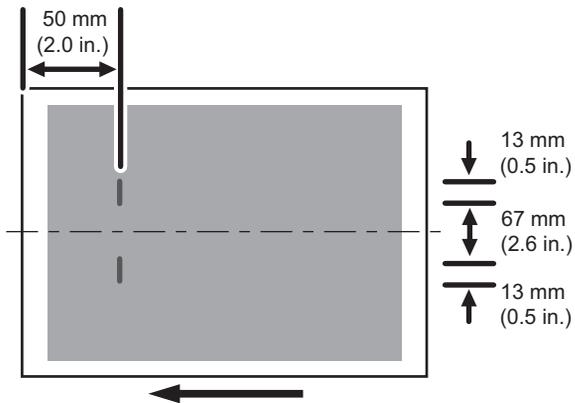
CZC313

Two 13-mm Long Vertical Streaks

Two 13-mm long vertical streaks appear within 50 mm (2.0 inches) from the leading edge.

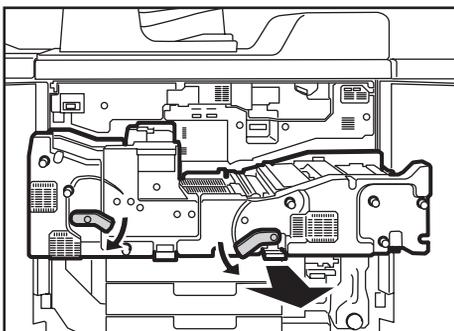
CZC300

1. Make sure that the system is turned off and the machine power cord is disconnected from the power source.
2. Open the front covers.
3. Lower the levers C1 and C2, and then pull the drawer out completely until it stops.

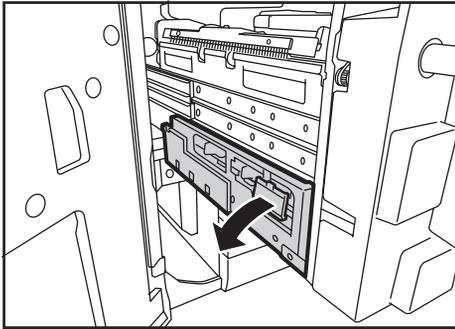
CZC301

4. Pull down and open the cover D4.

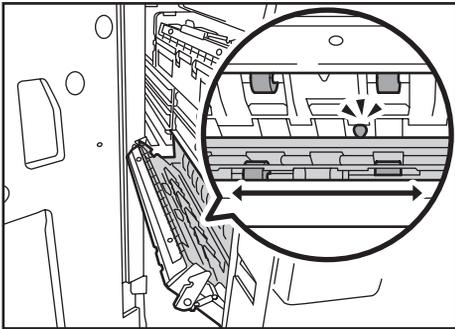
CZC302

5. Clean the rollers, sensors, and guide boards.

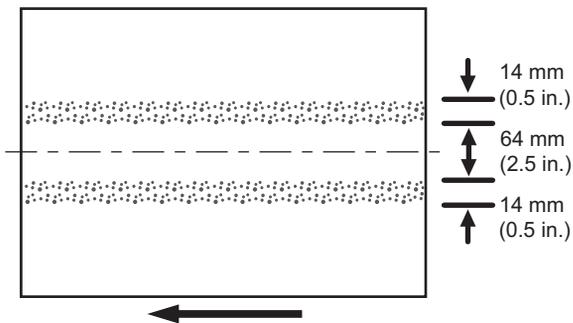
CZC314

Two 14-mm Wide Streaks

Two 14-mm wide streaks parallel to the paper feed direction appear.

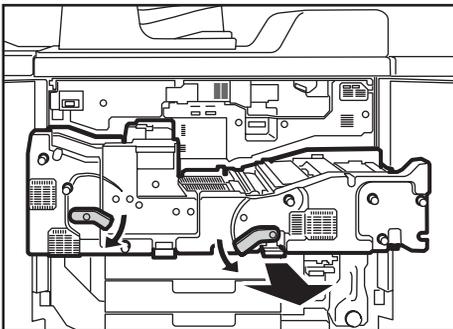
CZC300

1. Make sure that the system is turned off and the machine power cord is disconnected from the power source.
2. Open the front covers.
3. Lower the levers C1 and C2, and then pull the drawer out completely until it stops.

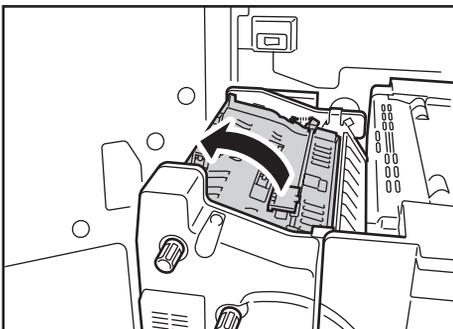
CZC341

4. Pull up and open the cover D3.

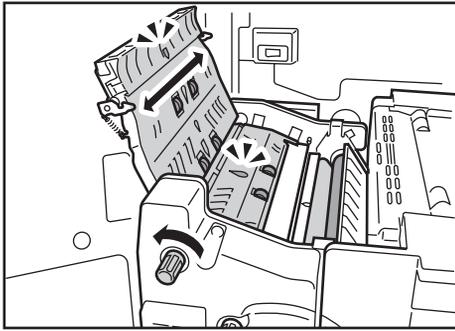
5. Clean the rollers while turning the knob D1. Clean the sensors and guide boards also.

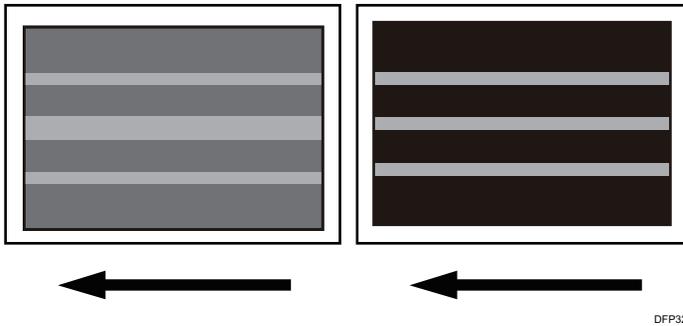
Horizontal White Bands

White bands parallel to the paper feed direction appear.

When the paper is fed from the two-tray wide LCT (Vacuum Feed LCIT RT5100), the static electricity produced by friction between the conveyer belt and paper may hamper toner adhesion on the paper, resulting in a horizontal band appearing at the vacuum port position.

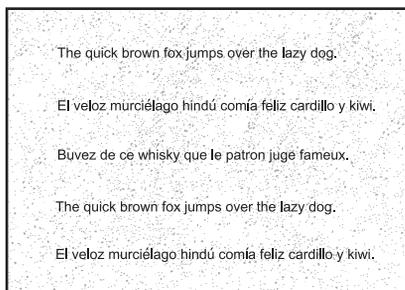
CEZ543

Completely stained background

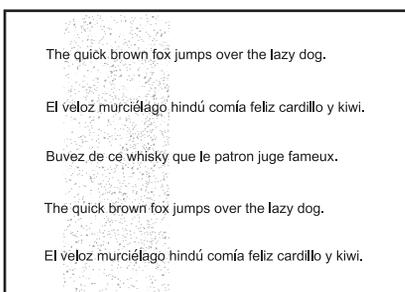
CEZ544

Partially stained background

This may occur because of wearing of the developer, drum unit, or charger.

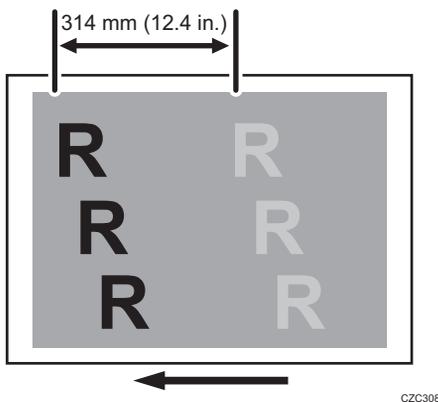
Ghosting

A ghost image of an image to be printed appears at a distance of 314 mm (12.4 in.) to the side of the intended image.

The image transfer current is transmitted to the drum, where a potential difference occurs between a developed area and non-developed area and causes the intended image to be reproduced.

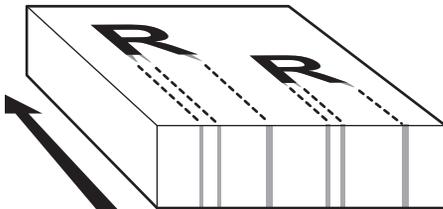
CNT008

Scratched Images and Stained Paper Edges

Scratched images or soiled paper edges appear.

When a relatively stiff, thick paper is delivered, the entrance guide board for the transfer unit is warped toward the intermediate transfer belt due to the stiffness of the paper. The edge of the entrance guide board comes into contact with the toner on the belt to cause images to be scratched and paper edges to be soiled.

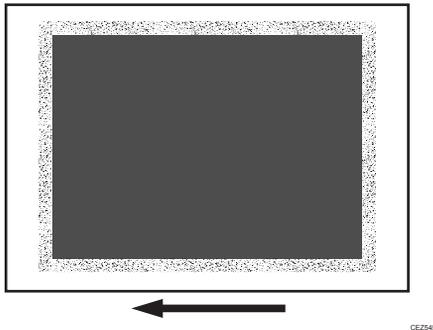
Toner Scatter (1)

Toner is scattered around a solid-fill print.

This may occur if printed at low temperature or humidity.

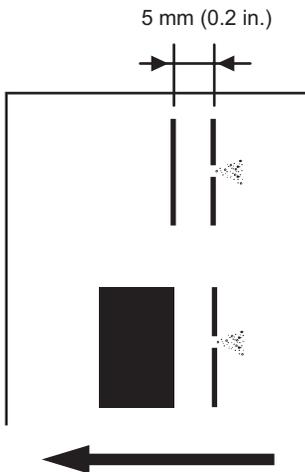
CZC309

Toner Scatter (2)

Parts of a line that is 5 mm (0.2 inches) or less from an image exhibit splatter.

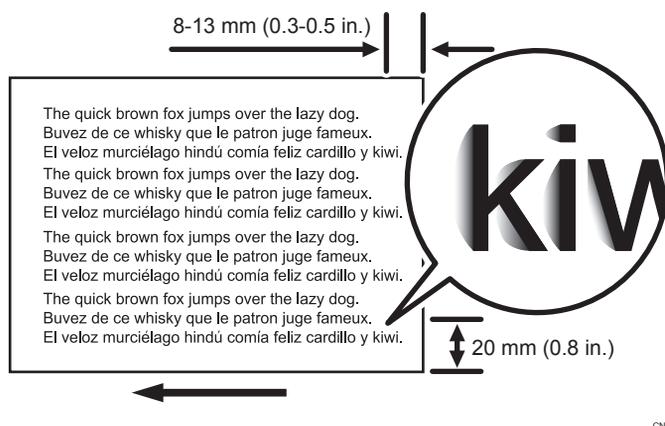
Toner Scatter (3)

Parts of a line or character exhibit splatter. This may occur in a line or character that is 8 to 13 mm (0.3 to 0.5 inches) from the trailing edge and 20 mm (0.8 inches) or less from the left edge facing the paper feed direction.

A shock jitter occurs when the trailing edge of the paper leaves the paper guide during paper transfer and causes toner scattering.

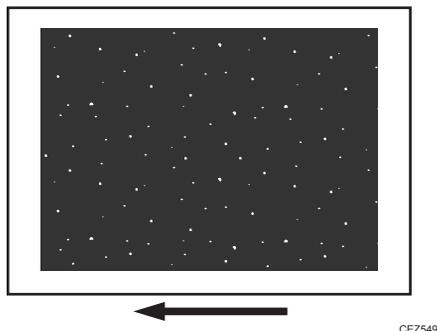
White Spots

White spots of 0.2–0.3 mm (0.008–0.01 inches) in diameter appear.

This may occur if printed at low temperature or humidity.

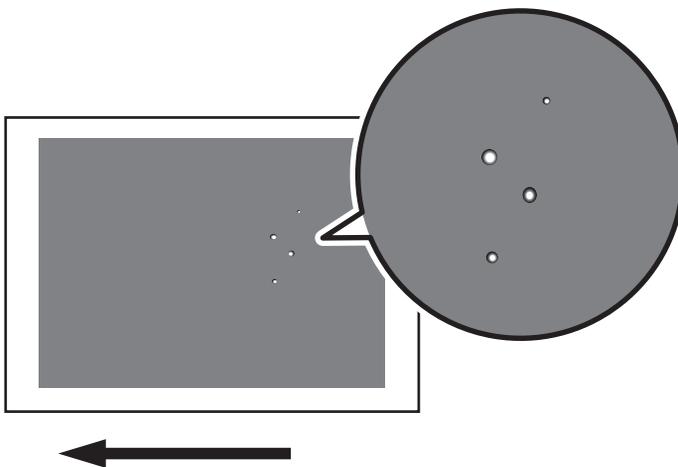
CEZ602

Blister-like White Spots

White spots 0.3–0.5 mm (0.01–0.02 inches) in diameter surrounded by denser spots (blister-like white spots) appear.

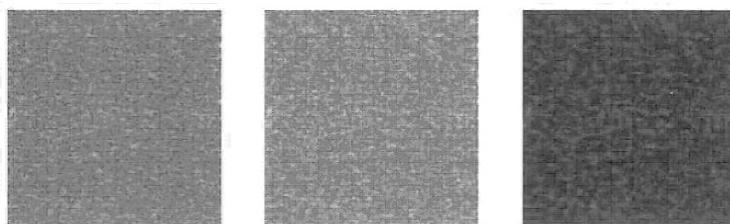
**Mottled**

Mottling occurs in solid-filled areas.

The transfer electric field on the concave portion of paper is weakened to cause a decrease in transcription.

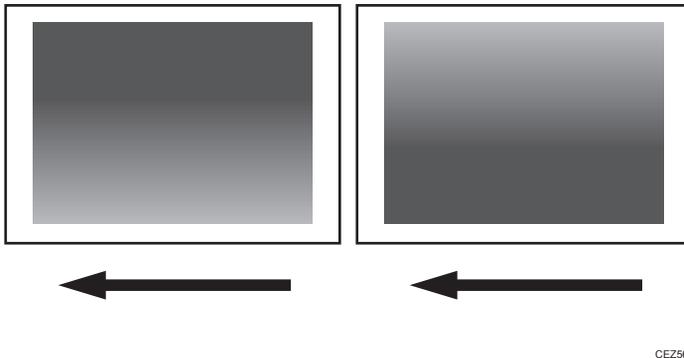
Uneven Density from Top to Bottom

The density is uneven from top to bottom.

This may occur at high temperature or humidity.

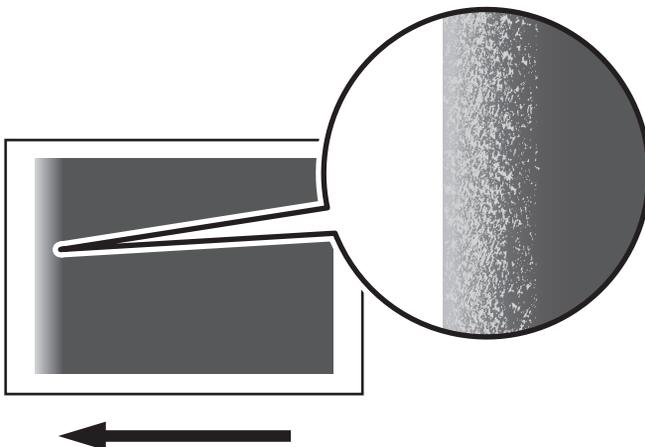
CEZ562

Fainter Leading Edge

The leading edge is fainter.

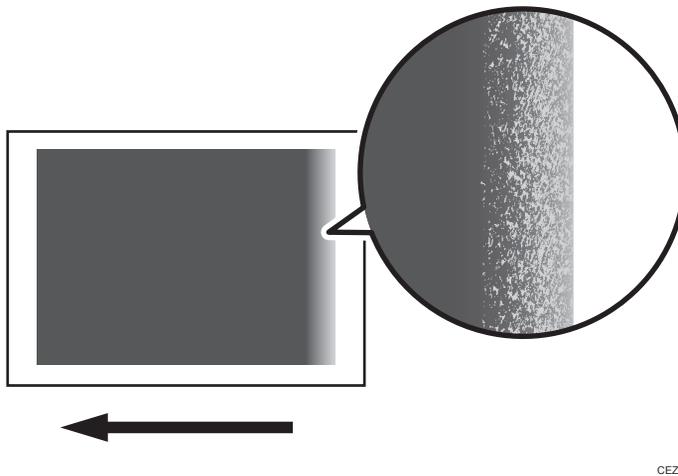
CEZ563

Fainter Trailing Edge

The trailing edge is fainter.

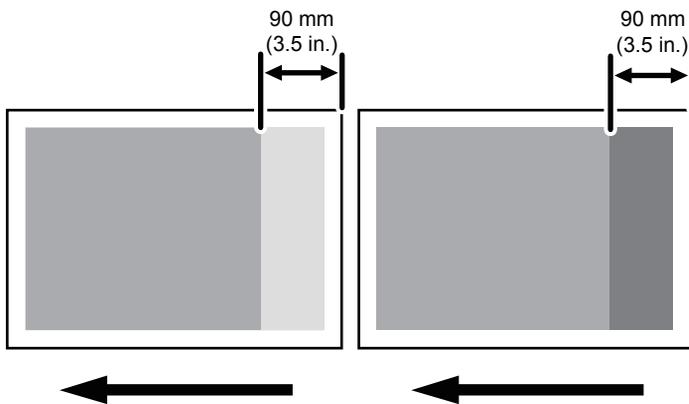
CEZ564

Uneven Density within 90 mm (3.5 in.) of the Trailing Edge

Printing in the area extending approximately 90 mm (3.5 inches) from the trailing edge is fainter or denser.

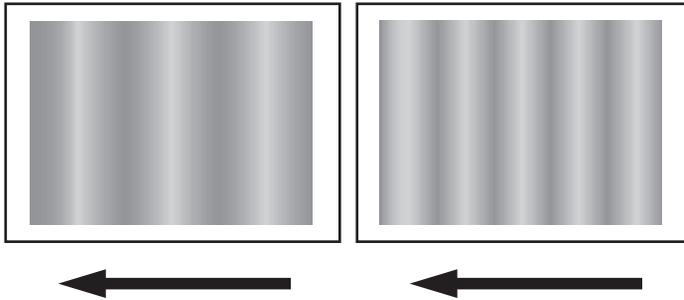
CWH407

Periodic Density Fluctuation

The vertical density fluctuates periodically.

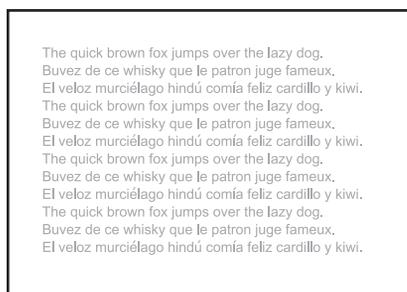
CEZ585

Entire Image Faint

The entire image is fainter than normal.

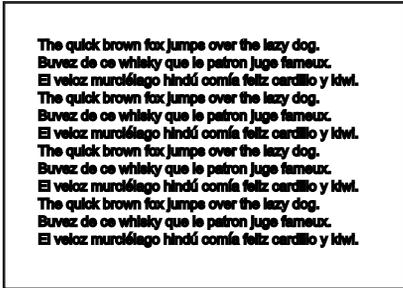
CEZ568

Color Is Too Dense

The entire image is denser than normal.

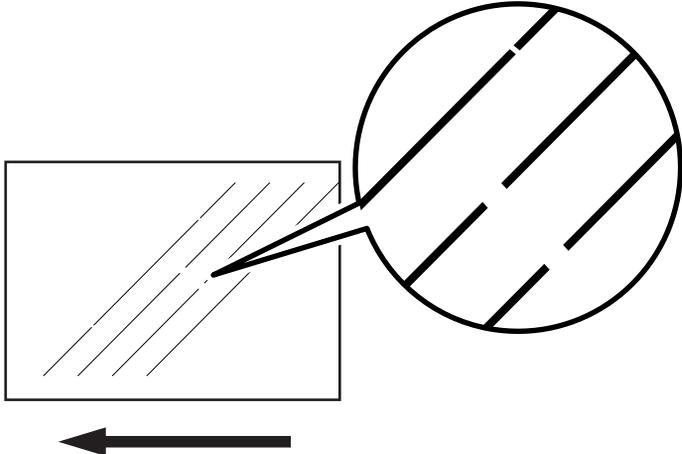
CEZ569

Broken Thin Lines

Thin lines (1 dot lines in 1200 dpi images) break.

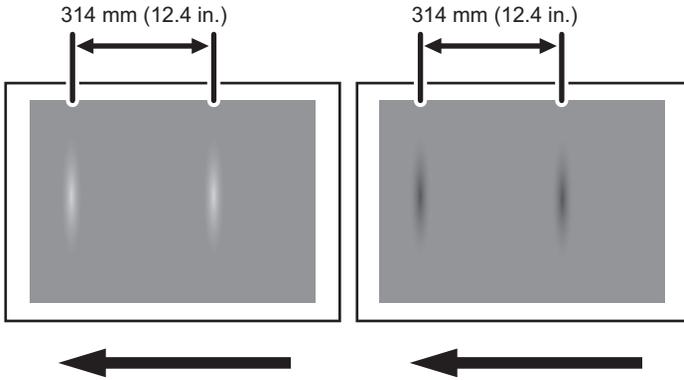
CZC310

Blurred Images

Lens-shaped blurred images appear at 314 mm (12.4 inches) intervals.

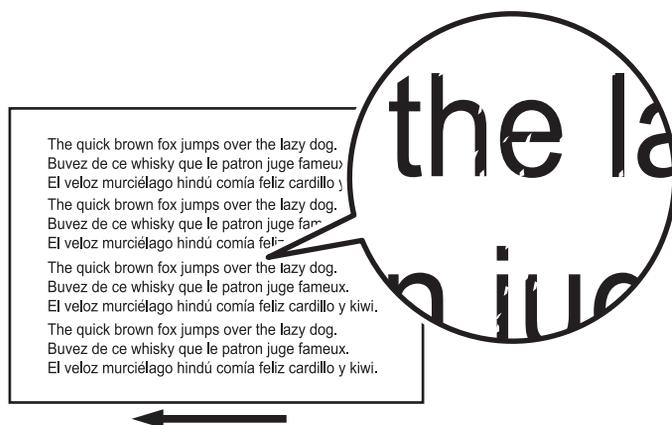
CNT003

Dropouts (Character Voids)

Dropouts (character voids) occur when characters or lines are printed.

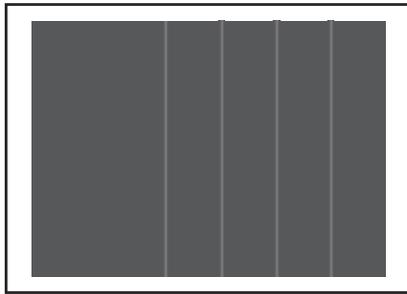
CZC312

White Streaks

White streaks perpendicular to the paper feed direction appear.

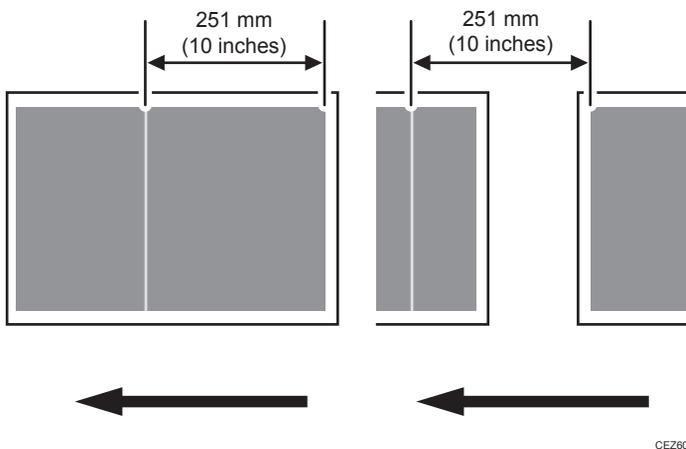
Vertical Glossy Lines

Glossy lines perpendicular to the paper feed direction appear.

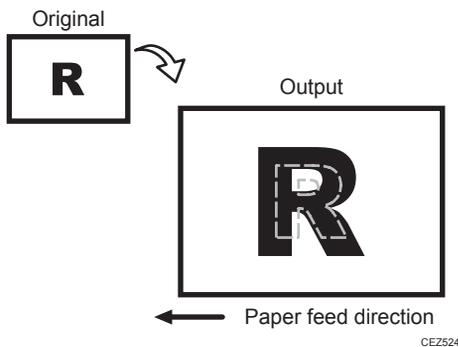
Image Scaling Error on the Side 1 of Paper

An image scaling error may occur because of expansion or contraction of the paper.

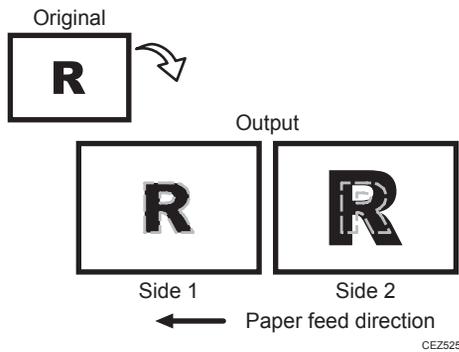
Image Scaling Error on the Side 2 of Paper

An image scaling error on the side 2 of the paper may occur because the paper expands or contracts after the image on the side 1 of the paper has been fused.

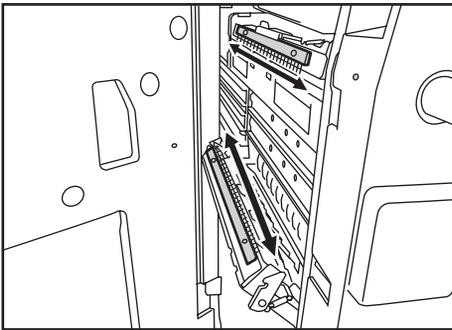
CZC306

Clean the antistatic brushes in the exit transport and inverter transport of the drawer with a blower brush.

- Antistatic brushes in the exit transport and inverter transport

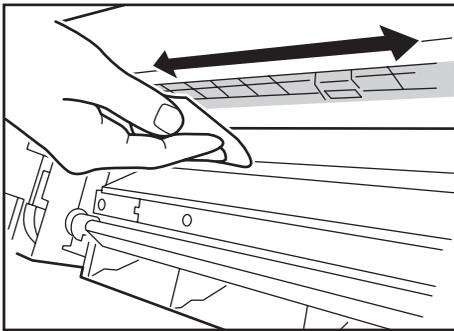
CZC348

Guide Board

Wipe the guide board with a well-wrung-out damp cloth. To clean the innermost recesses, use a cloth that is as large as your palm.

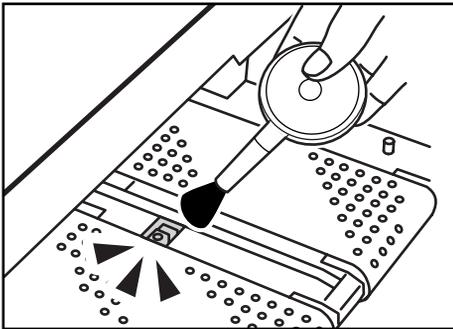
CZC347

Sensor

Remove dust with a blower brush.

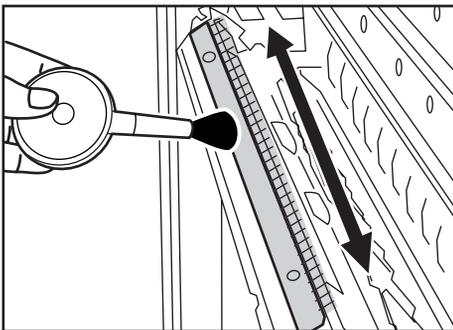
CZC351

Antistatic Brush

Remove dust with a blower brush.

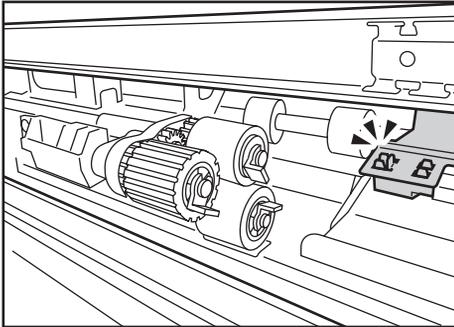
CZC316

2. Clean the sensor.

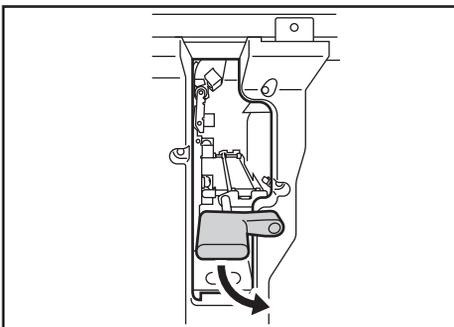
CZC317

2. Pull down the lever A1.

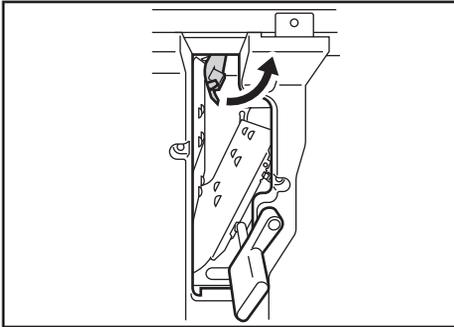
CZC318

3. Pull up the plate.

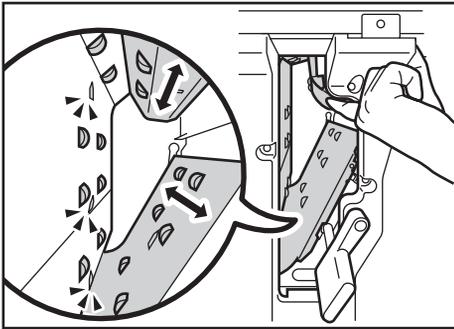
CZC319

4. Clean the rollers, sensors, and guide boards.

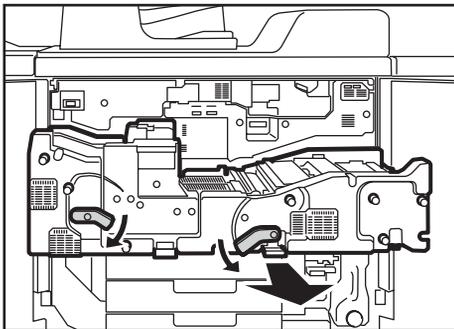
CZC300

2. Pull down the levers C1 and C2, and then pull the drawer out completely until it stops.

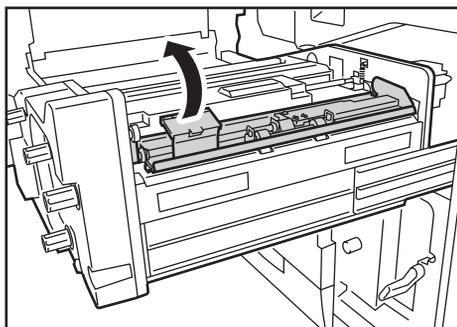
CZC321

3. Pull up and open the cover B6.

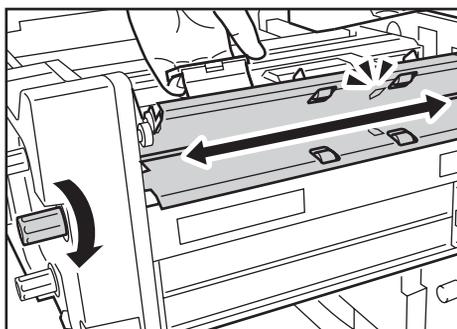
CZC322

4. Clean the rollers while turning the knob B2. Clean the sensors and guide boards also.

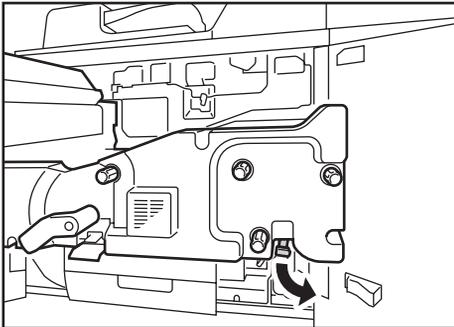
CZC325

7. Pull down and open the cover B3.

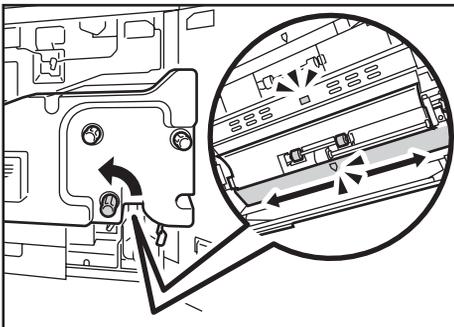
CZC326

8. Clean the rollers while turning the knob B1. Clean the sensors and guide boards also.

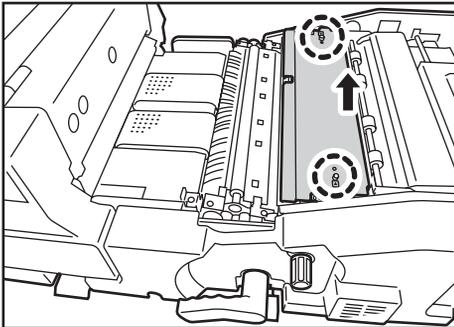
CZC328

10. Remove the 2 screws, and then remove the cover.

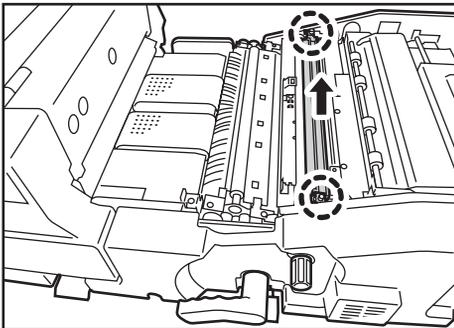
CZC329

11. Remove the 2 screws, and then remove the dust catcher.

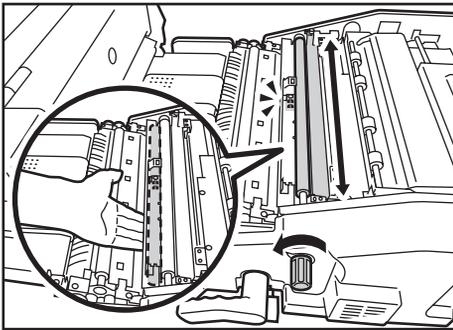
CZC330

13. Clean the roller while turning the knob B5. Clean the sensor, guide board, and roller in the paper transfer unit also.

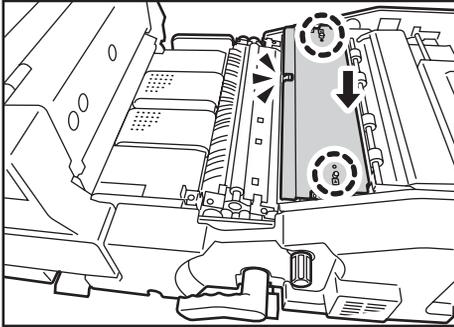
CZC331

15. Attach the cover, aligning the notch on the cover with the claw, and then secure it with the 2 screws.

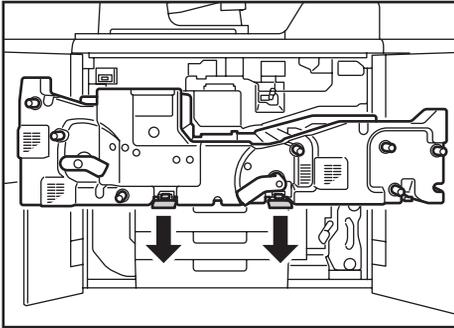
CZC333

16. Pull down the levers Z2 and Z3.

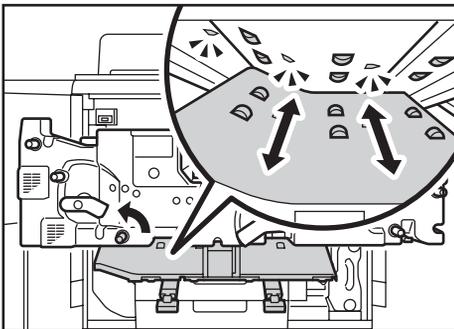
CZC334

17. Clean the left-hand side rollers while turning the knob Z1. Clean the left-hand side sensors and guide boards also.

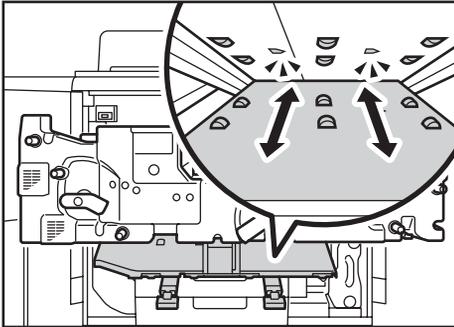
CZC335

18. Clean the right-hand side rollers, sensors, and guide boards.

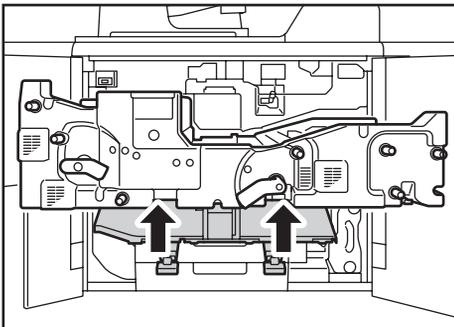
CZC336

19. Pull up the levers Z2 and Z3.

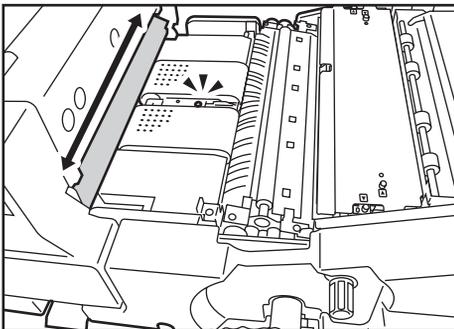
CZC337

20. Clean the sensor and guide board on the entrance of the fusing unit.

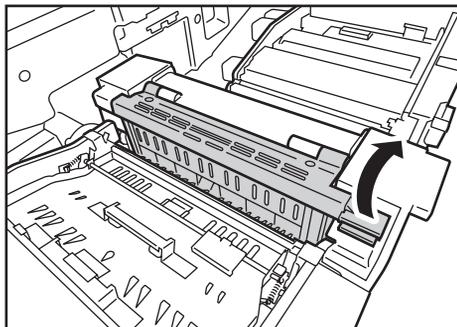
CZC338

21. Pull up and open the cover D2.

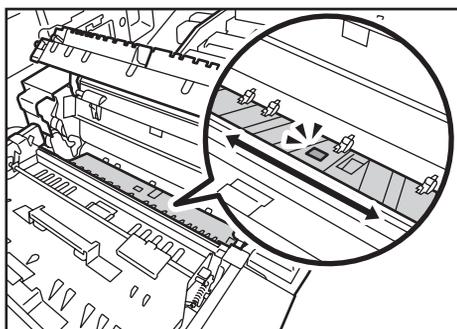
CZC339

22. Clean the sensor and guide board.

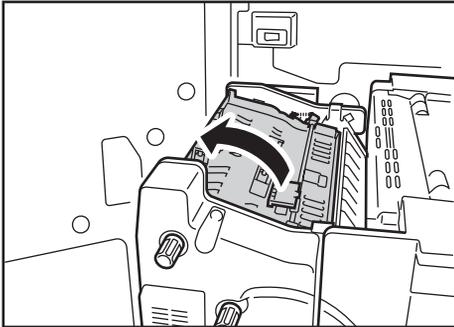
CZC341

24. Pull up and open the cover D3.

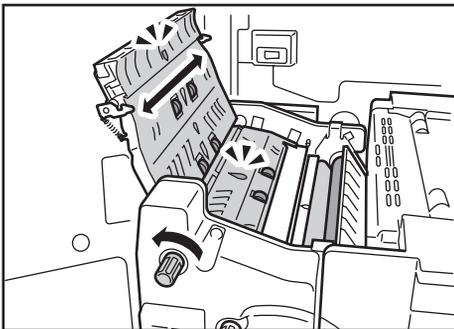
CZC342

25. Clean the rollers while turning the knob D1. Clean the sensors and guide boards also.

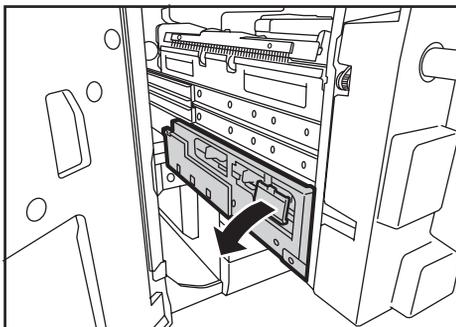
CZC301

27. Pull down and open the cover D4.

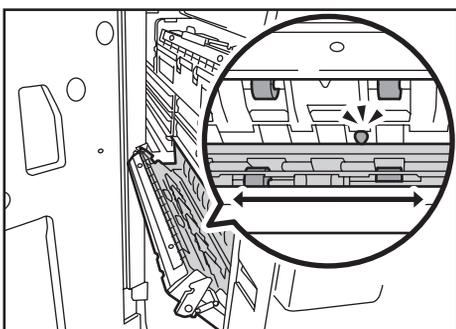
CZC302

28. Clean the rollers, sensor, and guide boards.

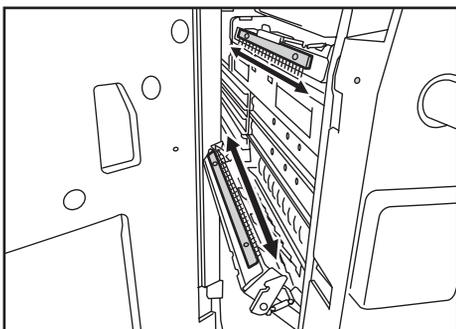
CZC306

29. Clean the antistatic brushes.

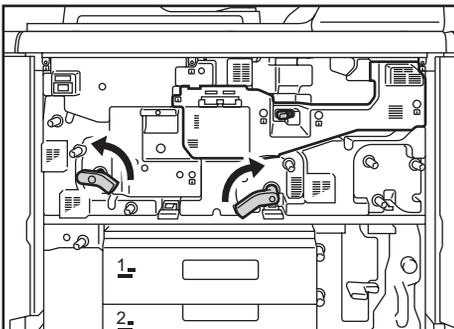
CZC086

32. Pull up the levers C1 and C2.

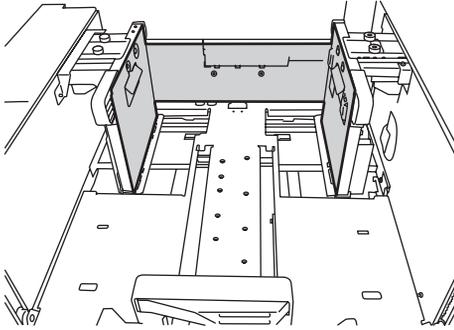
CEZ502

1. Clean the side fences and front guide.

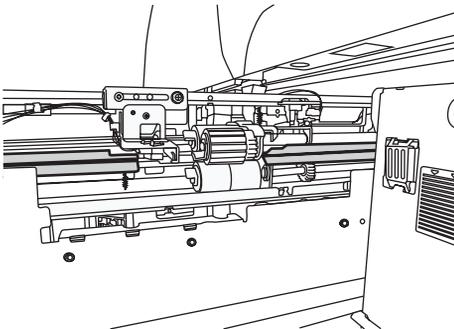
CEZ503

3. Clean the guide board of the paper feed unit.

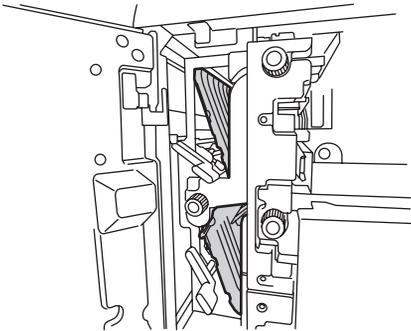
CZC305

4. Clean the guide board interior.

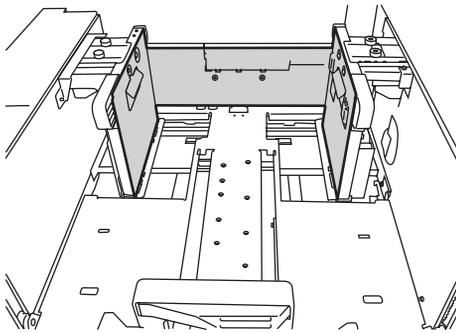
CEZ502

1. Clean the side fences and front guide.

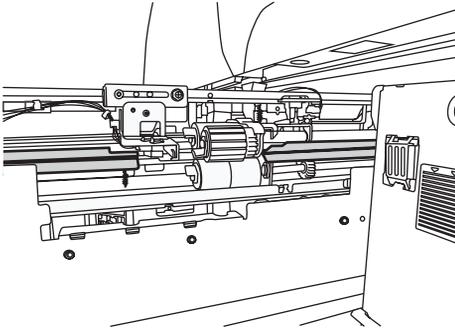
CEZ503

3. Clean the guide board of the paper feed unit.

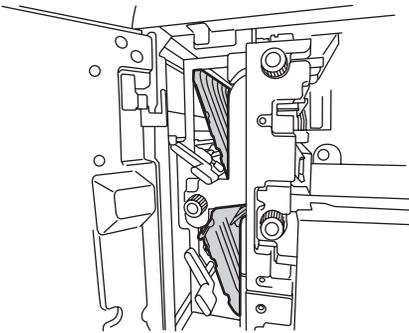
CZC305

4. Clean the guide board interior.

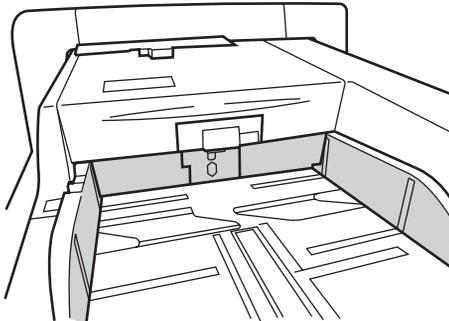
CEZ587

1. Clean the side fences and front guide.

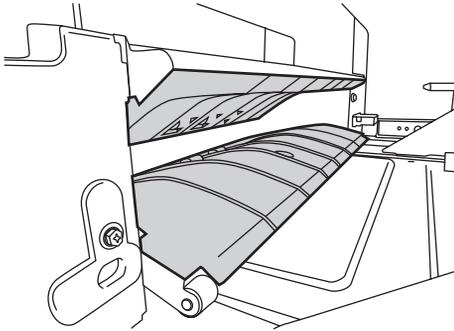
CEZ506

2. Clean the paper feed rollers.
3. Clean the guide board.

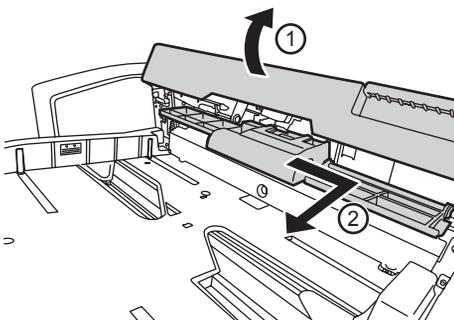
CEZ507

1. Remove the loaded paper.
2. Open the upper cover, and then detach the paper feed unit.

Pull it out slightly, release the metal shaft, and then detach it.

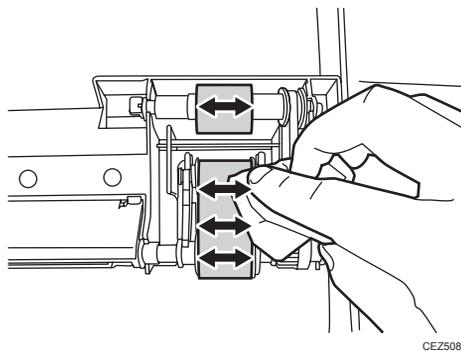
3. Clean the paper feed belt and paper feed rollers in the detached paper feed unit.

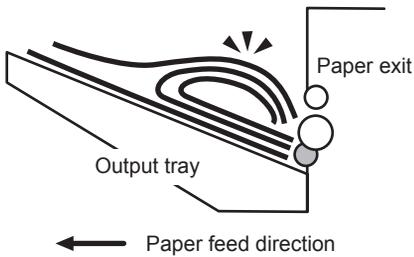
CEZ594

Sheet bending

The leading edge of the delivered sheet bends upward and backward.

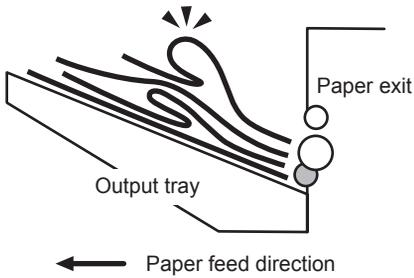
Paper deflection

Because of high paper friction, the delivered sheet may arch up and become crimped.

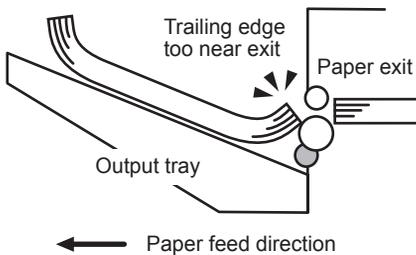
CEZ593

This is likely to occur if:

- There is a tight curl on a delivered set of stapled sheets.
- Limp paper such as thin or recycled paper is used.

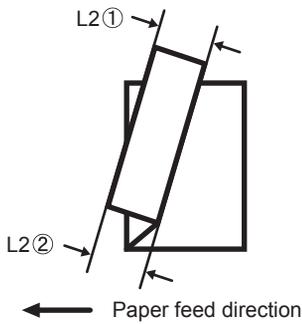
CEZ531

<Folding deviation sample of L2 for Z-fold>

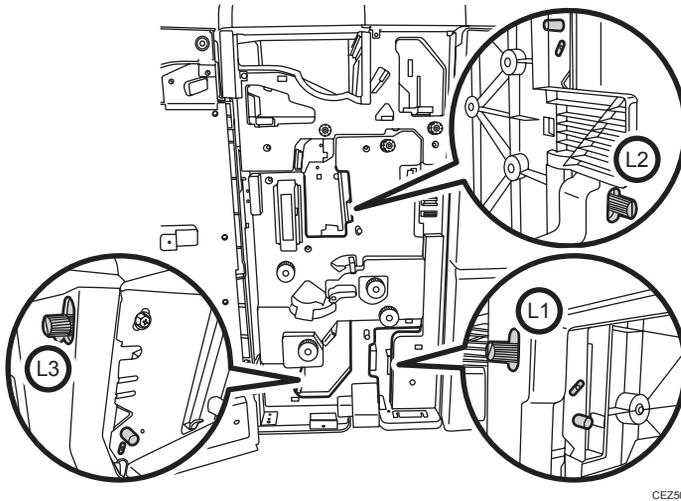
CEZ509

The multi-folding unit has three adjusting screws (L1, L2, and L3) to adjust deviation.

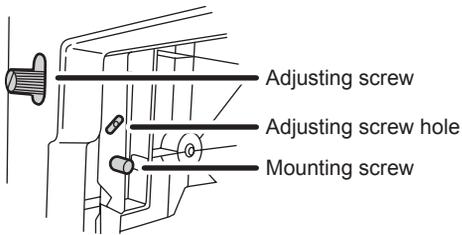
CEZ599

L1

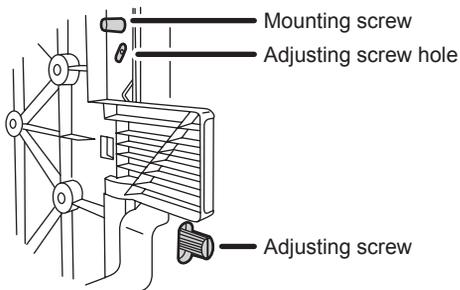
CEZ600

L2

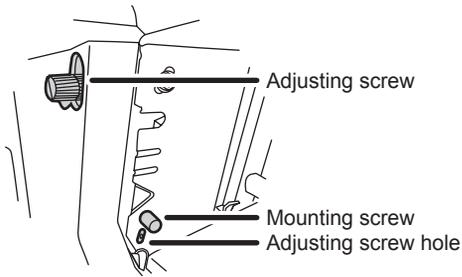
CEZ601

L3

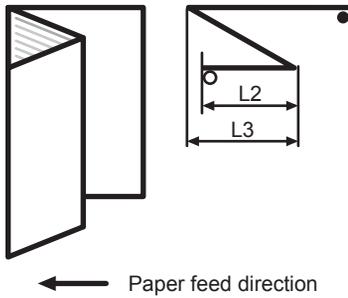
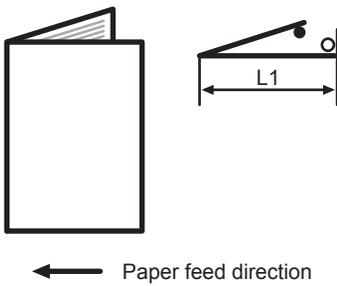
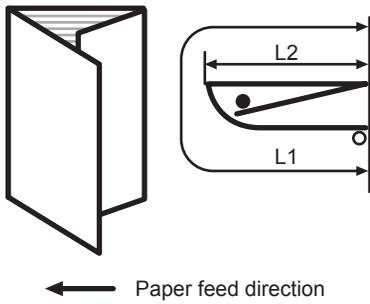
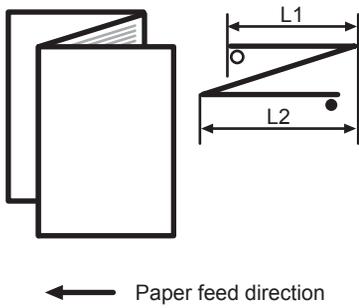
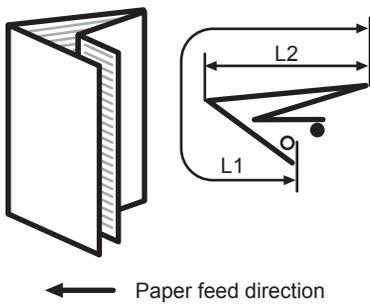
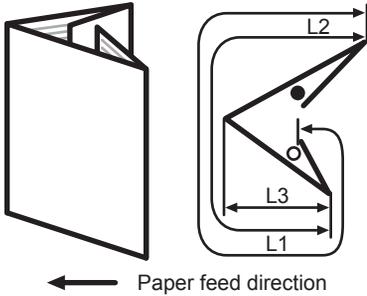
The screws adjust the folding deviations of the following parts:

Z-fold

Half Fold

Letter Fold-in

Letter Fold-out

Double Parallel

Gate Fold

The ○ mark indicates the leading edge (relative to the paper feed direction), and the ● mark indicates the trailing edge.

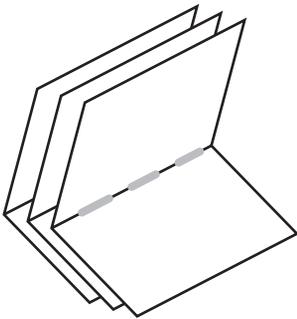
CEZ571

If multi-sheet folding is performed after a large number of Z-folds have been performed, the tip of the blade used for the multi-sheet folding may be soiled, resulting in soiled paper.

This will produce paper soil of 1-3 cm (0.4-1.2 inches) in width (equal to the width of the blade) in the fold in the center of paper.

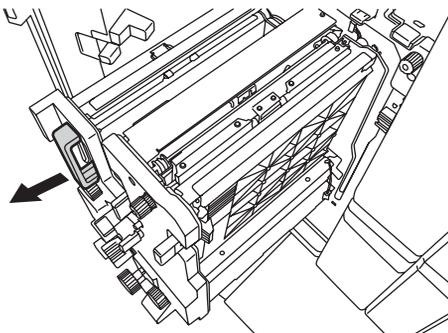
CEZ511

1. Open the front cover of the multi-folding unit.
2. Pull the multi-folding unit out.

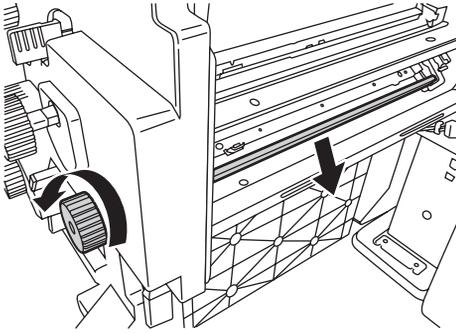
CEZ512

3. Turn the N11 dial counterclockwise until the blade appears.

The blade is located in the right part of the multi-folding unit.

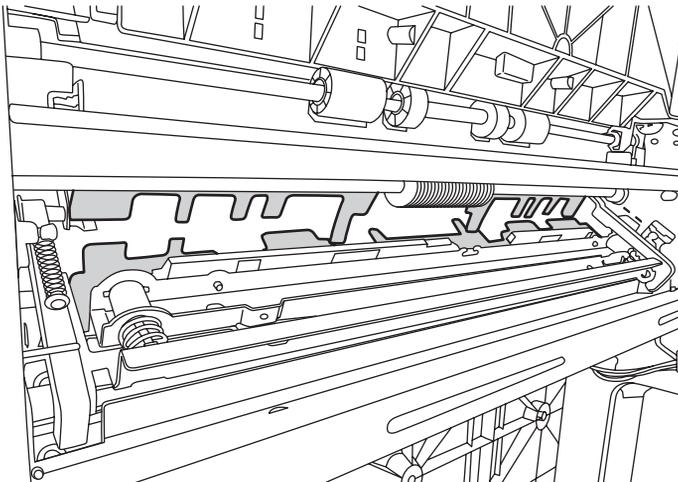
CEZ513

4. Wipe the tip and top of the blade with a soft dry cloth.

Be careful not to damage the blade.

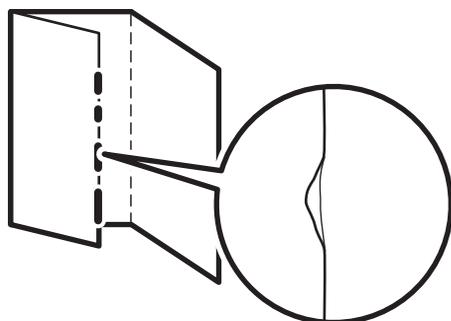
CEZ592

When letter folding is applied, the edge of the inner flap may become bent.

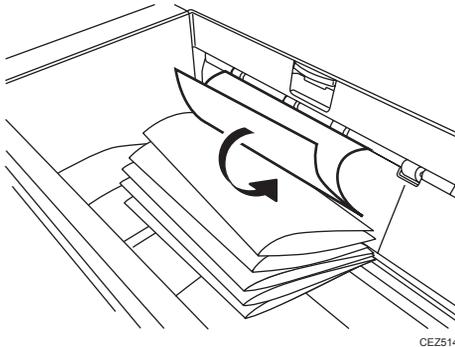
- Thick, relatively stiff paper is used.

As a bundle is delivered, its folded edge may droop and catch on the stacked bundles, causing the delivered bundle to flip over.

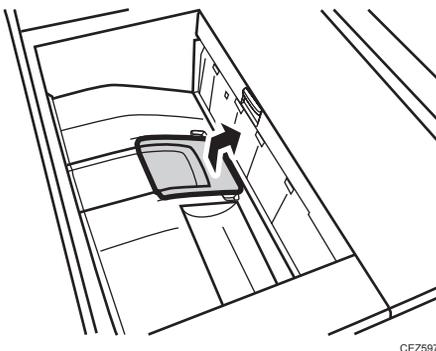
Use the Z-fold support tray for multi-folding unit.

This will reduce the angle of stacked bundles and prevent bundles flipping over as they are delivered.

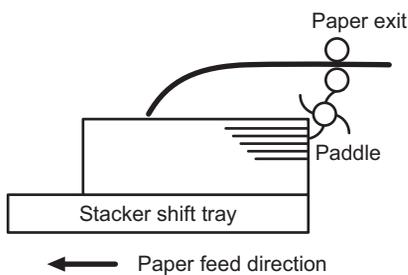
CEZ573

1. Downward curled paper is delivered to the stacker tray.

Sheets with downward curls cause strong friction on the leading edges. This may result in paper misfeeds. Sheets will not be ejected completely and the trailing edges will be left inside the paper exit. If this happens, other sheets may slip under the delivered sheets, so that the delivered sheets may be curled when loaded.

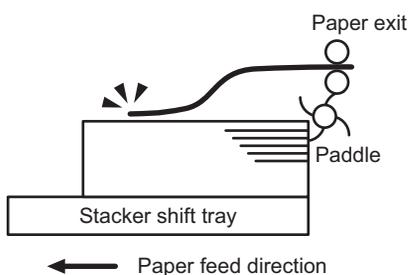
CEZ574

2. The leading edge of the sheet, while delivered, causes strong paper-to-paper friction against the top sheet of the stack. As there is no air gap between the sheets, and the delivered sheet becomes stuck.

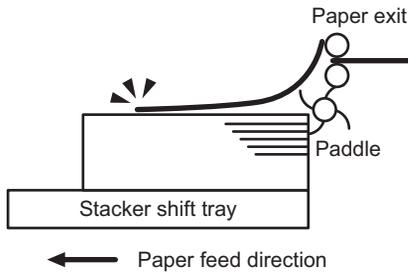
CEZ575

3. The trailing edge of the sheet, while delivered, is left in the paper exit.

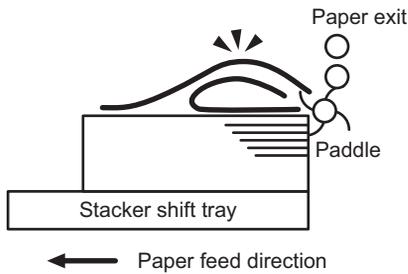
CEZ576

4. The next sheet to be delivered slips under the sheet still in the paper exit and bends back.

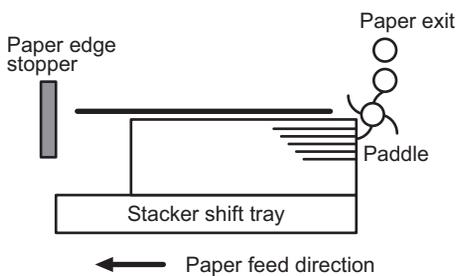
1. An uncurled sheet is delivered to the stacker shift tray.

When sheets are delivered to the stacker tray, because of paper-to-paper friction, the paddle fails to pull the trailing edge back into the front guide, resulting in misalignment.

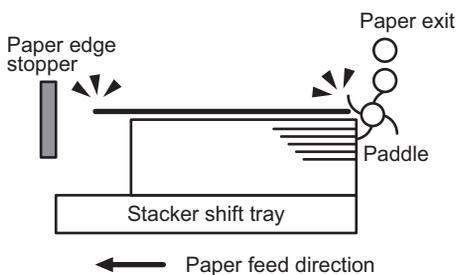
2. Strong friction occurs on the trailing edge so that the paddle cannot pull the sheet back and align the edges of the sheet with those of the stack.

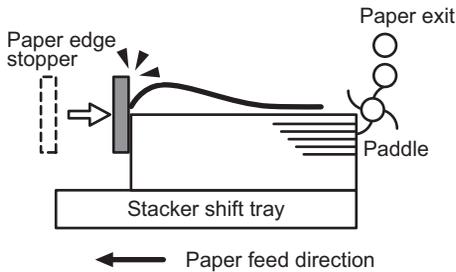
- The paper edge stopper fails to push back the protruding leading edge and align the sheet as required.

The paper edge stopper also fails to push back the protruding leading edge.

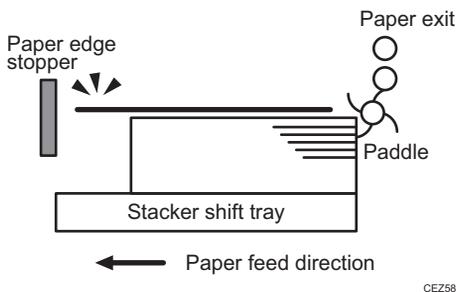
- Stacked sheets are not aligned properly.

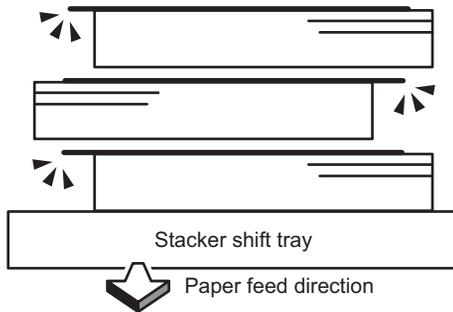
CEZ605

- The top sheet of each offset bundle of delivered sheets may protrude above the rest of the bundle by about 7 mm.
