Pro 8200s/8210s/8220s Pro 8210/8220

Operating Instructions Troubleshooting: TCRU/ORU

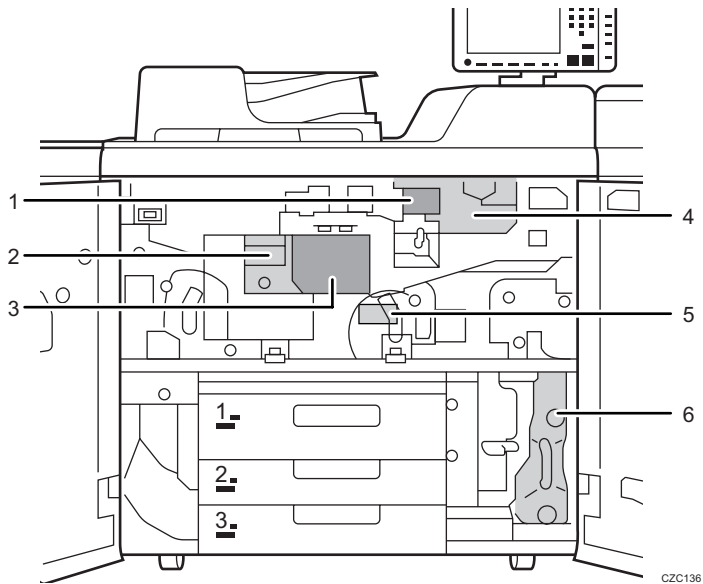
1. Developer Outlet/Inlet
2. Fusing Unit
3. Cleaning Unit for Intermediate Transfer Belt
4. Development Unit
5. Transfer Unit
6. Waste Toner Bottle

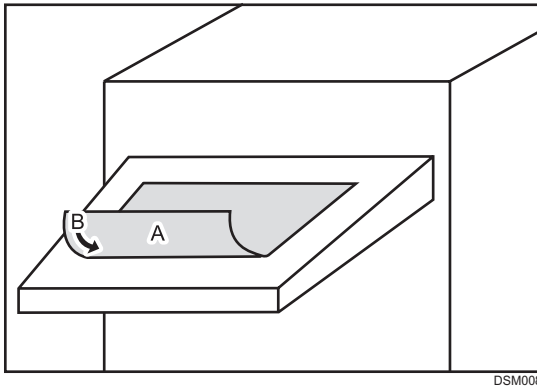
Single-sided printing: Printed side face down

A. Side 1

B. Paper feed direction of Side 1

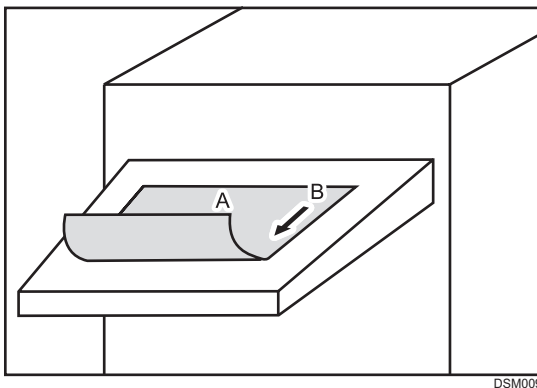
Single-sided printing: Printed side face up

A. Side 1

B. Paper feed direction of Side 1

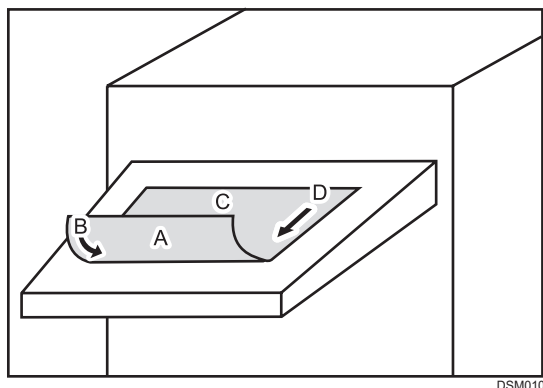
Duplex printing

- A. Side 1
- B. Paper feed direction of Side 1
- C. Side 2
- D. Paper feed direction of Side 2

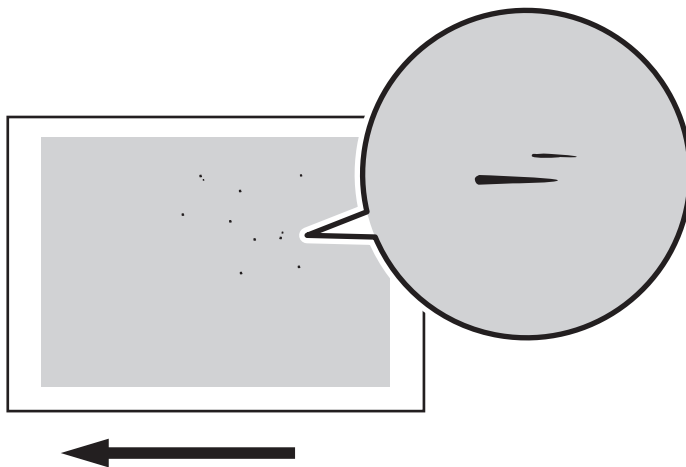
CEZ538

Paper is soiled with toner spots of 0.5–1 mm (0.02–0.04 inches) in diameter.

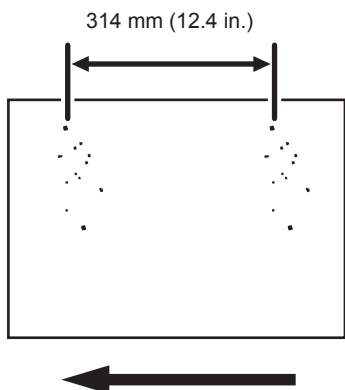
CZC307

Black spots appear at 314 mm (12.4 inches) intervals.

The drum is scratched or stained.

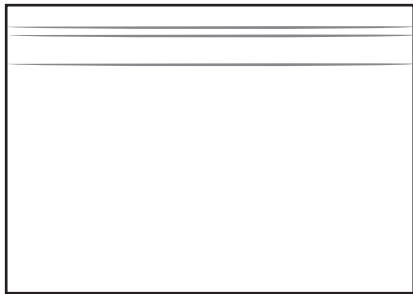
CZC346

Streaks parallel to the paper feed direction appear.

- The charger is stained.
- The cleaning unit for PCU has worn out.
- The drum surface is scratched.

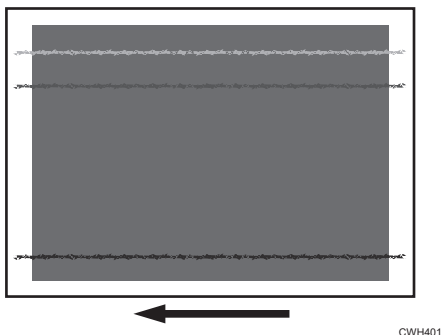
CWH401

Extended, blurred streaks parallel to the paper feed direction appear. The streaks also appear randomly in the margins.

If the temperature or humidity is low, remaining toner might be missed by the cleaning blade of the cleaning unit for intermediate transfer belt or transfer unit, causing streaks to appear sporadically.

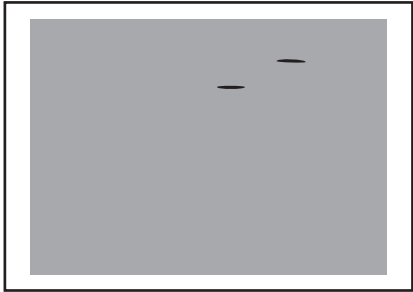
CEZ542

Streaks appear in solid-filled areas.

If the toner contains small clumps, they disintegrate in the development unit, producing streaks. This problem may occur if the machine is left unattended for a long period or the toner bottle is kept out of its moisture-proof bag for a long period.

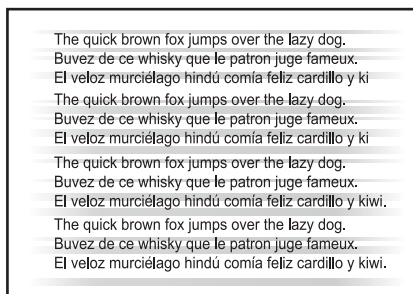
DTH009

Irregular black streaks appear, running parallel to the feed direction. This occurs on both sides regardless of whether printing one-sided or duplex.

If the machine remains in standby mode without paper or toner in it for a long time, friction between the pressure roller and the cleaning web may cause dust to accumulate, resulting in streaks.

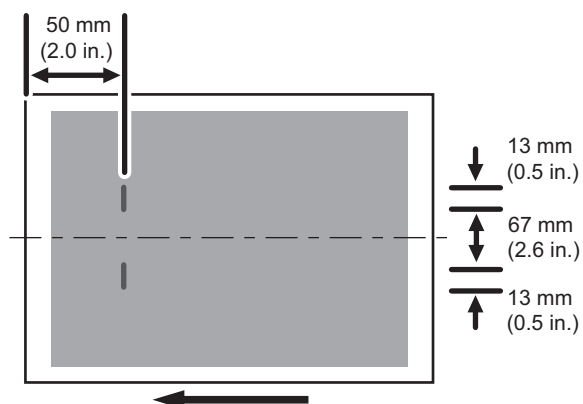
CZC313

Two 13-mm long vertical streaks appear within 50 mm (2.0 inches) from the leading edge.

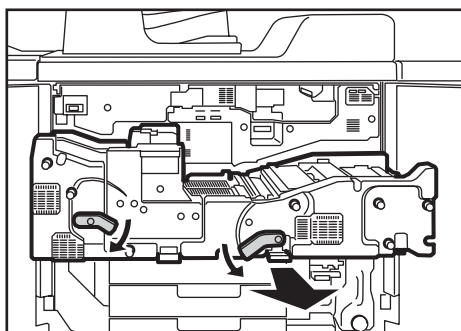
CZC300

1. Make sure that the system is turned off and the machine power cord is disconnected from the power source.
2. Open the front covers.
3. Lower the levers C1 and C2, and then pull the drawer out completely until it stops.

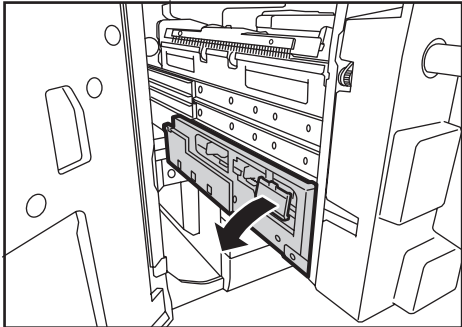
CZC301

4. Pull down and open the cover D4.

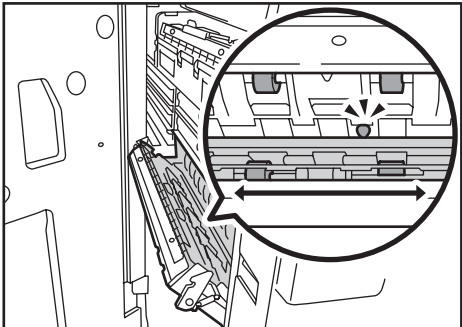
CZC302

5. Clean the rollers, sensors, and guide boards.

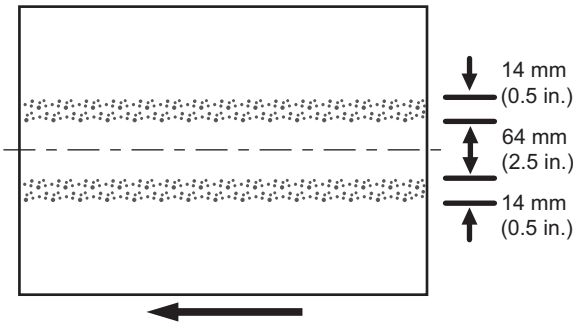
CZC314

Two 14-mm wide streaks parallel to the paper feed direction appear.

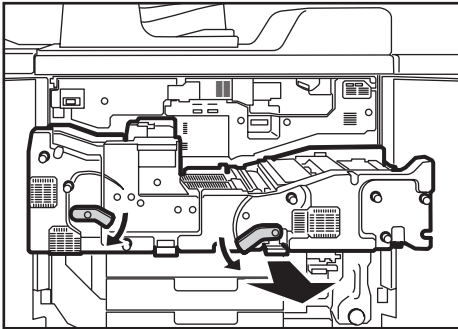
CZC300

1. **Make sure that the system is turned off and the machine power cord is disconnected from the power source.**
2. **Open the front covers.**
3. **Lower the levers C1 and C2, and then pull the drawer out completely until it stops.**

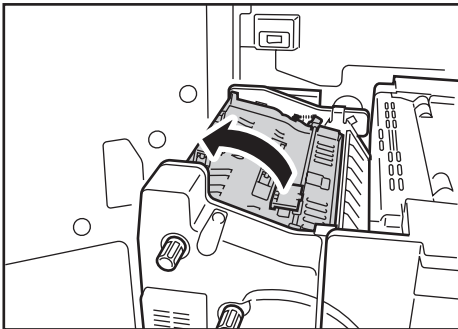
CZC341

4. **Pull up and open the cover D3.**

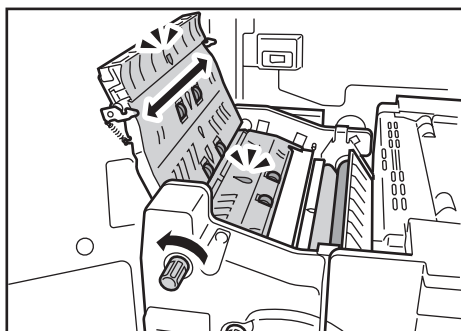
CZC342

5. **Clean the rollers while turning the knob D1. Clean the sensors and guide boards also.**

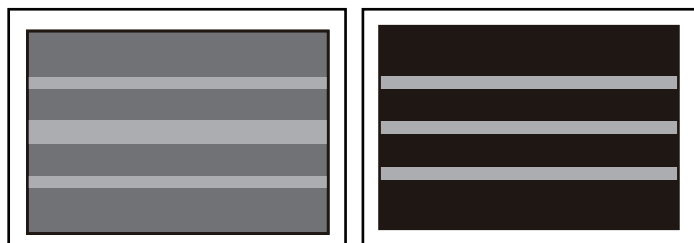
DFP322

White bands parallel to the paper feed direction appear.

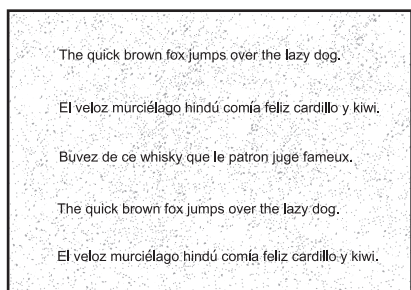
CEZ543

Completely stained background

This may occur because of wearing of the developer, drum unit, or charger.

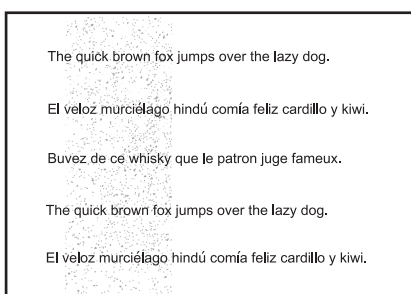
CEZ544

Partially stained background

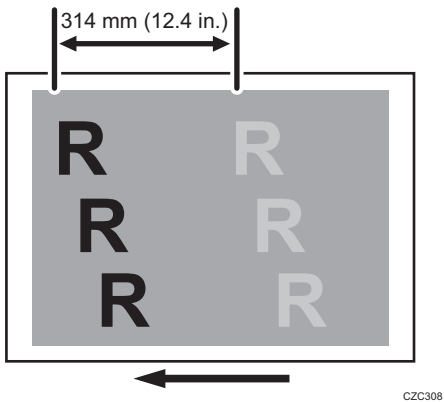
A ghost image of an image to be printed appears at a distance of 314 mm (12.4 in.) to the side of the intended image.

The image transfer current is transmitted to the drum, where a potential difference occurs between a developed area and non-developed area and causes the intended image to be reproduced.

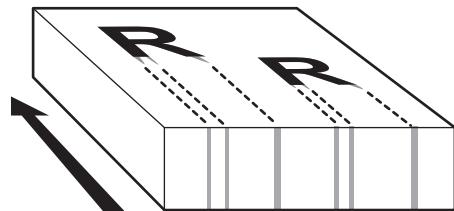
CNT008

Scratched images or soiled paper edges appear.

When a relatively stiff, thick paper is delivered, the entrance guide board for the transfer unit is warped toward the intermediate transfer belt due to the stiffness of the paper. The edge of the entrance guide board comes into contact with the toner on the belt to cause images to be scratched and paper edges to be soiled.

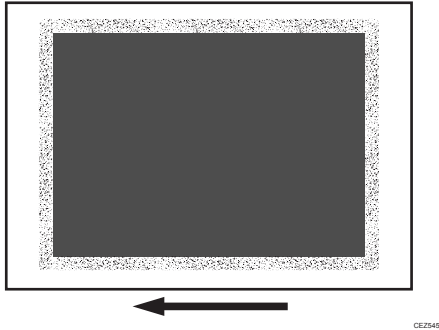
Toner is scattered around a solid-fill print.

This may occur if printed at low temperature or humidity.

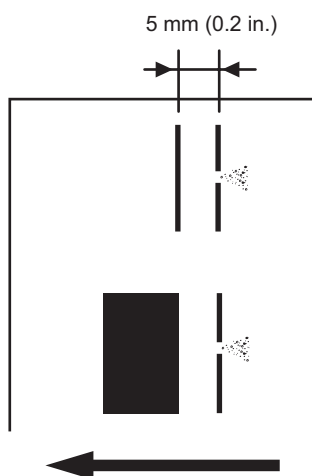
CZC309

Parts of a line that is 5 mm (0.2 inches) or less from an image exhibit splatter.

- Printing is done at high temperature or humidity
- Using coated or other slippery paper
- Printing line images at less than 5 mm (0.2 inches) intervals

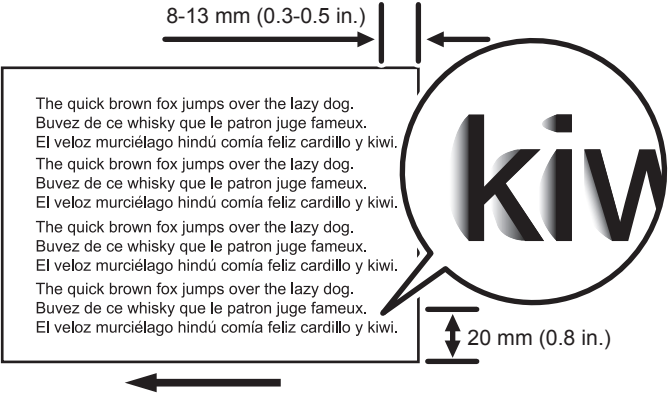
CNT009

Parts of a line or character exhibit splatter. This may occur in a line or character that is 8 to 13 mm (0.3 to 0.5 inches) from the trailing edge and 20 mm (0.8 inches) or less from the left edge facing the paper feed direction.

A shock jitter occurs when the trailing edge of the paper leaves the paper guide during paper transfer and causes toner scattering.

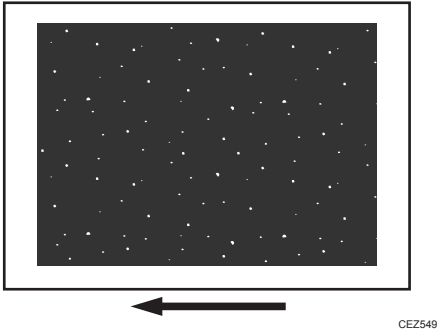
White spots of 0.2–0.3 mm (0.008–0.01 inches) in diameter appear.

This may occur if printed at low temperature or humidity.

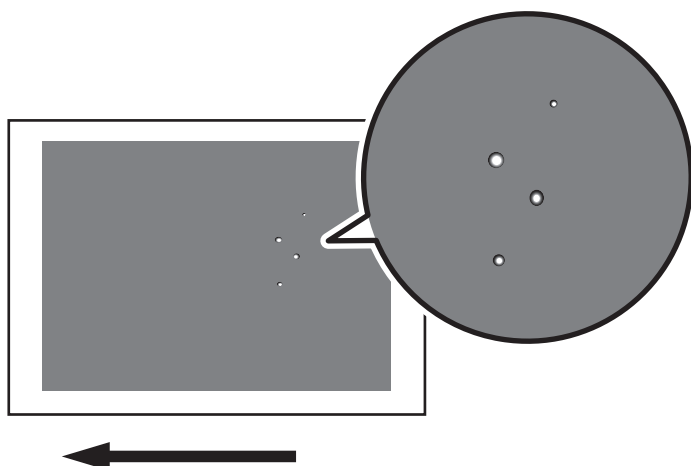
CEZ602

White spots 0.3–0.5 mm (0.01–0.02 inches) in diameter surrounded by denser spots (blister-like white spots) appear.

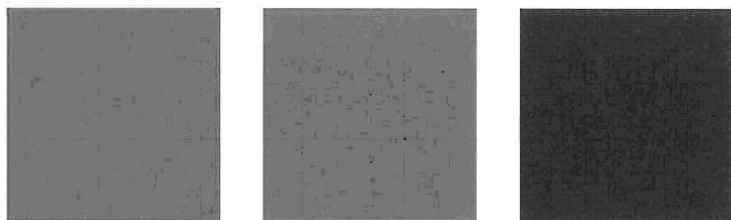
Normal

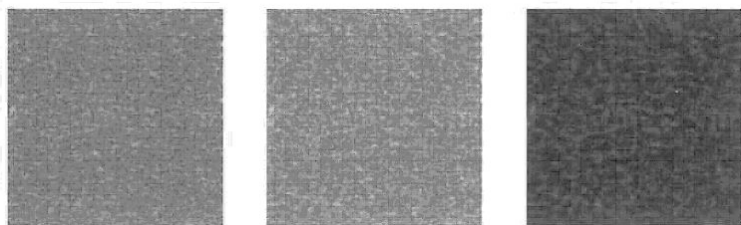
Mottling occurs in solid-filled areas.

Mottled

The transfer electric field on the concave portion of paper is weakened to cause a decrease in transcription.

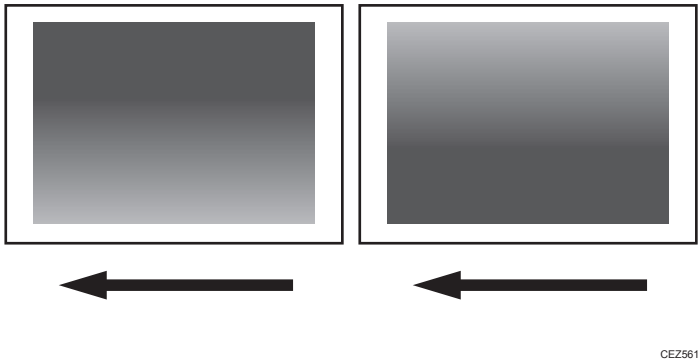
The density is uneven from top to bottom.

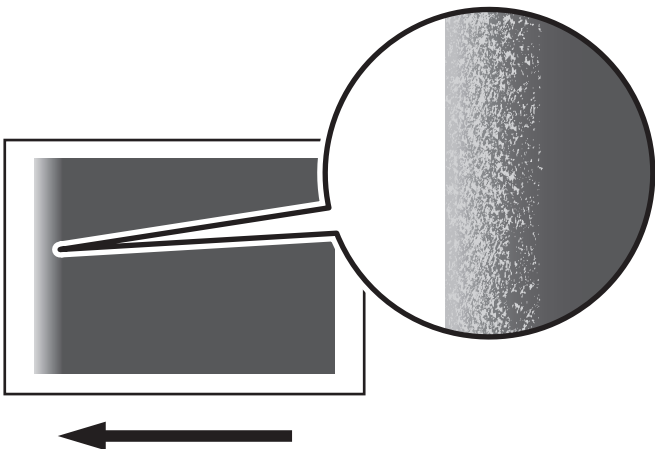
CEZ562

The leading edge is fainter.

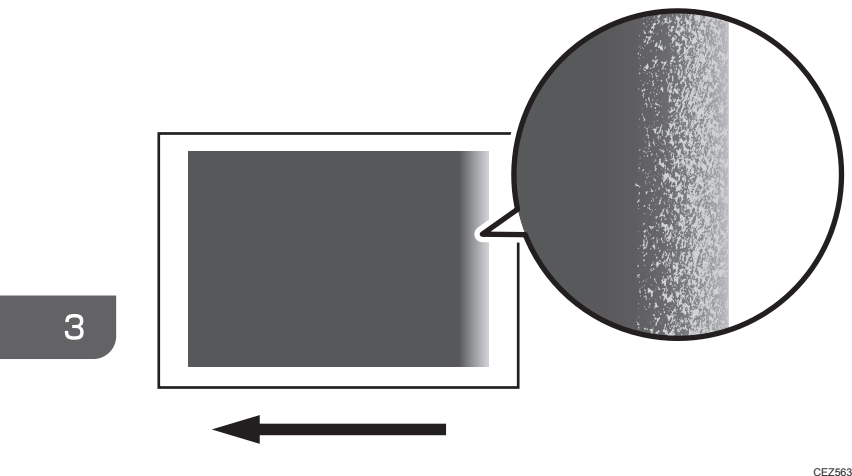
CEZ563

The trailing edge is fainter.

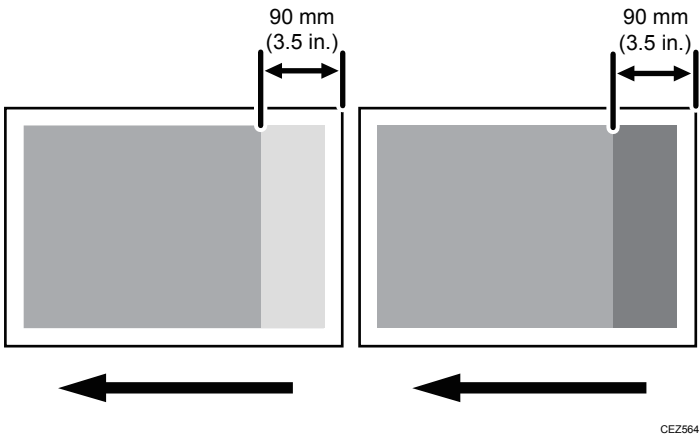
Printing in the area extending approximately 90 mm (3.5 inches) from the trailing edge is fainter or denser.

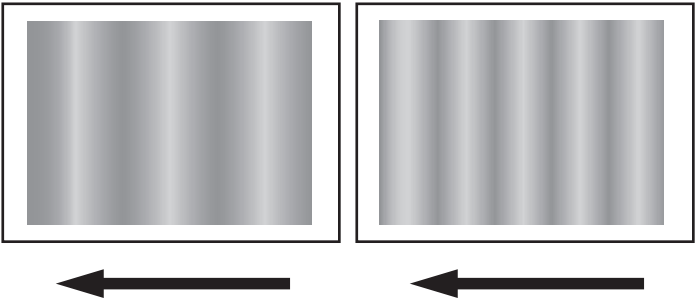
CWH407

The vertical density fluctuates periodically.

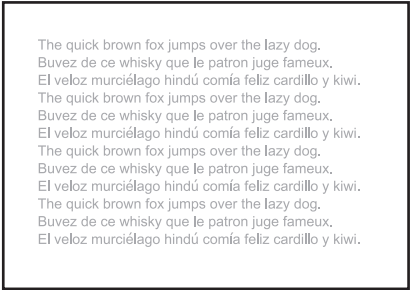
CEZ585

The entire image is fainter than normal.

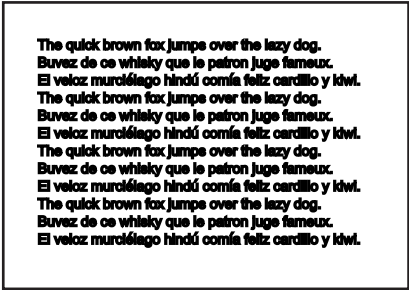
The entire image is denser than normal.

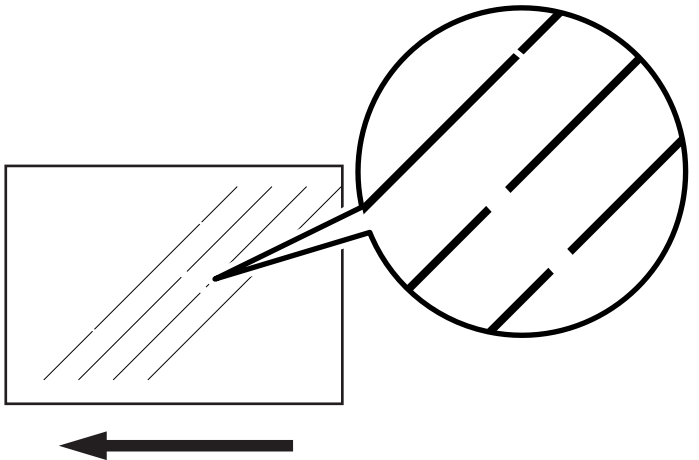
CEZ569

Thin lines (1 dot lines in 1200 dpi images) break.

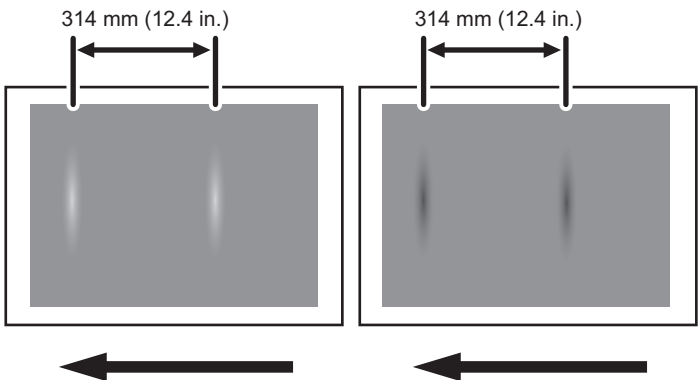
CZC310

Lens-shaped blurred images appear at 314 mm (12.4 inches) intervals.

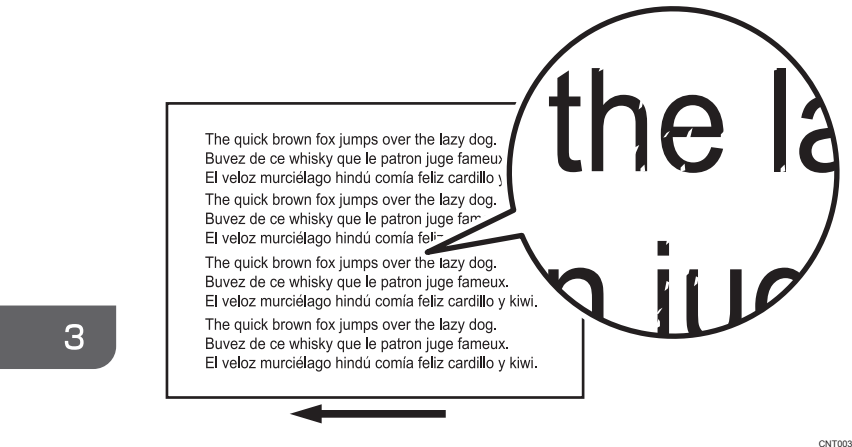
Dropouts (Character Voids)

Dropouts (character voids) occur when characters or lines are printed.

- Continuously printing an image that consumes much toner
- The machine has not been used for a long time
- The machine is located somewhere very humid and has not been used for a while

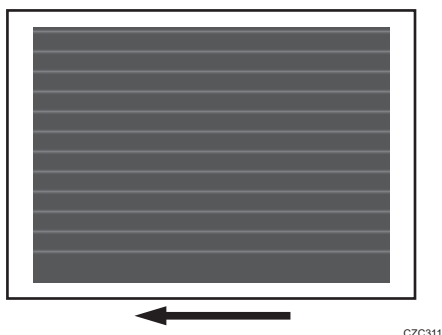
Afterimages

An afterimage of the image printed just before the intended image appears.

- Printing is done at high temperature or humidity
- Printing on thin coated paper (Paper Weight 3 or lower) or on transparent film
- Printing an extremely different type of image

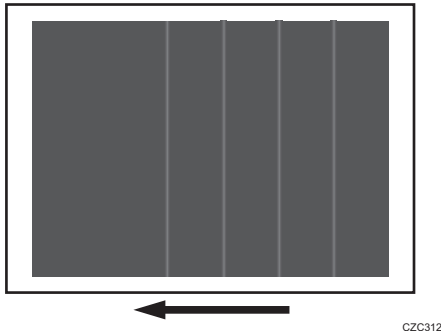
White Streaks

White streaks perpendicular to the paper feed direction appear.

A separating discharge occurs between the intermediate transfer belt and paper edge during paper transfer, which causes a streak-like electric charge on the intermediate transfer belt. This residual electric charge may cause white streaks during image transfer.

This may occur at low temperature or humidity.

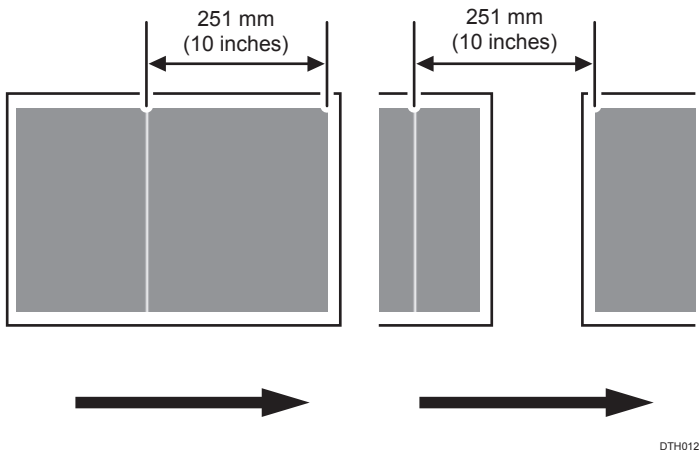
Glossy lines perpendicular to the paper feed direction appear.

Glossy lines perpendicular to the paper feed direction may appear 251 mm (10 inches) from the boundary of the margin and the solid image (in the paper feed direction).

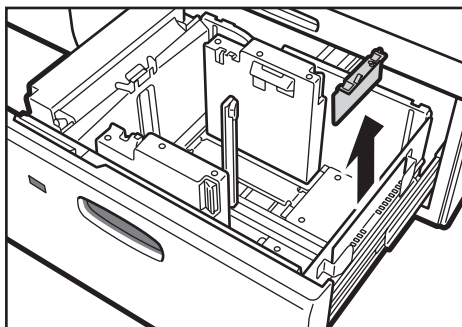
DTH010

1. Remove the tab fence (small) from the pocket on the right side of the paper tray, and set the tab fence.

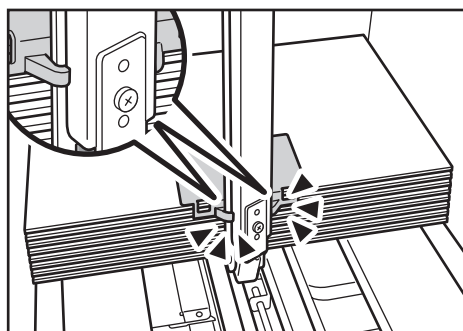
DTH011

2. Align the side fence with the paper size, and place the paper.
3. Attach the tab fence (small), and then align the end fence gently against the paper you loaded while pressing the release button of the end fence.

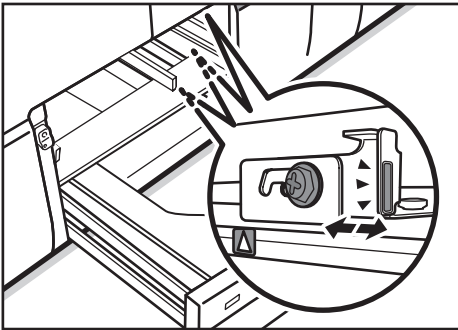
DTH015

Each of trays 1 to 3 is provided with a separation pressure adjuster, which can be set to one of three separation pressure levels.

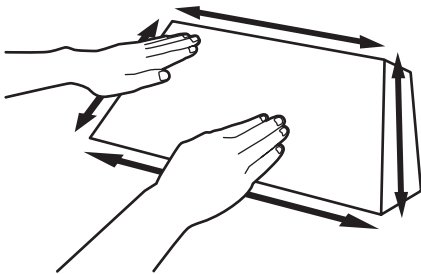
CEZ500

Flatten the envelope and all its edges to eliminate air before loading. If the envelope is curled, decurl it before loading.

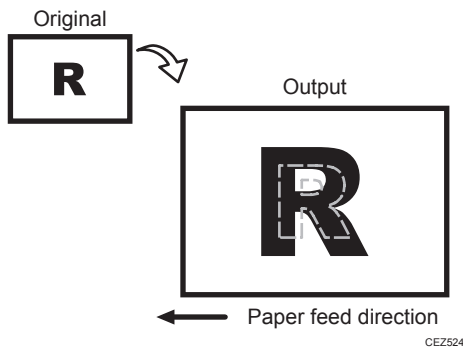
Image Scaling Error on the Side 1 of Paper

An image scaling error may occur because of expansion or contraction of the paper.

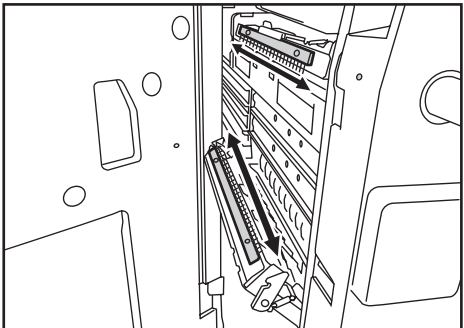
CZC306

Clean the antistatic brushes in the exit transport and inverter transport of the drawer with a blower brush.

- Antistatic brushes in the exit transport and inverter transport

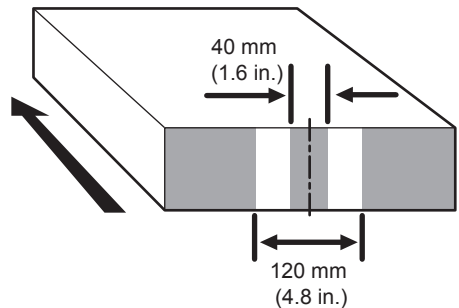
Paper Edges Are Soiled (3)

The paper feed speed of the decurler unit is too high.

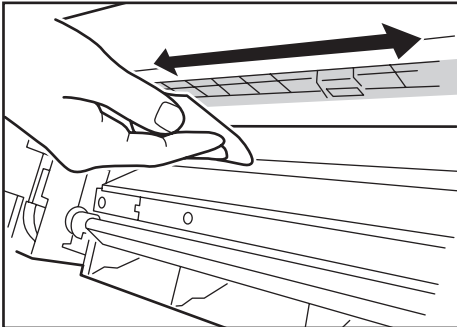
CZC348

Guide Board

Wipe the guide board with a well-wrung-out damp cloth. To clean the innermost recesses, use a cloth that is as large as your palm.

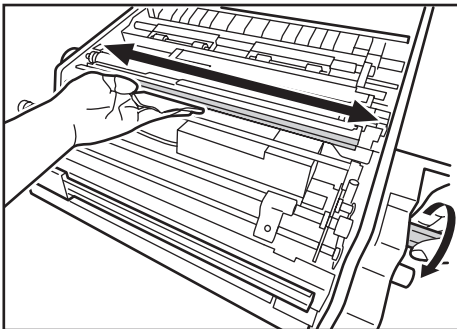
CZC349

Roller

Wipe the roller with a well-wrung-out damp cloth, and then wipe with a dry, unused, lint-free cloth until no moisture remains.

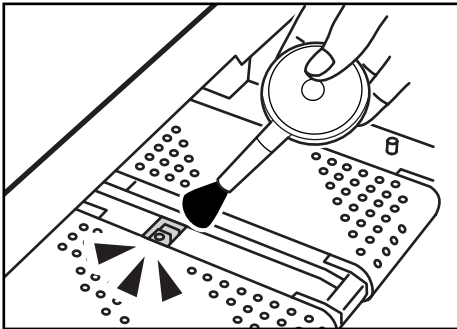
CZC347

Sensor

Remove dust with a blower brush.

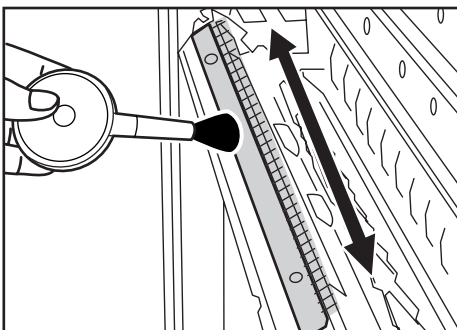
CZC351

Antistatic Brush

Remove dust with a blower brush.

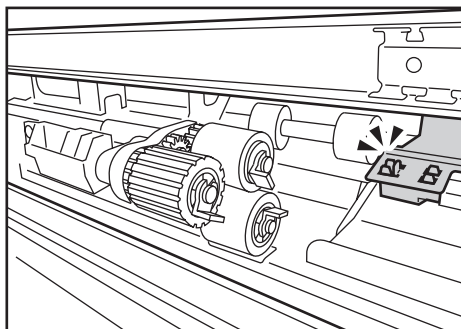
CZC316

2. Clean the sensor.

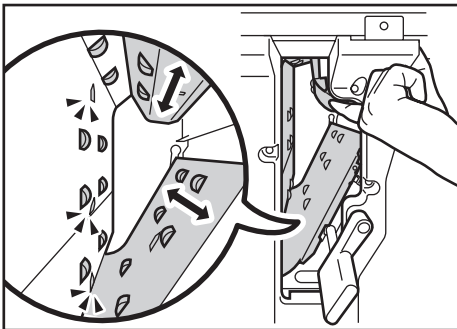
CZC319

4. Clean the rollers, sensors, and guide boards.

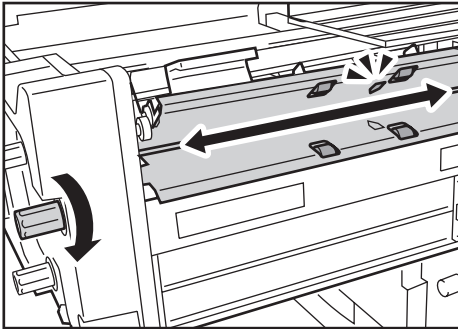
DTH018

4. Clean the rollers while turning the knob B2. Clean the sensors and guide boards also.

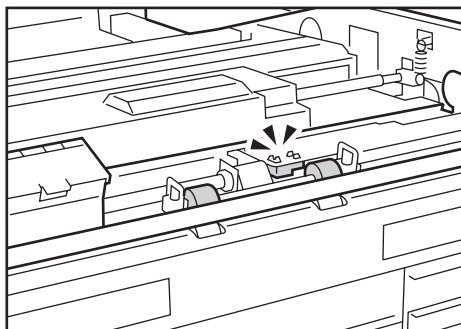
CZC324

6. Clean the rollers and sensors.

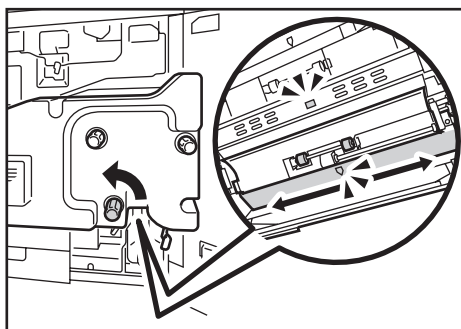
CZC326

8. Clean the rollers while turning the knob B1. Clean the sensors and guide boards also.

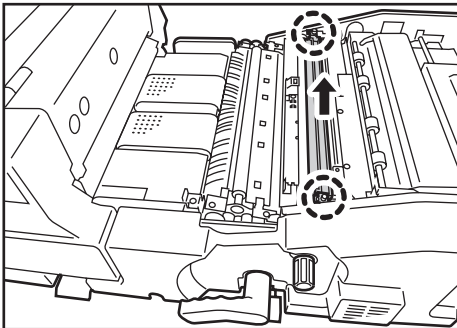
CZC329

11. Remove the 2 screws, and then remove the dust catcher.

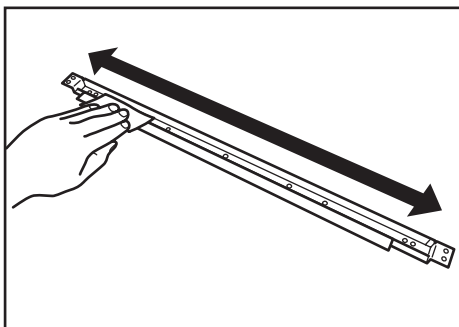
CZC345

12. Clean the dust catcher.

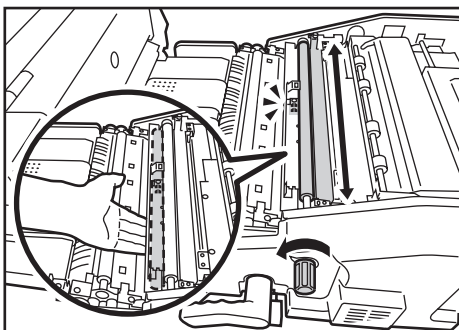
CZC330

13. Clean the roller while turning the knob B5. Clean the sensor, guide board, and roller in the paper transfer unit also.

Paper dust sticking to the paper transfer guide board, roller, paper feed roller, or sensor may cause white spots, paper jam, or double feeding. Clean the paper feed path from the paper tray to the paper exit in the drawer.

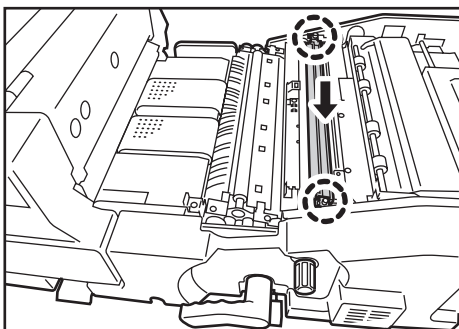
CZC332

14. Attach the dust catcher, and then secure it with the 2 screws.

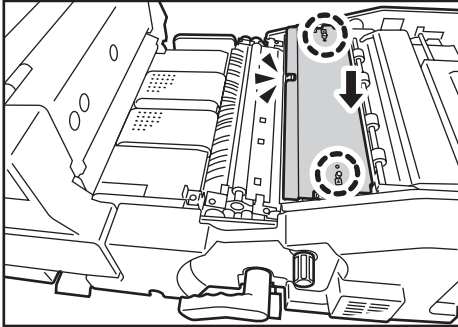
CZC331

15. Attach the cover, aligning the notch on the cover with the claw, and then secure it with the 2 screws.

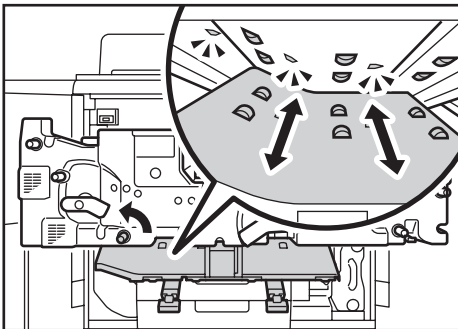
CZC334

17. Clean the left-hand side rollers while turning the knob Z1. Clean the left-hand side sensors and guide boards also.

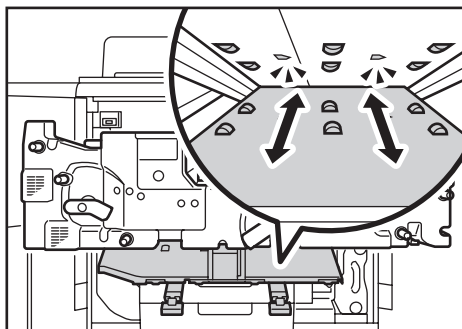
CZC335

18. Clean the right-hand side rollers, sensors, and guide boards.

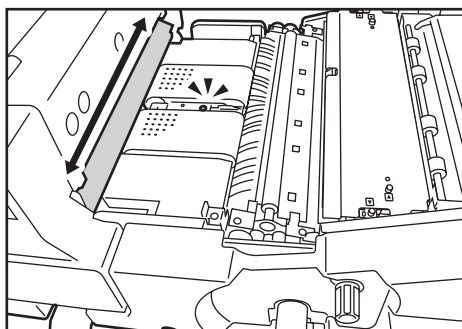
CZC337

20. Clean the sensor and guide board on the entrance of the fusing unit.

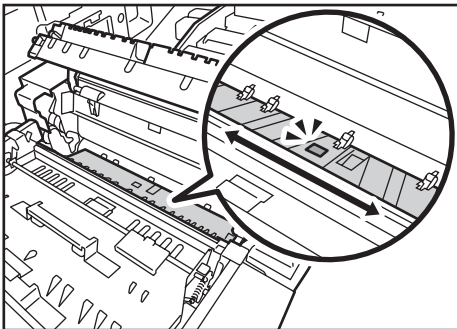
CZC339

22. Clean the sensor and guide board.

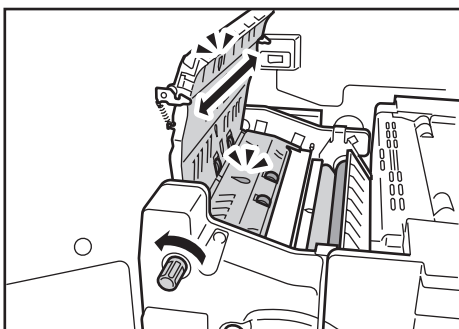
DTH021

25. Clean the rollers while turning the knob D1. Clean the sensors and guide boards also.

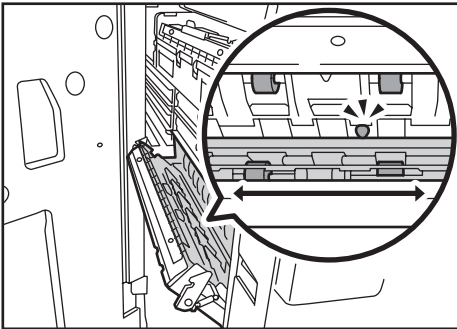
CZC302

28. Clean the rollers, sensor, and guide boards.

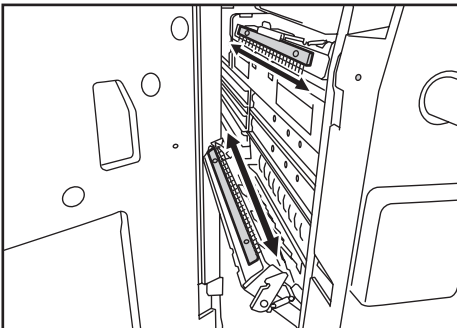
CZC306

29. Clean the antistatic brushes.

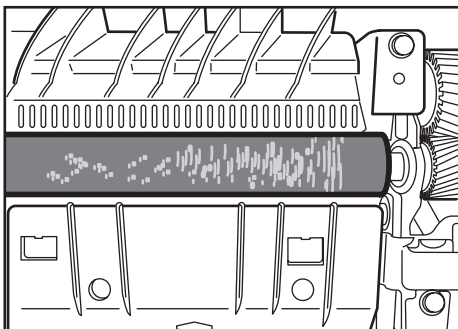
DTH024

Refer to the following figures to determine whether the paper transfer unit needs to be replaced.

Paper transfer unit still usable after cleaning

If there is a significant amount of dirt and dust on the paper transfer roller, the paper transfer unit needs to be replaced.

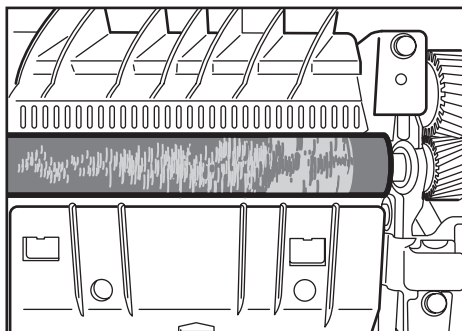
DTH025

Paper transfer unit needs replacing

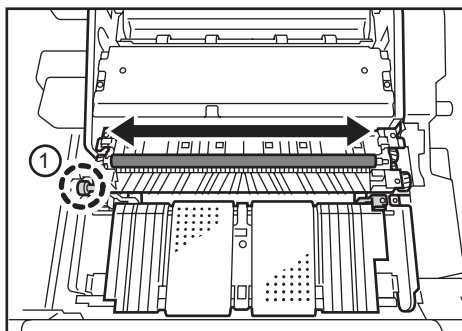
DTH026

1. Rotating the roller by turning the deep side of the drive axis clockwise (1), wipe the roller in the direction of the arrow from the front to the back.

Clean the roller until there is no visible dirt or dust on the entire circumference of the paper transfer roller.

If toner stains or black streaks appear, wipe the paper transfer roller with a rag or other dry cloth.

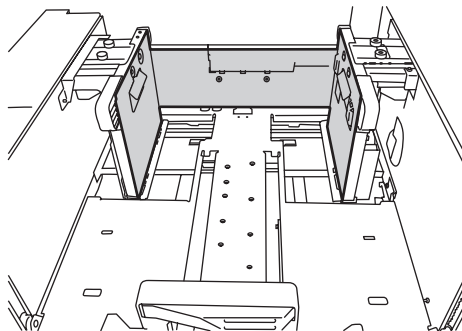
CEZ502

1. Clean the side fences and front guide.

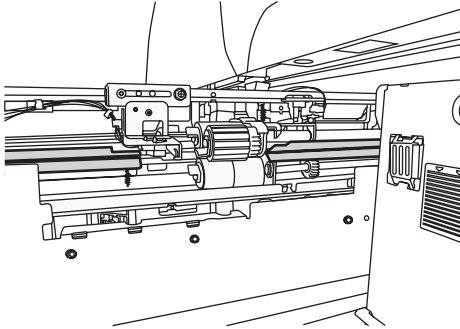
CEZ503

3. Clean the guide board of the paper feed unit.

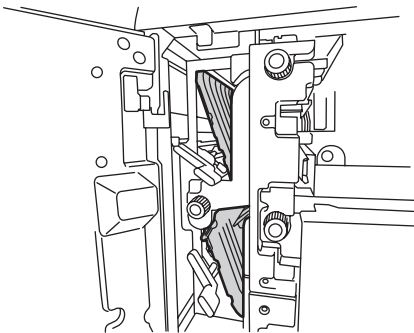
CZC305

4. Clean the guide board interior.

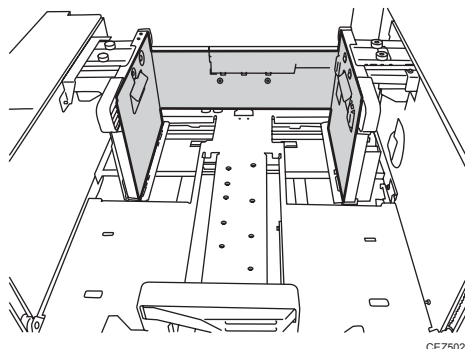
1. Clean the side fences and front guide.

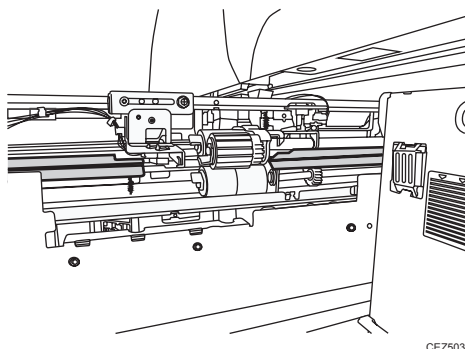
2. Clean the paper feed rollers.
3. Clean the guide board of the paper feed unit.

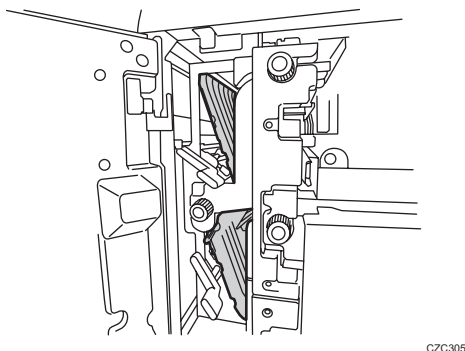
4. Clean the guide board interior.

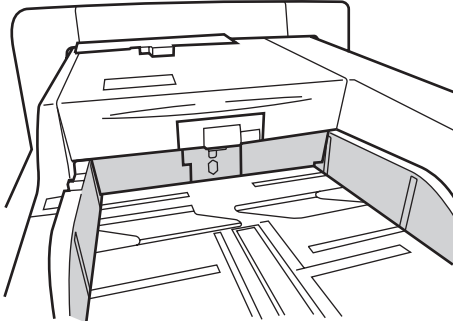
CEZ587

1. Clean the side fences and front guide.

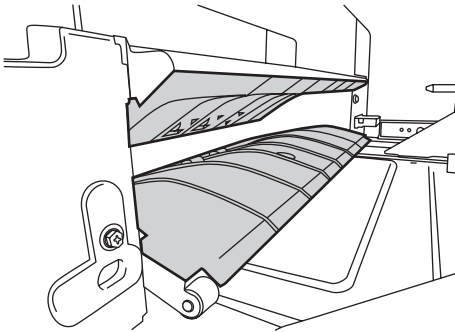
CEZ506

2. Clean the paper feed rollers.
3. Clean the guide board.

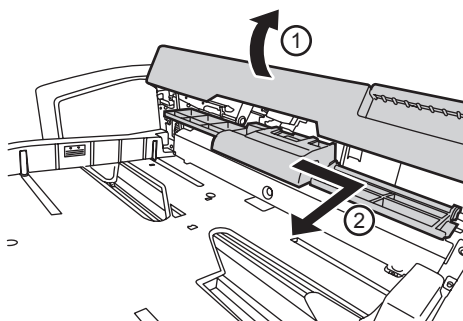
1. Remove the loaded paper.
2. Open the upper cover, and then detach the paper feed unit.

Pull it out slightly, release the metal shaft, and then detach it.

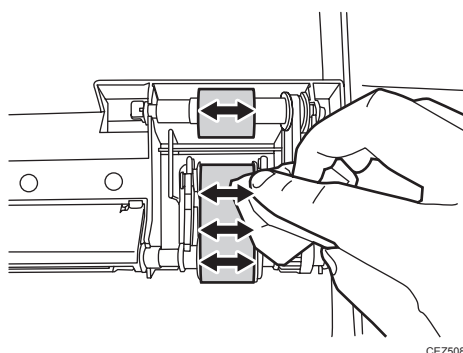
3. Clean the paper feed belt and paper feed rollers in the detached paper feed unit.

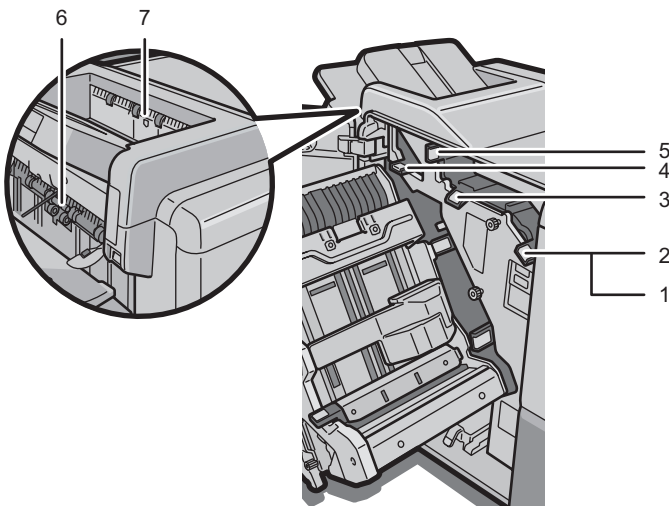
DVX001

Perform the following cleaning steps from Steps 1 to 7 in this order:

When a sheet with a high-density image on it is delivered or when the toner is not fused well, toner may stick to the rollers and guide boards in the finisher, where it may stain the transfer surface or sheet edge.

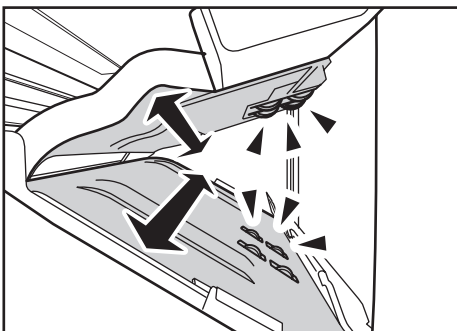
DVX004

1. Open the guide board (Rb1) and clean the rollers and guide board.

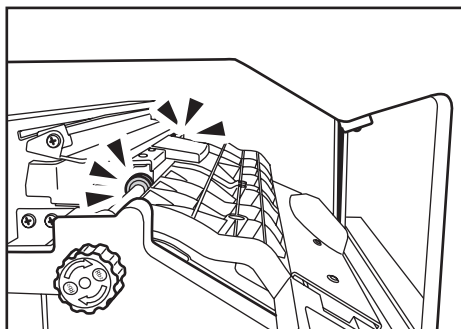
DVX002

2. Close the guide board (Rb1) and clean the rollers.

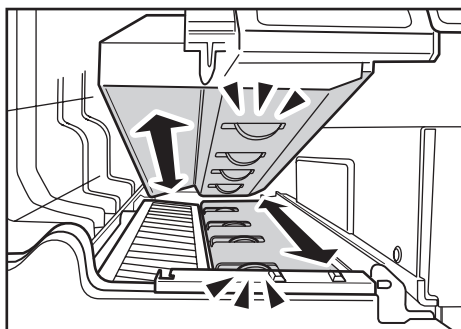
DVX005

3. Open the guide board (Rb3) and clean the rollers and guide board.

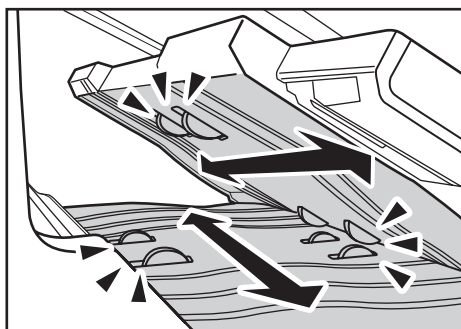
DVX006

4. Open the guide board (Rb5) and clean the rollers and guide board.

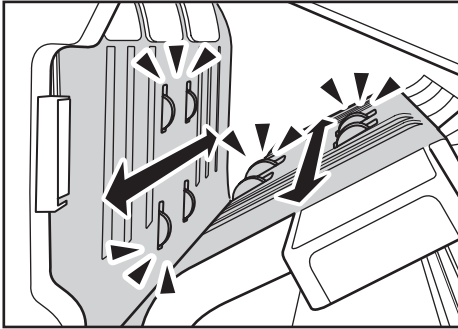
DVX009

5. Open the guide board (Rb4) and clean the rollers and guide board.

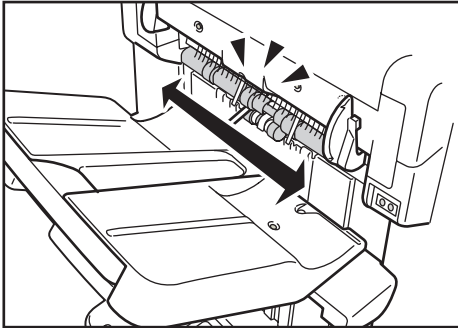
DVX007

6. Lower the shift tray and clean the guide board and rollers through the paper exit of the finisher shift tray.

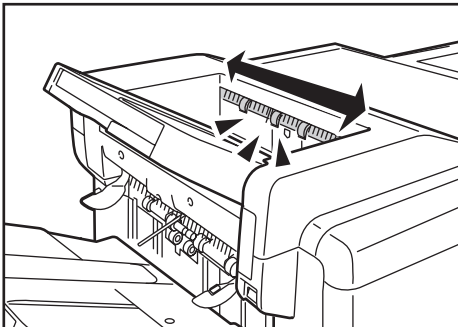
DVX008

7. Clean the rollers through the paper exit of the finisher upper tray.

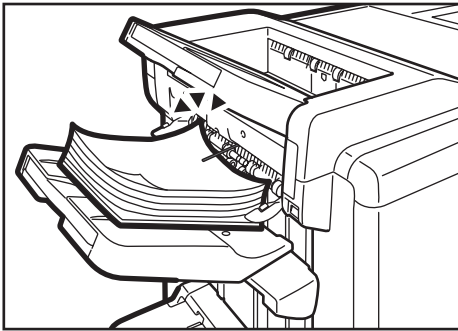
Sheet end curling

If curled sheets continued to be delivered and stacked, these curled sheets may cause both ends of the stack of delivered sheets to be swollen. If this occurs, the paper delivery fan touches the swollen portion, causing succeeding sheets to collide with the sheets already in the stack and be added to the stack obliquely.

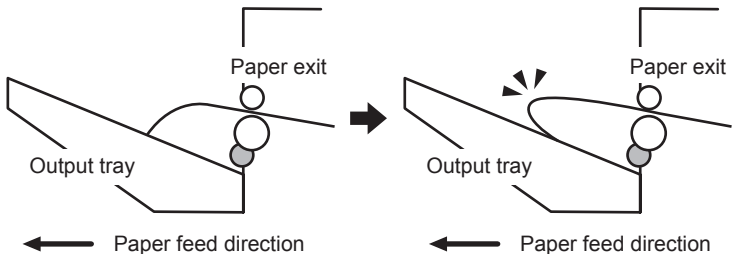
Sheet buckling

The tip of an easily-bent sheet may hang down as it is delivered. Depending on the angle at which the tip is hanging, the sheet may be caught on the shift tray, preventing it from being fed. As the opposite end of the sheet is pushed forward, the tip may be curled.

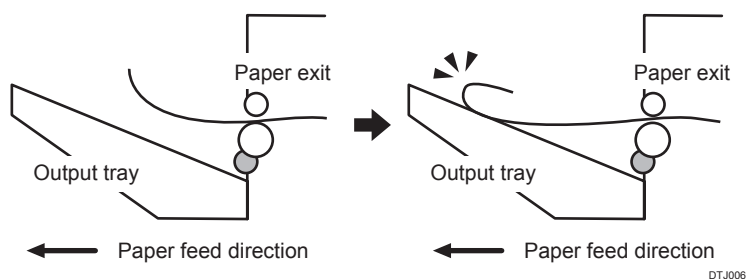
Tip curling-up

A thin, easily-bent sheet may be delivered with its tip bent upwards and curled due to air resistance.

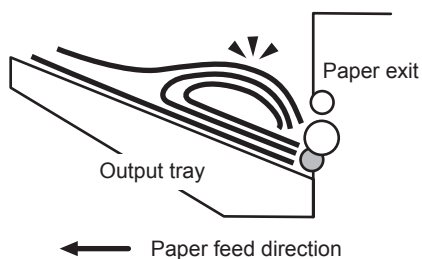
CEZ594

Sheet bending

The leading edge of the delivered sheet bends upward and backward.

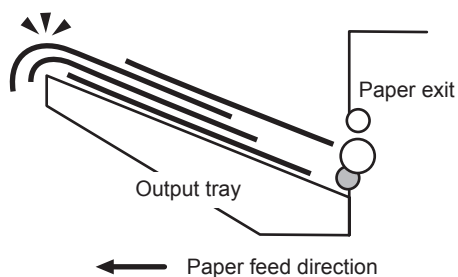
CEZ595

One sheet pushing out another

Because of high paper friction, the delivered sheet may get stuck and push out other sheets of paper.

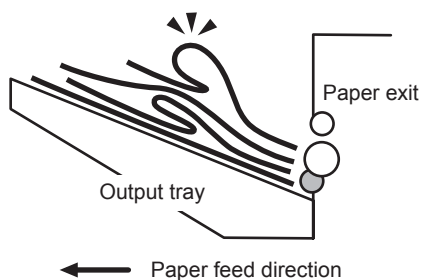
CEZ596

Paper deflection

Because of high paper friction, the delivered sheet may arch up and become crimped.

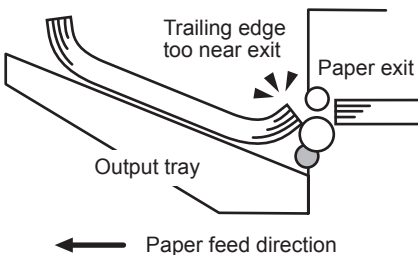
CEZ593

- There is a tight curl on a delivered set of stapled sheets.
- Limp paper such as thin or recycled paper is used.

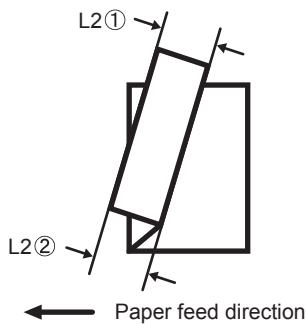
CEZ531

For example, in the following illustration, the dimensional difference between the top (L2[2]) and bottom (L2[1]) edges is a deviation.

<Folding deviation sample of L2 for Z-fold>

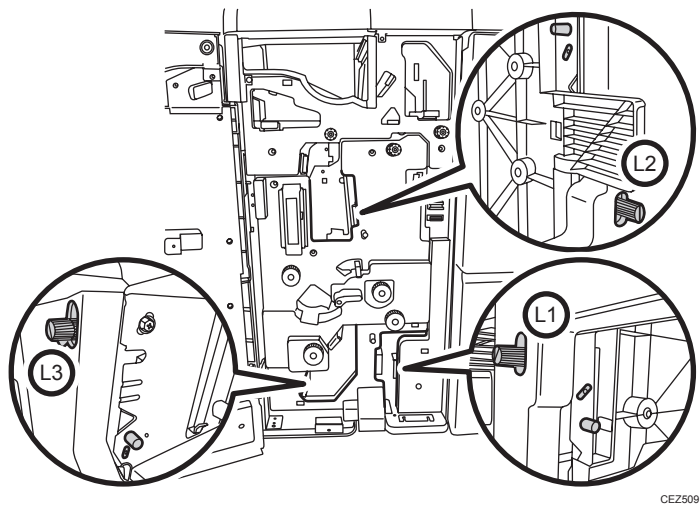
CEZ509

The multi-folding unit has three adjusting screws (L1, L2, and L3) to adjust deviation.

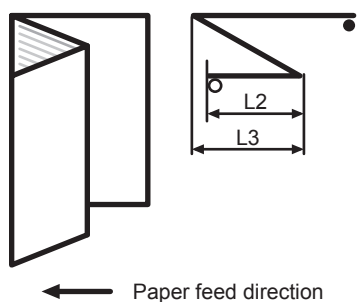
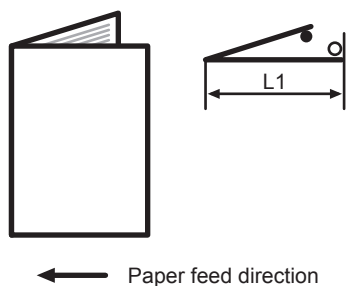
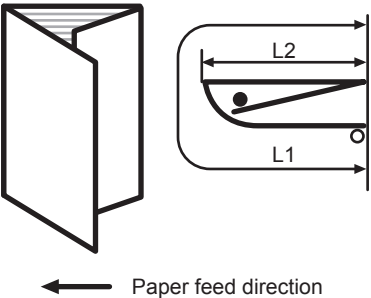
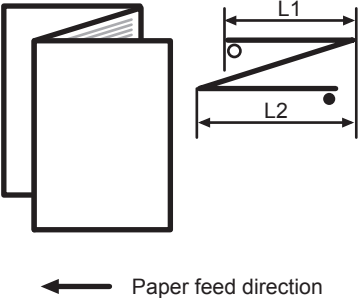
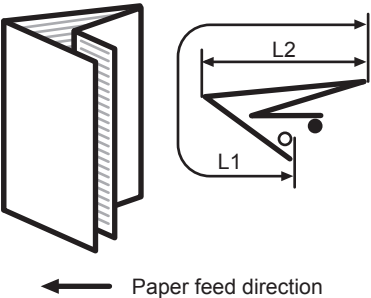
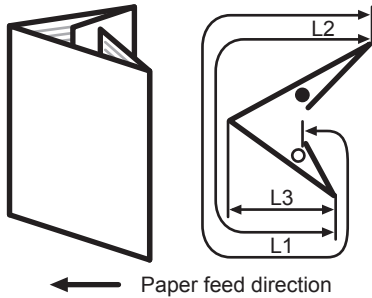
The screws adjust the folding deviations of the following parts:

The ○ mark indicates the leading edge (relative to the paper feed direction), and the ● mark indicates the trailing edge.

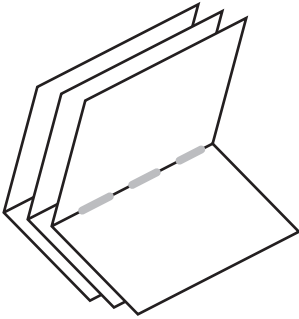
CEZ571

If multi-sheet folding is performed after a large number of Z-folds have been performed, the tip of the blade used for the multi-sheet folding may be soiled, resulting in soiled paper.

This will produce paper soil of 1-3 cm (0.4-1.2 inches) in width (equal to the width of the blade) in the fold in the center of paper.

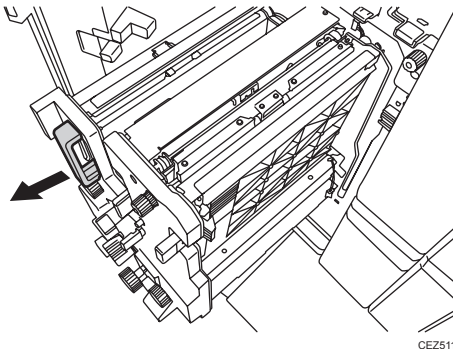
CEZ511

1. Open the front cover of the multi-folding unit.
2. Pull the multi-folding unit out.

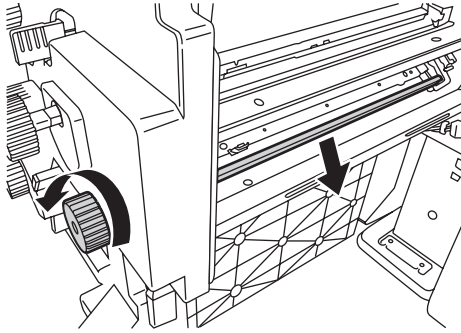
CEZ512

3. Turn the N11 dial counterclockwise until the blade appears.

The blade is located in the right part of the multi-folding unit.

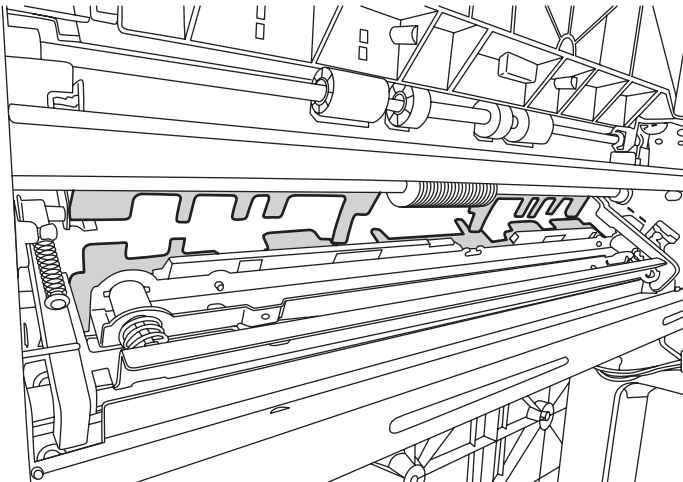
CEZ513

4. Wipe the tip and top of the blade with a soft dry cloth.

Be careful not to damage the blade.
